Research Paper

Research analysis on issues and risks associated with balcony defects

Date: 6 January 2023

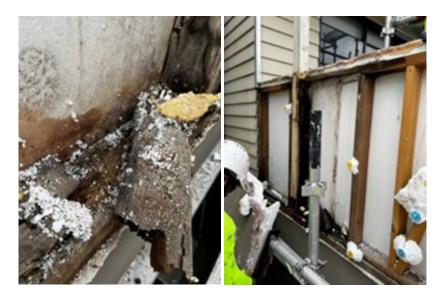
Figure 2 Example of water ingress affecting a balcony on a funded building in the CRP (comprising 26 sole occupancy units).

Above left: Bottom plate of timber framed balustrade.

Above right: Timber framed balustrade showing water damage coming through capping.

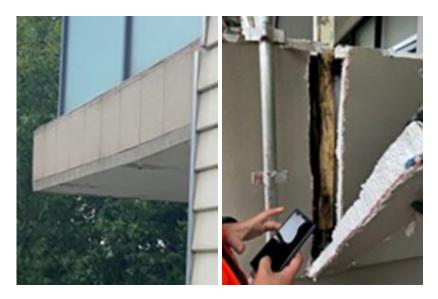
Above left: Water damage to soffit evident from balcony above.

Above right: Timber framing to balustrade rotten from water ingress. No sarking sitting behind EPS cladding.

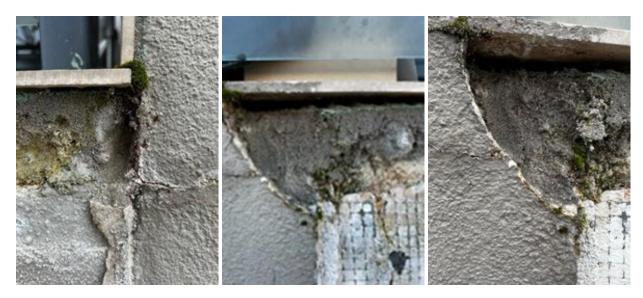
Above left, centre and right: Tiling not sitting flush on concrete slab. No screed or membrane present. Moss and mould evident from pooled water.

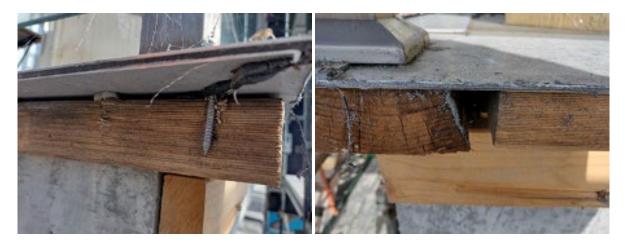
Figure 3 Example of balcony with structural issues on a funded building in the CRP (comprising 35 sole occupancy units).

Above left: The fixings into the timber supports missing the timber completely.

Above right: The timber supports are showing signs of degradation from water damage. Also noting this post is cantilevered over the slab edge.

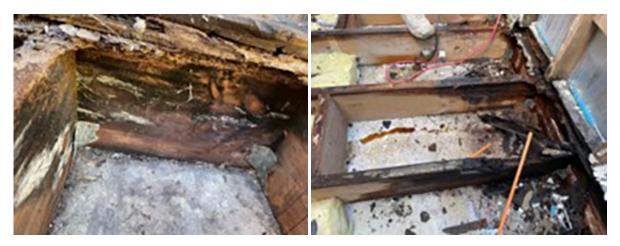
Figure 7 Example of insufficient or no waterproofing affecting a balustrade on a funded building in the CRP (comprising 12 sole occupancy units).

Above: Upper level balcony; tiling removed to show rotten timber to balcony structure, and

bottom of apartment stud wall.

Above: Underside of balcony; substrate with significant rot from water and timber joists showing rot.
