Office of the Chief Investigator  
Transport and Marine Safety Investigations

Rail Safety Investigation  
Report No 2007 / 09

**Level Crossing Collision  
V/Line Passenger Train 8042 and a Truck  
Near Kerang, Victoria  
5 June 2007**

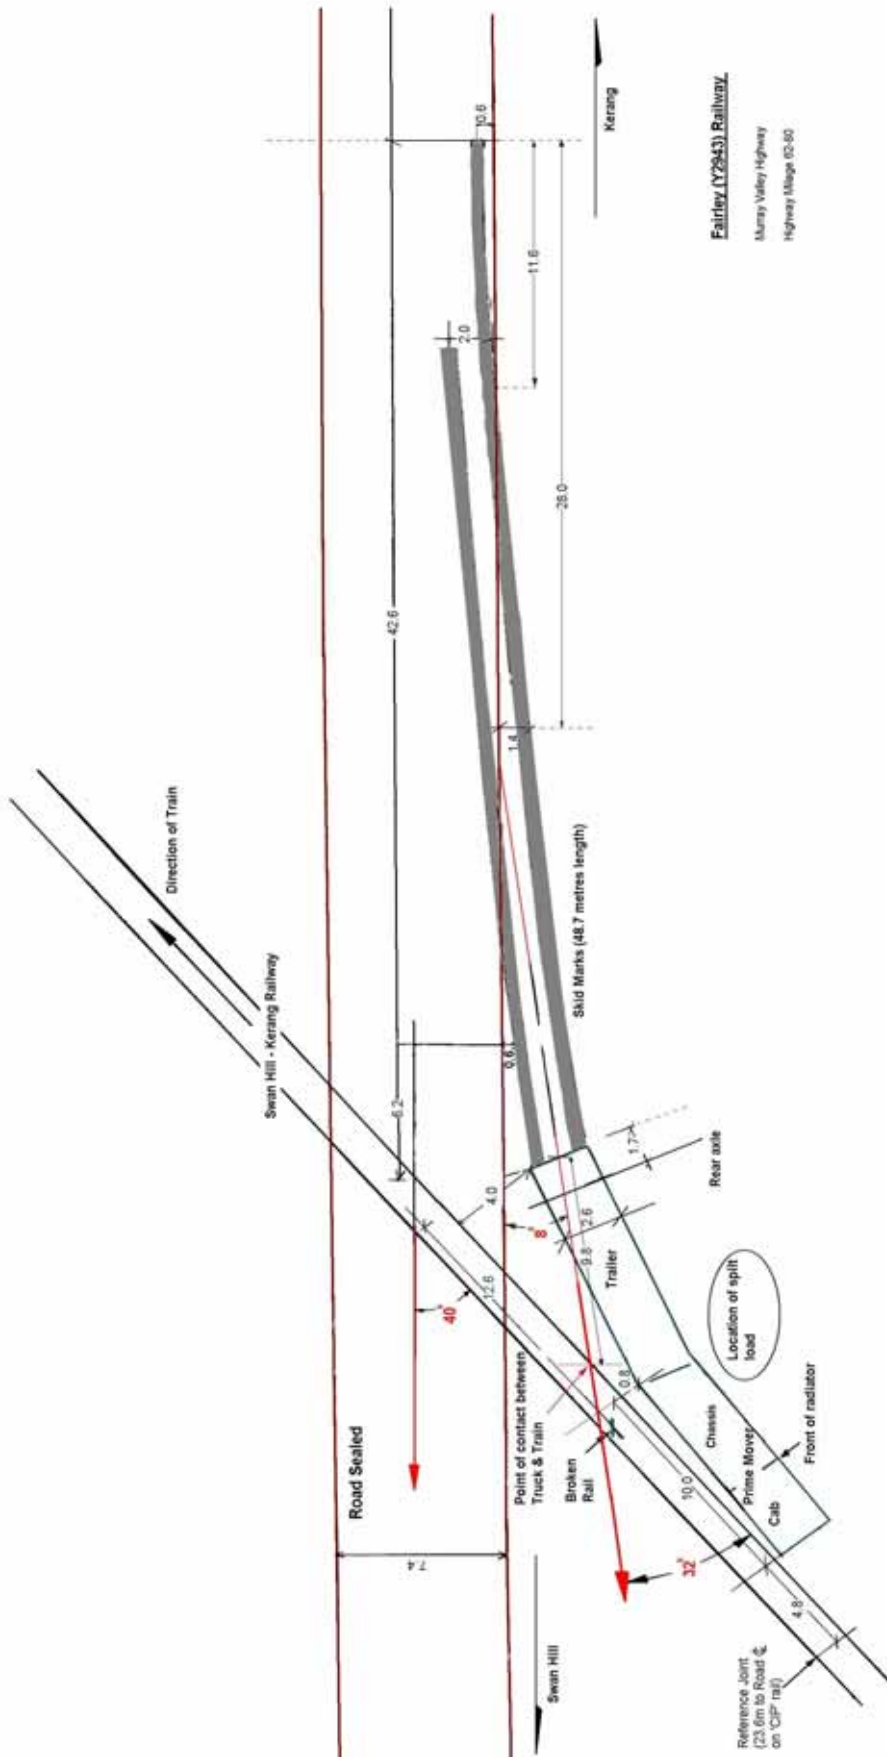
Figure 3. Track of truck to point of impact

Figure 3 details the final path of the truck prior to collision and coming to rest. The skid marks on the road indicate heavy braking of the truck prior to the collision. The marks commenced approximately 49 metres prior to the rail track and veered to the left off the bitumen road surface onto the loose road surface and aligned with the trailer wheels at the truck's resting position. The skid marks are considered to have come from the locking of the trailer wheels, with the prime mover braking continuing to be effective under ABS action.

The Murray Valley Highway intersects the rail line at an angle of about 40 degrees. It was estimated from the tyre skid marks that the truck deviated about eight degrees to the left of the highway. The angle of impact between the truck and the train was therefore estimated to be about 32 degrees. The impact angle is also consistent with the location of the broken rail as shown in Figure 3.

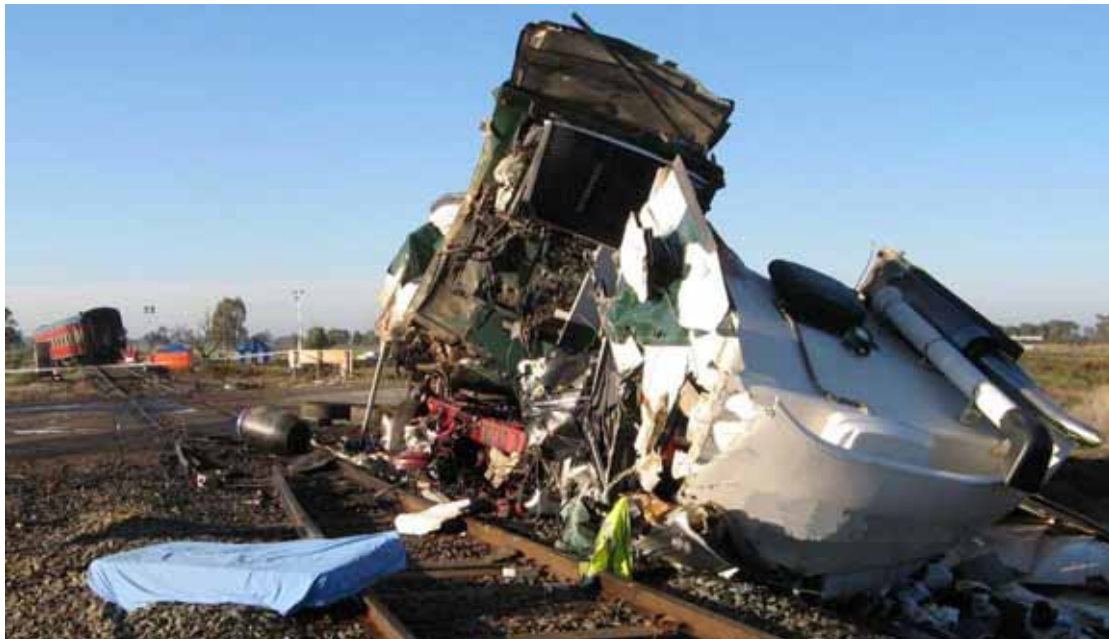
**Figure 4. Truck as found with cab rotated forward, car BN19 in background.**

The right side of the prime mover was severely damaged with the front and drive wheels dislodged. One wheel and a separate tyre were found on the opposite side of the highway.

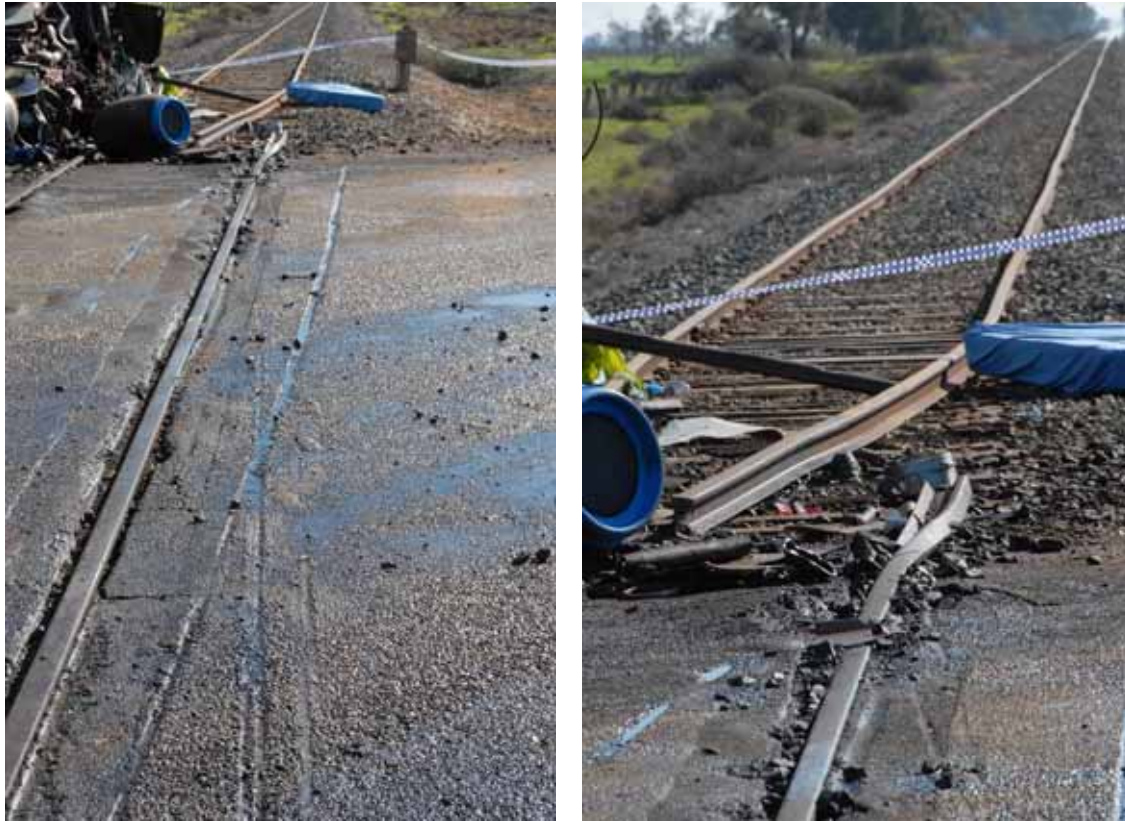
The Up rail (the rail on the north side of the crossing) was broken near a weld in the rail 12.6 metres prior to the centre of the crossing. The road surface at the crossing showed a number of rail wheel flange marks, some indicating that a wheel may have re-railed after initialing derailing. The road surface was covered in diesel fuel.

Figure 6. Looking towards Swan Hill, derailment marks (left) and broken rail (right)

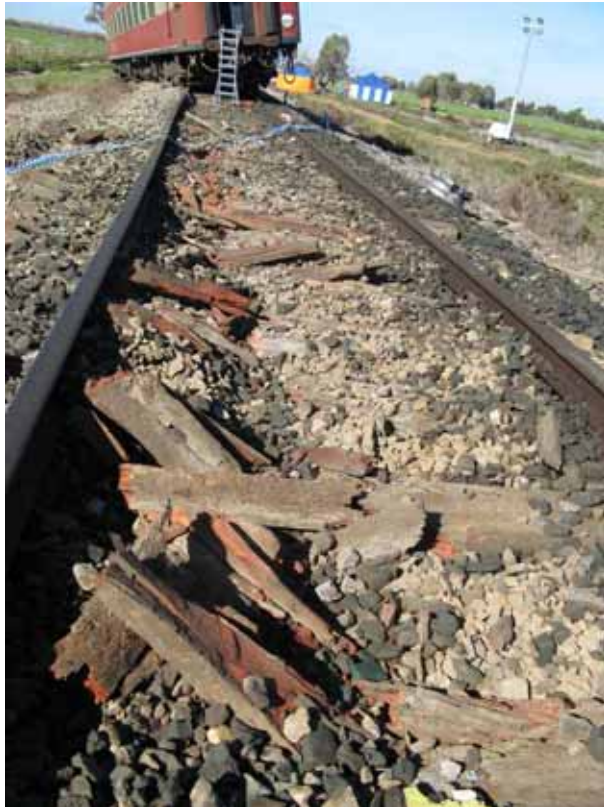
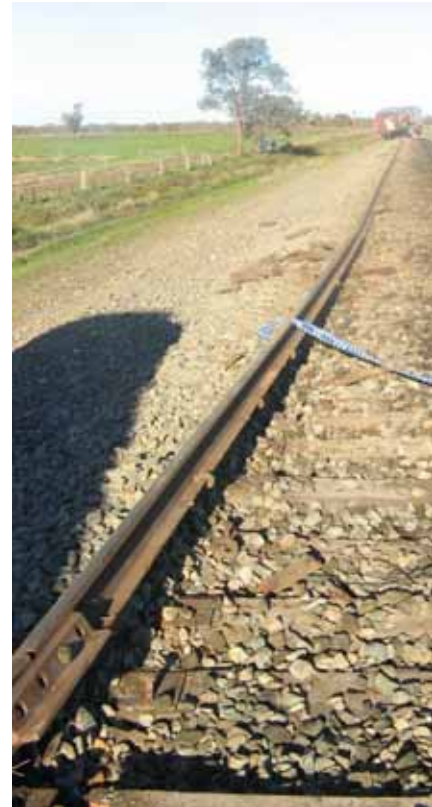
To the east of the crossing, the track sustained significant damage. A significant number of timber sleepers between the crossing and where BRN20 came to rest were either destroyed or damaged. The rail after the crossing was also dislodged from the sleepers and distorted (Figure 7). The crossing relay box situated on the north side of the track about 36 metres from the crossing was damaged.

Figure 7. Sleeper damage (left) and rail displacement (right)

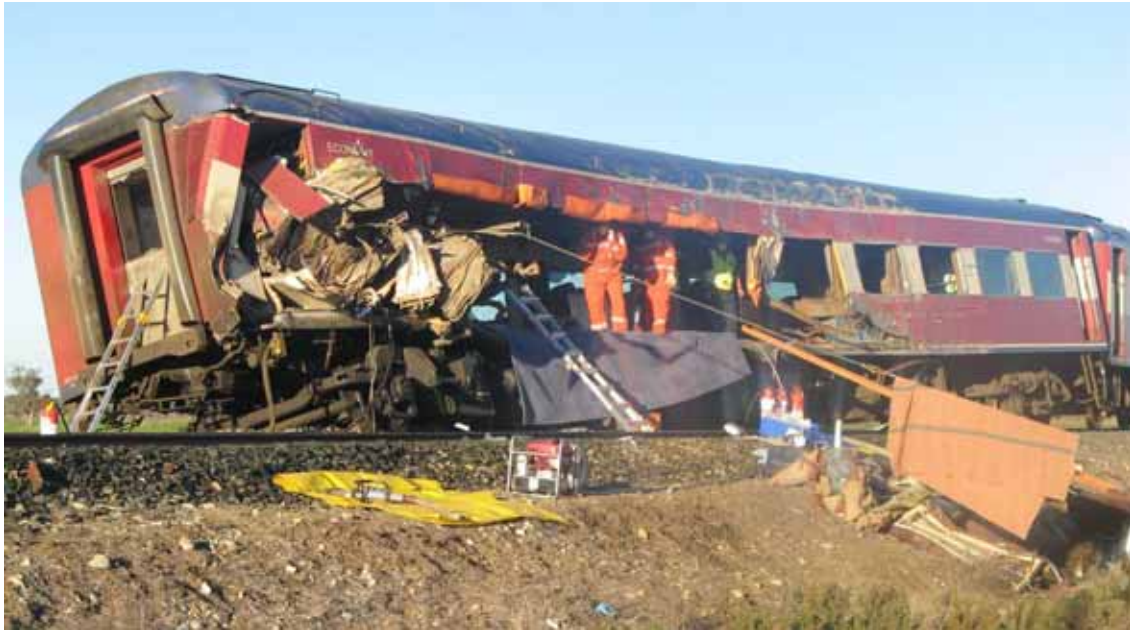
Of the two passenger cars, BRN20 suffered the more severe damage and incurred the majority of passenger casualties. BRN20 suffered extensive body shell damage on its A side, extending from just forward of the second window from its leading (East) end through the remaining length of the vehicle. Moving towards the rear of the car, the severity of damage progressively increased with full penetration of the body side from sole bar (floor) to cant rail (top of windows) commencing about 10 metres back from the east end.

Figure 8. An overview of damage to passenger car BRN20

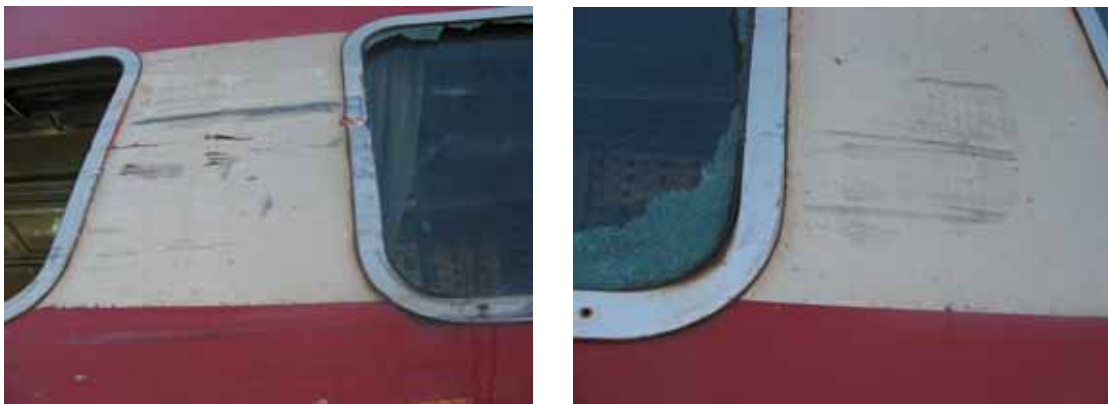
The forward-most body side damage consisted of initial scuffing, progressing to heavier gouging, loss of windows and roof side damage above the windows. The forward most scuff marks were consistent with initial contact with the truck prime mover cab. The subsequent deeper marks and window damage were similarly consistent with progressive impact with the truck cab.

Figure 9. Initial scuff mark forward of the second window (right) progressing to window frame notch and gouging (left).

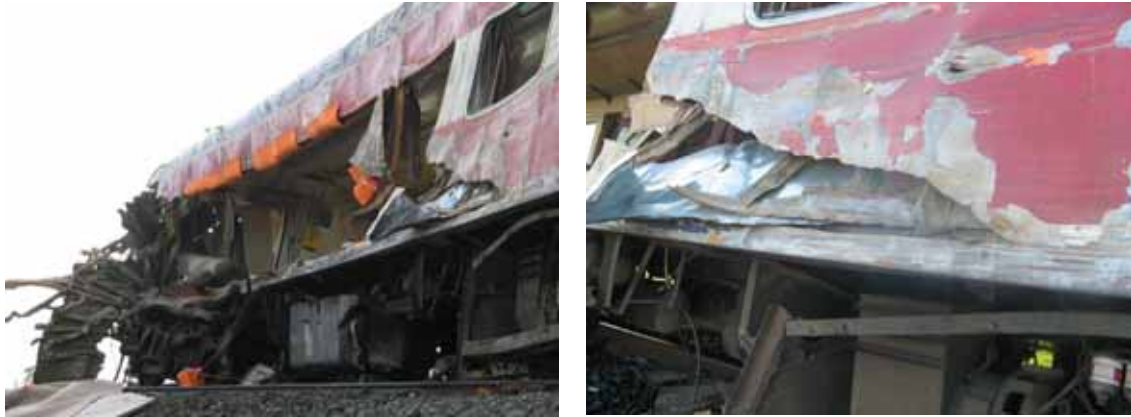
Penetration of the body side commenced with tearing of the sheet metal side panel just above the floor level. This tear progressively widened to the full height loss of the body side between sole bar and cant rail. The body-side panelling was concertinaed and pushed to the rear of the car. The initial tear and subsequent ripping of the body side was consistent with an override of the carriage sole bar by a flat rigid body, most likely to have been the tray of the truck trailer.

**Figure10. Initial tear (right) progressing to substantial loss of body side of BRN20**

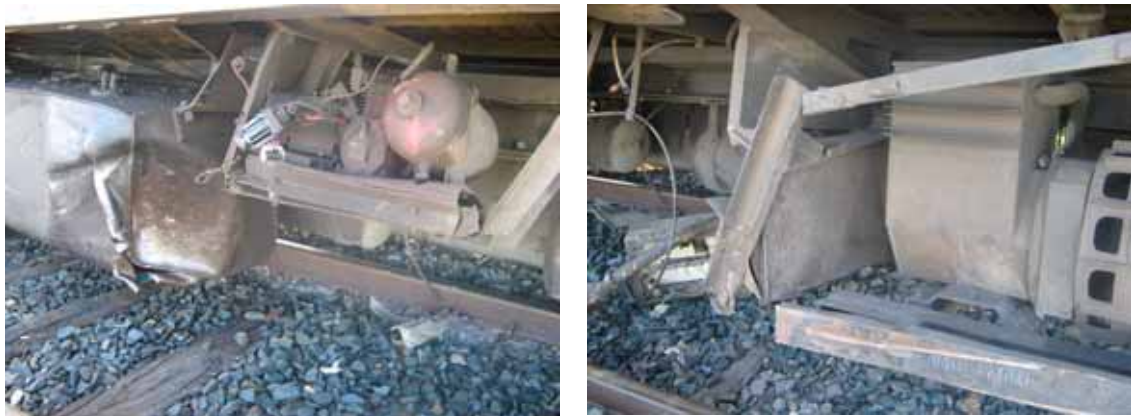
Damage to underframe equipment on BRN20 commenced from a similar point to the body-side damage. A number of items were damaged including the fuel tank, which was breached. The nature of the damage to underframe items on the A side of the car was consistent with impact by the lower parts of the truck, most probably wheels and lower structures of the prime mover.

**Figure 11. Underframe damage including breached fuel tank (left)**

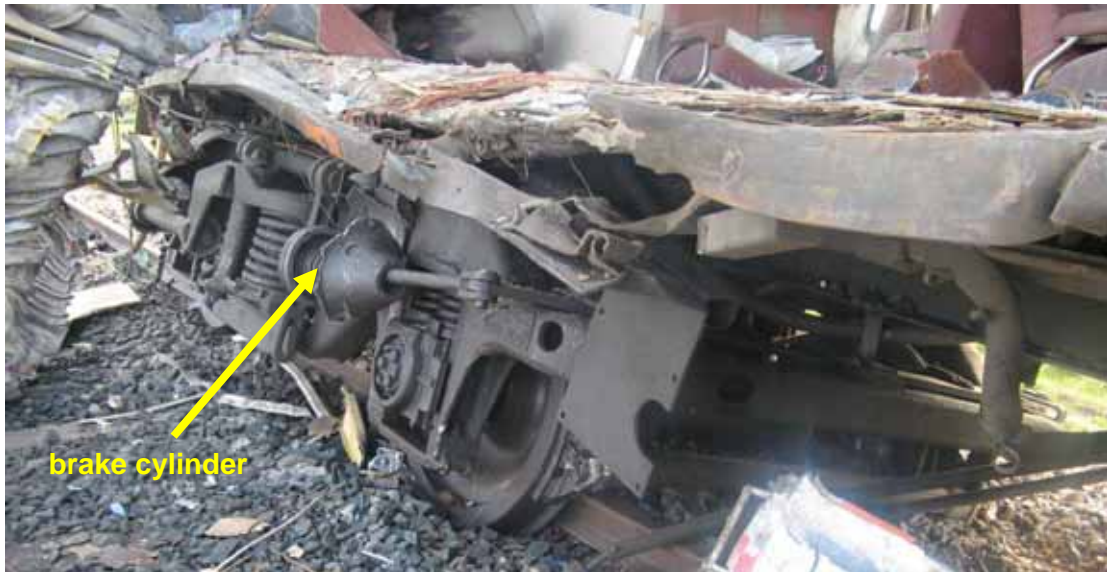
Damage to the trailing bogie of BRN20 included the loss of the brake cylinder casing, consistent with heavy impact with the truck, most probably the low and heavier structures of the prime mover chassis (Figure 12).

**Figure 12. BRN20 trailing bogie, note damage to brake cylinder**

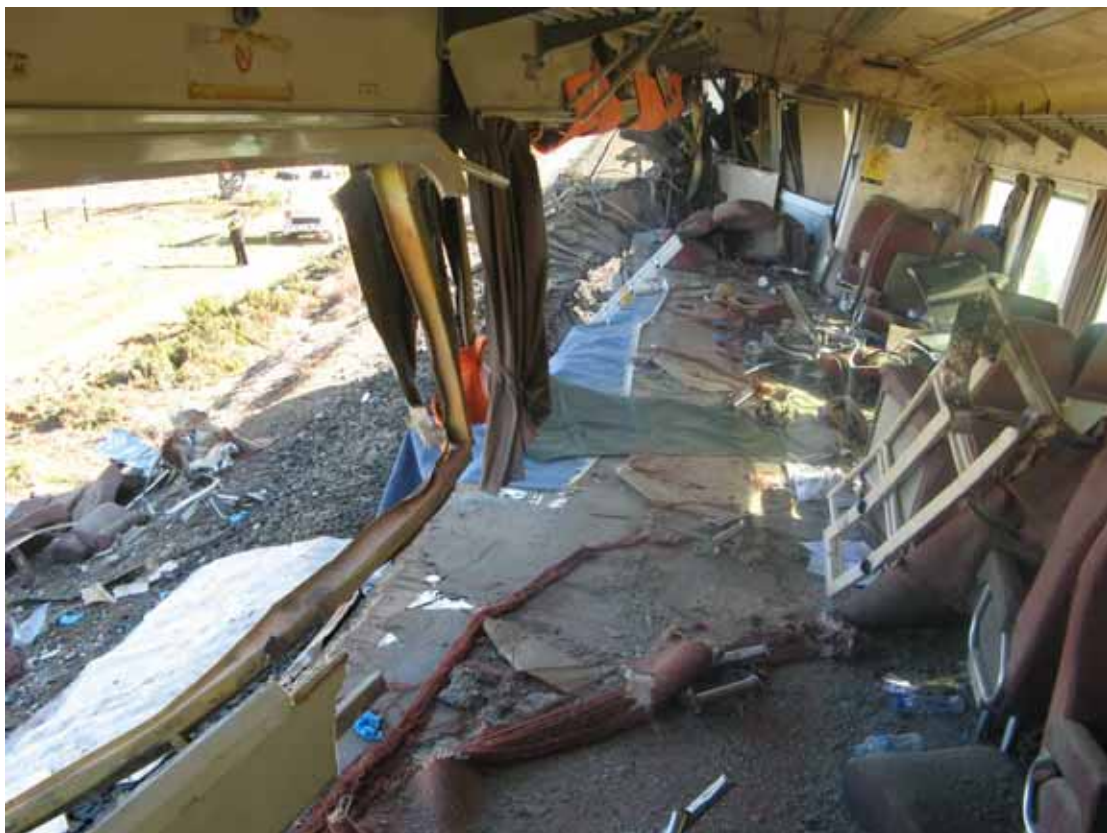
The damage to the interior of BRN20 was extensive (Figure 13). On the A side of the car, seat set 35/36/37 was dislodged and all seats to the rear of this set, from seat 42 back, were gone. On the B side, back-to-back seat sets 68/69 and 70/71 were gone, but all other seating was in-situ.

**Figure 13. Internal damage to BRN20, noting that dislodged seats had been removed by emergency services to assist the recovery of injured passengers.**

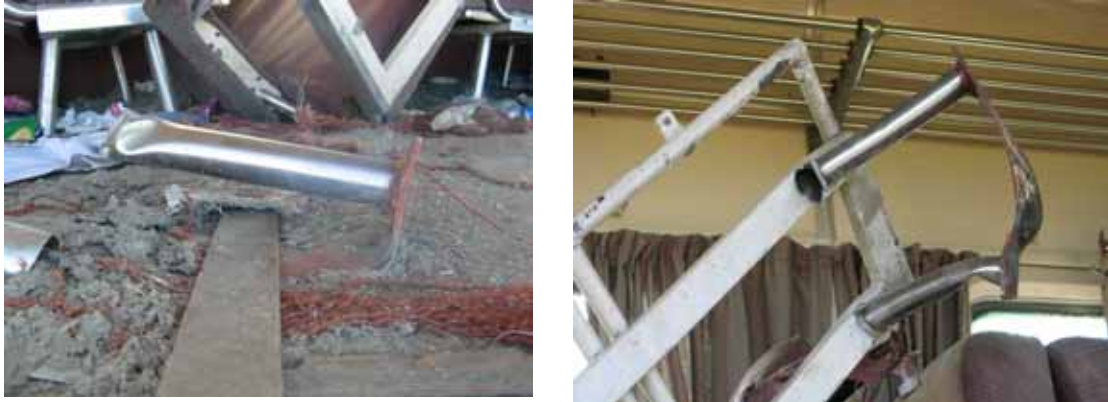
The damage to seating included the failure of seat-to-floor connection bolts, bending of seating base plates and ripping of seat legs from seat frames. Failures were consistent with impact from an external object in the direction opposite to train travel, most probably the trailer of the truck.

**Figure 14. Bent base plate (left) and failure of upright to frame connection (right)**

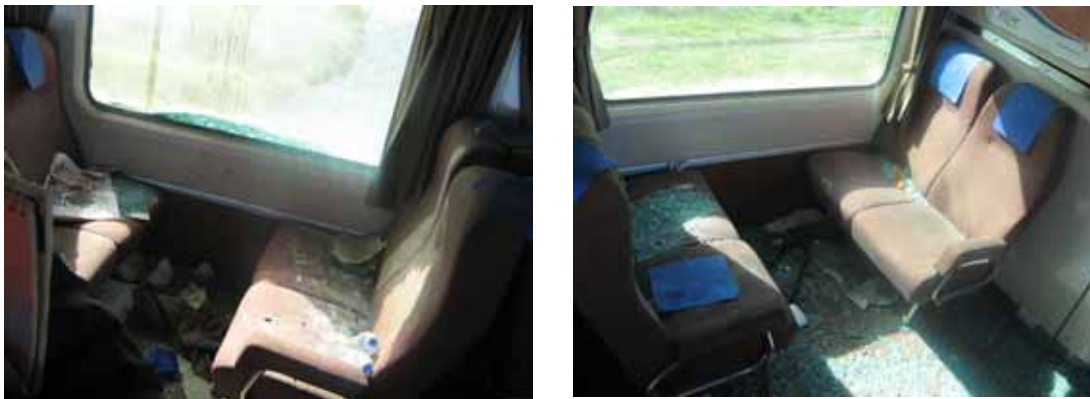
Glass fragments from shattered windows were found throughout the compartment. The loss of several inner panes from the B side of BRN20 was consistent with impact damage from loose objects within the compartment.

**Figure 15. Glass fragments, seating bay 23/24/28/29 (right) and bay 30/31/38/39 (left)**

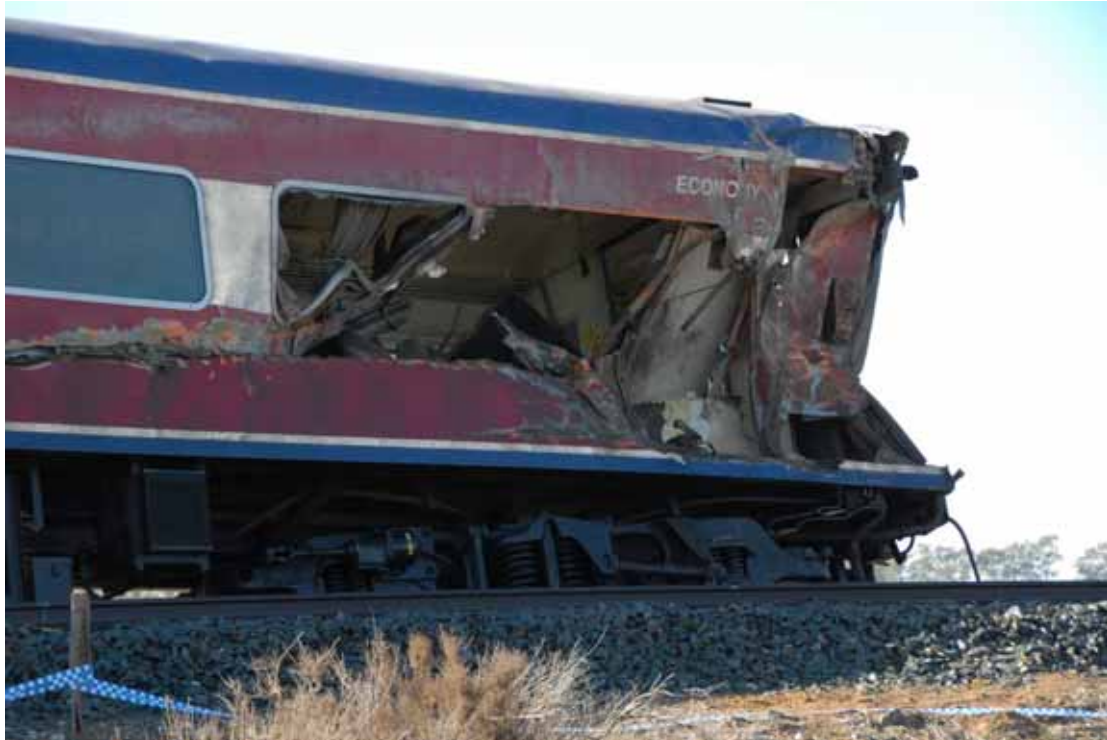
BN19 suffered extensive side body and end damage at its leading (East) end on the A side. The damage included the loss of the corner end post, severe deformation of the outer gangway end post and extensive end and body side deformation. The more extensive body side damage extended for about five metres before leading to a 2.5 metre exit tear.

Figure 16. Overview of damage to BN19 leading (East) end

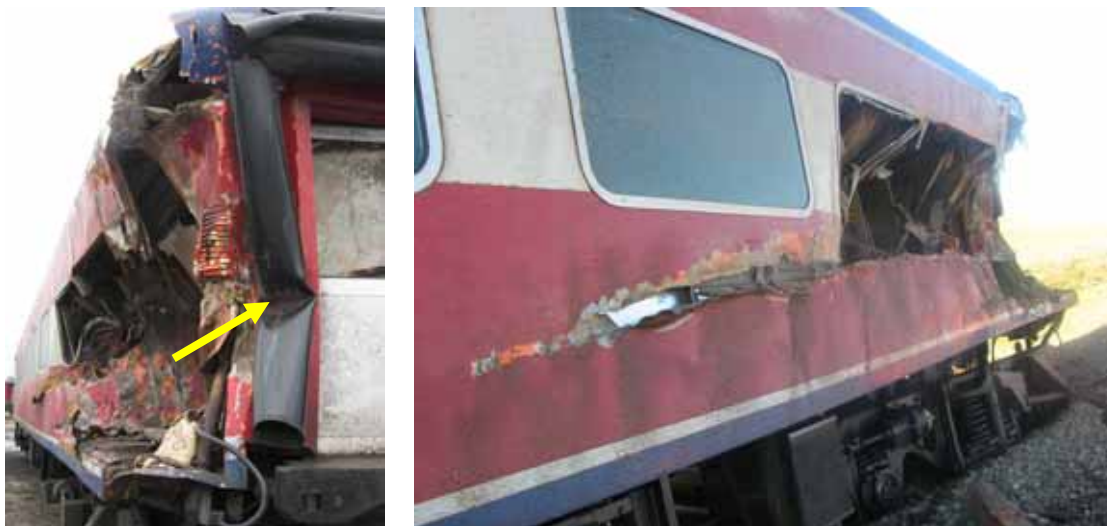
Figure 17. Initial point of impact on BN19 (left) and exit scar (right)

The nature of the body damage to BN19 is consistent with a flat rigid body, most likely the tray of the truck trailer, impacting the front corner of the car causing the deformation to the gangway end post and then proceeding into the passenger compartment before exiting the space via the exit scar. The outward rolling over of the bottom edge of the exit scar suggests the tray was drawn out and down as it exited the body side.

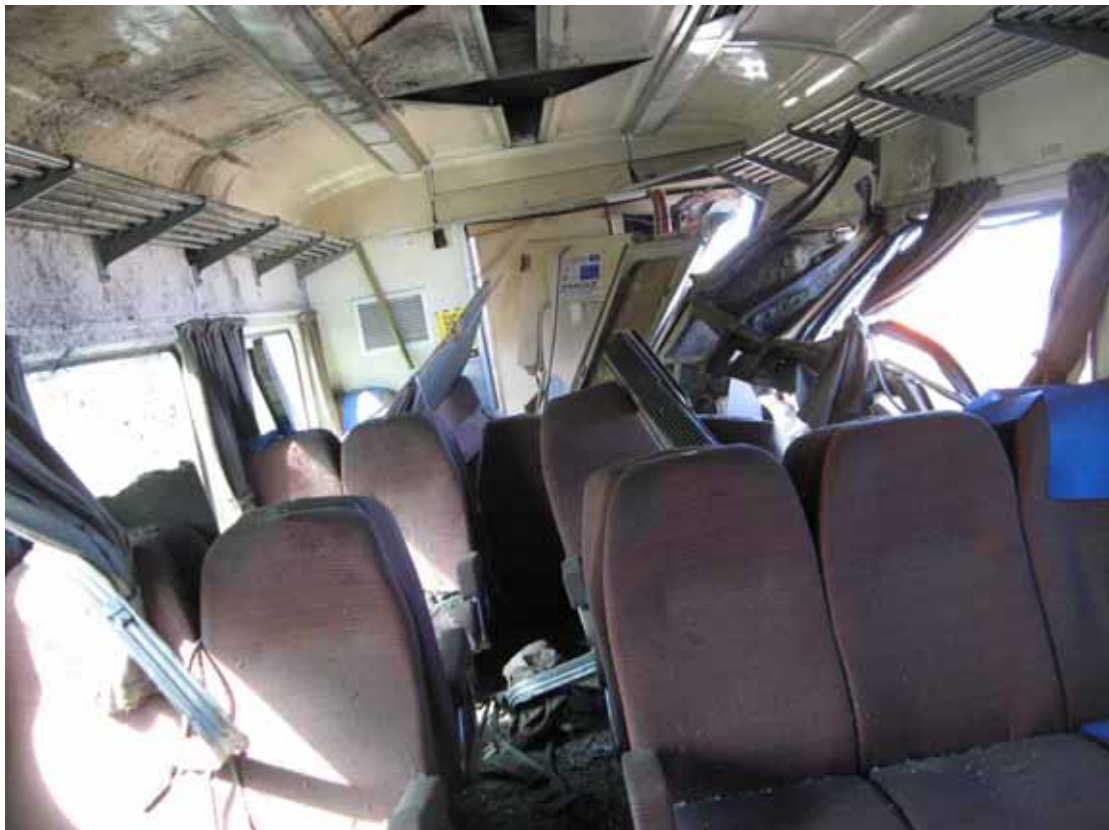
The damage to the interior of BN19 was confined to the leading end of the car and included seating damage, window debris and truck components (Figures 18, 19 & 20).

**Figure 18. Interior of BN19 looking forward**

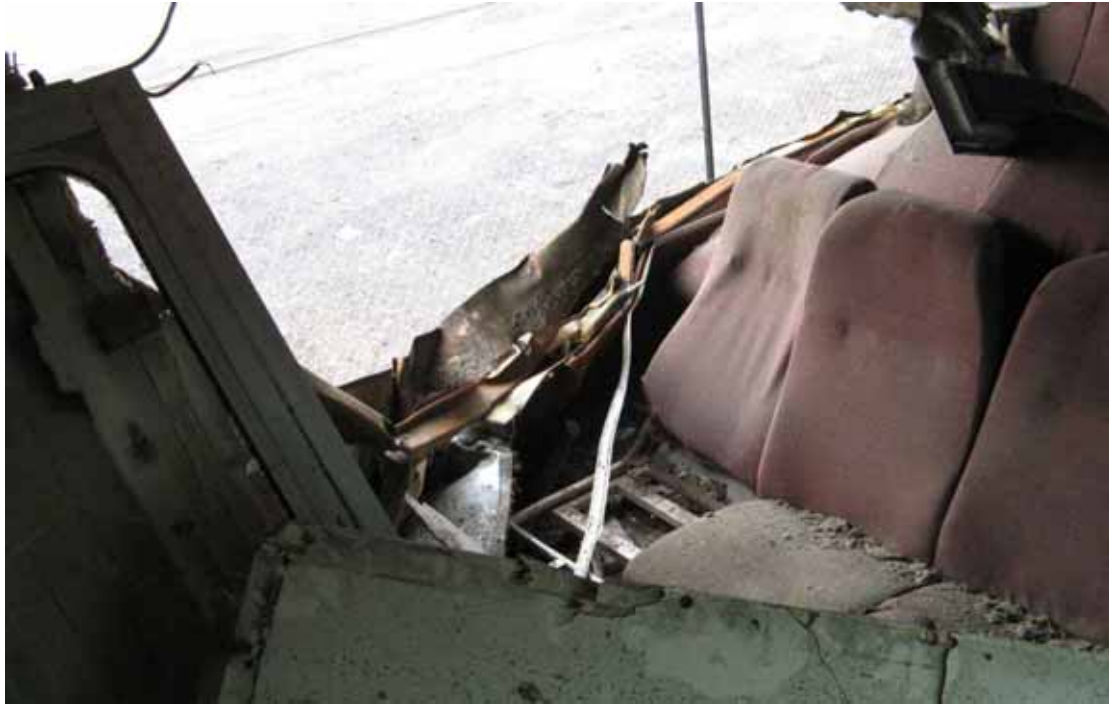
**Figure 19. Damage to seat 5 (adjacent to window) in BN19**

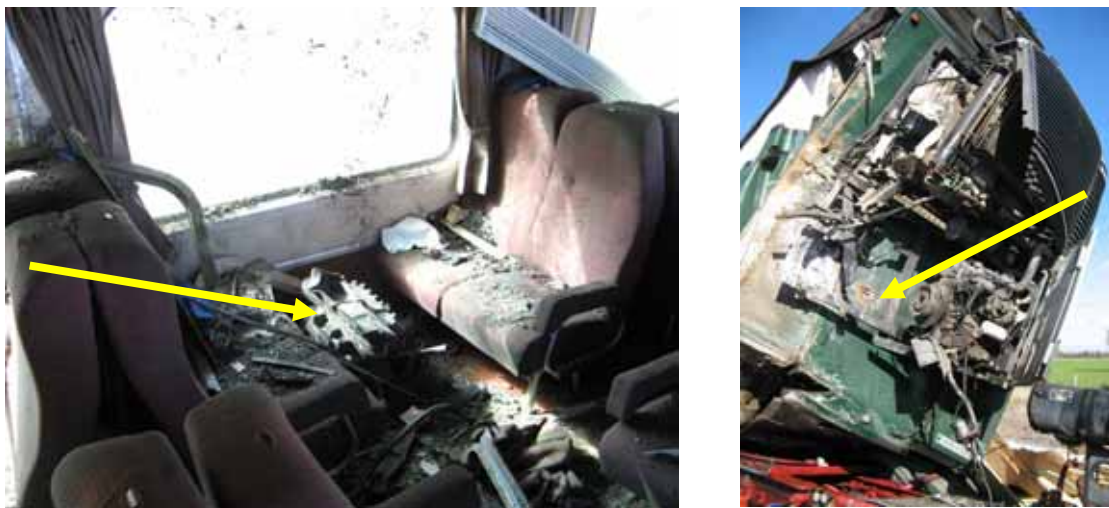
The trailer refrigeration compressor was found between seats 10 and 19 on the B side of BN19 having been dislodged from its mounting position at the front of the trailer. The failure of the mounts and final location of the compressor are consistent with the truck trailer making heavy contact with the front corner of BN19.

**Figure 20. Truck compressor at bay 10/11/18/19 (left) and mounting position (right)**

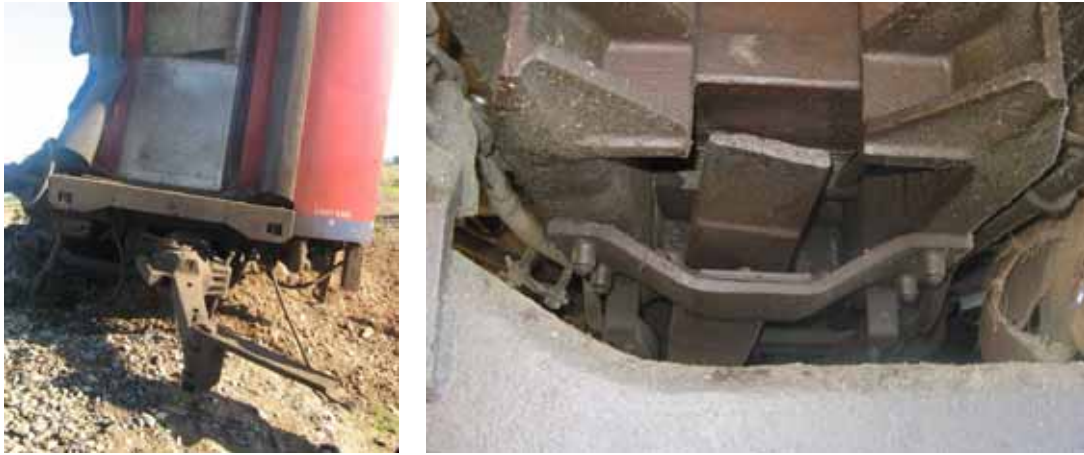
Vehicles BRN20 and BN19 parted following the fracture of the draft yoke beneath the rear end of BRN20, as shown in Figure 21.

Figure 21. Fractured draft yoke at site, forward end of BN19 (left) and rear of BRN20 (right).

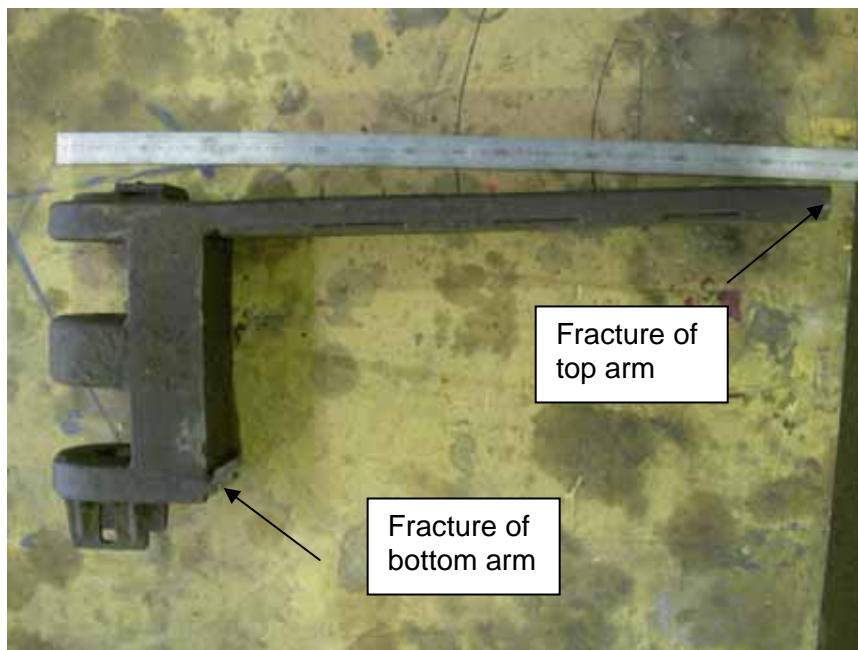
The remains of the fractured draft yoke attached to BN19 were removed from the site and subjected to metallurgical testing to assist in the determination of the mechanism of fracture and to identify any pre-existing condition which may have contributed to the fracture of the component. The component was found to have fractured at two locations as shown in Figure 22.

Figure 22. Tested draft yoke

The primary fracture mode of the top arm appeared to be a tensile overload in moderately ductile material with no evidence of any progressive cracking mechanism present prior to failure. Two distinct fracture origins were observed on either side of the arm consistent with predominantly axial loading at the time of failure. Both fracture origins corresponded with the location of an original casting discontinuity.

The bottom arm showed a similar set of fracture features in the bulk section (overload in moderately ductile material) with the fracture origin at a casting discontinuity at the upper right hand corner. Some evidence of fatigue-like propagation of the fracture on the corroded region was observed, but was not considered conclusive. The fracture direction was right to left, no evidence of bending was observed on the left hand side, hence the final loading was considered to be predominantly axial.

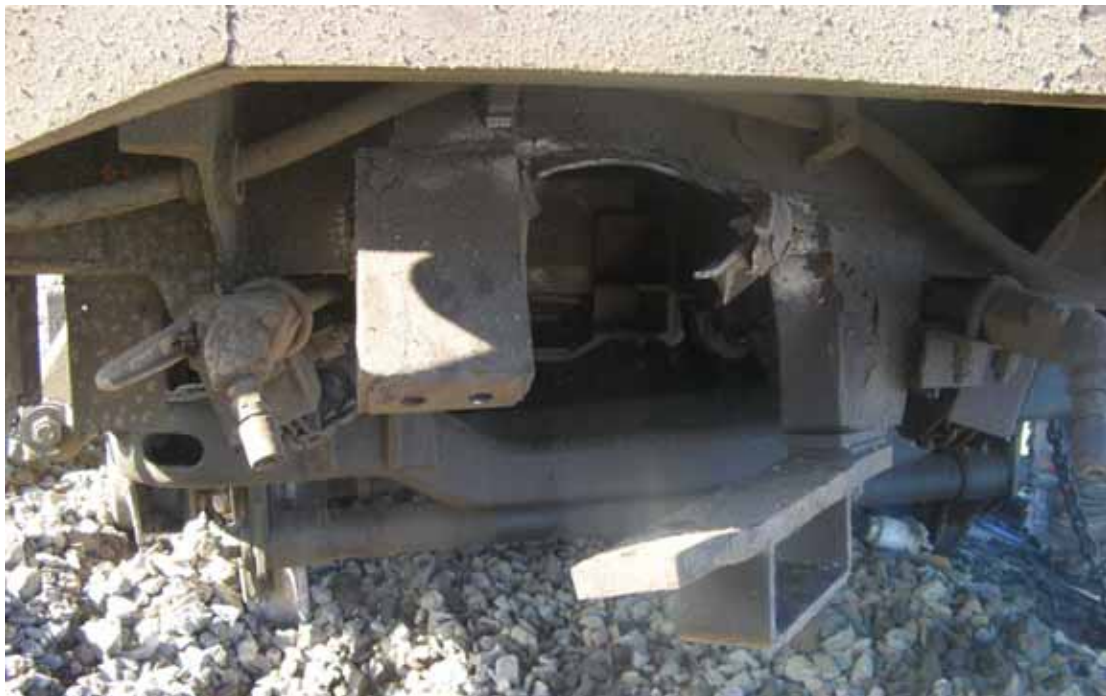
The striker plate at the rear of BRN20 was heavily distorted, indicating that the coupler shank had been forced beyond normal operational limits. The damage was consistent with the rear of BRN20 being displaced laterally to the north of the track, away from the impacting truck (Figure 23).

**Figure 23. Rear of BRN20 showing distorted and damaged striking plate**

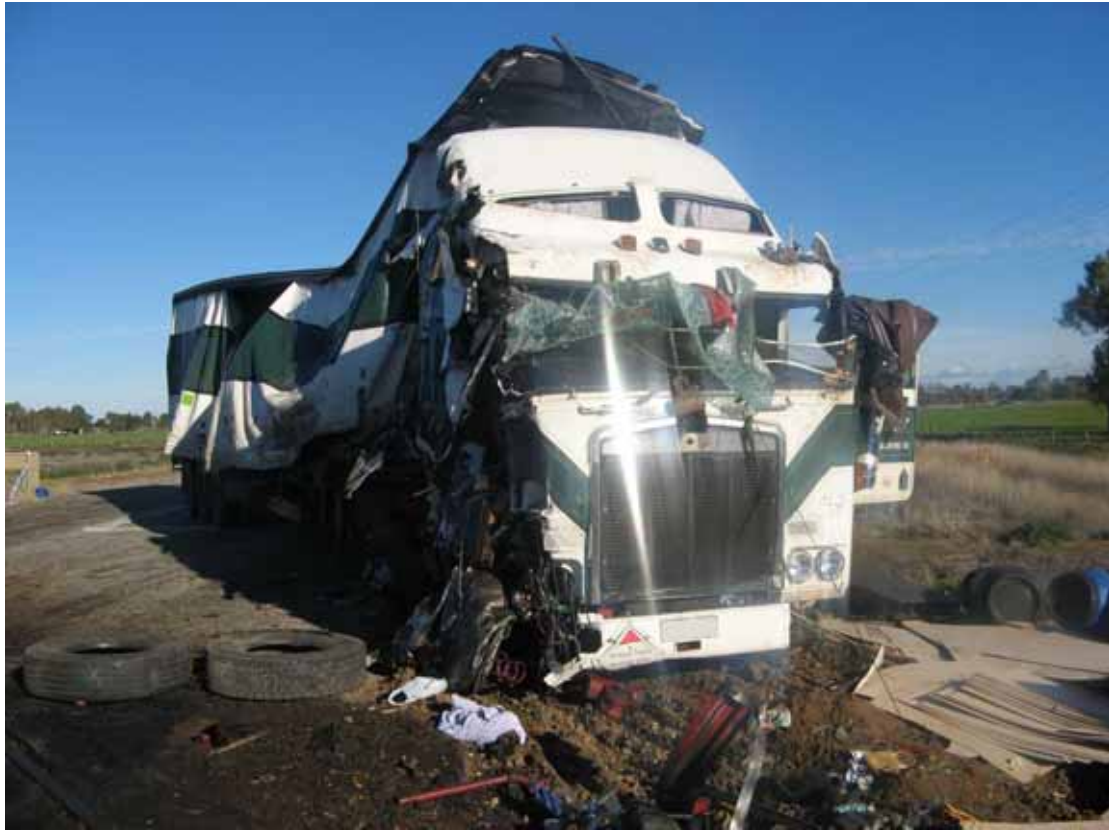
The prime mover cab sustained damage to the front right corner consistent with it being the first point of contact with rail car BRN20. During the impact sequence the tilt cabin of the prime mover fell forward. The prime mover was damaged beyond economical repair.

**Figure 24. Prime mover during recovery with cabin returned to normal position**

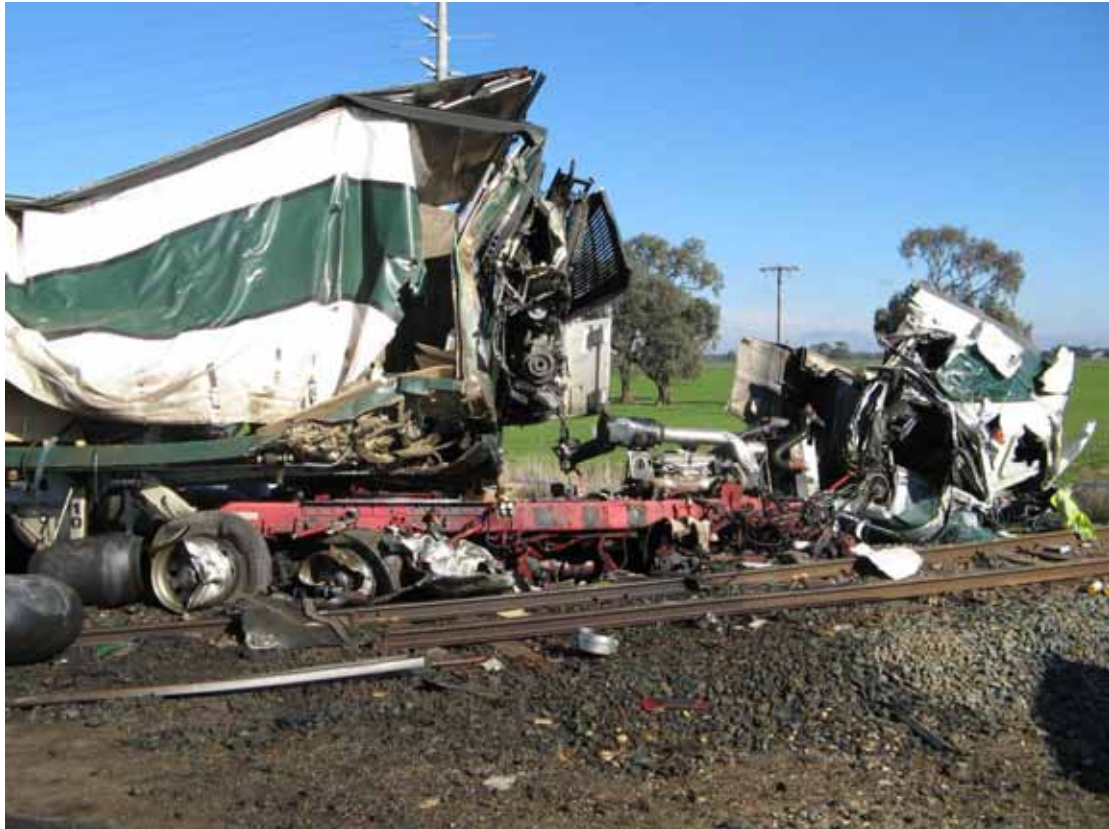
The trailer suffered extensive damage to its forward section, particularly to the front right side of the trailer tray and the refrigeration unit. Of note, as shown in Figure 25, is the upward bending of the front right corner of the trailer consistent with impact with and breaching of passenger cars BRN20 and BN19.

Figure 25. Overview of damage to prime mover and front, right of trailer

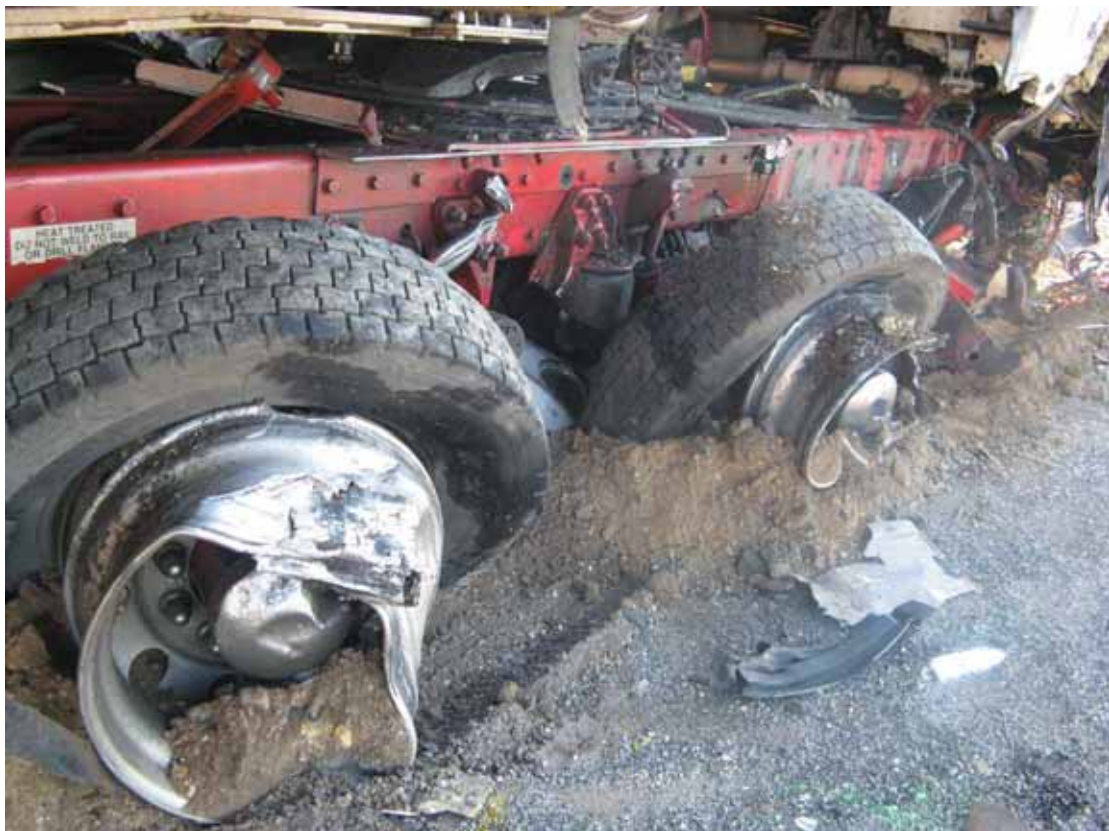
The right side of the prime mover suffered significant damage with the loss of the front wheel and heavy damage to the drive wheels. Damage was consistent with the lower parts of the prime mover coming into contact with the passenger car undercarriage.

Figure 26. Prime mover right side drive wheel damage.

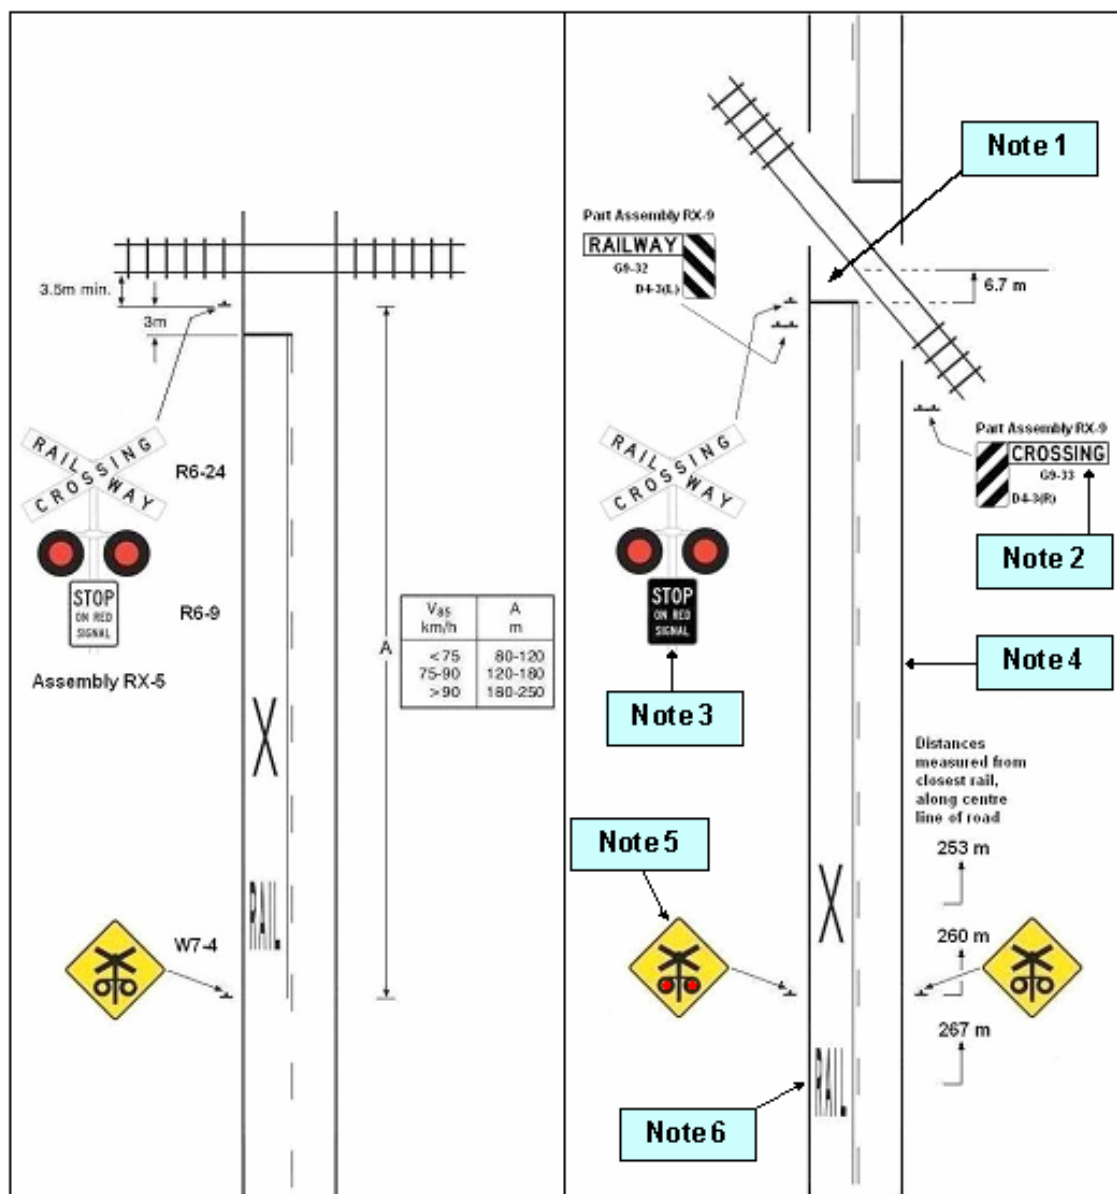
An examination of road markings and signage at the level crossing identified slight variations from the requirements specified in AS 1742.7-2007. The illustrations in Figure 31 show the minimum traffic control requirements as specified in this Australian Standard and the actual traffic control installation at the level crossing at the time of the incident.

Figure 31. Signage as required (minimum) by AS 1742.7-2007 (left) and signage as installed at the Murray Valley Highway level crossing at Kerang on 5 June 2007 (right)

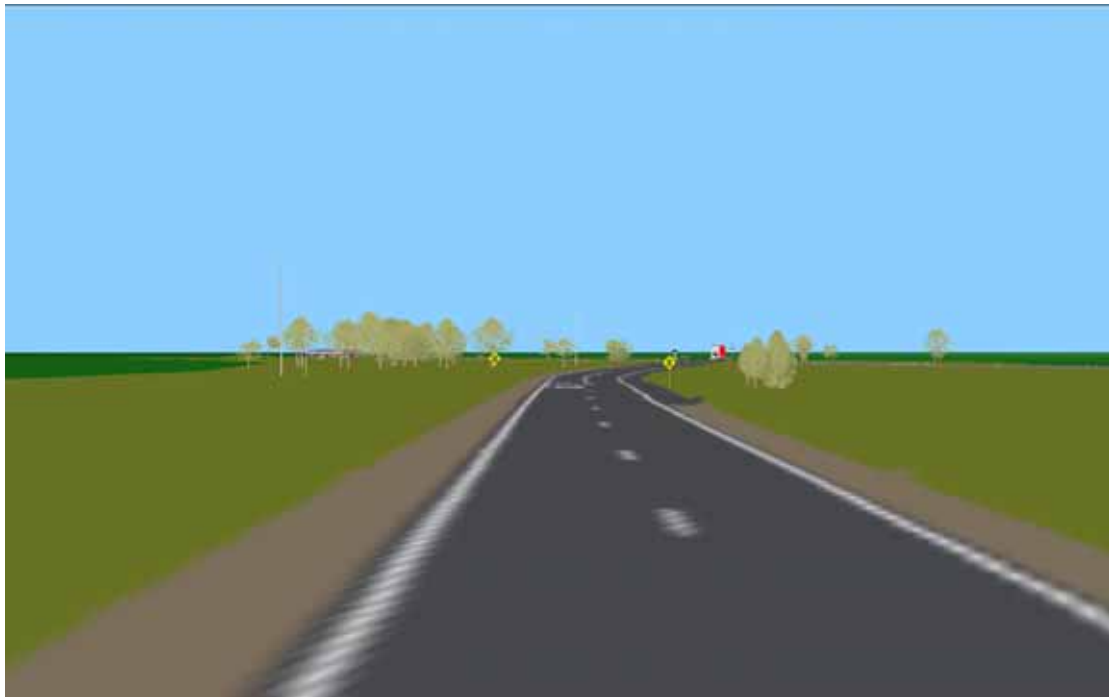
Figure 34 also indicates that the train appears as a relatively small object partially visible through the trees and may not have been detected by the truck driver.

**Figure 34. The estimated view from truck cab 360 metres from the level crossing stop line and 100 metres from the advance warning sign**

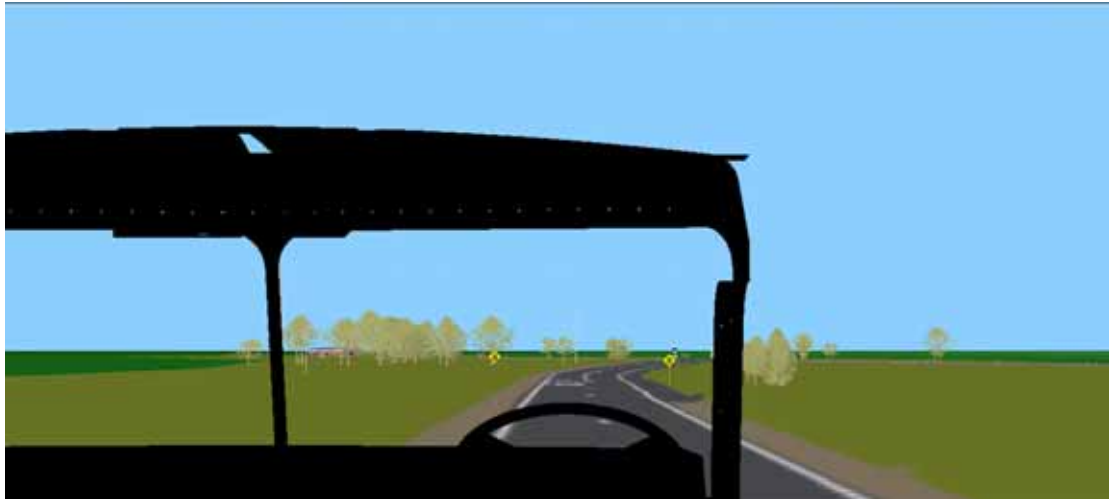
In Figure 35 a depiction of the front section of the cab (except for mirrors and the stone guard) has been superimposed to demonstrate potential obstructions to the driver's view. The vehicle that is stationary at the crossing is partially obscured by the driver's side A-pillar of the truck; however, this obstruction could be circumvented by appropriate movement by the truck driver.

**Figure 35.** A view showing the potential influence of the driver's side A-pillar on seeing the crossing lights and stationary vehicle. Note the central 'pillar' is an external support for windscreen stone guard.
