Office of the Chief Investigator  
Transport and Marine Safety Investigations

Rail Safety Investigation  
Report No 2007 / 09

**Level Crossing Collision  
V/Line Passenger Train 8042 and a Truck  
Near Kerang, Victoria  
5 June 2007**

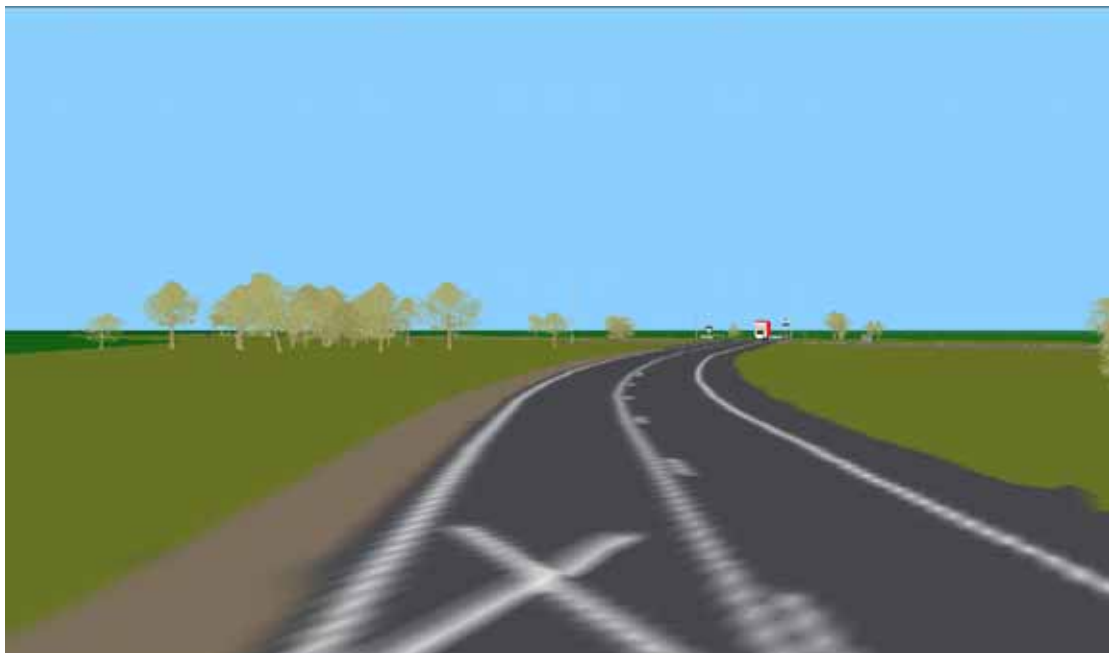
Figure 36 shows the estimated view from the truck cab at 260 metres from the level crossing; at about the location of the advance warning sign and still about nine seconds prior to the collision. The flashing light assemblies and stationary vehicles are visible. The train at this point is mostly obscured by the trees.

**Figure 36.** The estimated view from the truck cab at the advance warning sign 260 metres from the level crossing stop line.

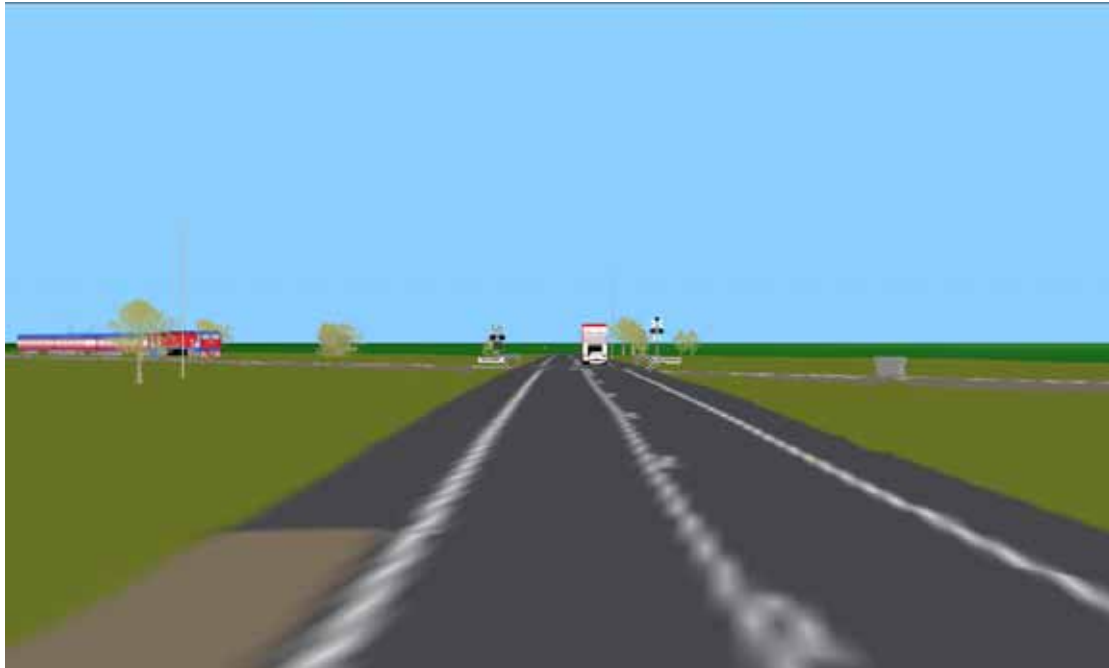
It is not until approximately 106 metres from the crossing (Figure 37) that the truck reaches the straight section of the road. At this point, it is estimated that the truck was travelling at a speed of 100 km/h (27.8 m/s). Both flashing lights are clearly visible and should have been visible through the windscreen to the driver, as should any stationary vehicles at the level crossing. The distance from the end of the curve to the estimated commencement of braking (about 55 metres) would have been covered in approximately two seconds, assuming no change in vehicle speed.

**Figure 37. The estimated view from the truck cab 106 metres from the level crossing stop line.**

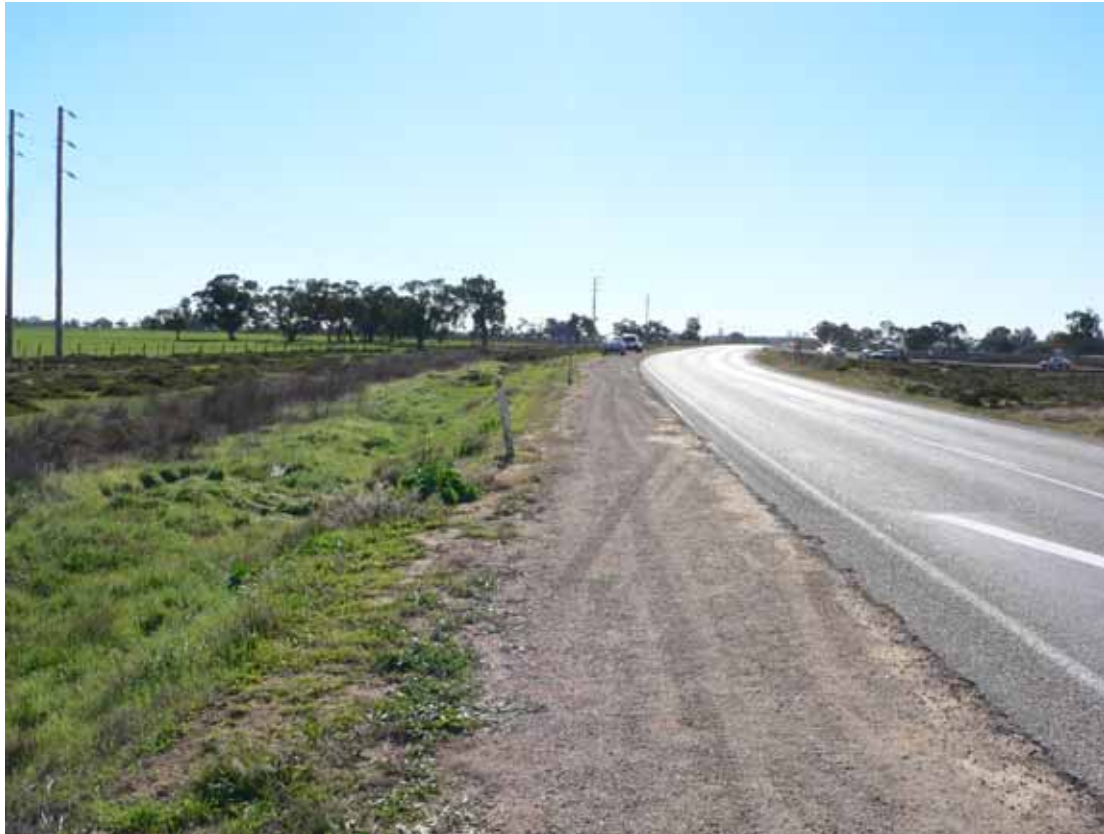
**Figure 38. Photo taken from the advance warning sign at about 1335 on 14 June 2007 as the scheduled train approached the crossing. Note: sun glare from the road.**
