**Rail Safety Investigation**

**No 2007 / 12**

# Brief Report

Southern Cross Passenger Yard

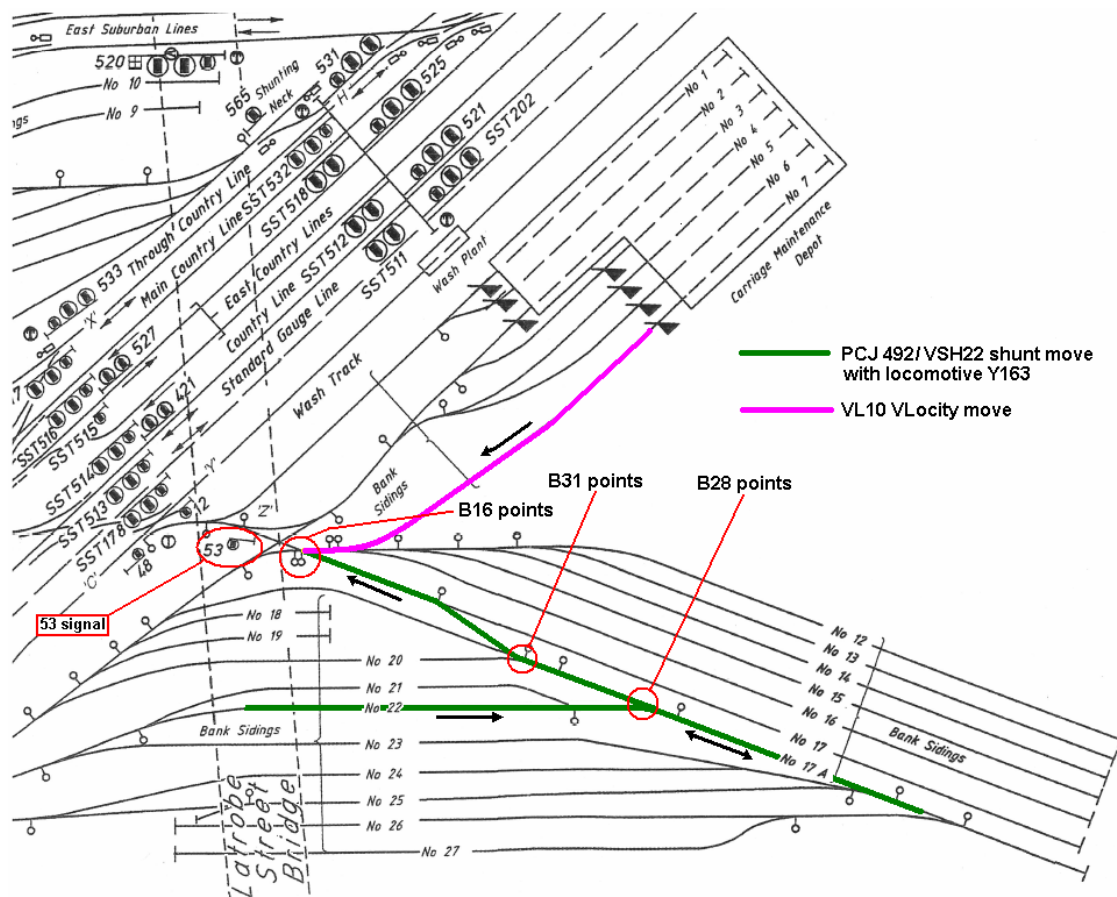
Figure 1. Yard with relevant tracks identified
