Office of the Chief Investigator
Transport and Marine Safety Investigations

Rail Safety Investigation

No 2008 / 01

Level Crossing Collision between a
B-Double Truck and a
Pacific National Freight Train
Red Cliffs (near Mildura)
16 January 2008

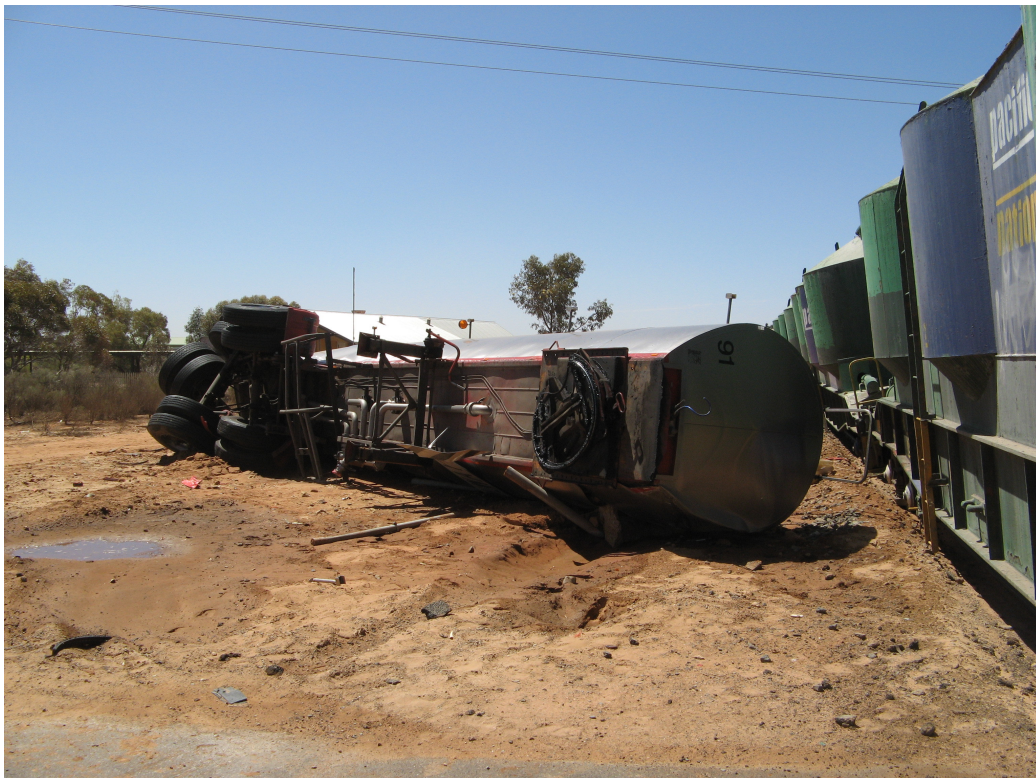
The locomotive collided with the rearward end of the second trailer of the B-Double, detaching it from its turntable assembly (5th wheel) and rotating it through approximately 160 degrees to deposit it close to the train and perpendicular to it.
