Office of the Chief Investigator  
Transport and Marine Safety Investigations

**Rail Safety Investigation  
Report No 2008/06**

**Level Crossing Short Warning Time  
Freight Train 9251  
Queen Street Colac  
9 July 2008**

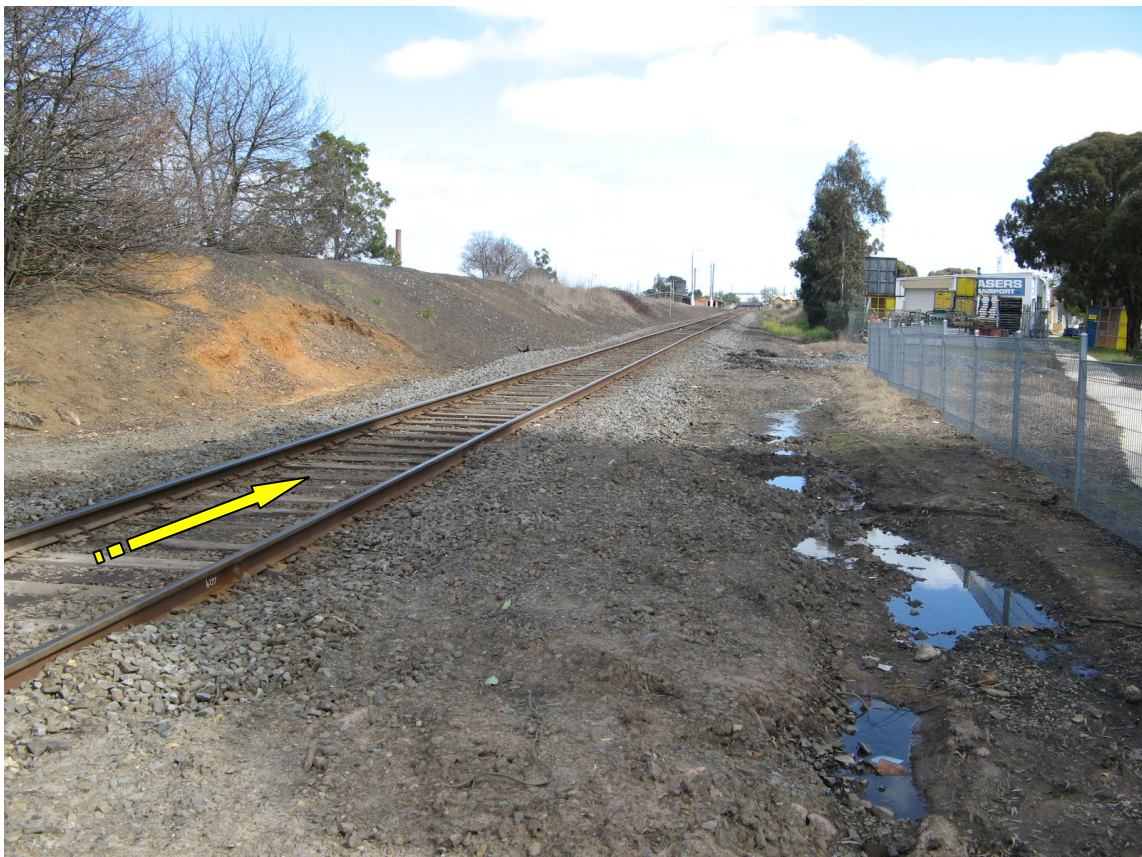
Figure 3: View of the Down approach to Queen Street, looking towards Warrnambool.

On the approach from Melbourne, the Queen Street level crossing is situated on a rising gradient of two per cent (1:50). The track is rated as Class 2 with timber sleepers and CWR (Continuous Welded Rail) of 47 kg/m. On the approach to Queen Street the ballast was fouled with mud and had a thin, low shoulder (see Figure 3).

While ballast conditions were not ideal and the ballast on the approach was fouled, the HXP-3 makes provision for system correction and the BC setting had been adjusted on-site. There is no evidence to indicate that the ballast conditions or the BC adjustment contributed to the incident.

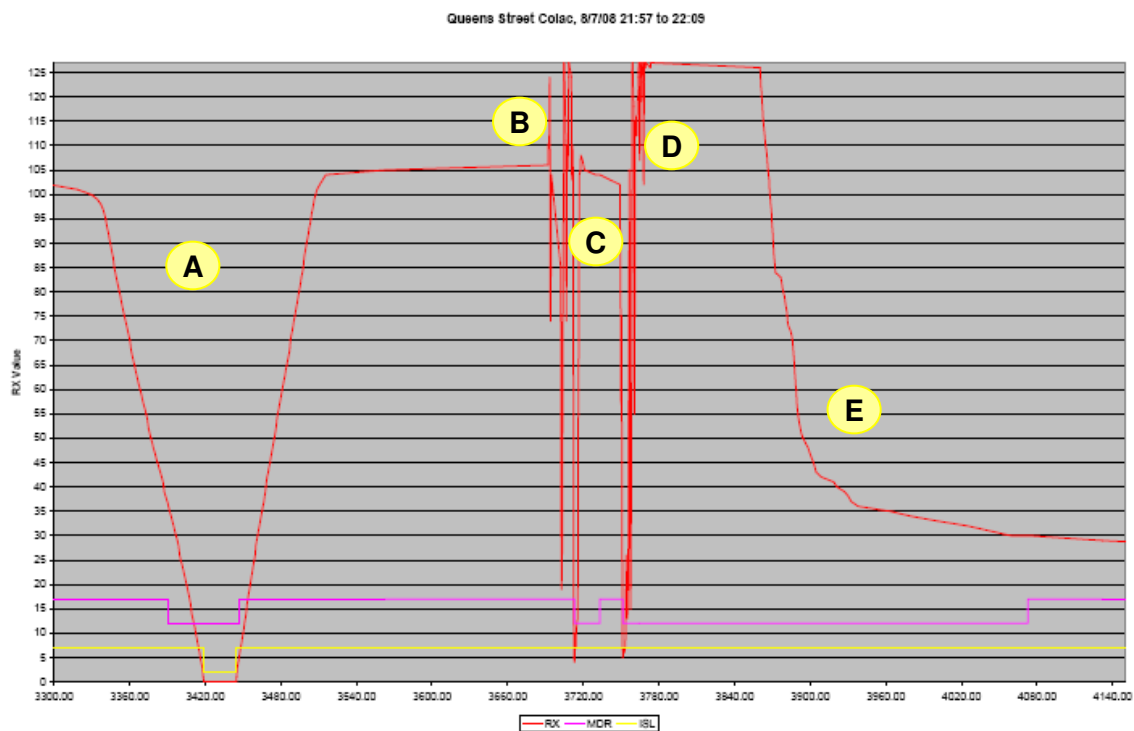
Figure 6: Variation in RX between approximately 2157 and 2209 on Tuesday 8 July 2008.

The RX drops suddenly and is again erratic suggesting the presence of a second, imperfect false shunt. Following further fluctuations, the RX signal indicates the system going into a high signal condition, staying at its maximum value of 127 for around one minute 25 seconds. Similar to the first imperfect shunt, the equipment manufacturer advised that a high resistance shunt may cause the RX to rise, potentially accounting for the high signal condition.

The protection activated about two seconds after the RX initially began to drop and immediately after it reached its lowest value of about five. The system first re-entered a high signal condition more than six seconds after the crossing activation.

After remaining at its maximum RX for an extended period, the indicated RX value then began to decay. This decay was approximately reconstructed with an assumed time constant of 60 seconds. The signal reduced to an RX of 30 over approximately three minutes.

The cause of the decay in the RX signal is not evident from the signal itself. The equipment manufacturer opined that temperature changes may have caused the rails to move slightly, thereby affecting the shunt over time. The shunt may have likewise been impacted by other physical or environmental factors which might have varied the interface between the rail and sign-post over this short period of time.

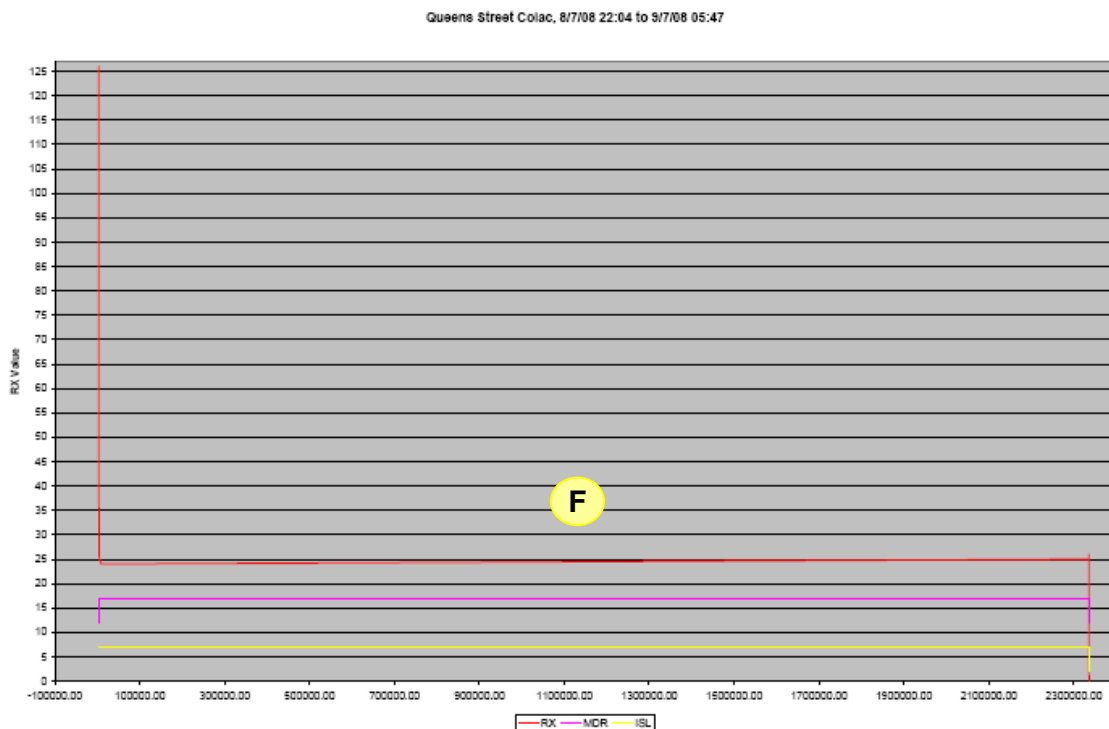
Figure 7: Variation in RX after stabilising and prior to passage of freight train.

After recovering from its high signal condition and stabilising for a short period at an RX of 30, the RX reduced further to about 24 before remaining reasonably stable for more than seven hours overnight and until the early hours of the morning. The level crossing protection remained inactive throughout the night.

The system remained in a low RX state of between 30 and 25 for about seven hours and 45 minutes. In this condition the shunt caused by the sign-post would have masked an approaching train and prevented the timely activation of the level crossing warning flashing lights and boom barriers.

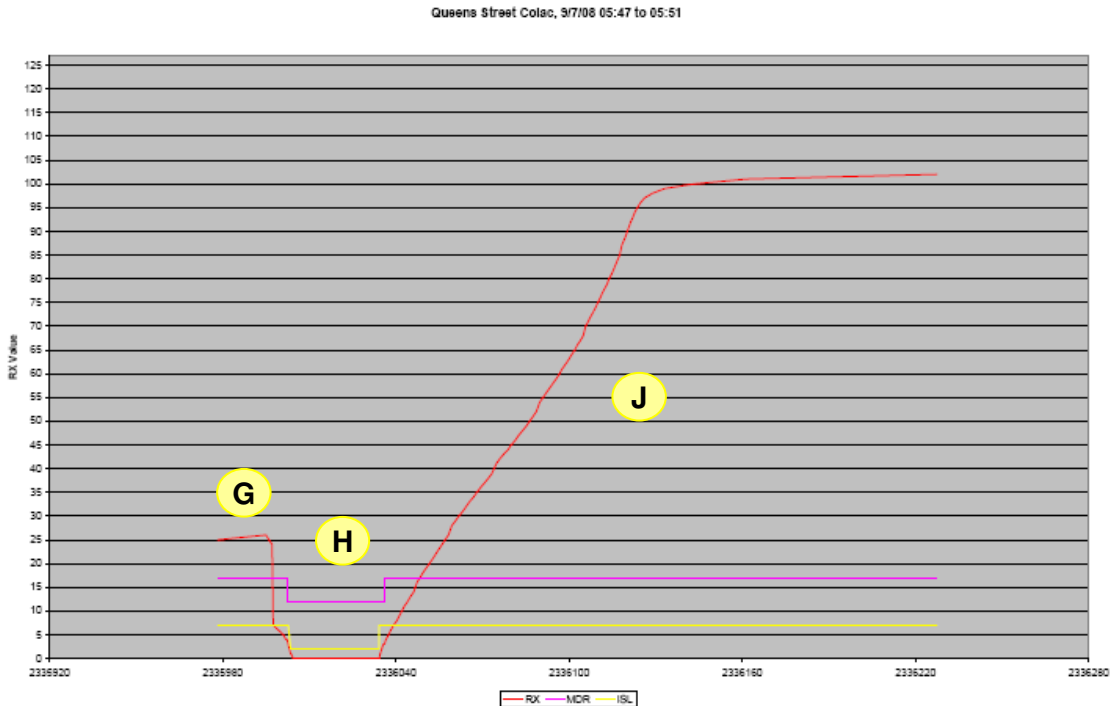
Figure 8: Variation in RX between 0547 and 0551 on Wednesday 9 July 2008.

While the precise mechanism of the system response has not been confirmed, it is clear that the system failed to adequately detect the presence of the false shunt caused by the sign-post. This condition resulted in the masking of the approach of a subsequent train.

*“To reduce the risk of the level crossing at Colac Queen Street and Hart Street failing to operate as expected if a similar false shunt were to be placed across the track sometime in the future, Rail Signalling Services make the following recommendation :- That the Positive Start Timer be set at a value of 99, to ensure whenever Queen Street and Hart Street level crossings are activated by the Positive Start feature, that they will continue to operate indefinitely until the approach sections are clear.”*
