Office of the Chief Investigator  
Transport and Marine Safety Investigations

**Rail Safety Investigation  
Report No 2009/11**

**Derailment of V/Line Passenger Train 8243**

**12 September 2009**

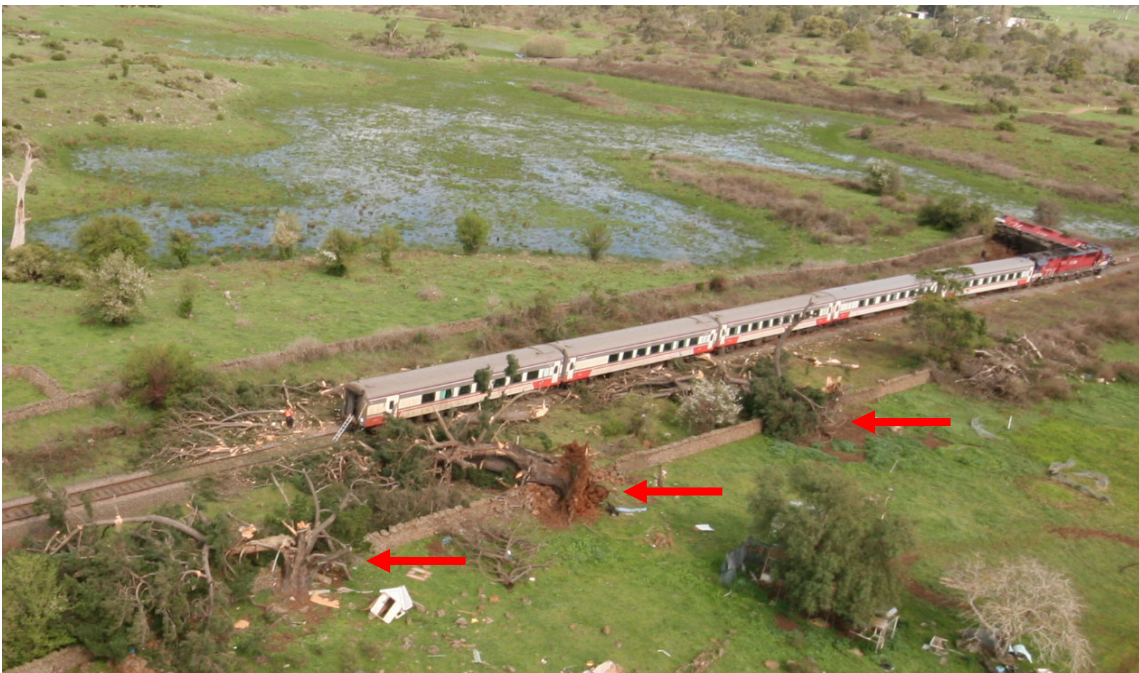
At about 2050<sup>1</sup> on Saturday 12 September 2009 a Melbourne to Warrnambool V/Line passenger train collided with trees lying across the track about 500 metres east of the Stoneyford Road<sup>2</sup> level crossing, in the locality of Stonyford. The trees had been felled by strong winds.

Figure 1 – Overview of derailment showing three fallen trees

Although three adjacent trees had fallen at this location, only two of them had impacted and obstructed the railway track structure (see Figure 1). The investigation engaged the services of an arborist to conduct an examination of the latter two trees. Due to the nature of trees and the practical limitations in accurately assessing the structural integrity of all parts of a tree it was not possible to make a completely accurate assessment of their condition. The recommendations in the arborist's report are based on visual assessments and external indicators and include some degree of subjectivity.

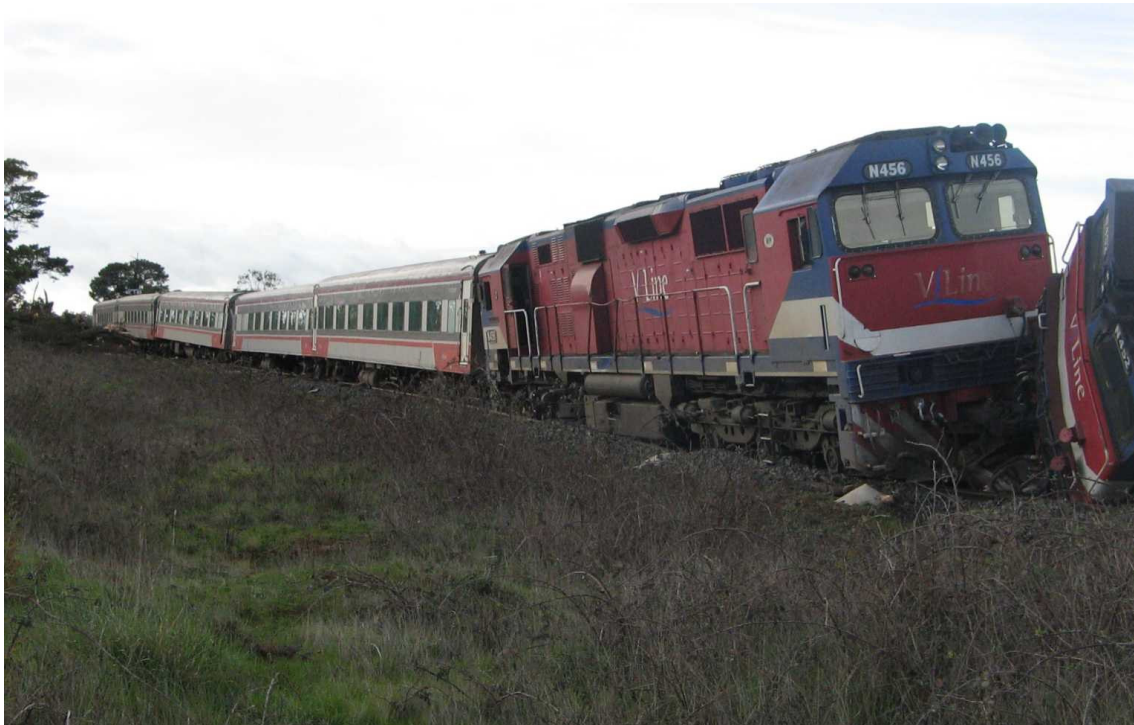
**Figure 3 – The second locomotive (N456) and passenger cars remained upright**

Locomotive N456 sustained scuff and abrasion damage to wheels, lower traction motor portions, and the fuel tank, from ploughing — in a derailed state — through ballast.

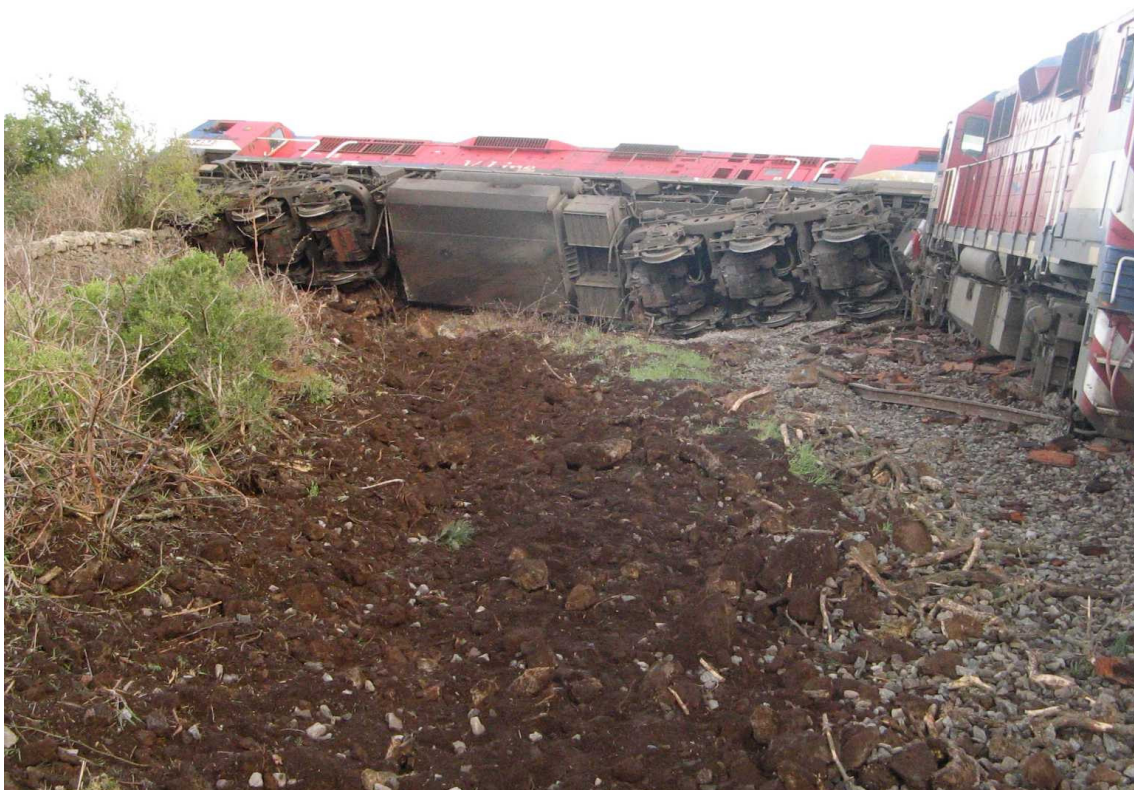
Locomotive N452 sustained impact and derailment damage to the headstock, cab, hood structure, bogies and traction motor gear cases as well as to some engine-room equipment. The N class locomotives are fitted with 6800 litre fuel tanks and N452 lost a significant amount of diesel fuel into a line-side drain as a result of a punctured fuel tank.

**Figure 4 – The path of the derailed lead locomotive (N452)**

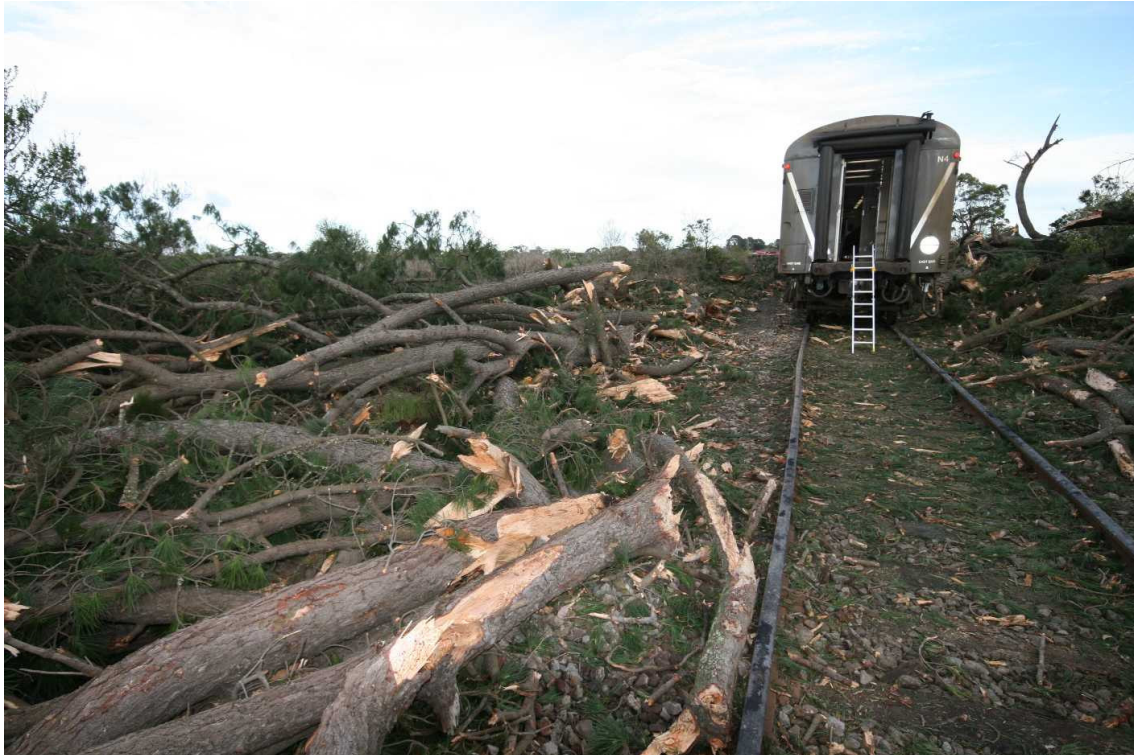
Figure 5 – Fallen tree coverage across track

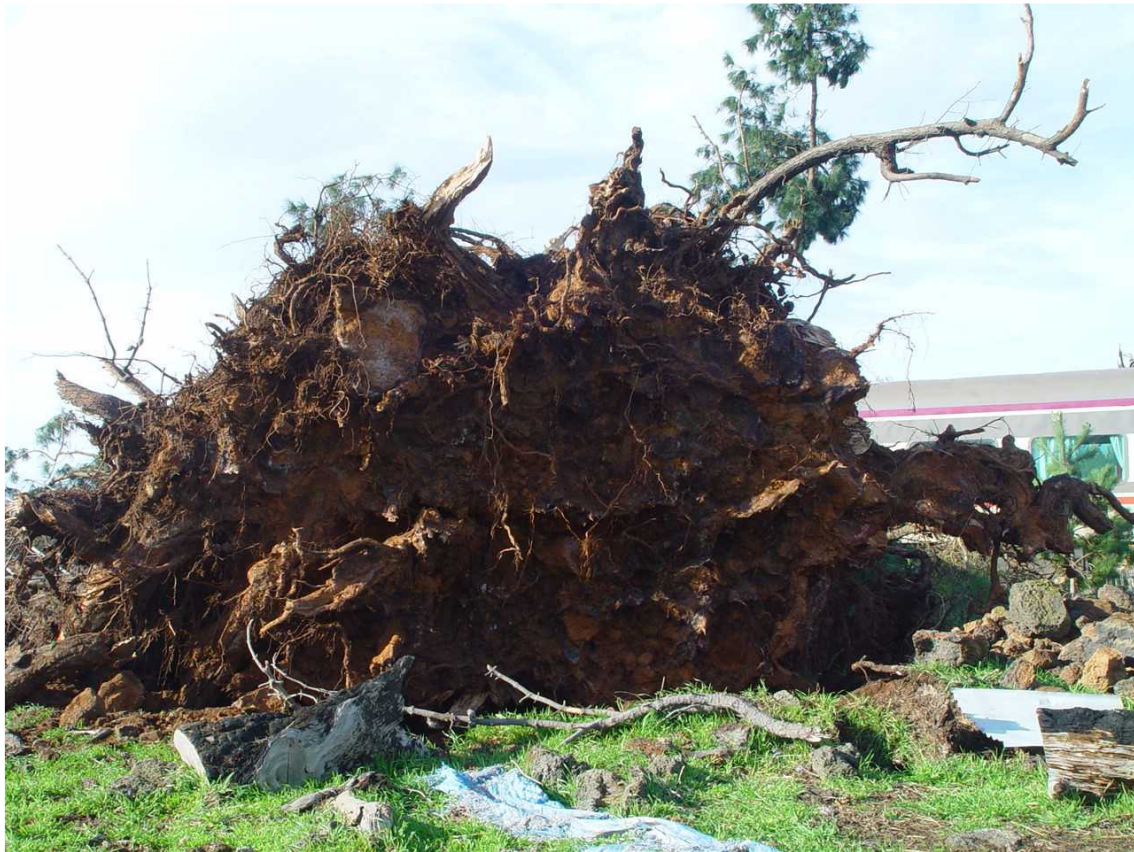
The country to the north-northwest of Stonyford is open and relatively flat, and presents little in the way of restriction to the flow of wind across it. Both of these trees were growing in close proximity to a stone fence and on very rocky (volcanic) ground and it was observed that one had a root system of shallow depth and assumed that the other would be likewise (Note that one of the felled trees assessed had been completely uprooted while the other had been snapped off at the trunk about 3.2 metres above ground level).

**Figure 6 – Uprooted tree**

With this shallow root system and the existence of sustained, gusty winds from the north-northwest, it was the view of the arborist that these conditions — along with their assumed height (18-20 metres), age (estimated at 90-110 years), and sail area (estimated at 120 square meters) — rendered it likely that these trees would fail.

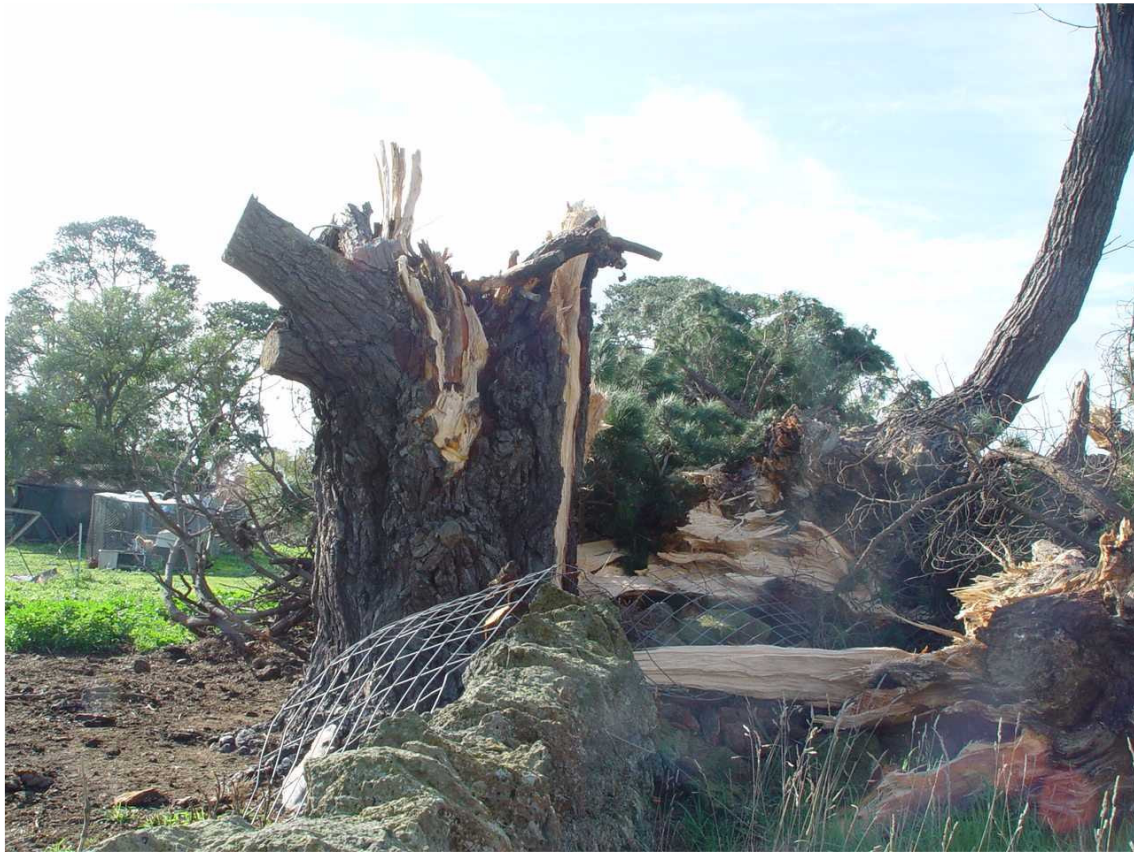
**Figure 7 – Break in trunk of tree (note also its proximity to rock wall)**

Although assessed as 'healthy', it was apparent that both of the fallen trees exhibited physical conditions affecting their sturdiness, including, scarring, borer infestation, and fire burns. *Scarring* (also known as 'wound response'), relates to certain events happening to the anatomy of a tree, affecting either the outer bark (the trees' protection from the outside world), inner bark (the conduit by which nourishment is passed to other parts of the tree), the cambium layer (the growing or 'living' part of the trunk), sapwood (the conduit by which moisture is conveyed within the tree) and heartwood (the supporting pillar of the tree). The trees' biological response is to attempt to 'wall off' infection to the different layers of the trunk at the affected site; this process being referred-to as 'codit' (compartmentalisation of decay in trees). The scarring evident on these trees affected all of the above-mentioned layers to different degrees.

The report concludes that it would have been difficult for any casual and untrained observer to determine these faults prior to the trees falling. The evidence suggests that both pine trees failed due to weather conditions, their age, and structural faults either at ground level (shallow root system) or higher ('included' bark<sup>7</sup>).

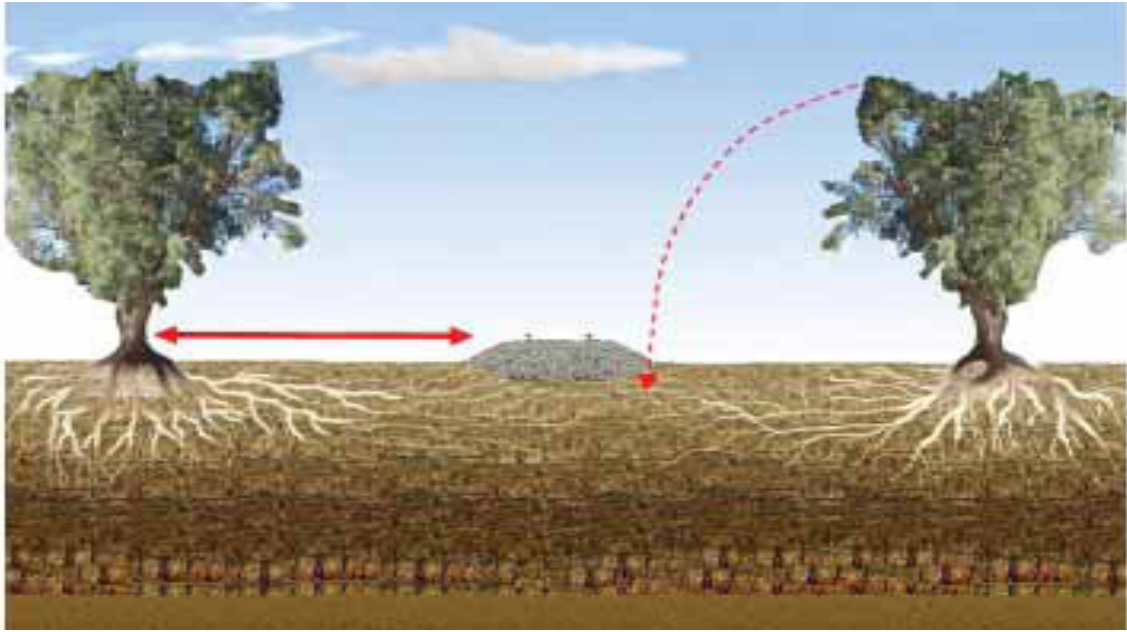
Under a heading, ‘Vegetation Fouling Track’ (page 20), the Guidelines state (in part); *“Trees and branches falling onto tracks present a risk for train drivers. A clearance envelope must be maintained to prevent vegetation growing too close and fouling passage of trains. To avoid future occurrences, keep new plantings a safe distance...away from the track...equal to the mature height of the tree...as shown.”* (Figure 8).

Figure 8 – Guidelines for new plantings (*Vegetation Management Guidelines for Rail Corridors*)

The Guidelines mention the need to maintain a 'clearance envelope' (this being presented in the context of new plantings rather than the management and control of existing growth) and the potential risk presented to train drivers of trees and branches falling onto tracks, however, there is no reference to a *public* danger. Specific mention is made in one passage of the need "...to prevent vegetation growing too close and fouling passage of trains...", but none is made of the danger of trees falling and then lying foul of the track. Any implicit warning of this potential danger relies upon interpretation of a singular illustration (Figure 8) depicting the relationship between the height of a tree and its distance to the track structure.

That VicTrack, through the Victorian Rail Industry Environmental Forum, develop and publish a formal process for managing vegetation growth both within and outside of rail reserve easements so as to control as much as possible any threat posed to public safety by this vegetation should it become physically degraded or be subject to a dangerous external condition (such as high winds or fire).

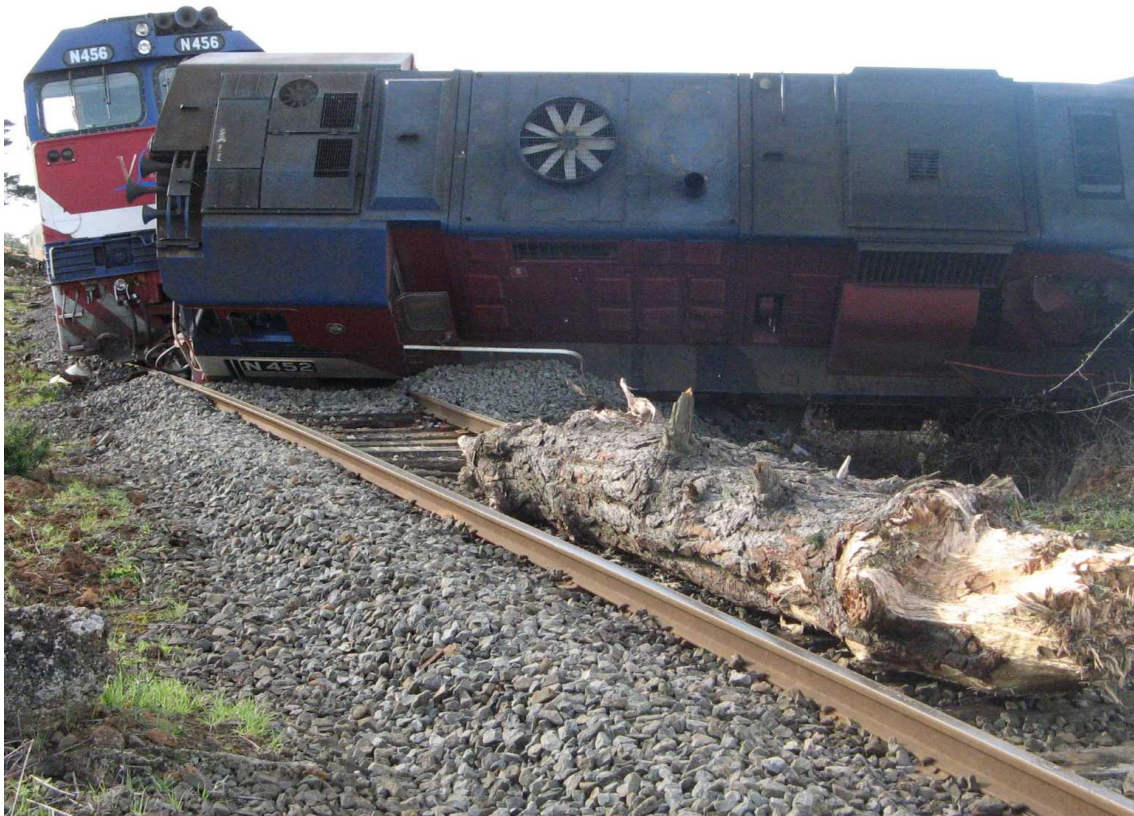
The nature of the obstruction presented to the locomotive was exemplified by a remnant portion of tree trunk about 5.8 metres long and 2.2 metres in circumference that remained ahead of the locomotives following the incident and was lying between the rails (see Figure 9). This log had been splintered at both ends and its exterior bark surface severely abraded as a result of its contact with the locomotive.

**Figure 9 – Photo showing displaced log ahead of derailed train**
