Office of the Chief Investigator
Transport Safety

**Rail Investigation
Report No 2009/13**

**Derailment
Passenger Train 8235
Footscray
15 October 2009**

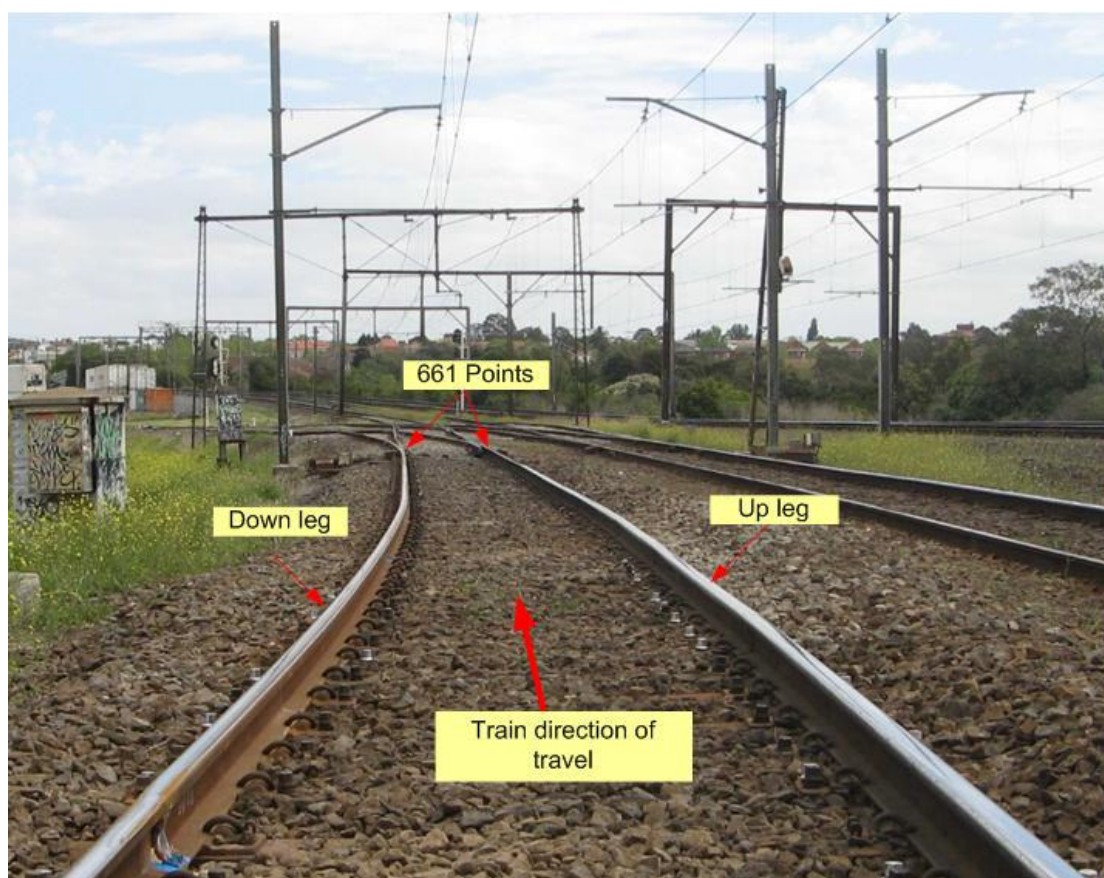
Figure 1 - Derailment site

A broken rail was observed on the down leg⁵ of the track approximately 2.5 metres from points 661. The break was observed to be at a welded rail joint. The rail head was split and the crack extended for about 20 millimetres vertically into the web before tapering off at an angle to the foot of the rail. A triangular section of metal had fractured off the foot of the rail.

The track repair was completed and included the replacement of approximately 40 metres of rail, the installation of a new set of points, and the reinstatement of the fastenings. Rail services were resumed the following morning.

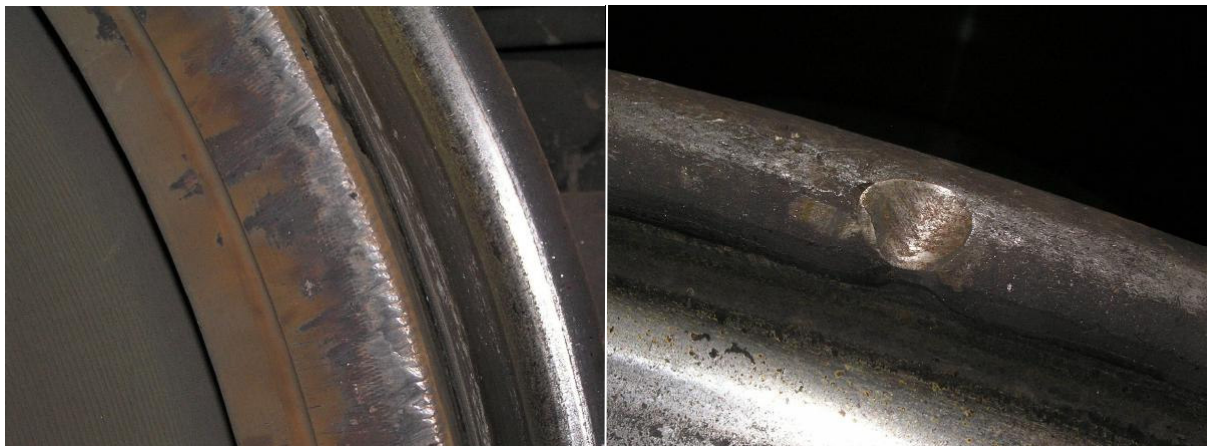
Figure 3 - Wheel 7 scuff marks and indentation

The flange of wheel 7 was observed to have a deep indentation and scuffing was observed on the tread corner and side of the rim surface.

The investigation was advised by the operator that “wheels Nos.7 and 8 on the leading bogie of rail car VL 1241 were significantly damaged to warrant replacement and the damaged wheels were replaced before the vehicle resumed its service”.

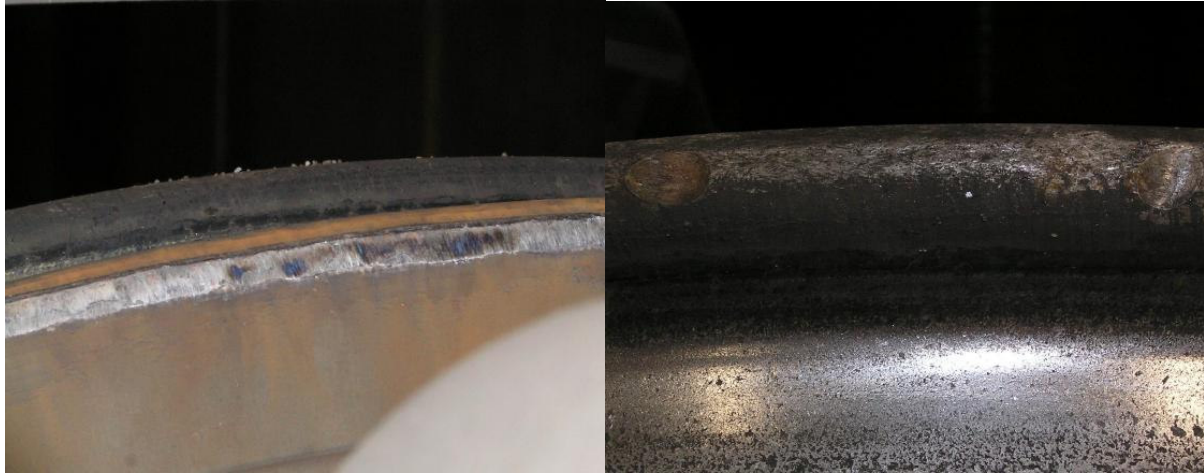
Figure 4 - Wheel 8 scuff marks and indentation

The flange of wheel 8 was observed to have two deep indentations and scuffing was observed on the tread corner and side of the rim surface.

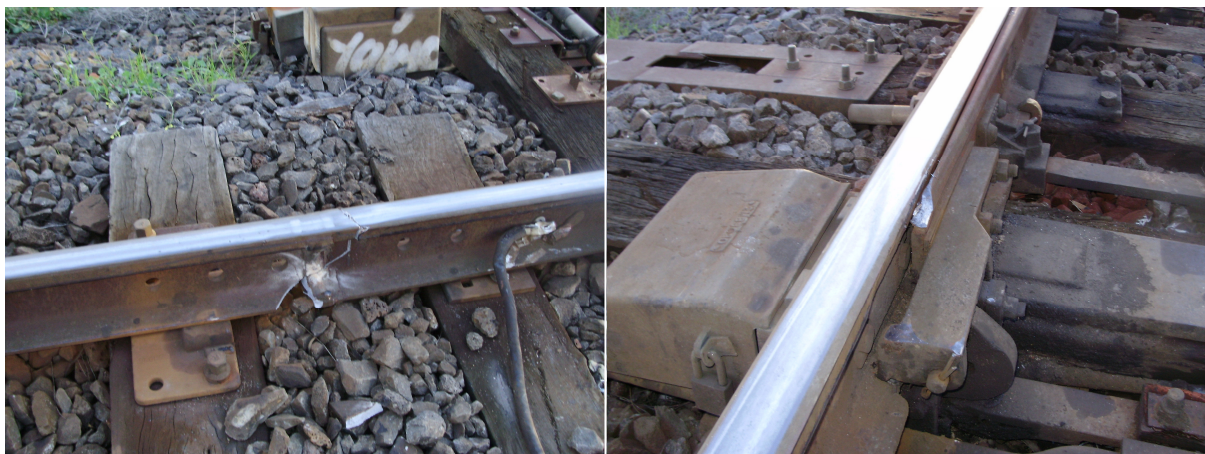
Figure 7 - Rail and Points damage

A further 20 metres of rail was found to be battered and crippled⁶ due to the impact of running wheels and the leading edge (toe) of the point blade on the down leg also sustained wheel impact damage. Several severely corroded and fractured 'S' and 'R' screws, dislodged lock spikes and clips and damaged timber sleepers were also found at the incident site. It was also observed that several screws did not have spring washers.

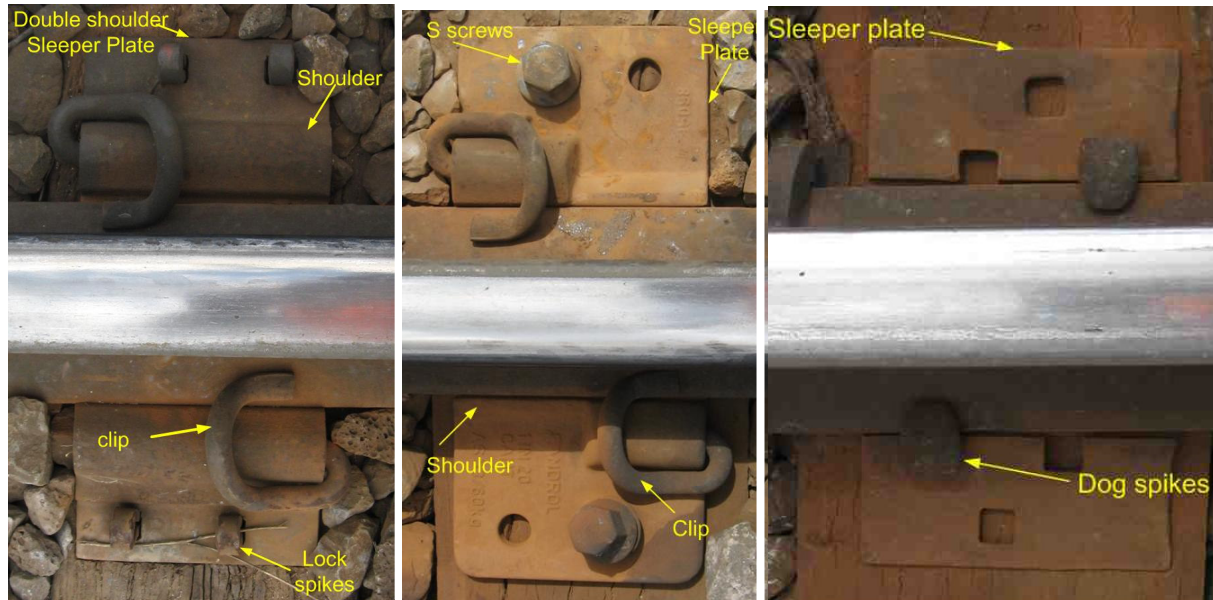
Figure 8 - Securing arrangements at site

MTM has conducted a detailed inspection of nominated locations on curved track and identified and replaced broken screw fastenings. MTM advised that an ongoing inspection and monitoring program has been implemented to manage the risk of future defective screw spikes.

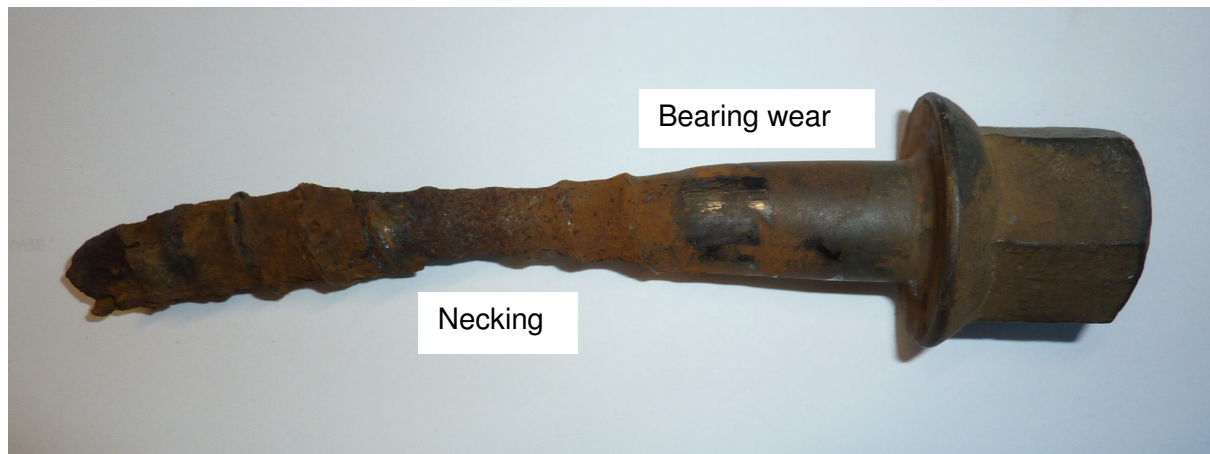
Figure 9 - Corroded 'S' Screw showing bearing wear on shank

Visual examination of the screws indicated that heavy corrosion had resulted in necking and some screws had fractured. The screws also exhibited bearing wear on the shank. The wear bands were located from 10-35 mm below the head of the 'S' screws and 15-40 mm below the head of the 'R' screws.

The bearing wear and transverse depressions observed on the screws resulted from metal to metal contact and relative movement between the sleeper plate and the screws. The material of the screws or metallurgically undesirable features or inclusions did not contribute to the failure of the screws. There was minimum galvanizing on the screws indicating that they had been in service and subjected to corrosion for a significant period of time.

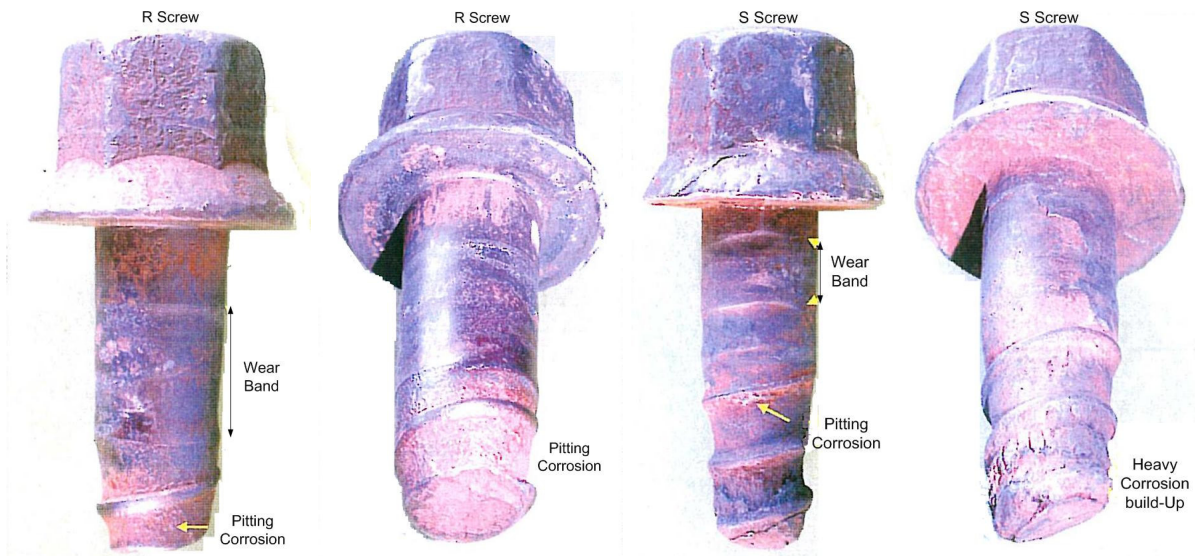
Microscopic and metallographic examinations were carried out on several fractured 'S' and 'R' screws. The examinations indicated evidence of pitting corrosion and heavy oxidation in the vicinity of the fracture surfaces. The fracture surface was also oxidised and the lack of fresh metallic surface indicated that the screws had fractured some time prior to the incident.

Figure 10 – Broken ‘R’ and ‘S’ Screws

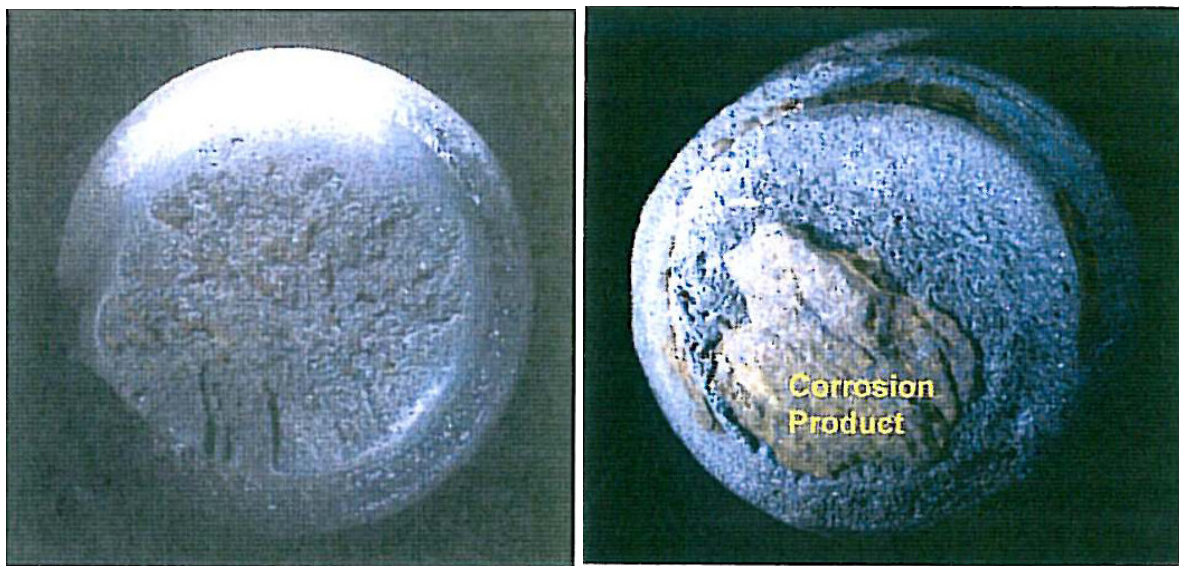
The fracture surface of the screws was pitted and abraded around the circumference of the fracture. Cracks were detected at the root of the threads adjacent to the fractures.

Figure 11 - Fracture surface of 'R' and 'S' screws
