Office of the Chief Investigator
Transport Safety

**Rail Safety Investigation
Report No 2010/15**

**Locomotive Fire
V/Line Passenger Train
Marshall Railway Station
30 December 2010**

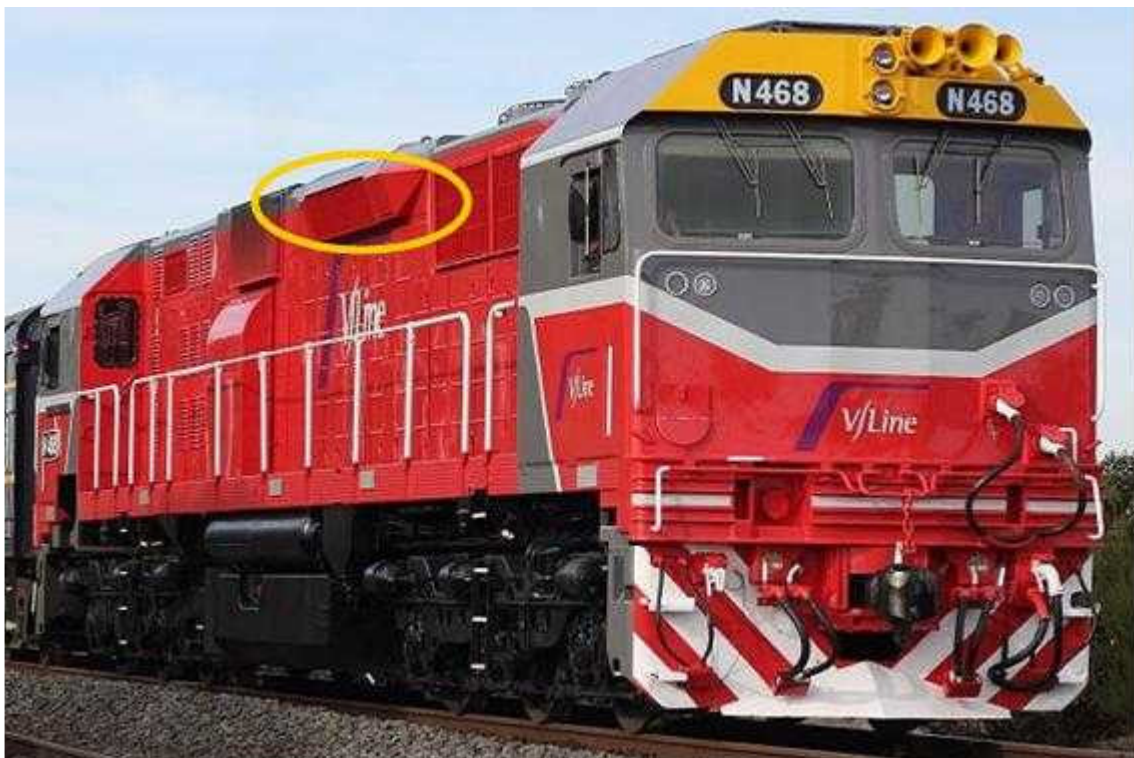
Figure 1 - An N-class locomotive, with the air intake to the dynamic brake grids circled

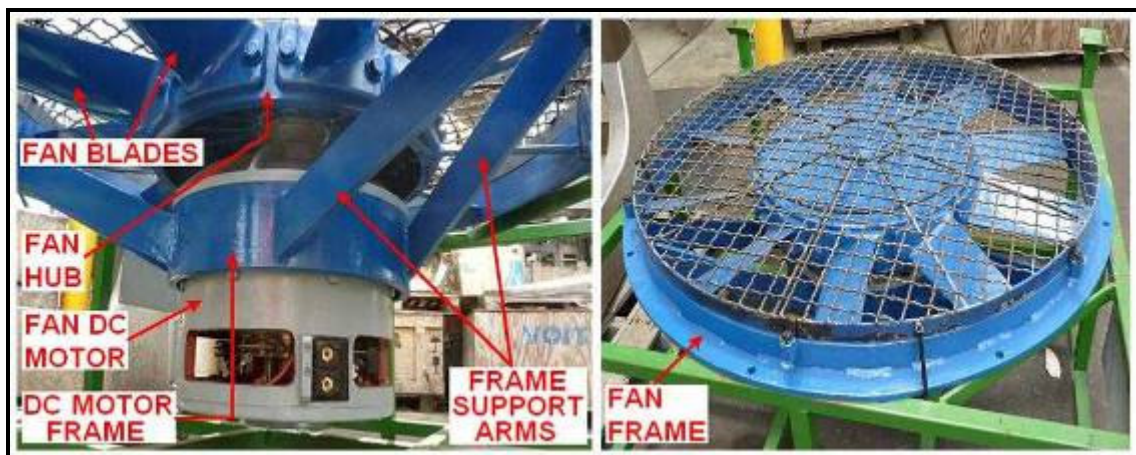
Figure 2 - Dynamic brake grid blower assembly showing component parts

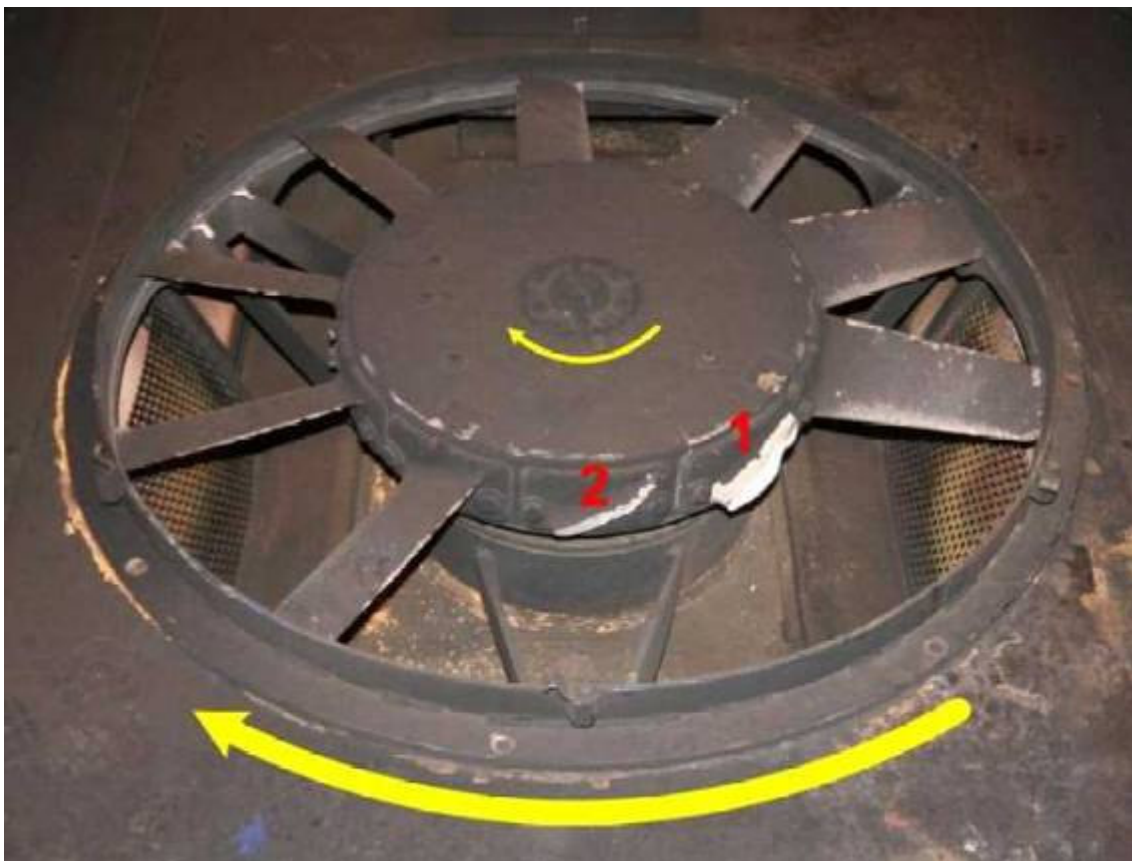
Figure 3 - Damaged fan assembly, showing direction of rotation of fan and frame

It was apparent that the circular fan frame had rotated at least a quarter of a turn in the clockwise direction. All eight bolts securing this frame to the roof of the locomotive

were missing. The electrical connections to the fan direct-current motor had been wrenched and separated.

Two fan blades had fractured and were missing, believed to have been ejected after their separation. The stubs of the missing blades—forming part of the blade-to-hub mounting base—were removed for metallurgical assessment.

Light but recent abrasion damage was evident along the upper trailing edge surfaces of the remaining eight blades. The leading-edge tips of these eight blades had all been bent upward, with corresponding heavy abrasion damage to the underside of each tip and at the outer ends of all six frame support arms.

There was impact damage and associated deformation of one of the fan frame support arms and the trailing blade stub (Figure 3, blade № 1) had been bent upwards, with corresponding evidence of cracking across the hub surface.

The investigation found that the first fan blade to fail was the leading blade (Figure 3, blade № 2) of the two that failed; as a result of fatigue fracture. The investigation concluded that this blade then fell between the fan frame and the following blade (Figure 3, № 1) causing the fan frame mounting bolts to shear, the frame to rotate and the second blade to fail in overload. The fan motor electrical connections were separated at this time.

That V/Line reviews its policy for the replacement of dynamic brake cooling fans and considers adopting the six-year maintenance interval for renewal of the dynamic brake cooling fan assembly.

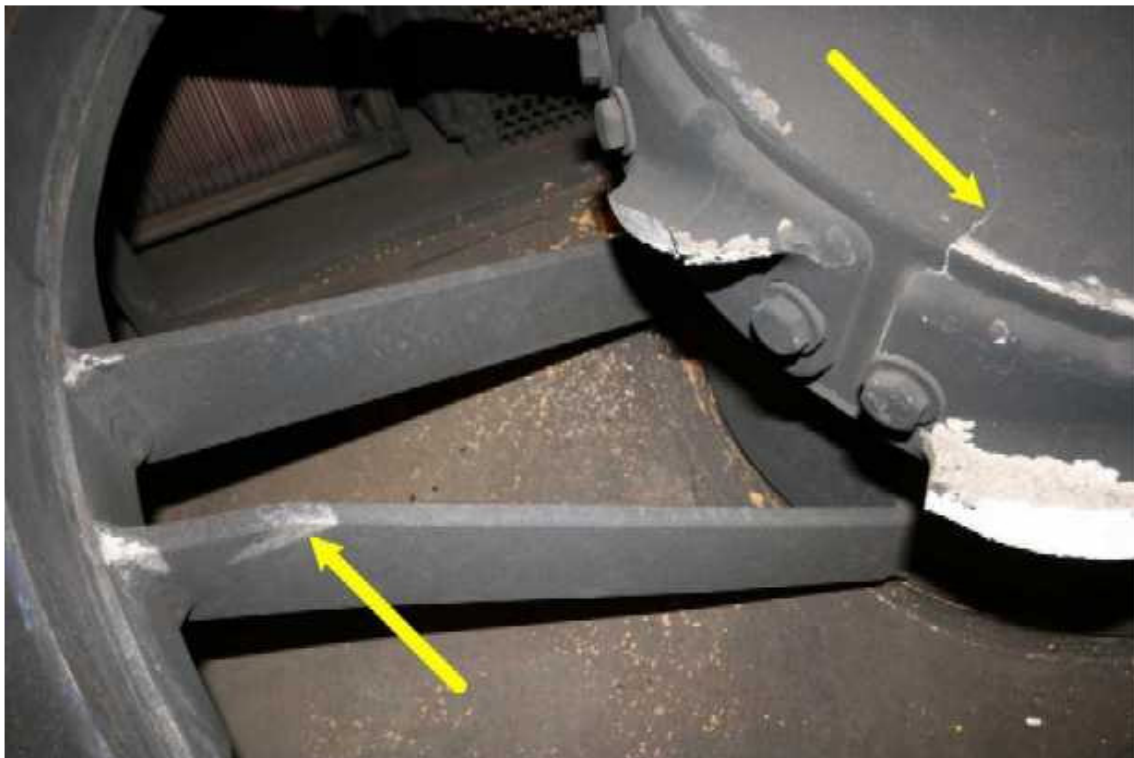
Figure 4 - Deformation of fan frame support arm and cracking of hub

The fracture surface of the stub from the trailing fractured blade (Figure 3, blade № 1) was assessed. The mechanism by which cracking was induced was found to be consistent with instantaneous ductile overload. It was considered likely that this fracture had occurred as a result of an external force.

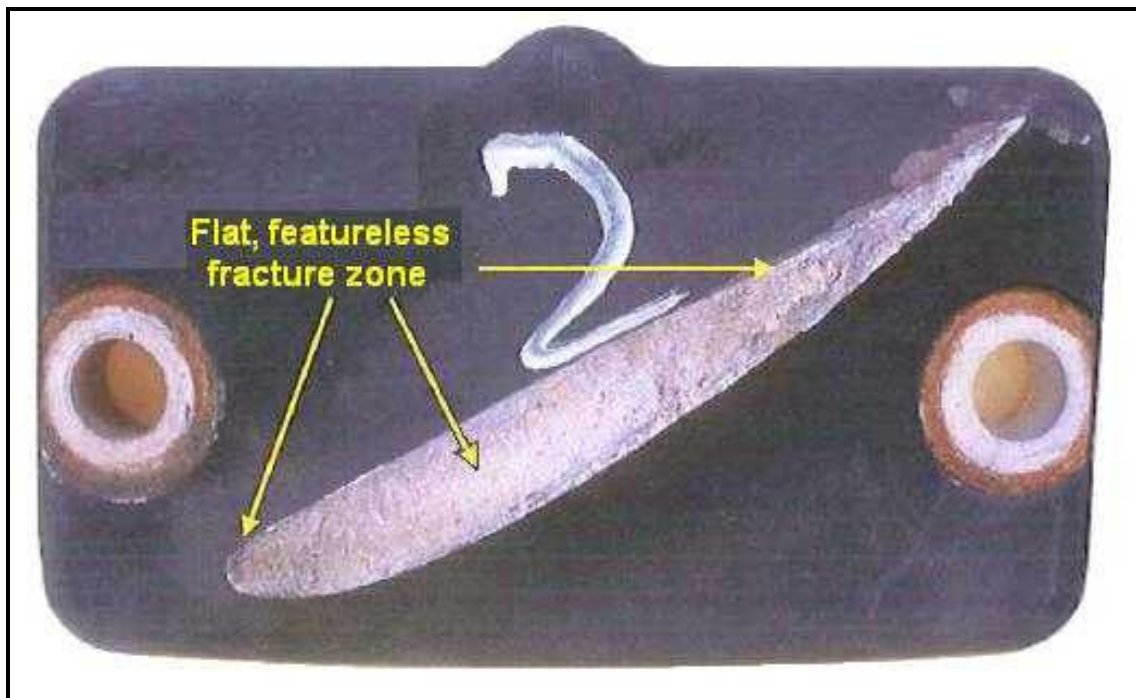
The fracture surface of the stub from the leading fractured blade (Figure 3, blade № 2) was assessed. The cracking mechanism was found to have derived from fatigue and ductile overload. The small amount of ductile overload fracture at the trailing edge suggests that the fatigue fracture had occurred through a low-stress/high-cycle mechanism, indicating progression of the fatigue crack over a significant part of the service life of the component.

Figure 5 - The fracture surface of the leading blade - note the flat featureless zone (fatigue crack) through to fibrous ductile fracture at the trailing edge

The fracture surface in the vicinity of the fatigue fracture origin did not show any signs of pitting or surface indentation that could have contributed to stress concentration in the fatigue mechanism. There were also no metallurgical defects identified that could have contributed to the fatigue failure mechanism. There were signs of slight mechanical damage at the origin of the fatigue fracture. However, without the remainder of the separated blade, the testing laboratory did not form an opinion as to whether this damage could have been present prior to the initiation of the fatigue crack.

The testing laboratory considered that potential contributors to the cracking of the blade included external factors such as higher-than-design fatigue loading, the fatigue limit of the material being exceeded during the service life of the blade, and high residual stresses as a result of fabrication techniques or bending and/or straightening during service maintenance.

The cause of the fatigue crack in the leading blade could not be determined with any certainty, although it is possible it was initiated by mechanical damage at some point in the blade's service life.
