Office of the Chief Investigator
Transport Safety

**Rail Safety Investigation
Report No 2011/07**

**Derailment
Freight Train
Warracknabeal
5 June 2011**

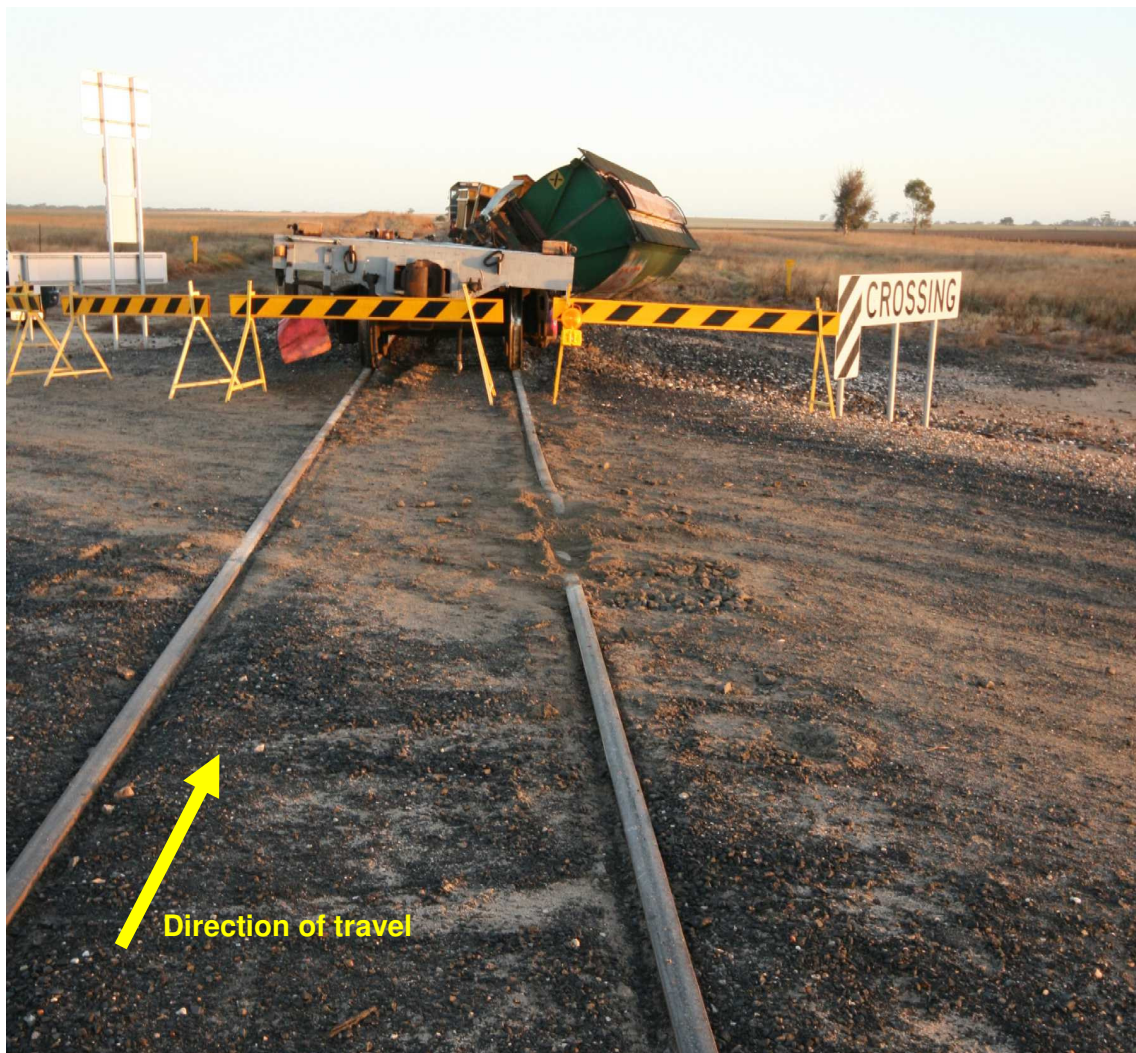
At about 2225, all wagons derailed at the Mellis Road level crossing, about five kilometres south-east of Warracknabeal. The locomotive did not derail and there were no injuries.

Figure 1 – Mellis Road level crossing and the derailed wagons in the background

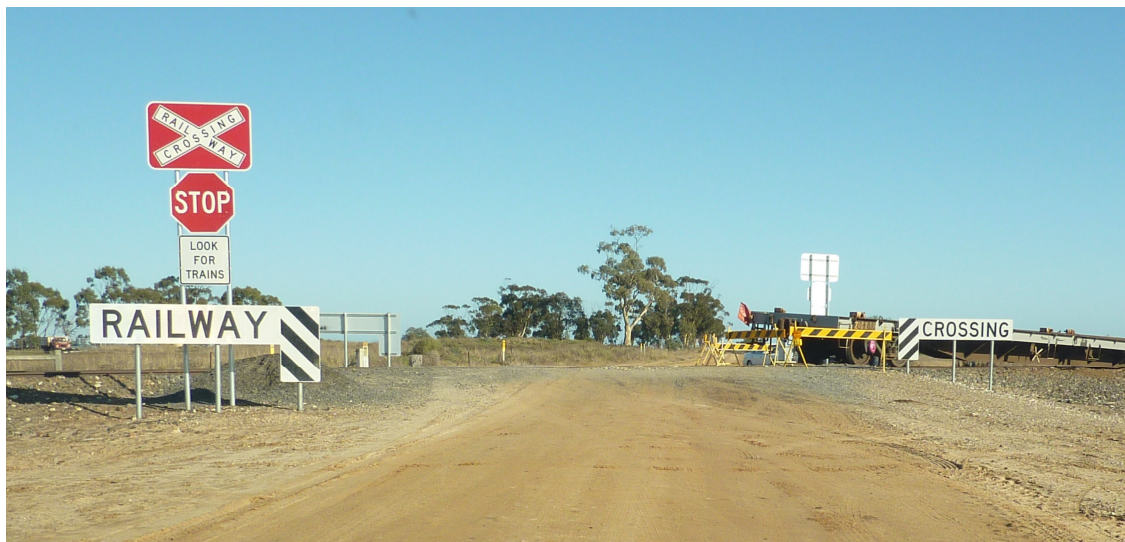
Mellis Road is an unsealed road used predominantly by local traffic, including farm machinery. It intersects the rail track at an angle of about 40 degrees with the road sloping down on either side of the crossing. The rail head was slightly proud of the road surface with roughly formed flangeways for wheel flanges. The rail web and foot and all rail supports were covered by road materials and not visible.

Figure 3 - Mellis Road level crossing

The V/Line standard for level crossings provides only limited detail on the construction requirements for unsealed level crossings. The nature of a crossing such as that at Mellis Road provides a potentially corrosive environment and limits the ability to inspect the condition of the track including rails and support structures.

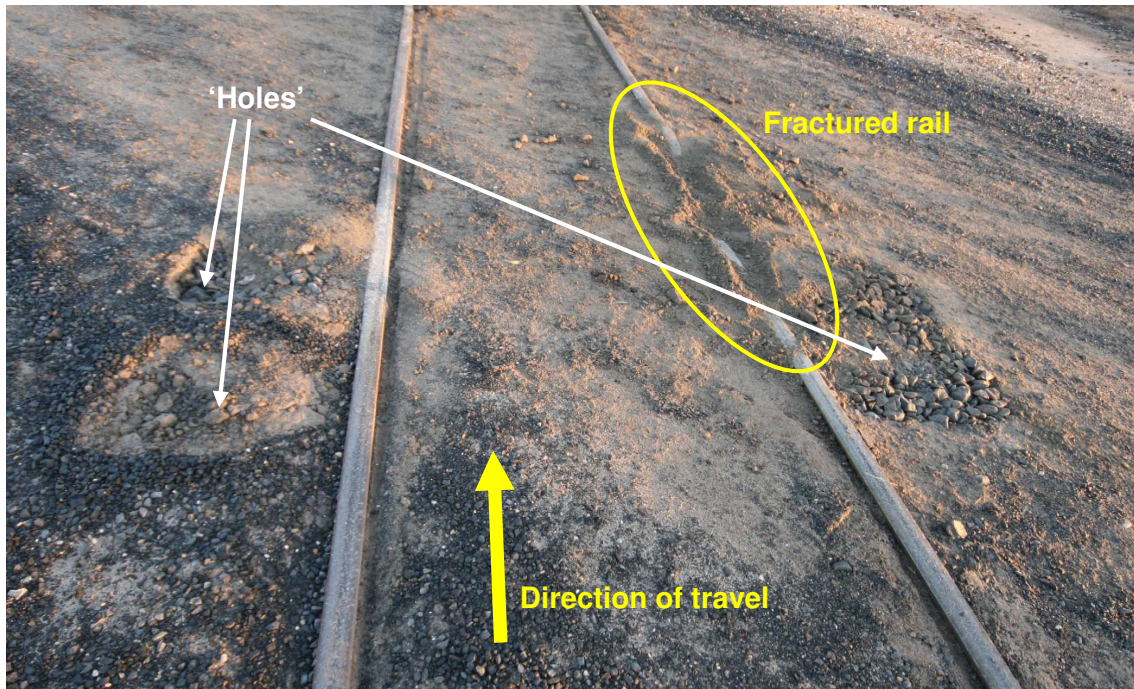
A section of the right hand rail (in the direction of train travel) was found to be severely damaged. The road surface was disturbed by the derailment although there had been minor restoration of the road surface prior to the investigation team arriving on site. Near the fracture, there were indications either side of the track of 'holes' in the road that contained loose, uncompacted materials (see Figure 4).

Figure 4 – Condition of level crossing on arrival at site

Site evidence of a loss of sleeper support on the Up end of the horizontal web fracture and 'holes' with loose fill in the adjacent road surface suggest that there may have been some pumping of the track around the defect location.

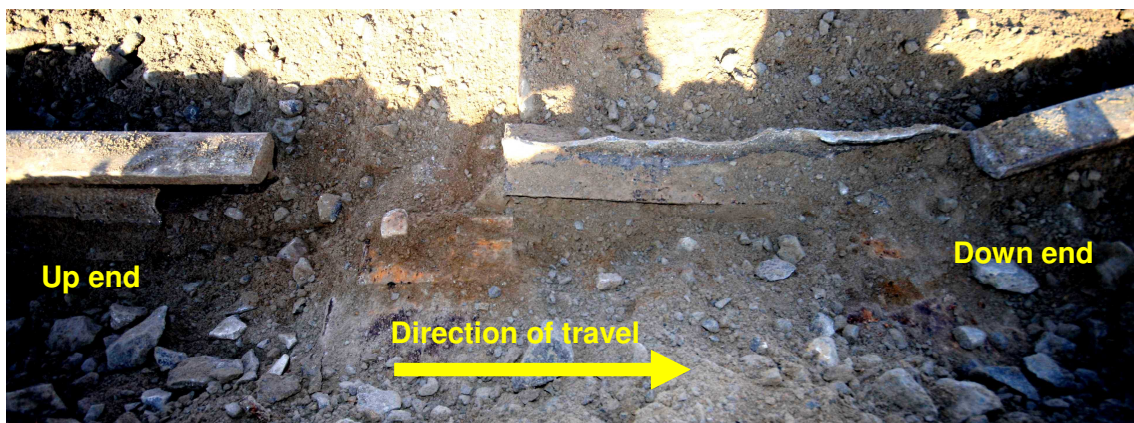
Road materials were removed from the area of the damaged rail. The rail was found to be fractured into several pieces, with a horizontal fracture in the web extending for about 1400 mm. There was a gap of 830 mm between the intact ends of the rail head. There was no evidence of a bituminous or other coating on the rail.

Figure 5 - Damaged section of rail after excavation and removal of fractured pieces of rail

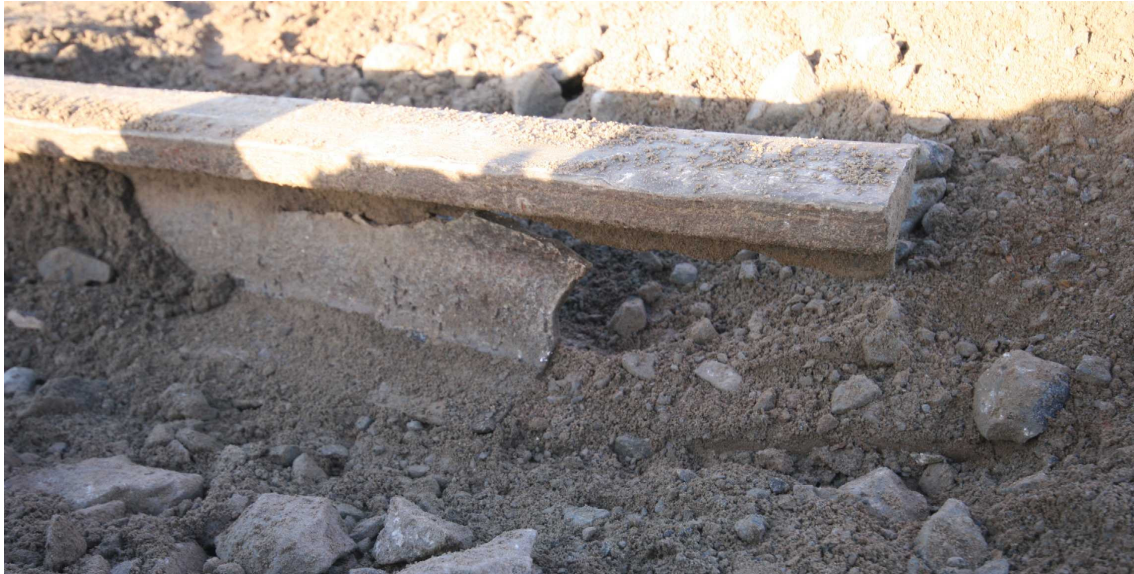
Figure 6 – Up end of fracture, in-situ (note continuation of horizontal web fracture)

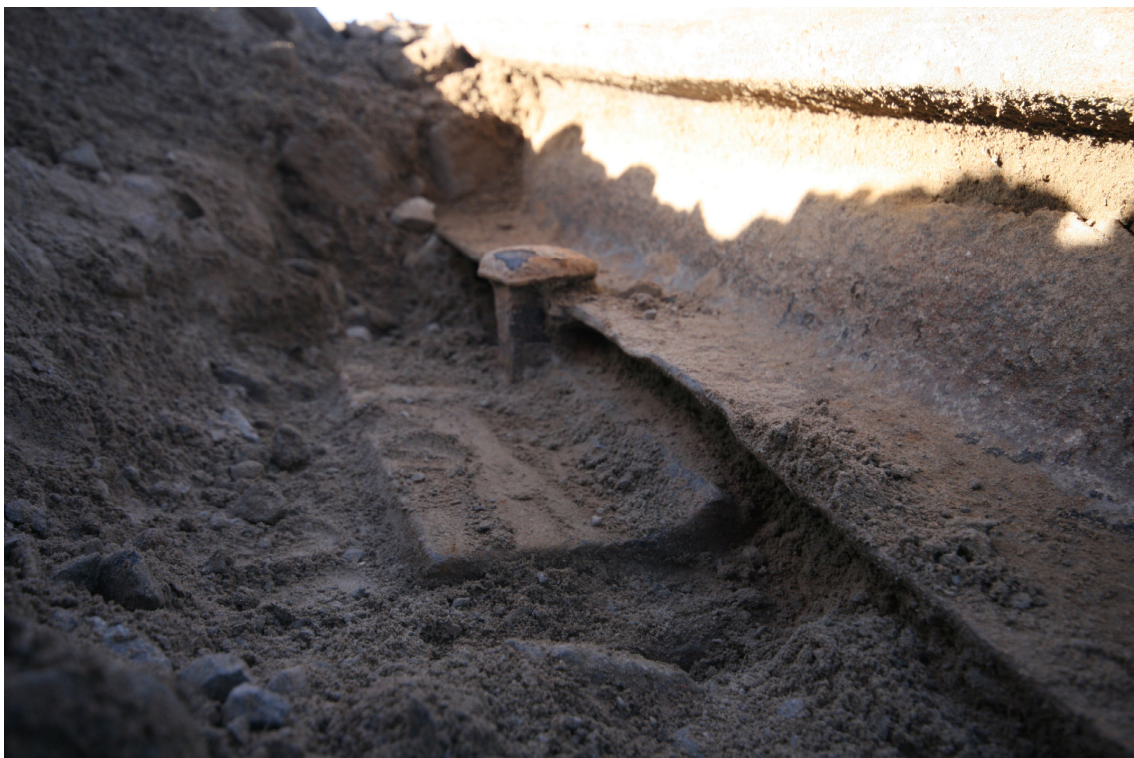
At the Up² end of the damaged rail, just beyond the web fracture, the sleeper had dropped by about 50 mm and was not providing effective support to the rail.

Figure 7 – Gap between sleeper support and rail at the Up end of the fracture

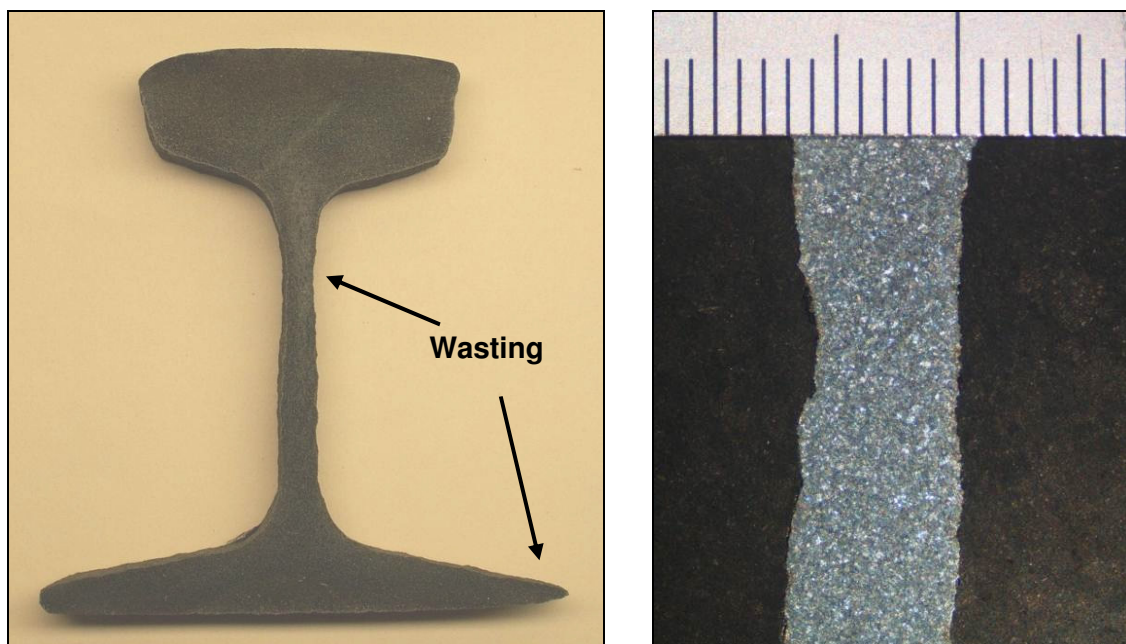
The broken rail was heavily corroded. The external surfaces of the rail foot and the web had been wasted by corrosion. The web had been reduced to a minimum thickness of approximately 5.5 mm after removal of the surface oxide layer. The minimum thickness of the new rail would have been in the range of 13 to 14 mm. As a result, the reduction in web thickness for the section examined was considered to have been between 7.5 and 8.5 mm.

Figure 8 - Rail cross section, indicating wasting of the foot and web (shown right with 1 mm scale)

The presence of a band in the web where the corrosion was worst suggested the presence of a localised interface between moisture and air where corrosive conditions were at a maximum. The rail web was wasted in a horizontal band approximately 15 mm wide and about 50 mm below the top of the rail head, along the full length of the rail examined.

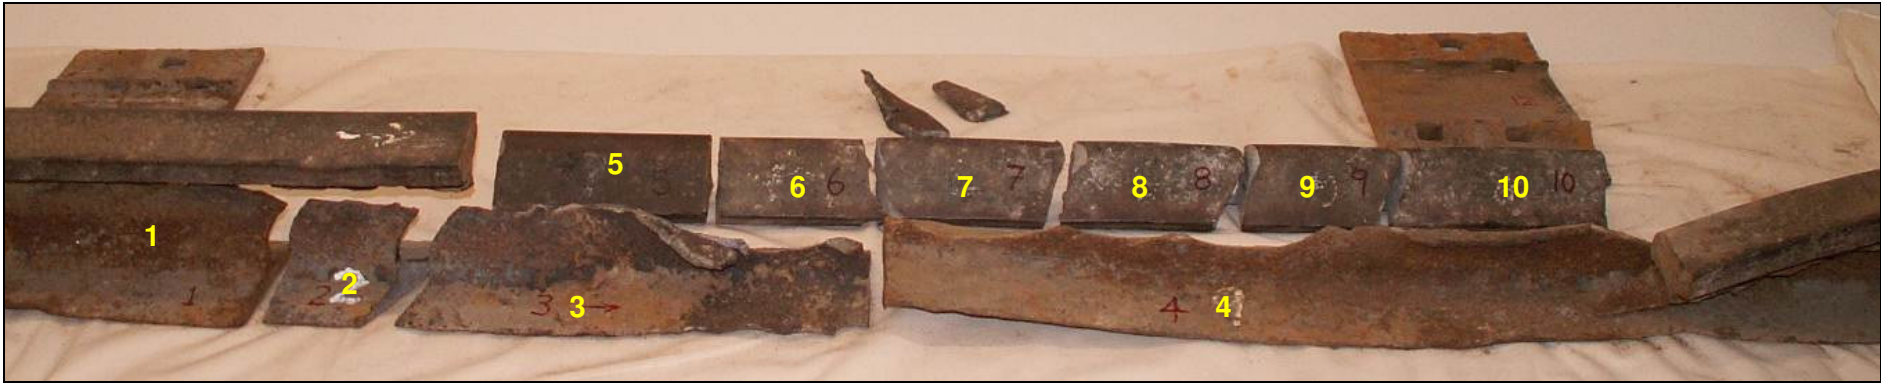
A detailed metallurgical examination was made of the damaged rail (see Figure 9).

Figure 9 - Side elevation of the broken rail subject to metallurgical inspection

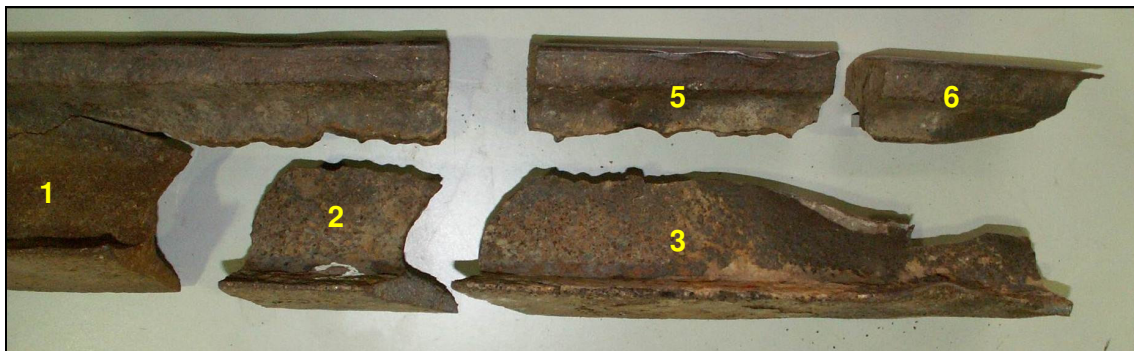
The transverse rail head fractures between rail pieces 5 and 6 and 5 and 1 (see Figure 10) both showed light corrosion on the rail head fracture surfaces. Also, the mating surfaces of broken rail pieces 5 and 6 had been battered on the head by passing wheelsets.

The fracture surfaces between rail pieces 1 and 2 were heavily corroded in the web and lightly corroded in the foot, indicating that the web fracture had been present longer than the foot fracture. The light corrosion of these foot fracture surfaces suggested this fracture had been present for a short period of time prior to the incident.

Figure 10 - Side elevation showing corroded web fracture
