Office of the Chief Investigator
Transport Safety

**Rail Safety Investigation
Report No 2011/12**

**Signal Passed At Danger
V/Line Empty Car Movement
Southern Cross Station
23 December 2011**

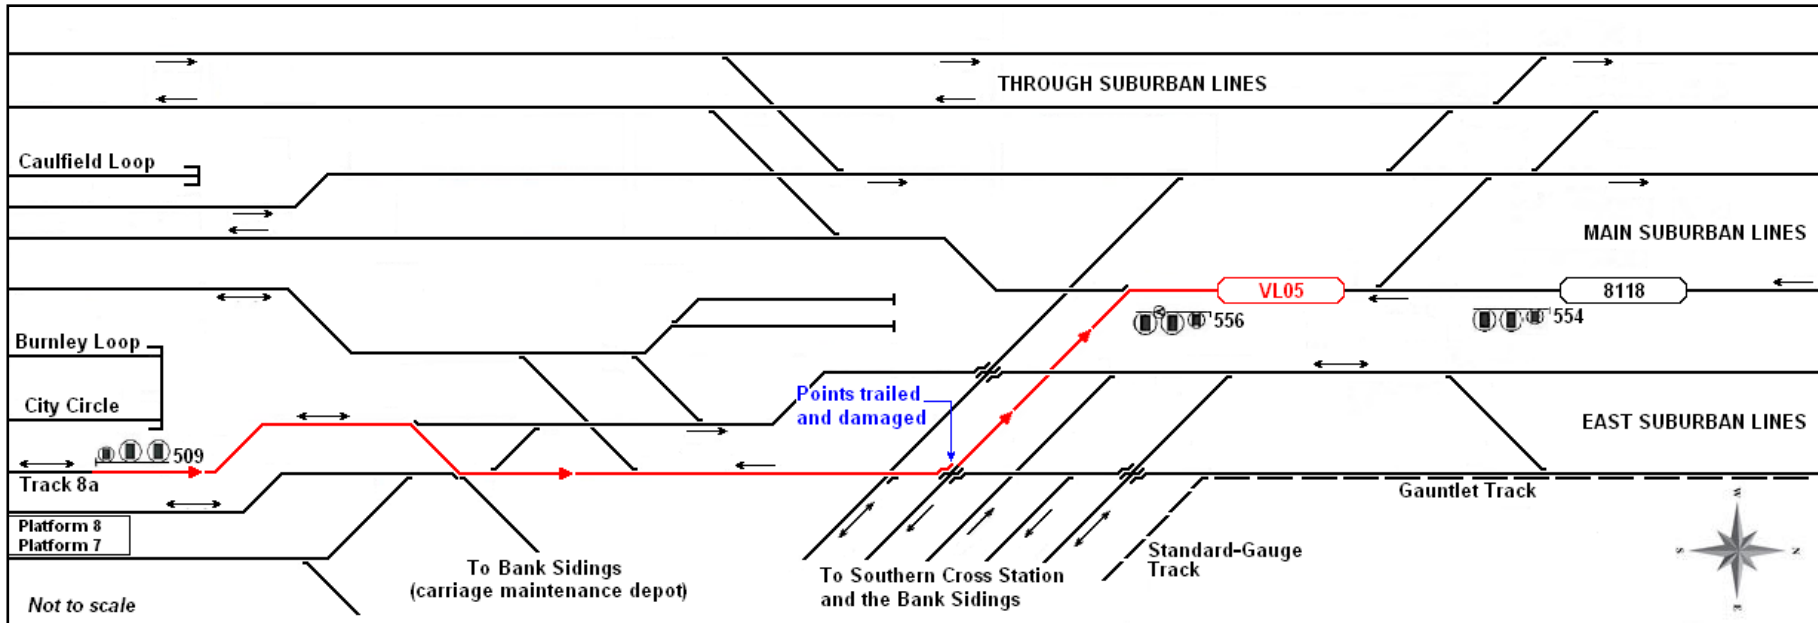
Figure 1: Diagram of route taken by VL05 from signal 509 to beyond signal 556

VL05 departed Platform 8 South and travelled in accordance with signal indications from the platform along track 8a before stopping at Down² Home signal 509. After remaining stationary for 51 seconds VL05 then proceeded against the Stop indication displayed. The movement continued on an unauthorised route against the flow of traffic for about 800 metres before coming to a stand about 60 metres beyond signal 556 on the Up Main Suburban line near Franklin Street. During this move one set of points were run-through in the trailing position³ resulting in damage to associated rodding and interlocking mechanisms. The driver changed position to the opposite-end driving cab and moved VL05 towards signal 556 in readiness to proceed to the maintenance facility.

At the time VL05 entered the Up Main Suburban Line an opposing V/Line passenger train, № 8118, was also on this line at North Melbourne Station. It travelled up to signal 482, about 240 metres from where VL05 was standing. Signals 482 and 554, had reverted to Stop as a result of VL05 having occupied the track between signals 556 and 554 (Figure 1).

After departing Platform 8 South, VL05 stopped at signal 509 for less than a minute and when it restarted, it was against the Stop indication displayed on the signal. VL05 then travelled towards oncoming traffic on an unsignalled and unauthorised route traversing a set of points that were set against it. VL05 was brought to a stand just beyond signal 556 as if the driver was satisfied that he had taken the correct route and in anticipation of a move back towards the maintenance facility. Had the driver not stopped in the vicinity of signal 556 there was the potential for VL05 to continue along the Up Main Suburban Line, increasing the risk of a collision with the opposing train 8118.

The signalling system provided intervention by displaying a Stop indication to the opposing train(8118) when signals 482 and 554 reverted to Stop once VL05 occupied the track between signals 556 and 554. There were no signals facing VL05 in this section of track and the potential existed for VL05 to have continued unchecked into conflict with train 8118.

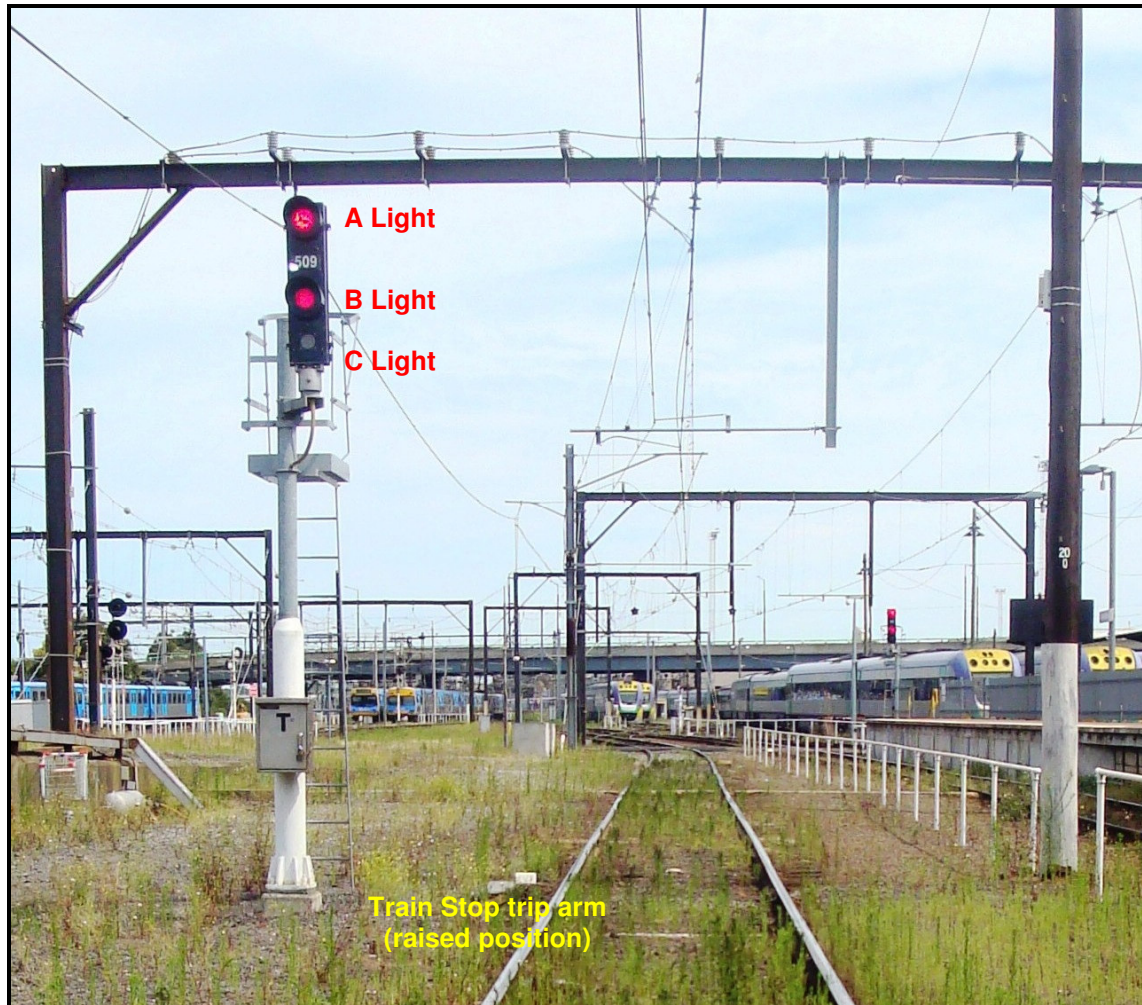
Figure 2: Signal 509 at Stop

Signal 509 is a three-position Down Home signal fitted with LED-type lamps and short hoods⁴. It controls movements along track 8a towards the Southern Cross carriage sidings, the Down East Suburban Line, and the Down Main Suburban Line. The 'A' light (top) is a fixed red marker light; the 'B' light (middle) is a tri-colour lens and a 'C' light that displays a Low Speed indication as required (Figure 2). A Train Stop device is also provided as an engineering intervention against suburban trains passing the signal at Stop (See section 2.5.2).

A review of the signalling system event recorder identified that signal 509 was and remained at Stop when VL05 was first brought to a stand and when the subsequent movement towards the Up East Suburban Line was made. The position and alignment of this signal did not contribute to any phantom aspects being displayed and the investigation did not identify any sighting issues. There was no history of SPAD events at this signal.

The investigation concluded that signal 509 was passed at Stop due to the driver's diminished cognitive performance and loss of situational awareness. The investigation did not identify the reason(s) for this reduced level of performance. The driver was experienced in the signalling system and routes at Southern Cross Station and maintained that he was not distracted or preoccupied when the SPAD occurred. There were no sighting issues with signal 509 and all infrastructure operated as designed.

That Metro Trains Melbourne reviews the risks associated with a SPAD event by a non-suburban train within the Southern Cross precinct and the options for risk controls, including train protection.
