Loss of propulsion on passenger cruise ship *Norwegian Star*

Bass Strait, 22 NM SW of Cape Liptrap, Victoria | 10 February 2017

ATSB Transport Safety Report
Marine Occurrence Investigation
MO-2017-003
Final – 24 May 2018

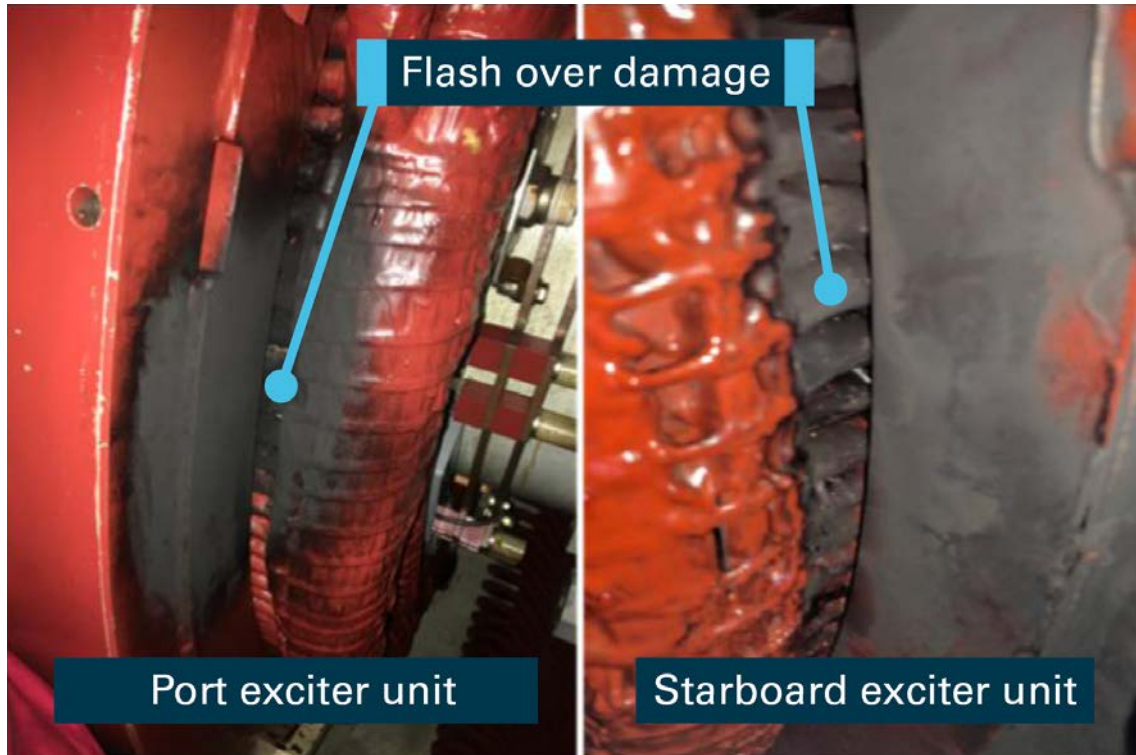
Figure 5: Flashover damage from the port and starboard exciter units

Inspection of the starboard and port exciter units after their first-time failures (on 11 December 2016 and 24 January 2017 respectively) found evidence of flashover marks on the stator windings in both units (Figure 5), suggesting a similar cause of the flashover and failure.

There are a number of factors that can lead to flashover, including insulation breakdown and insulation damage as a result of bearing failure. Post-incident inspection by Norwegian Cruise Line Holdings Ltd (NCLH) found no evidence of bearing failure and therefore this has been discounted as a possible failure mechanism.

Based on the evidence available, deterioration of the insulation material remains the most probable cause of the failures of the brushless exciter units. *Norwegian Star's* Azipods were the oldest in the fleet and had the highest running hours. Age, heat, moisture and contamination are all possible factors that may have contributed to this deterioration.

The Australian Transport Safety Bureau recommends that NCLH reviews the shipboard processes for monitoring the condition of the brushless exciter units used in Azipod installations. The review should incorporate findings from the examination of the failed equipment following the dry docking of *Norwegian Star*.

The Australian Transport Safety Bureau recommends that ABB reviews the manufacturer's instructions for monitoring the condition of the brushless exciter units used in Azipod installations. The review should incorporate findings from the examination of the failed equipment following the dry docking of *Norwegian Star*.

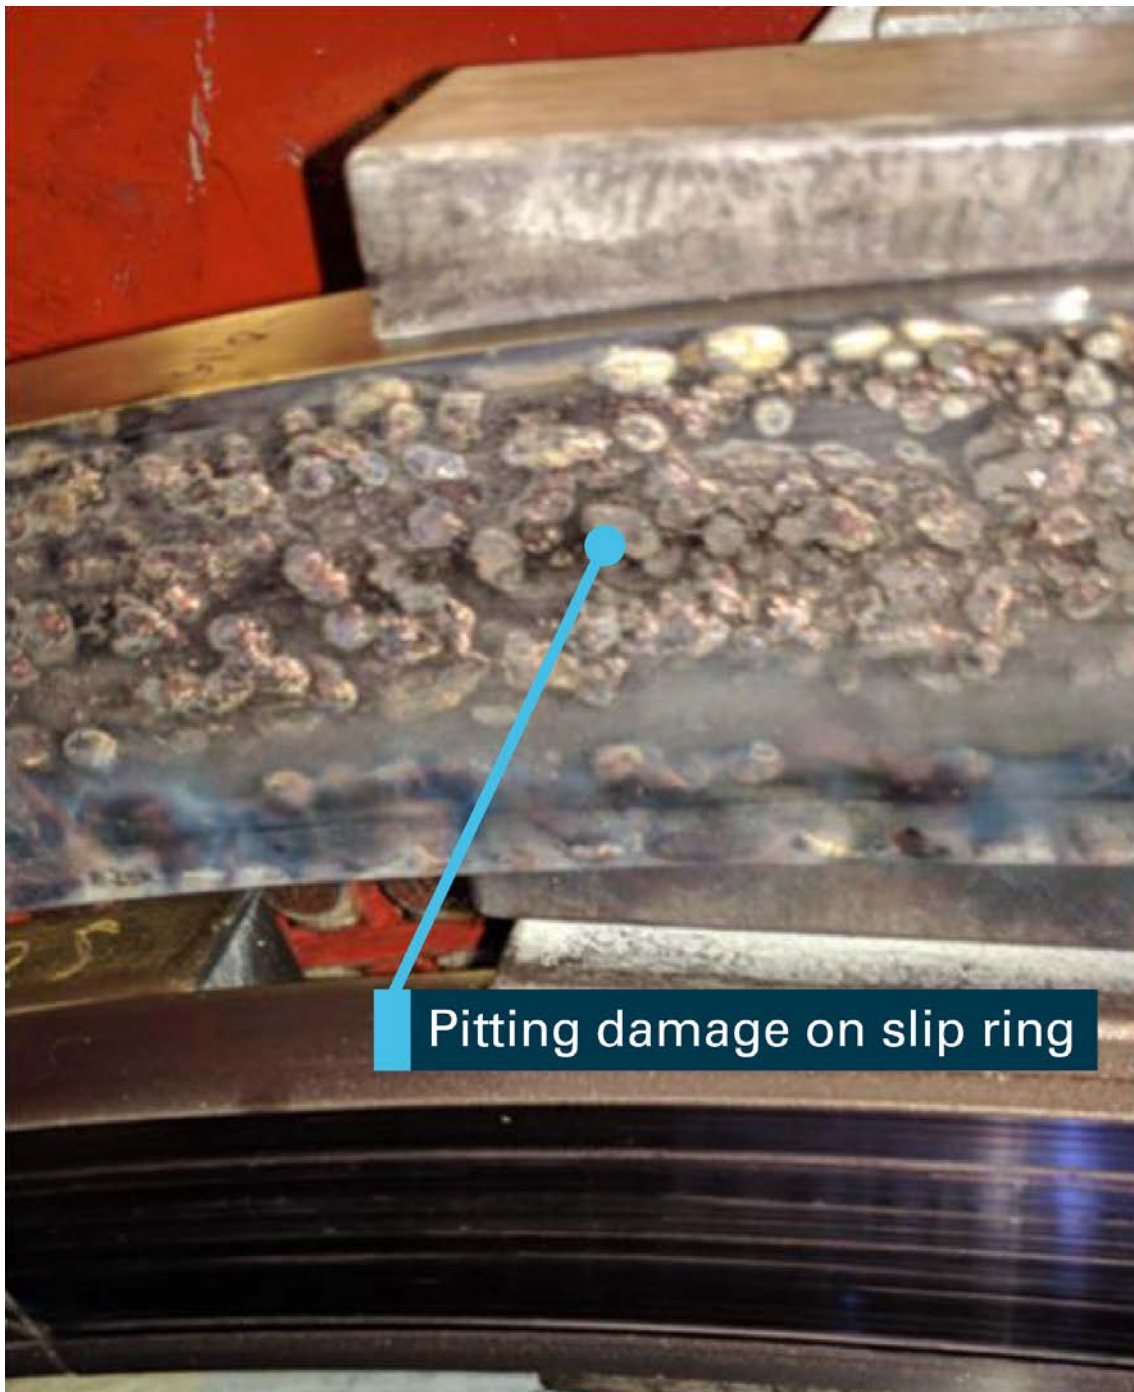
Figure 6: Arcing damage on the outer slipring

On 10 February 2017 while *Norwegian Star* was transiting Bass Strait, the modified exciter unit installed on the starboard propulsion unit failed, rendering the ship without propulsion. Pitting on the outer slipring was observed (Figure 6). Brush holders were also damaged (Figure 7).

Detailed examination and assessment by ABB found that the damage to and failure of the unit was the result of insufficient clearance between the brush holder and sliprings. It was identified that axial movement and thermal expansion of components was more than had been allowed for in the design.

- The cause of grooving found on the sliprings of the modified starboard exciter unit was not explored nor remedied prior to the failure of the unit. The slipring grooving was probably a precursor event to the unit's failure.

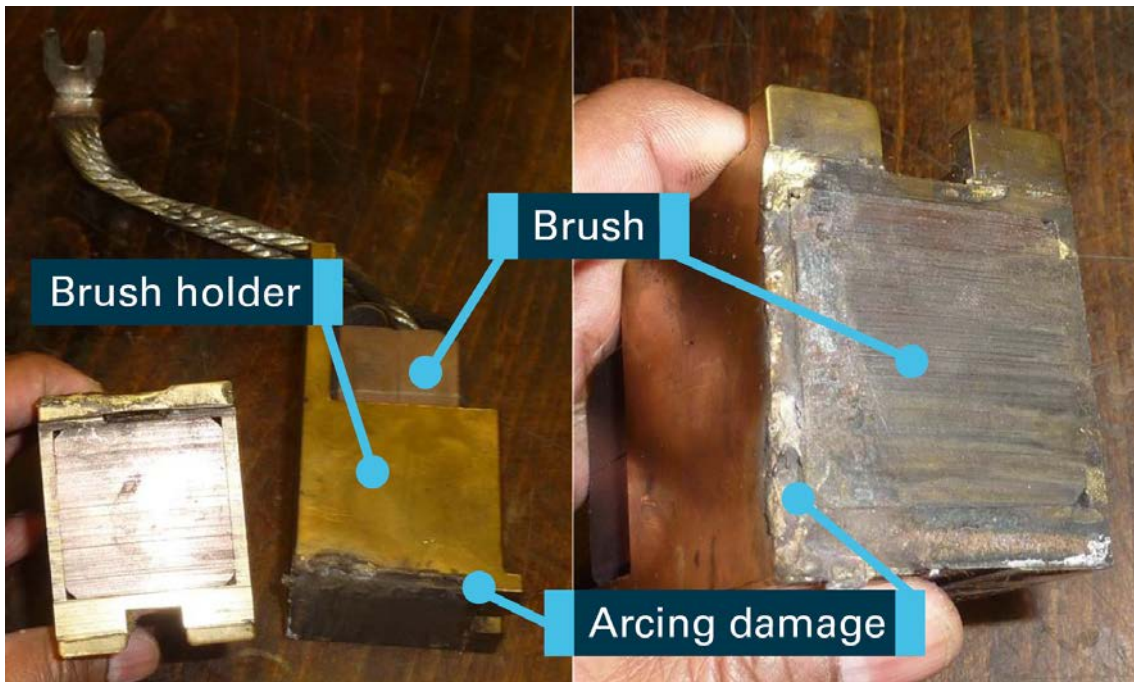
Figure 7: Arcing damage to brush holders

- There was an error made in the design of the modified exciter unit used in the repair of the starboard propulsion unit. Clearance between the brush holders and the sliprings was less than required.
