Office of the Chief Investigator  
Transport Safety

**Marine Safety Investigation  
Report No 2010/14**

**Capsize of  
Vessel 'The Ultimate'  
Off Point Nepean  
12 December 2010**

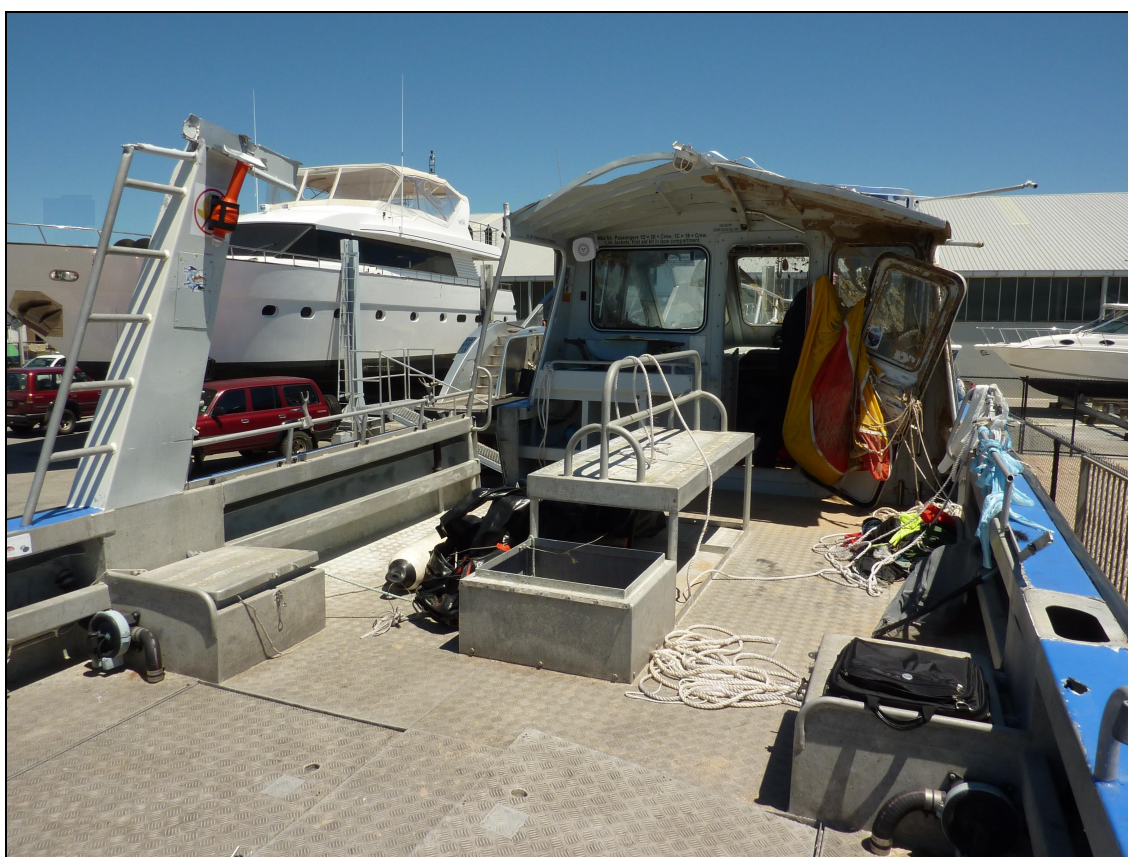
**Figure 4 - The Ultimate after capsizing**

Subsequent to the incident, the vessel was transported to Queenscliff harbour and inspected. There was no noticeable damage to the vessel hull or the stern drives. However, most of the wheelhouse equipment, propulsion machinery and electrical systems were unserviceable due to seawater damage. Various tools and personal life saving appliances were scattered around the wheelhouse and rope, fishing equipment and the sea anchor were dispersed on the external deck area.

The wheelhouse controls were caked with sand and several gauges and an indicator panel had broken away from their mountings. A significant amount of sand was also found in the forepeak compartment of the vessel. The upper hinge of the watertight door of the wheelhouse was ripped out and the door was hanging ajar from the lower hinge that was still attached to the bulkhead.

The awning, the starboard awning support and side framing and screens had been ripped off the vessel. A number of cracks were present across the welds in the areas around the fixed awning supports and on the weather deck gunwale top and side plates.

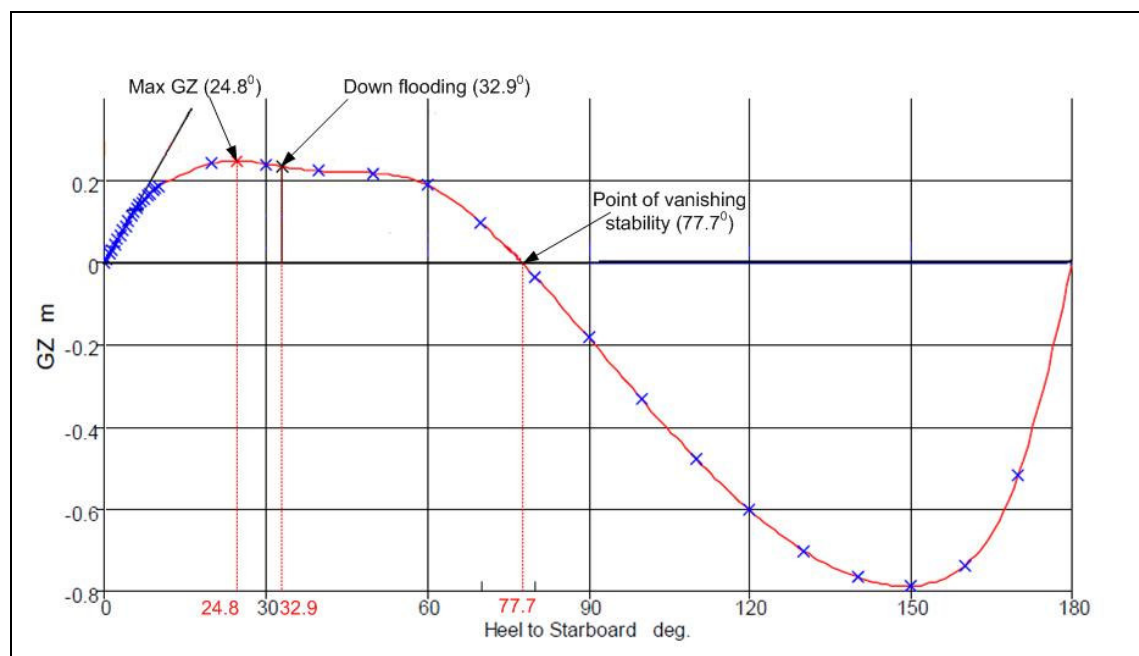
**Figure 10 - Curve of statical stability (GZ curve) for arrival condition with 3 crew and 9 passengers**

In the incident load condition, the only criterion not satisfied was the area under the GZ-curve between 30 and 40 degrees heel due to the truncation of the GZ-curve (and therefore truncation of the under-curve area) at 32.9 degrees, the assumed point of downflooding. In the incident condition, this criterion and therefore all stability criteria would be met if the angle of downflooding was greater than 40 degrees.

Figure 10 shows the vessel's GZ-curve for the incident condition and the flattening of the curve after about 20 degrees inclination.

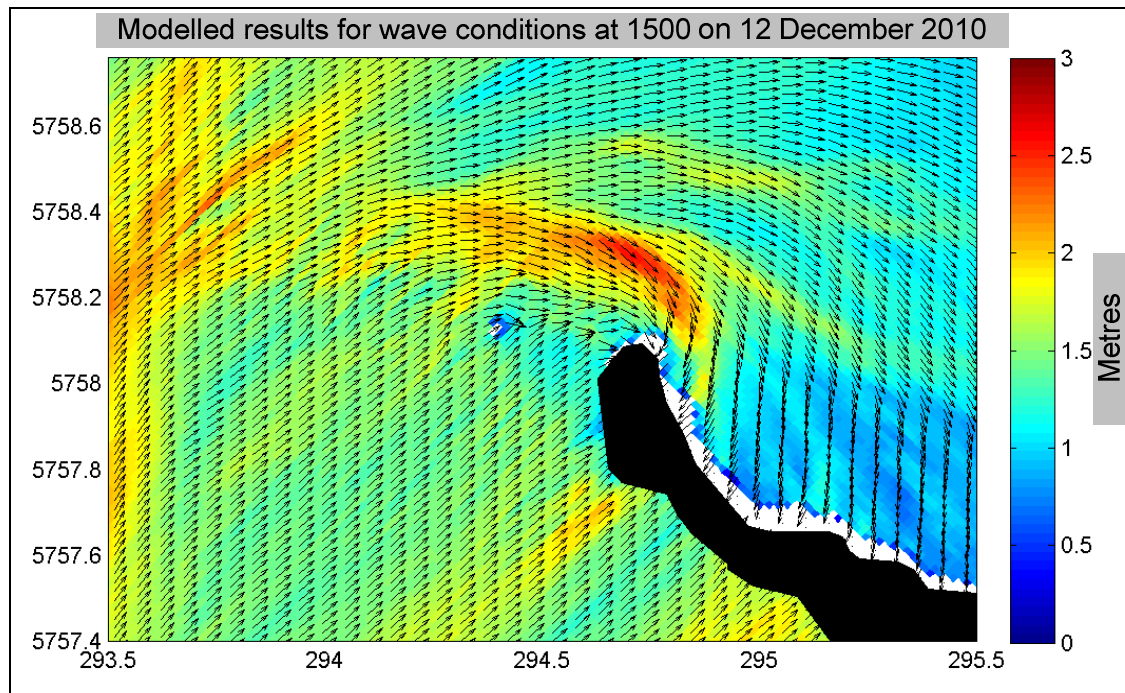
**Figure 13 - Model results for the wave conditions adjacent to Pt Nepean at approximately 1500 on 12 December 2010**

Modelling indicates that incoming waves refract towards Point Nepean. The modelled significant wave heights in the assumed area of operation indicate that waves of between 2.0 metres and 2.5 metres may be generated in this area. These are average wave conditions and are the result of a combination of the incoming wave conditions, the seabed topography, and the tidal conditions, both elevation and tidal current.
