**Marine Safety Investigation  
Report No 2008/10**

**Collision  
Police Vessel VP02-08  
and Recreational Vessel LC873  
Near the entrance to Patterson River Port Phillip  
1 November 2008**

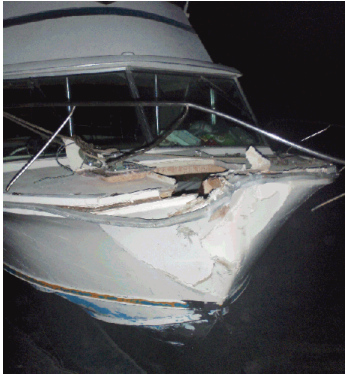
Figure 1: Damage to LC873

LC873: The bow up to about 900 mm aft of the stem bar was crushed and askew with guardrails broken. The anchor rope holding cleat was severed causing the vessel to be adrift. The keel board was split allowing some water ingress. The five occupants reported receiving minor bruising.

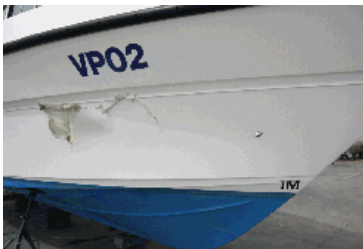
Figure 2: Damage to VP02-08

VP02-08: The starboard bow was holed over an area approximately 1050 mm x 550 mm commencing approximately 1230 mm aft of the stem bar. There was moderate water ingress. The two occupants reported that they did not receive any injury.

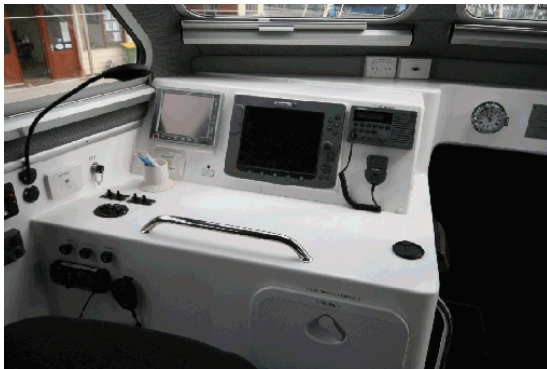
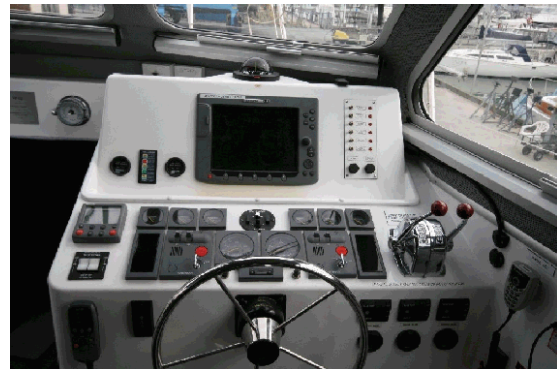
**Figure 3: Helm and Observer Stations**

When standing at the helm position, the starboard corner strut caused a blind sector of about 15 degrees, between about 35 and 50 degrees to the right of the helmsman and the starboard inboard strut caused an obstruction of about 11 degrees, between about 24 and 35 degrees to the left of the observer. The two struts on the port side would have caused similar blind sectors to the observer.
