Office of the Chief Investigator
Transport Safety

**Marine Safety Investigation
Report No 2015/01**

Collision
Recreational vessel *Who Cares* and № 6 Beacon
West Channel, Port Phillip Bay
13 December 2015

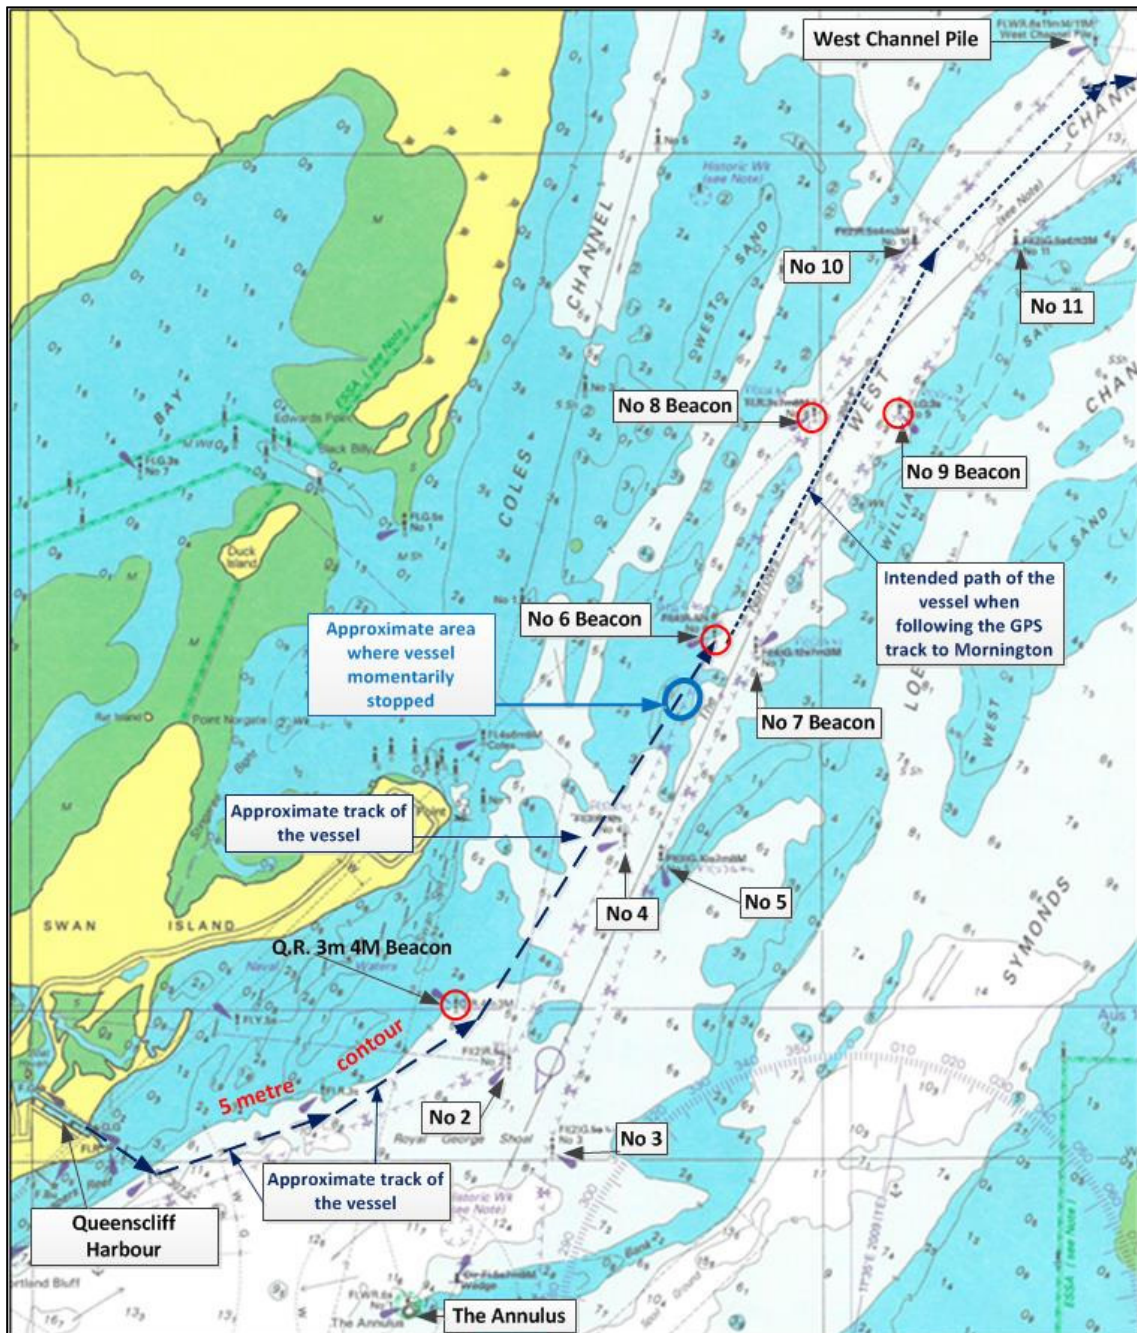
Figure 1: The West Channel and the estimated track of Who Cares. № 13 beacon (not in picture) was about 900 m to the south east of West Channel Pile

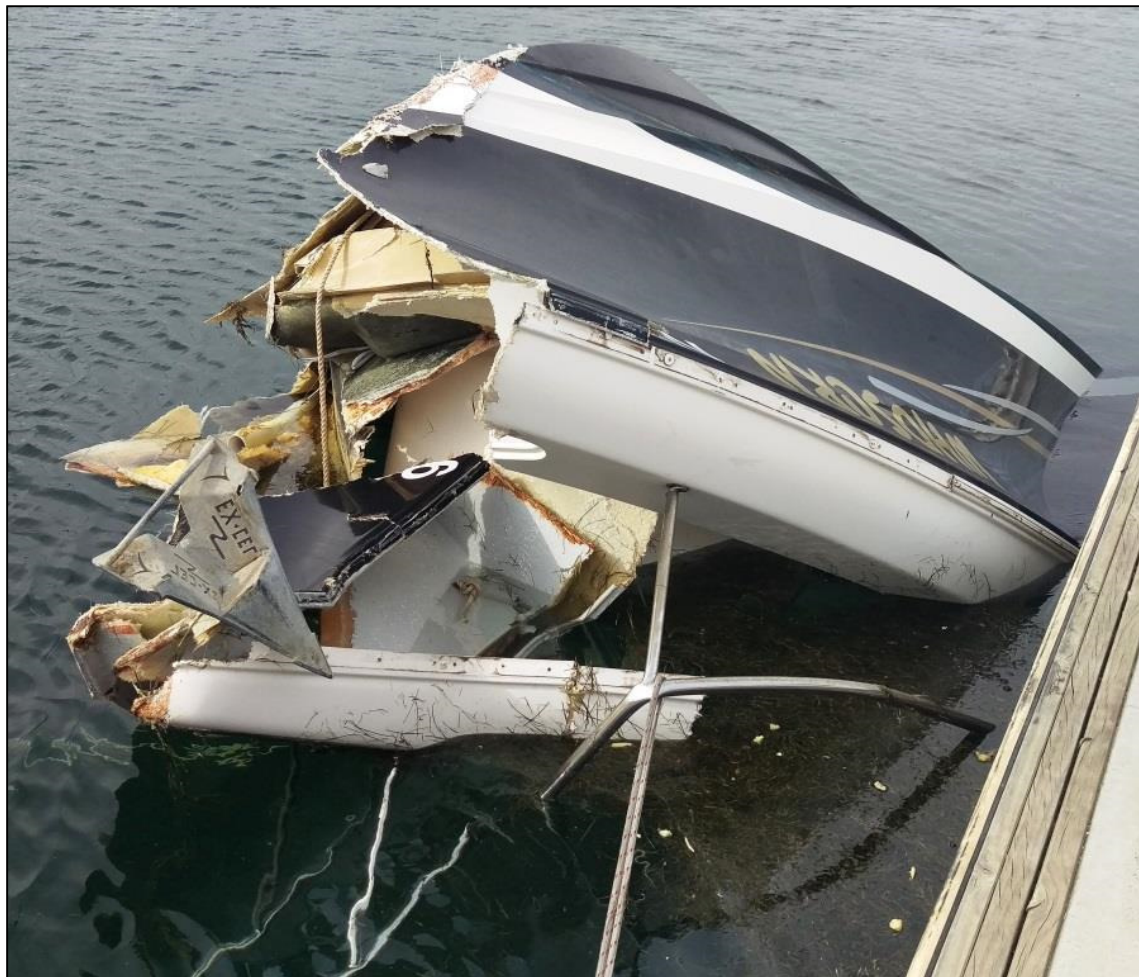
As a result of the collision, two passengers sitting aft were thrown forward and suffered serious injuries. Two passengers in the forward cabin and the skipper suffered bruising. The bow of the vessel suffered severe impact damage and the vessel subsequently capsized after being evacuated (Figure 2).

Figure 2: The overturned and damaged *Who Cares* alongside at Queenscliff

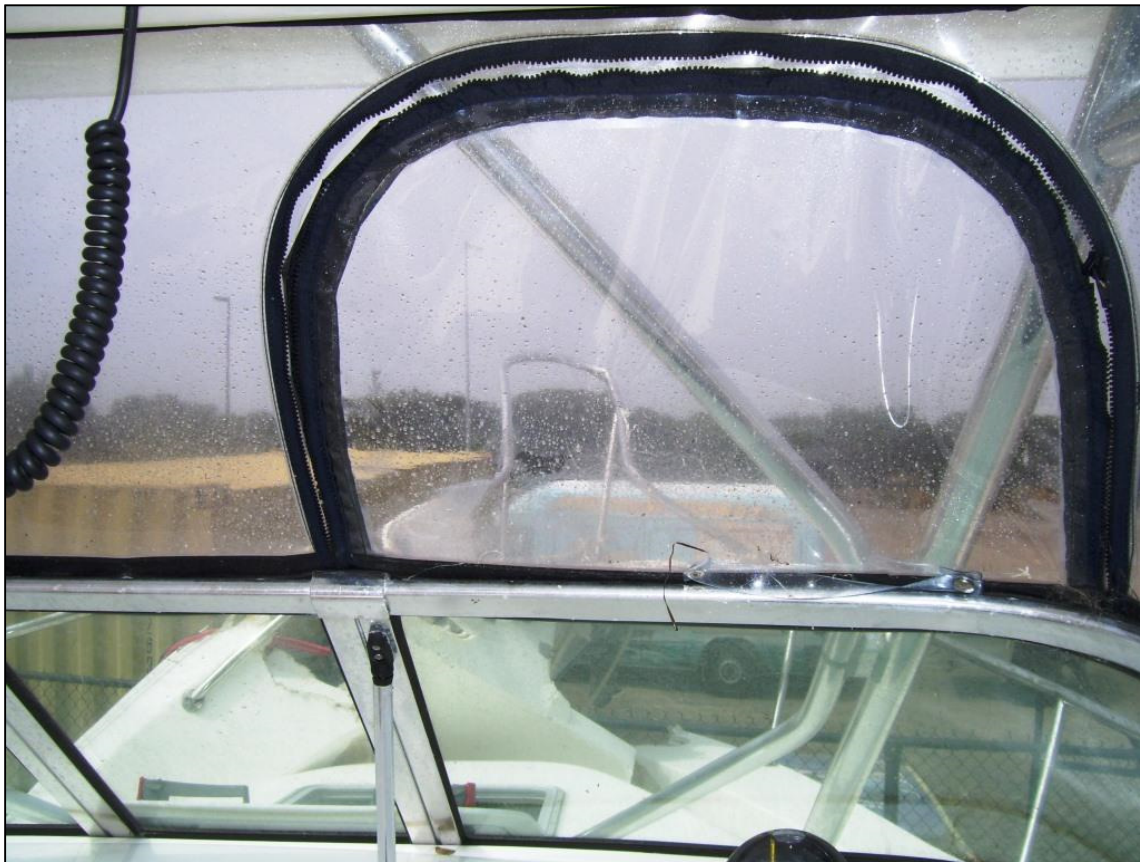
Figure 3: Forward view from the conning position

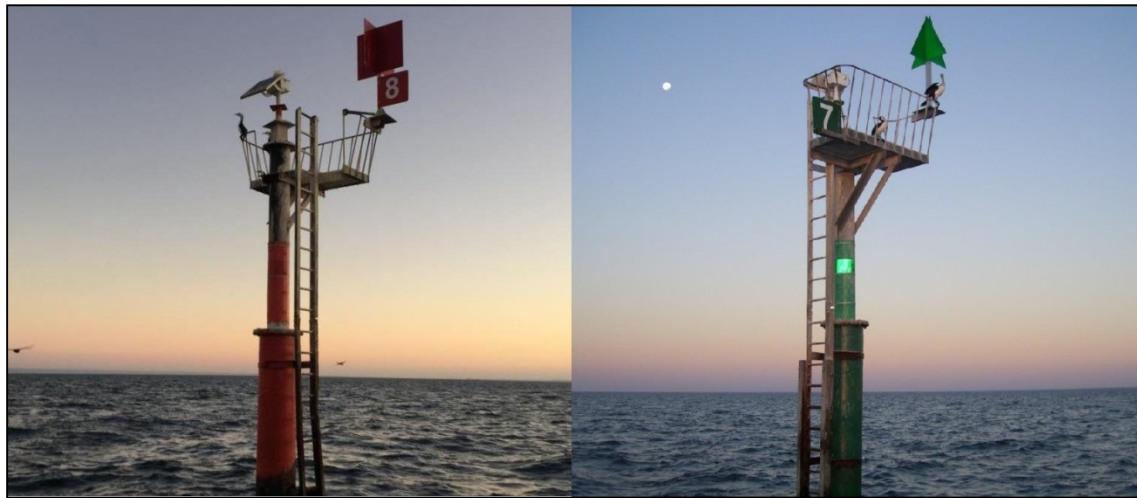
Figure 4: West Channel beacons Nos 8 (port-hand) and 7 (starboard-hand) markers. No 6 beacon was similar in design and construction to No 8 beacon shown below left

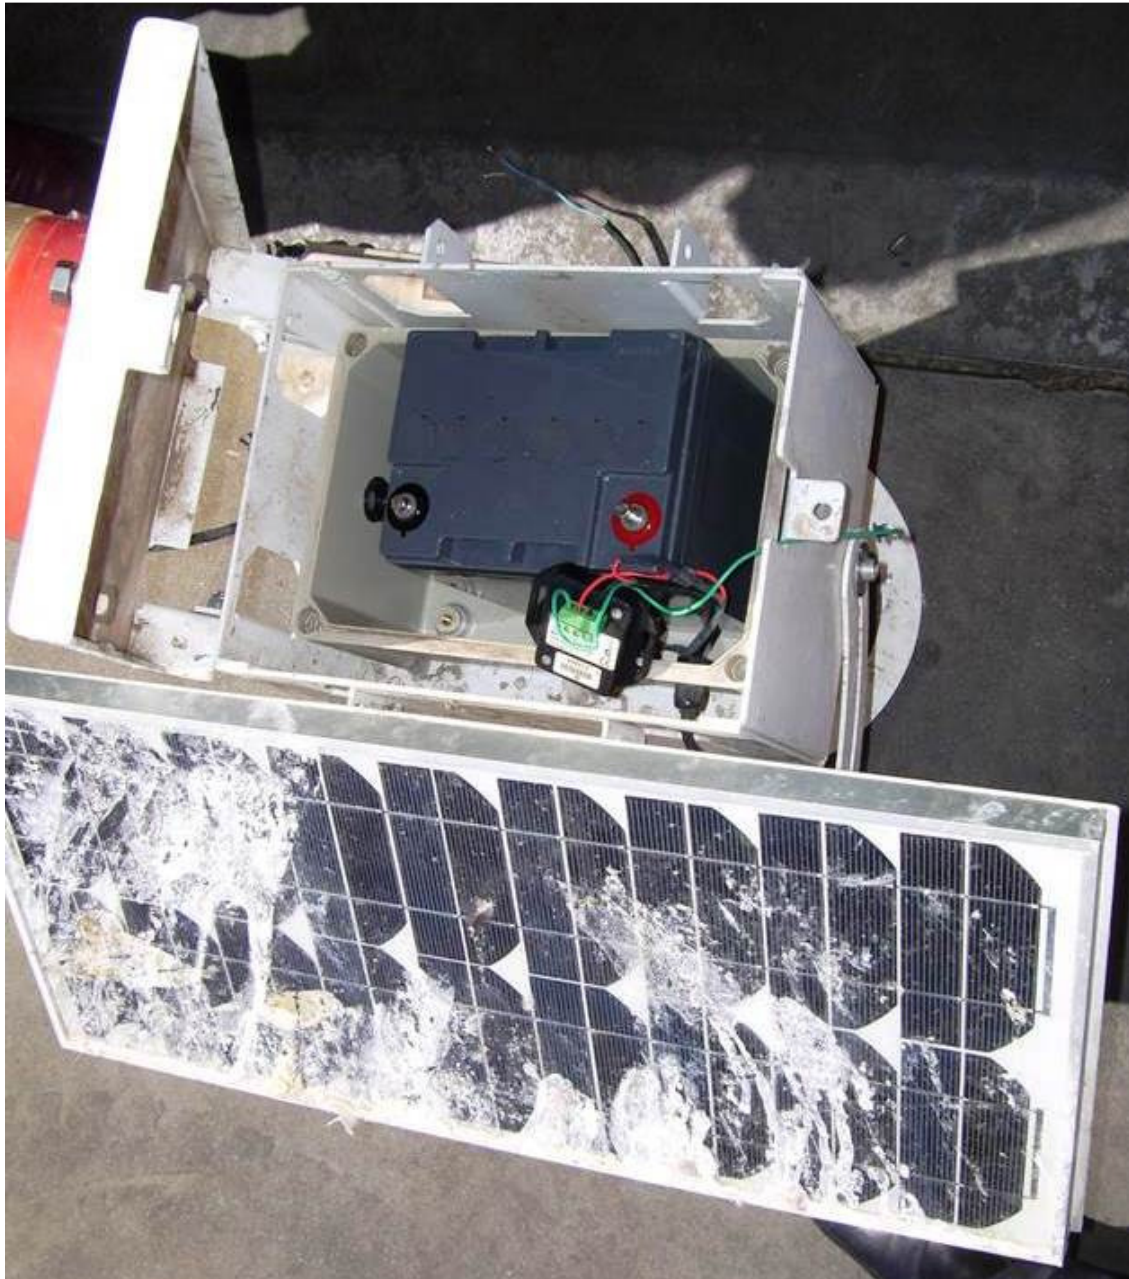
The lighting system of № 6 beacon, including the solar cell and battery, was recovered and transported to the manufacturer (Sealite) for inspection (Figure 5). With the solar cell exposed to sunlight, the battery charged sufficiently for the lantern to operate normally.

Figure 5: Solar cell, charging unit and battery of № 6 beacon at Sealite workshop

There was considerable coverage of the solar cell with bird droppings and markings that indicated that coverage of the cell was probably more extensive prior to the unit's recovery.

Bird droppings had covered a substantial area of the solar cell of № 6 beacon. As no other critical fault was found, it is probable that coverage of the solar cell was the primary cause of degraded lighting system performance and the outage.

This action significantly reduces the issue of bird dropping obscuring the solar cells but does not replace the requirement for inspection and monitoring of the beacon light performance.

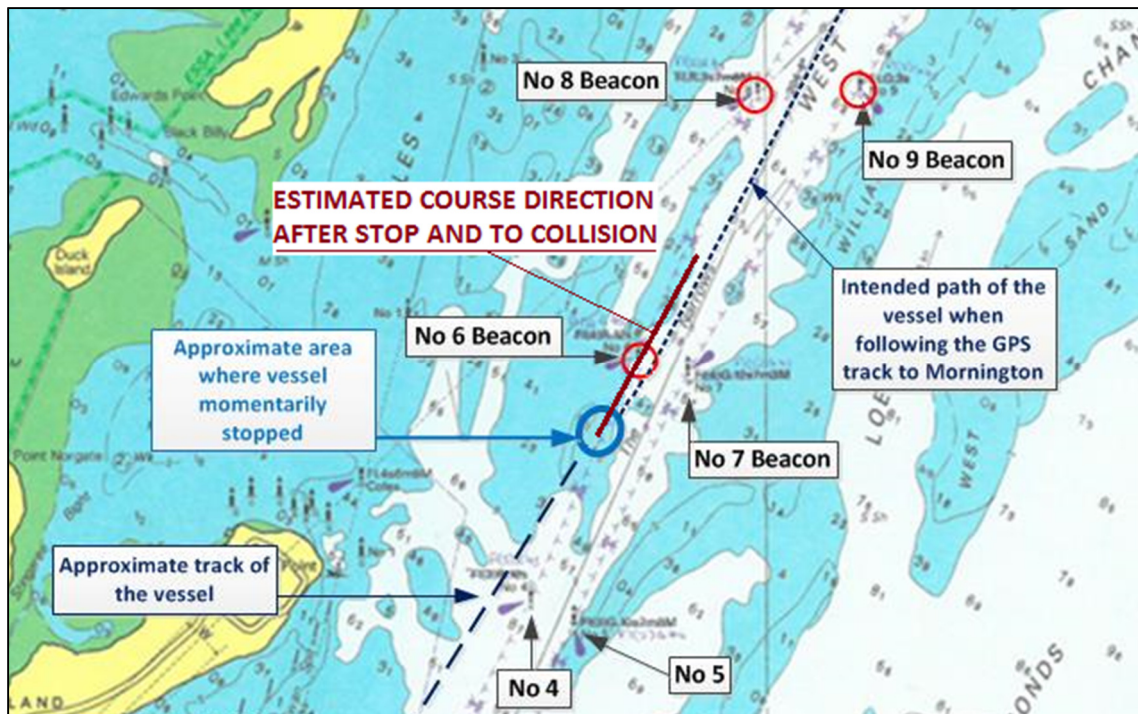
At this point the skipper altered his method of navigation, from equipment-aided navigation to visual. On resuming his voyage, he made a course to pass between the next pair of observed lights on № 8 and № 9 beacons. This course took him on a path to the west of that he would normally take, and he collided with № 6 beacon (Figure 6).

Figure 6: The estimated course of *Who Cares*, leading to the collision with № 6 beacon

Instead, the skipper observed the lights on the port and starboard beacons № 8 and № 9. The skipper made a course to pass between these beacons probably in the belief that they were the next pair of channel beacons marking the channel edges. However, this course was to the west of his normal path, and the vessel collided with № 6 beacon.
