Office of the Chief Investigator
Transport and Marine Safety Investigations

**Marine Safety Investigation
Report No 2007 / 07**

Collision between
Livestock Carrier “MV BISON EXPRESS”
and Ore Carrier “MV PORTLAND”
Port of Portland
22 May 2007

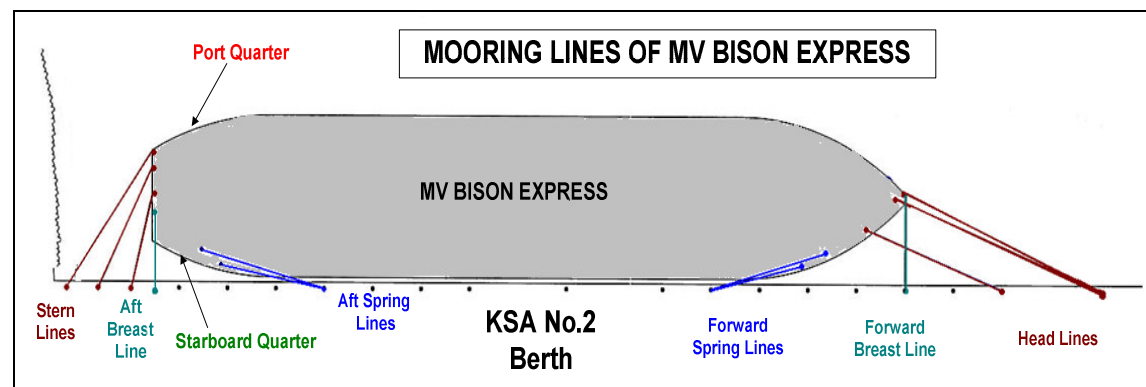
Figure 1. Mooring arrangement of MV Bison Express.

The vessel was berthed starboard side alongside at berth No.2 of the KS Anderson (KSA) wharf (Appendix A) and moored with three head lines (bow lines), one forward breast line, two forward spring lines, three stern lines, one aft breast line and two aft spring lines.

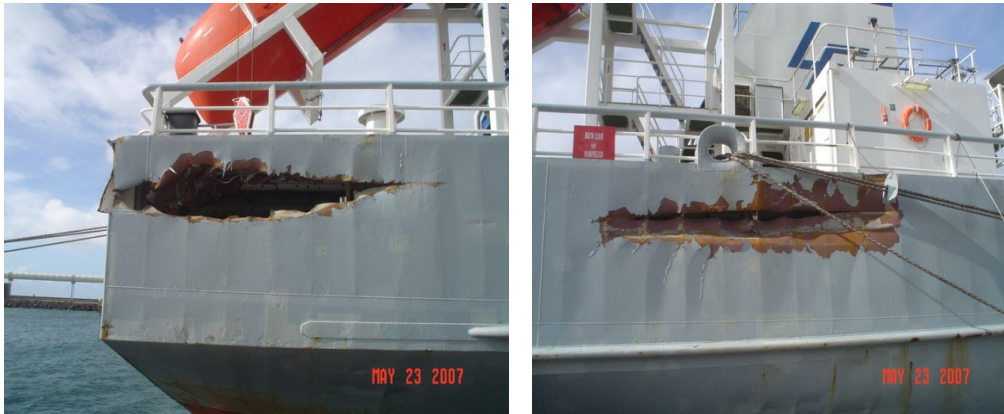
Figure 2. MV Bison Express ship side damage.

The starboard aft side of MV Bison Express sustained hull plate damage in two areas. A hole of up to one metre wide extended from the transom for approximately 5.5 metres to hull frame eight and a 4.5 metre rip from frames 11 to 19.

The chief officer said that he felt the impact of MV Bison Express on MV Portland and then observed two holes on the starboard quarter of MV Bison Express as it passed MV Portland. He stated that the master of MV Portland entered the bridge and they both observed MV Bison Express clear the breakwater.

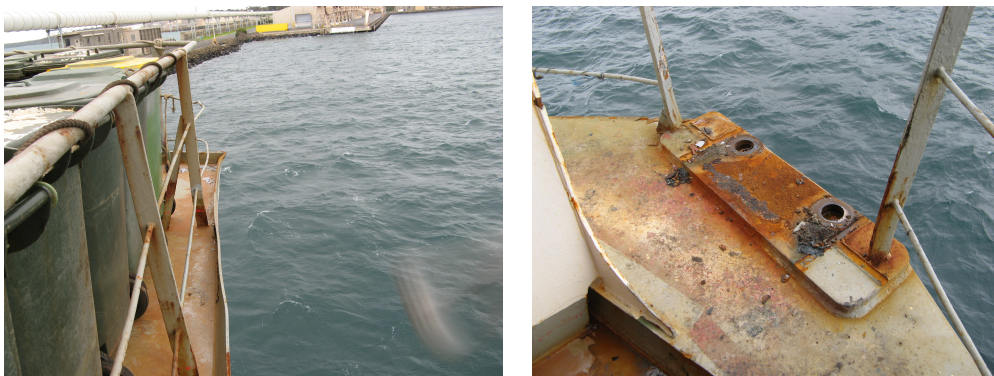
Figure 3. Damage to MV Portland.

The MV Portland's port quarter hull plating sustained some indentation, the guard rails were stoved in and the roller fairlead assembly, located on the sponson, was dislodged from its mountings.

The master of MV Portland stated that he was in his cabin at the time of the incident and it was purely by chance that he observed MV Bison Express through his cabin port-hole. After he felt the impact he went to the bridge and observed MV Bison Express navigate past the breakwater. The master then made an assessment of the damage to his vessel, which he observed to be a damaged fair lead roller assembly and some minor hull damage to the port quarter.

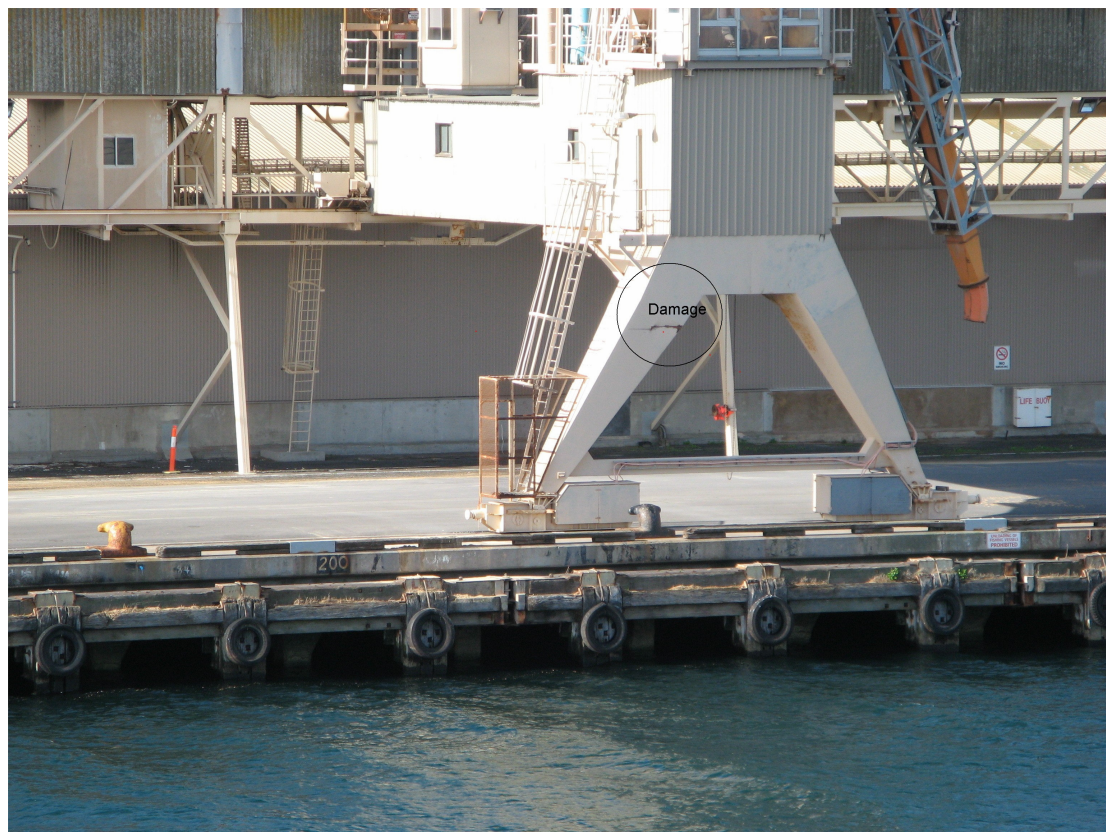
Figure 6. Damage to grain loader foot.

The vessel moved approximately 130 metres forward when the vessel's starboard quarter contacted the grain loader, resulting in minor damage to the vessel and the loader. The vessel continued a further 200 metres past No.1 berth when its starboard quarter contacted the end of the wharf and then another 330 metres before colliding with MV Portland which was berthed at the smelter berth.

The grain loader sustained minor damage to its left foot.
