Office of the Chief Investigator
Transport Safety

**Rail Safety Investigation
Report No 2009/07**

**Derailment
Pacific National Train 9564
ABB Siding, Dandenong
1 June 2009**

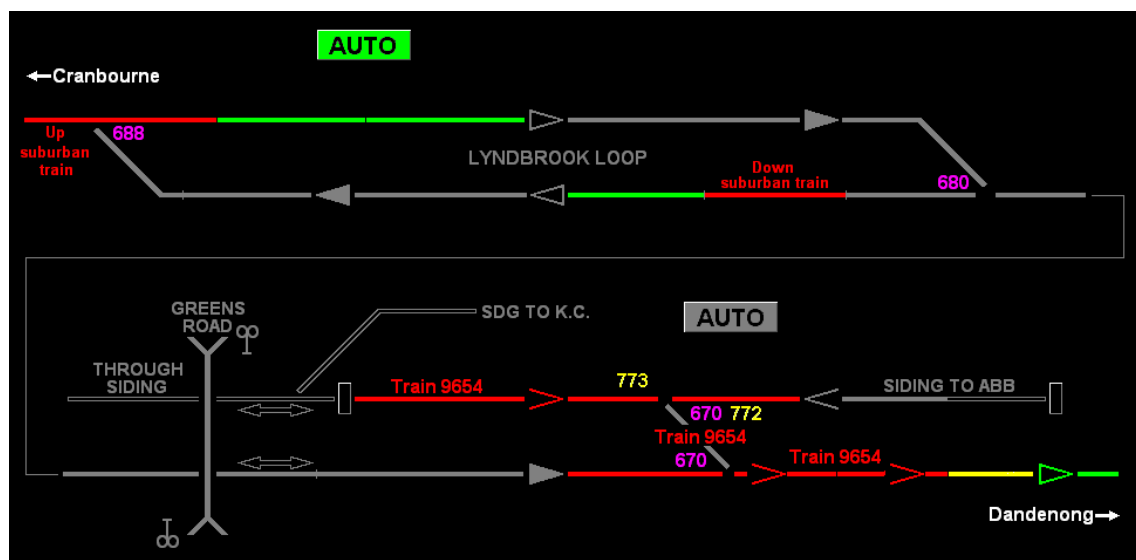
Figure 2 – Train locations and System conditions at Lynbrook Loop and the Through Siding at time of derailment.

The automatic route request by the system was the 'trigger' event that resulted in points 670 moving from 'reverse' to 'normal' as the ninth vehicle of train 9564 travelled over them. The lead bogie of the ninth vehicle (VHQB-204C) was travelling through the points towards the mainline while the rear bogie travelled towards the ABB siding causing the bogie to derail about six metres beyond the points. The derailment resulted in damage to an Explorer passenger car, 670 points and destroyed dwarf signal DNG772.

This particular combination of train movements and system status was the first such occurrence since the system was upgraded on 17 May 2009. The result was a 'wrong side' failure of the signalling system.

The investigation found that a data programming error caused the design to fail in two places by:

- (1) locking other signal routes requiring the points in the opposite position, and
- (2) allowing 670 points to move while a train was traversing them.
