Office of the Chief Investigator  
Transport Safety

**Marine Safety Investigation  
Report No 2017/05**

Engine fire  
Hire and Drive vessel MB22M  
Lakes Entrance  
03 October 2017

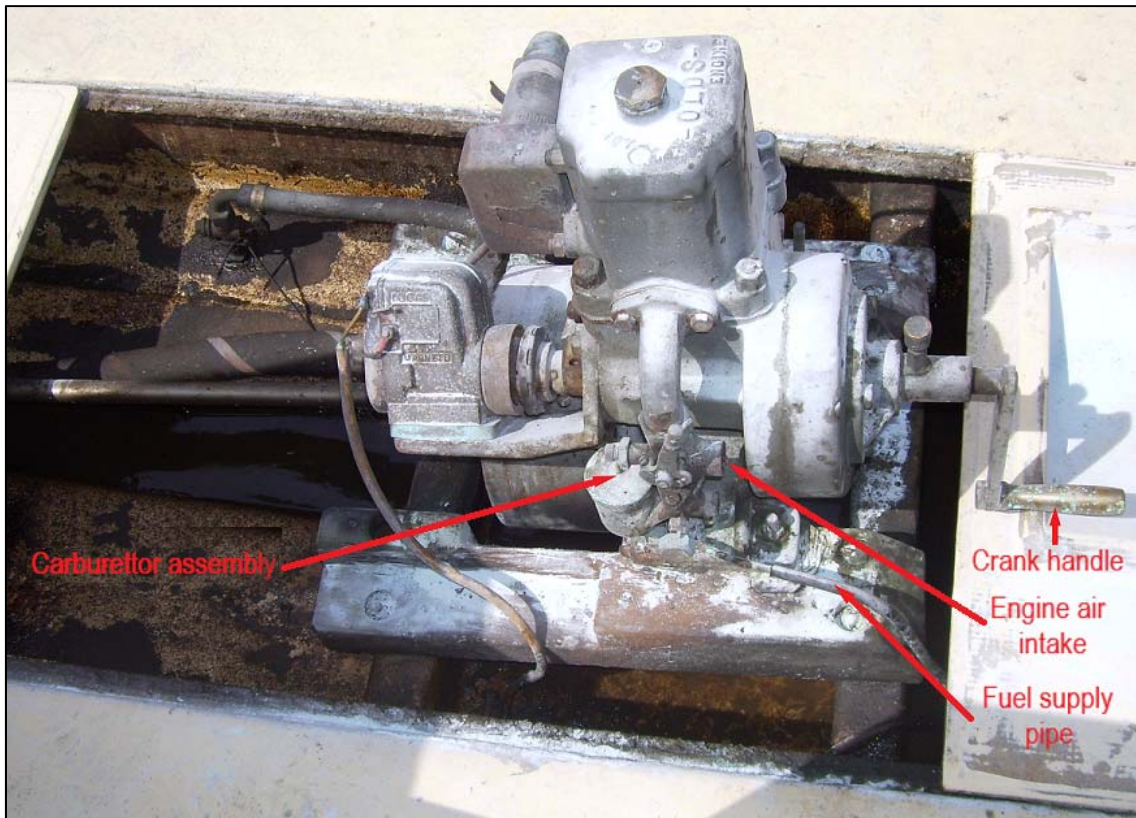
There was a mixture of water, oil, and dry chemical powder (from the discharge of a portable fire extinguisher) in the bilge of the boat, as well as a strong smell of petrol. The engine was coated with dry chemical powder (Figure 5).

Figure 5: Inboard petrol engine with cover removed, photographed after the incident

There were also soot deposits, consistent with a flash fire, on the under-side of the engine cover and in the air intake. The carburettor drip tray had been displaced and was found loose in the bilge.

It is probable that the source of the fuel was an overflow from the carburettor. It is possible that either the sticking of the float valve (that regulated the quantity of petrol in the carburettor) or the accumulation of dirt on the fuel inlet valve seat in the carburettor resulted in petrol overflowing from the carburettor and out of the air intake into the engine space. It is also possible that there was a leak at the fuel line connection to the carburettor. The engine cover had no vents apart from an aperture to accommodate the crank handle shank.<sup>13</sup> As a result, vaporised fuel could accumulate in this space.

Victor Boat Hire and the two other boat hire fleets at Lakes Entrance with inboard petrol engines have replaced engines on their hire boats with outboard engines.

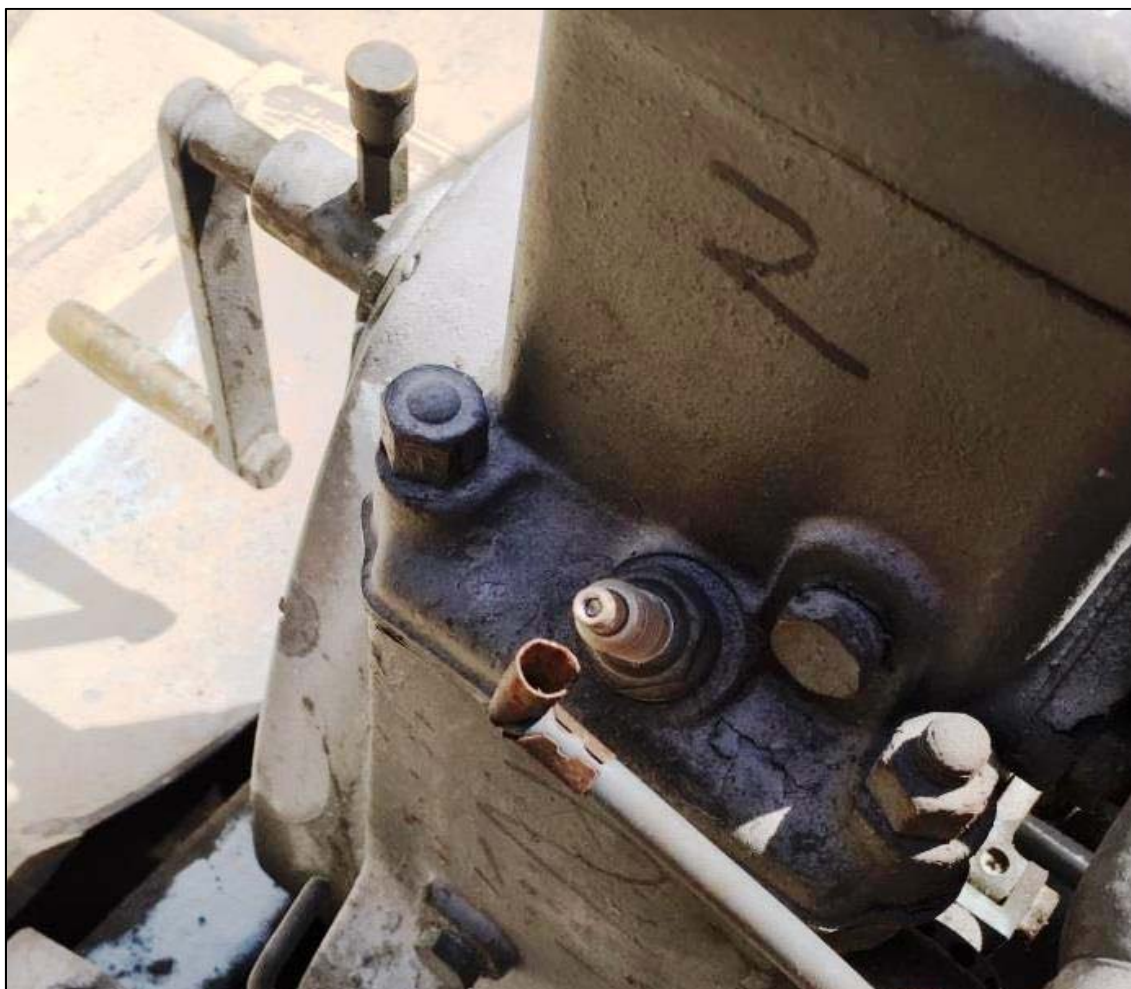
The right-angled terminal connection between the high-tension ignition lead and spark plug was loose-fitting (Figure 6), indicating that the metal-to-metal electrical connection was probably unreliable. This terminal connection was exposed, and not enclosed with a protective boot. Other boats inspected in the fleet were fitted with a different and more electrically-secure connection than MB22M.

**Figure 6: Connecting arrangement between high-tension lead and spark plug. The terminal connection could easily be lifted from the spark plug as shown**

The probable ignition source was a spark at the loose-fitting terminal connection between the high-tension ignition lead and the spark plug during hand cranking. It is probable that the ignition lead terminal connector had loosened over time, reducing the effectiveness of the electrical connection and possibly also contributing to the difficulty in starting the engine. In addition, the spark plug connector was not protected by a rubber boot.
