Office of the Chief Investigator
Transport Safety

**Rail Safety Investigation
Report No 2017/07**

Collision
Trams 6042 and Tram 6019
Nicholson Street, Melbourne
15 October 2017

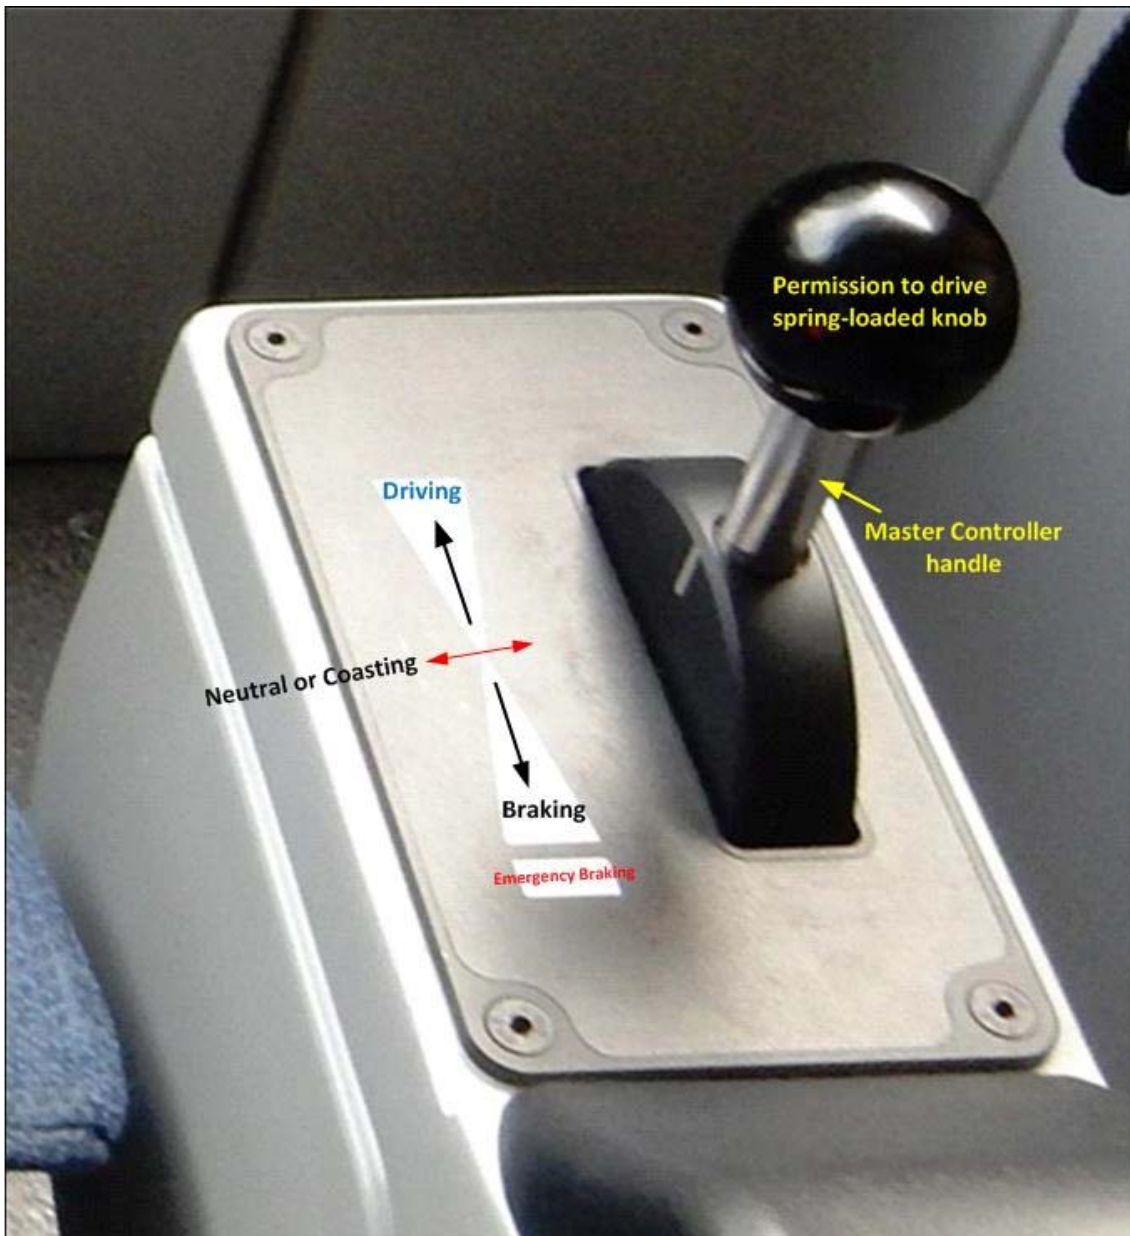
Figure 3: Master Controller

All driving controls are installed on the driver's seat armrests. The master controller is installed on the right armrest (Figure 3).

The controller must be depressed to activate the driving/braking function. The handle can then be moved forward to drive the tram and backward to brake. Post-incident testing of the incident tram indicated that a downward force of about 15N was needed to activate the driving/braking function.

The deadman function is integrated within the master controller. Depressing the controller handle and maintaining the controller in its driving/braking mode will prevent a deadman system response. The force required to maintain the handle in the driving/braking mode was specified as 6N \pm 3N. This force can typically be achieved with the resting weight of the hand and forearm. Post-incident testing of the incident tram driving end found that the force required to maintain the master controller in its active position was within the specified range.

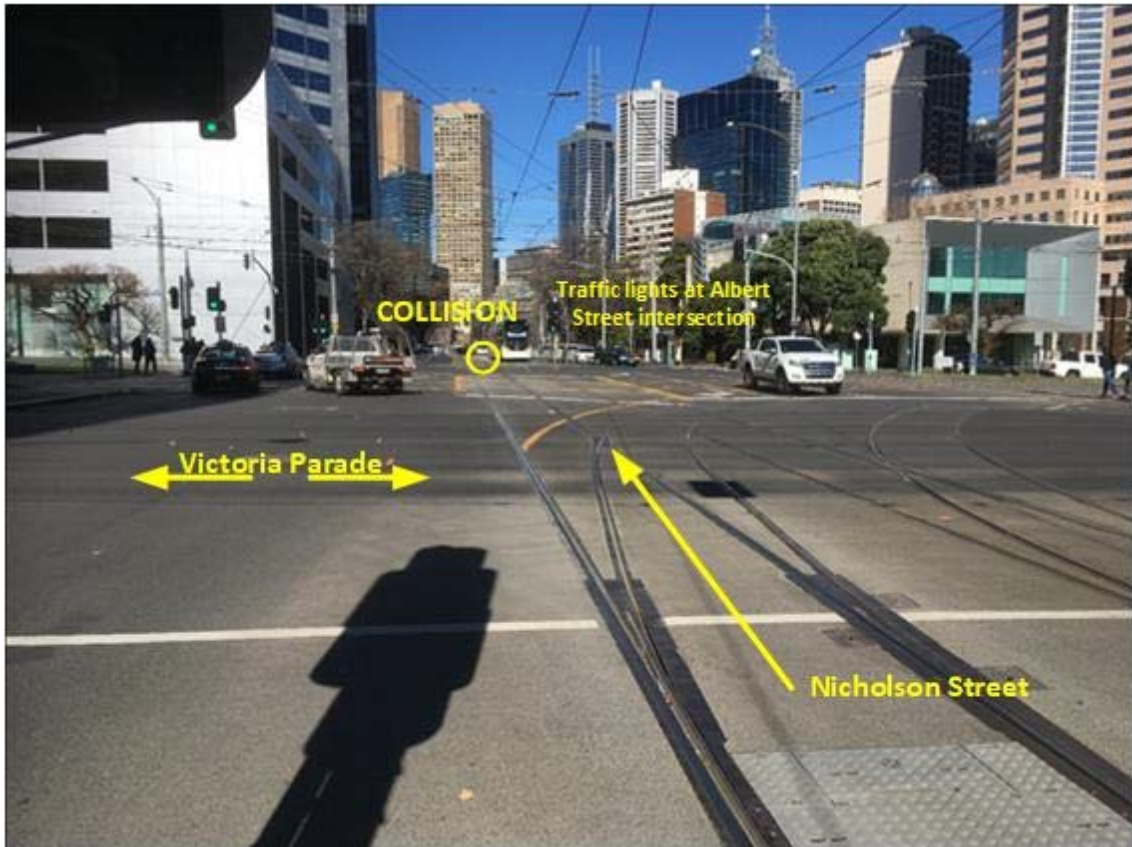
Figure 4: Looking from Stop 11, across Victoria Parade and towards Albert Street intersection

Nicholson Street is a major thoroughfare providing access to the Melbourne CBD from the north. The street runs in an approximate north-south direction, merging with Spring Street near Parliament House. The distance from Stop No 11 (north of the Victoria Parade intersection) to the rear of Tram 6019, when stopped north of the intersection with Albert Street, was about 130 m. Visibility along the tram corridor is good and the track in the vicinity of the incident dry and clean.

The driver reported feeling drowsy about nine minutes before the collision, when the tram arrived at the intersection of Smith and Gertrude Streets. Later, after departing Stop 11 at the intersection of Nicolson Street and Victoria Parade (Figure 4), there was no driver action for about 10 seconds before the collision. This equates to a travelled distance of about 60 m. This suggests that the driver lost attention between this point and impact.
