Office of the Chief Investigator
Transport Safety

**Rail Safety Investigation
Report No 2017/03**

**Collision
Tram 6008 and Tram 6005
Bourke Street, Melbourne
02 August 2017**

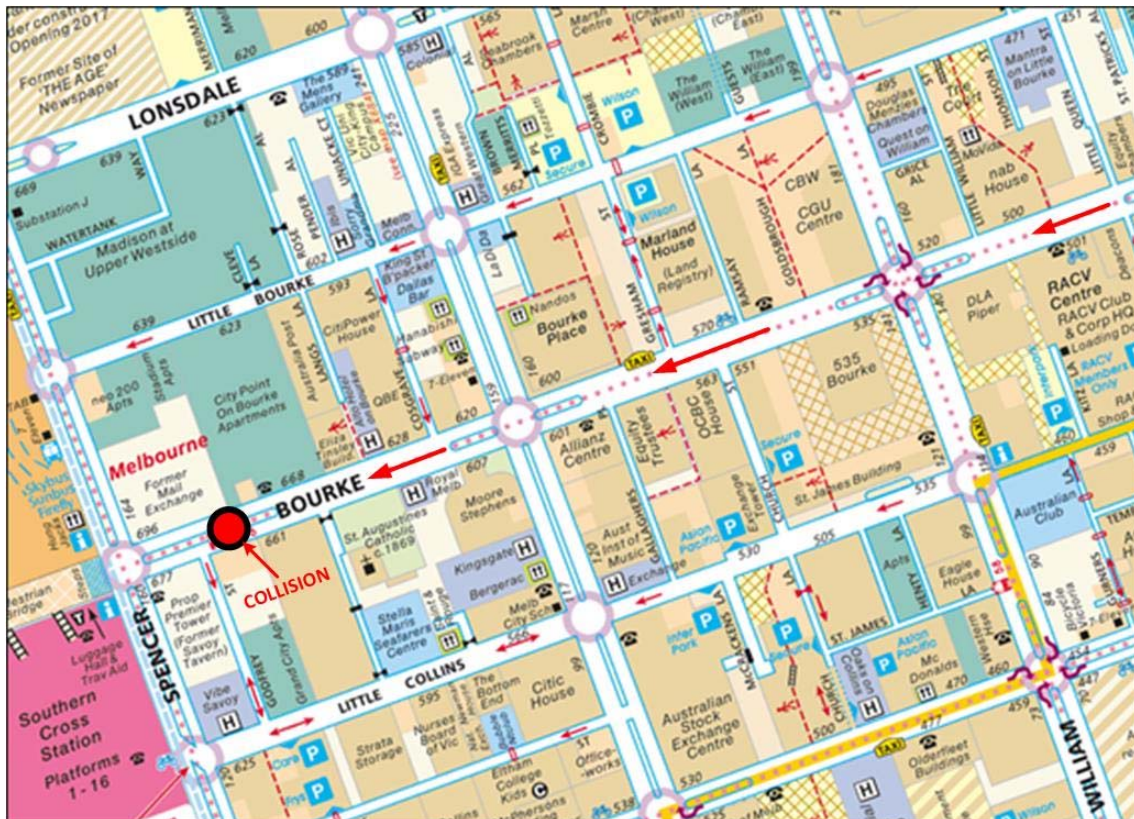
Figure 1: Bourke Street, between William and Spencer Streets and path of trams to collision point

Tram 6008 continued along Bourke Street and stopped at William Street (Stop 3) at about 1434. The tram departed this stop about 20 seconds later. At around this time, Tram 6005, ahead, was approaching the Spencer Street stop (Figure 1).

After Tram 6008 departed the William Street stop, there were several traction and braking applications made by the driver. After crossing King Street, the last recorded driver action was a brief brake command about 30 m from the stationary tram ahead. The tram master controller then remained in the coast position until collision.

Tram 6008 was travelling at a speed of about 15 km/h when it collided with the rear of Tram 6005 at about 1436. The brakes on Tram 6008 were not being applied at the time of the collision and the slight downhill grade had resulted in a small increase in speed as it coasted into the stop. Tram 6005 was stationary at the Spencer Street stop and disembarking passengers.

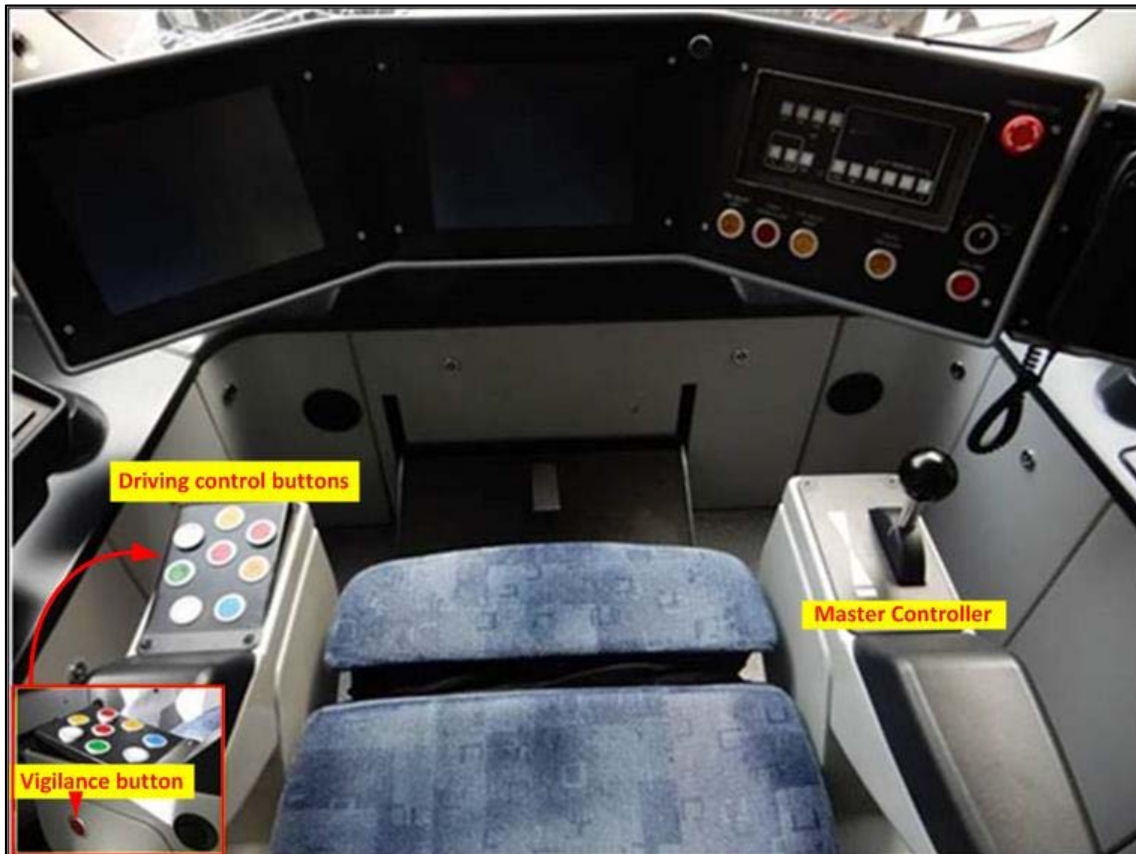
Figure 3: E Class tram driving controls. Inset: vigilance button on the side of the armrest.

All driving controls are installed on the driver's seat armrests. The master controller is installed on the right armrest and the control buttons for horn, gong, sand, door select, track brake, hazard lights and headlight flasher are on the left armrest. On the side of the left armrest is the red vigilance button (Figure 3).

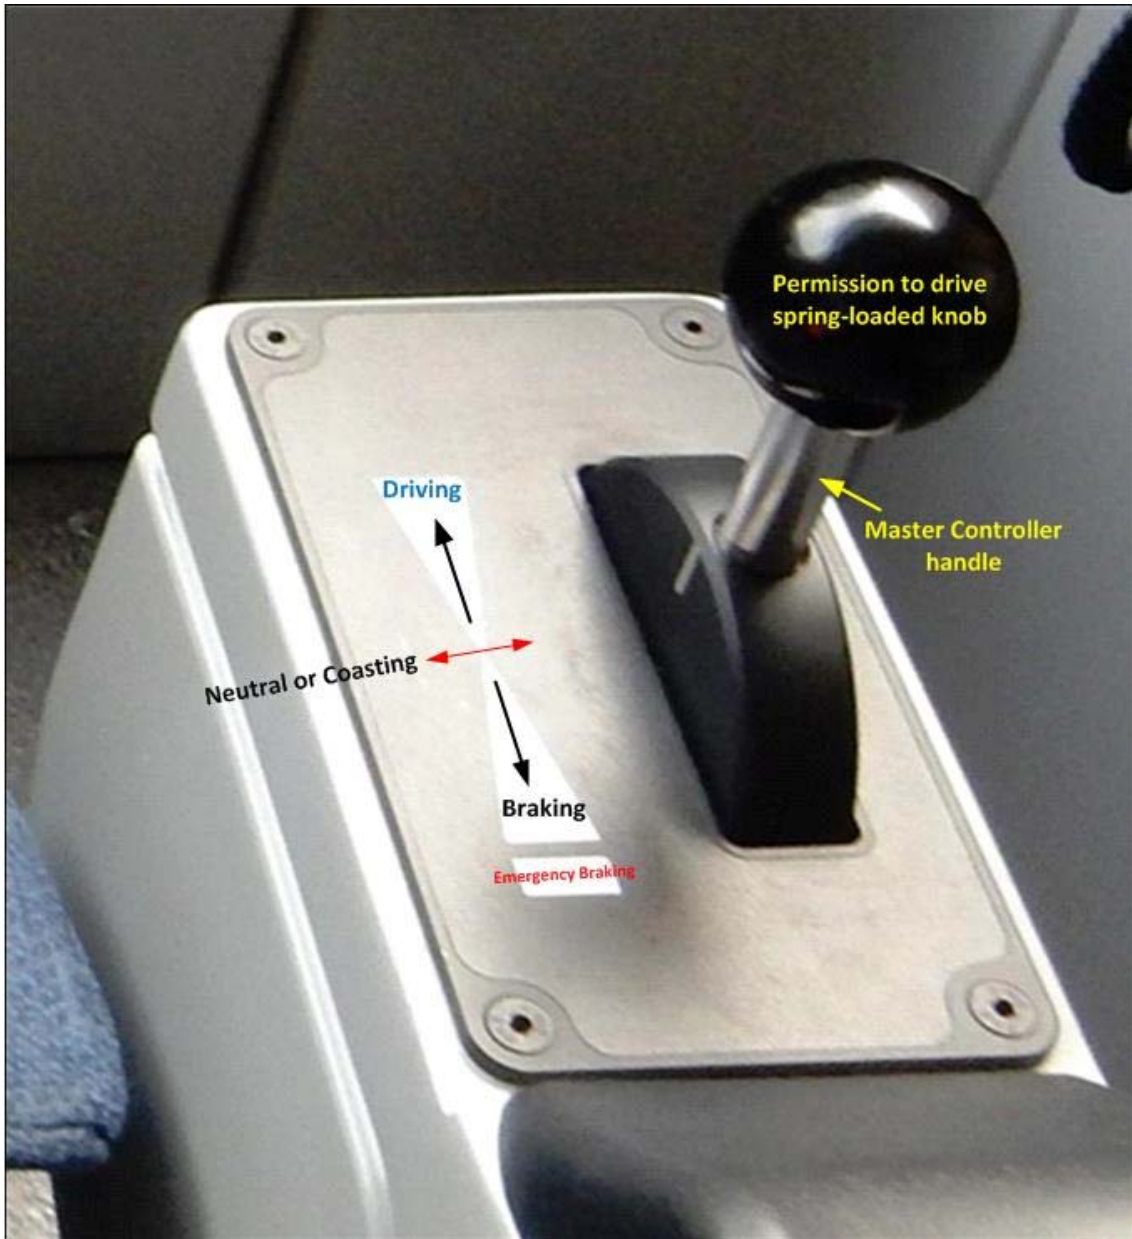
Figure 4: Master Controller

On the E Class trams, traction and braking are controlled by a master controller (Figure 4). The controller must be depressed to activate the driving/braking function. The handle can then be moved forward to drive the tram and backward to brake. Post-incident testing of the incident tram indicated that a downward force of about 15N was needed to activate the driving/braking function.

The deadman function is integrated within the master controller. Depressing the controller handle and maintaining the controller in its driving/braking mode will prevent a deadman system response. The force required to maintain the handle in the driving/braking mode was specified as $6\text{N} \pm 3\text{N}$. This force can typically be achieved with the resting weight of the hand and forearm. Post-incident testing of the incident tram driving end found that the force required to maintain the master controller in its active position was within the specified range.

If the master controller is released, there is a rapid system response. The response includes acoustic and visual warnings, followed 2 seconds later by a forced braking application.

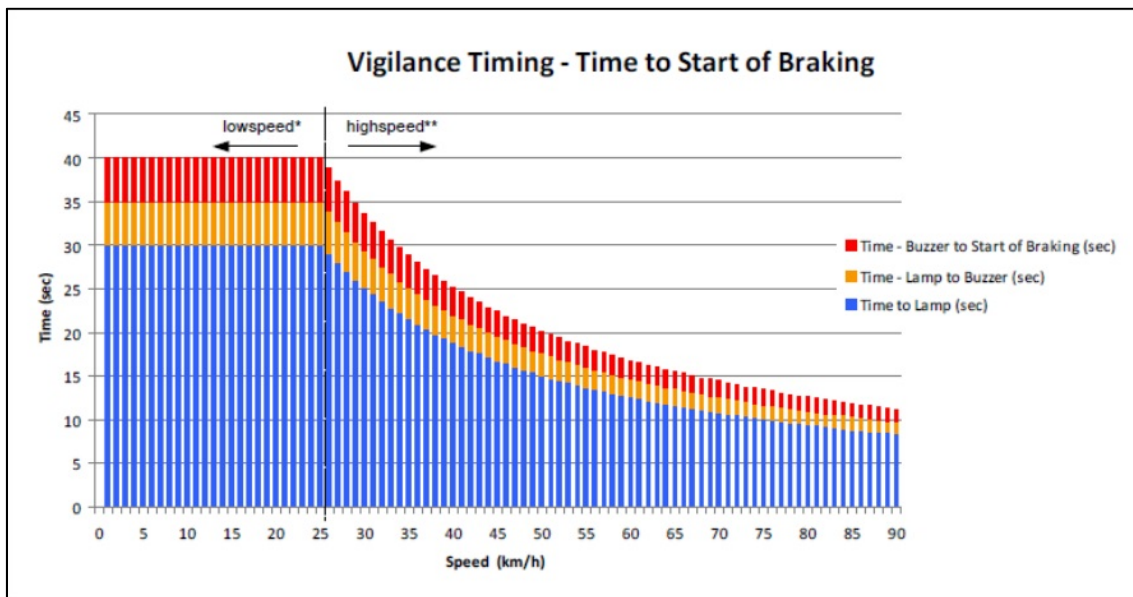
Figure 5: Vigilance timing graph

The response time of the vigilance system varies depending on the speed of the tram (Figure 5). If the speed of the tram is less than 25 km/h, the visual warning will commence after 30 seconds. If not acknowledged within 5 seconds, the audible warning will commence, and 5 seconds later forced braking is activated. If the speed of the tram is 25 km/h or greater, the system response is based on distance travelled rather than time. The visual warning commences after the tram has travelled about 210 m, the audible warning after a further 35 m, and forced braking after a further 35 m.

The E Class tram vigilance system is designed to respond to driver inaction after the tram had travelled 210 m (or 30 seconds). Yarra Trams operate six other Class of trams on their network that have a range of Deadman and vigilance facilities (Table 1).

The W, C, D and E Class trams are fitted with some form of vigilance system. The permissible interval without driver acknowledgement of these systems is about 30 seconds, except the W Class which is 12 seconds. The E Class time settings are therefore consistent with several other trams within the Yarra Trams fleet. However, the 30 seconds setting was not able to detect and respond to a shorter period of inattention as occurred in this instance.

- the E-Class vigilance system, to determine the most suitable timing of vigilance control actions for the hazards and risks unique to the Melbourne tram network and its operating environment;
- availability of suitable new in-cab technology to assist with driver alertness/drowsiness detection and management;

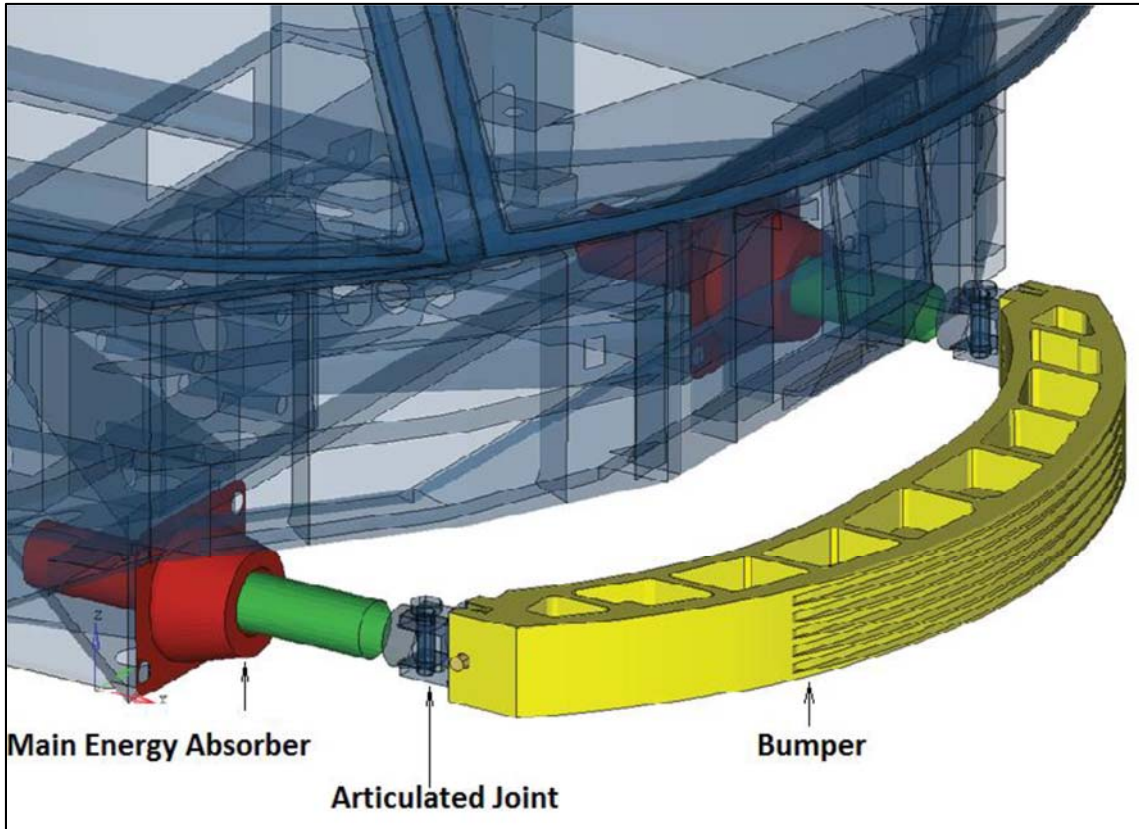
Figure 6: Drawing of tram collision absorption system

A reversible stage has an 80 mm stroke and uses a gas-hydraulic element intended to absorb energy from very low speed impact and then return the element to its original position. This system can therefore accommodate repeated small impacts. A second, irreversible stage for higher speed impacts uses deformation tubes that do not return to their original condition. The deformation tubes in this irreversible stage have a maximum stroke of 270 mm at a constant force of 250 kN. The energy absorption capability of the two tubes located at the tram ends is 67.5 kJ that equates to a design impact speed of around 17 km/h.

In this collision, the end-to-end impact resulted in energy absorption within both trams. The energy of impact exceeded the capacity of the reversible systems and the deformation tubes were deployed on both trams. Post-incident Inspection identified that most crash energy had been absorbed by the engagement of one deformation tube on each tram; the left tube on the moving Tram 6008 and the diagonally opposed tube on the stationary Tram 6005.

The length of tube deformation on Tram 6008 was about 250 mm and on Tram 6005 was about 200 mm. There was a small amount of deformation on the other two tubes. The combined energy absorbed by the deformation tubes on the two trams was consistent with the design energy associated with a impact speed of about 15 km/h. That two diagonally opposed tubes absorbed the majority of the energy was probably the result of imperfect alignment of forces at the point of impact.

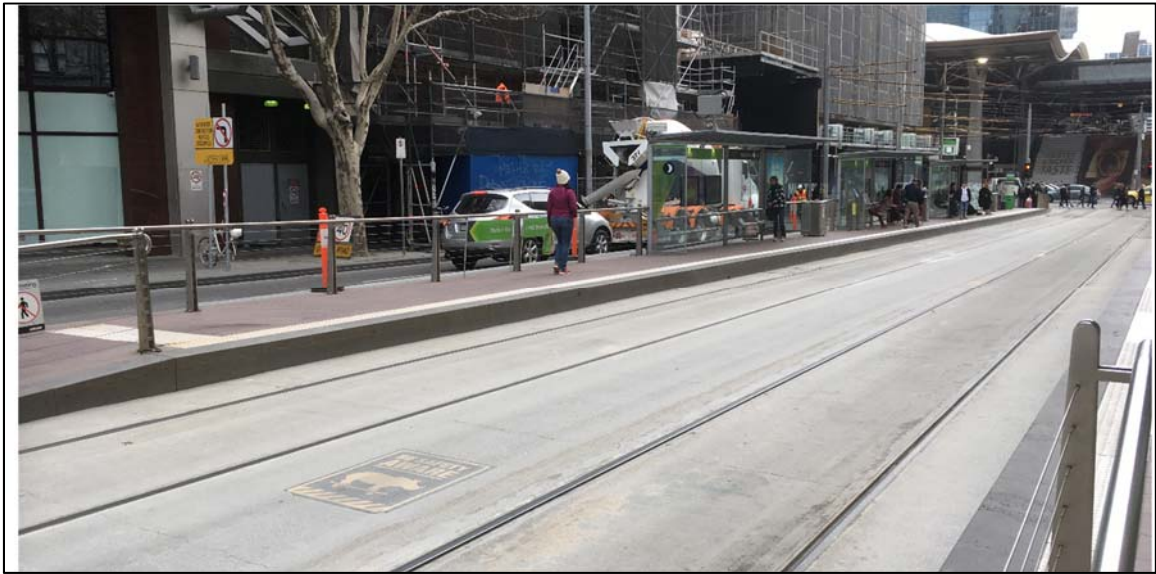
Figure 7: Spencer Street tram stop on Bourke Street.

The length of the platform is about 58 m and the safety zone extends a further 11.5 m at the Spencer Street end and 8.5 m at the other end. Two E Class trams can be accommodated at the platform, with all doors opening onto the platform.
