Office of the Chief Investigator
Transport and Marine Safety Investigations

**Marine Safety Investigation
Report No 2007 / 01**

Fire on board
Passenger charter vessel "Moonraker"
Popes Eye Marine National Park
14 January 2007

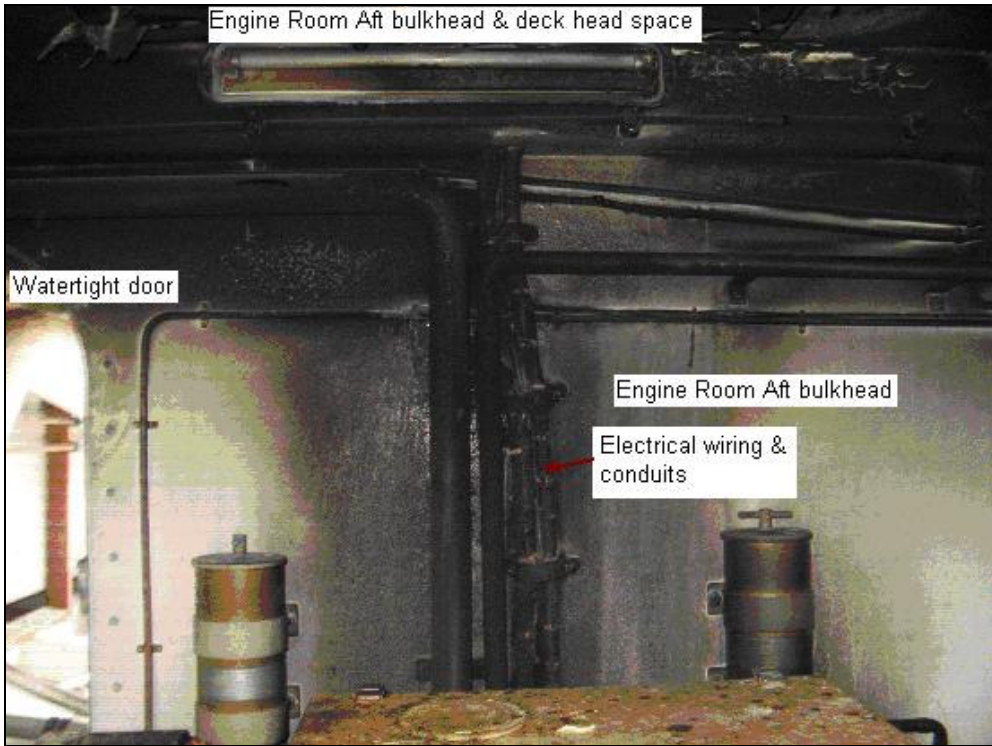
Figure 2 - Engine room aft watertight bulkhead

The seat of the fire was observed to be in the vicinity of the bilge well, against the aft bulkhead.

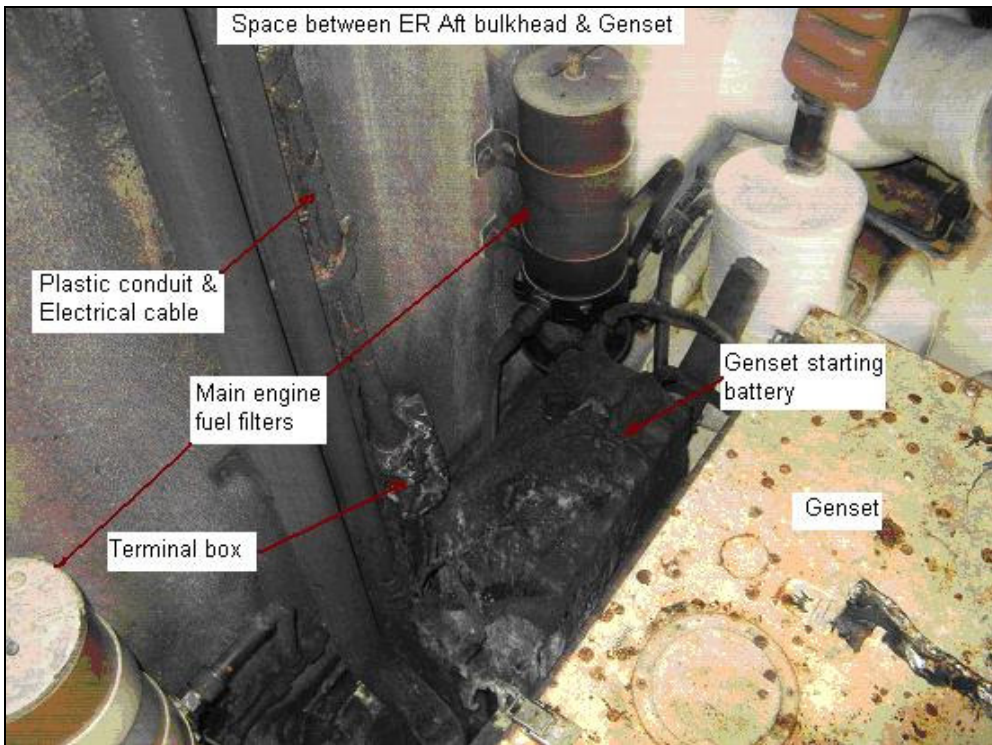
Figure 3 - Space between aft engine room bulkhead and Genset

The starting battery for the Genset is mounted between the Genset and the aft engine room bulkhead and is also between and below the main engine fuel filters.

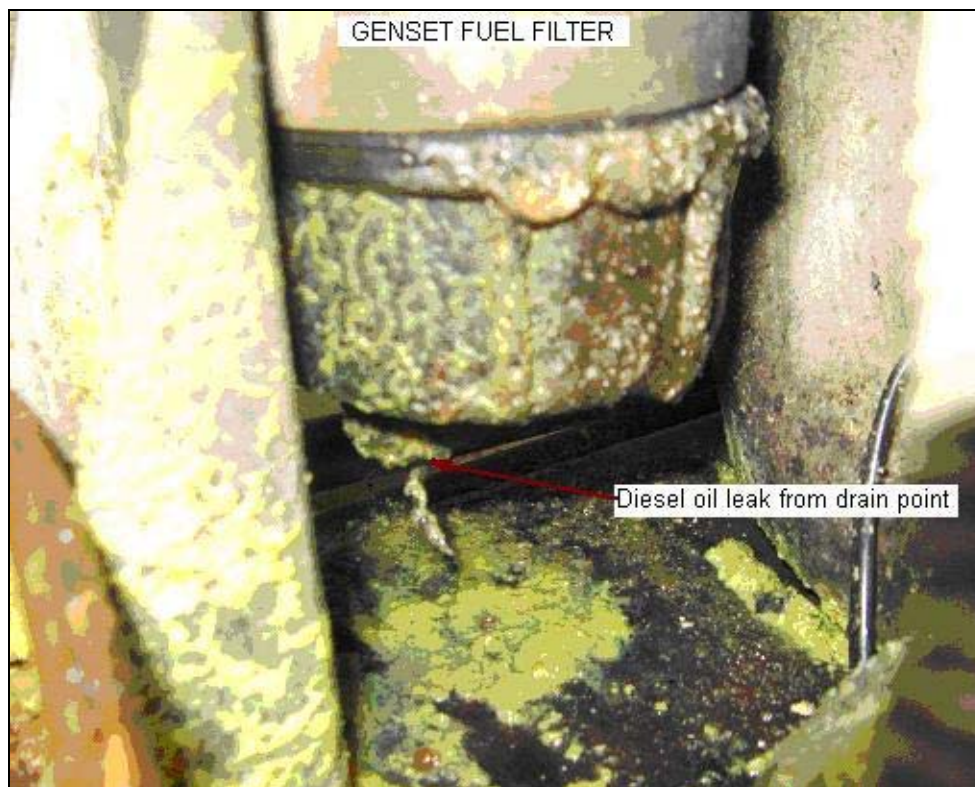
Figure 4 - Leaking Genset fuel filter

The Genset fuel filter was found to be leaking from the filter drain plug and there was a consistent dribble of diesel fuel from this filter drain point. The leaking fuel was accumulating in the cofferdam / bilge space under the Genset.

The area surrounding the Genset fuel filter was coated with diesel oil and the Genset battery support board was heavily impregnated with diesel oil.

At the time of the inspection the cofferdam / bilge space under the Genset was found to contain approximately 53 litres of bilge fluid. Analysis of the bilge fluid indicated that approximately 10% (5.3 litres) of the bilge fluid consisted of diesel oil. This investigation concludes that the diesel fuel found in the bilge space came from the leaking Genset filter and was the major source of fuel for the fire.

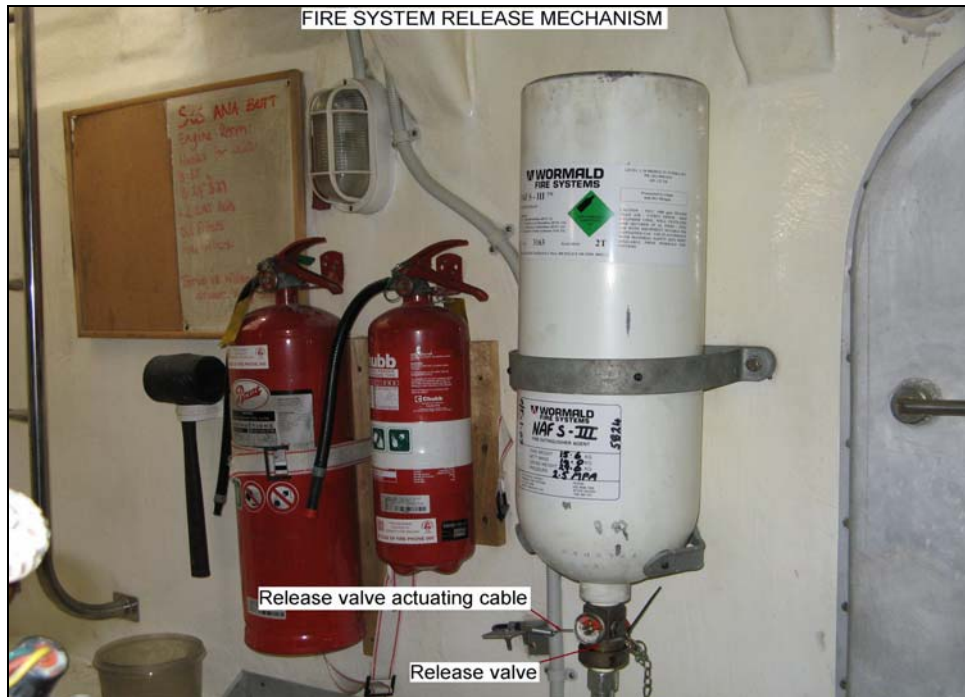
Figure 5 - Fire system release cable & valve

The investigation found that the engine room fire suppression system had not been released and did not contribute to the extinguishing of the fire. The fire suppression system release mechanism was not operational and the release cable was seized.

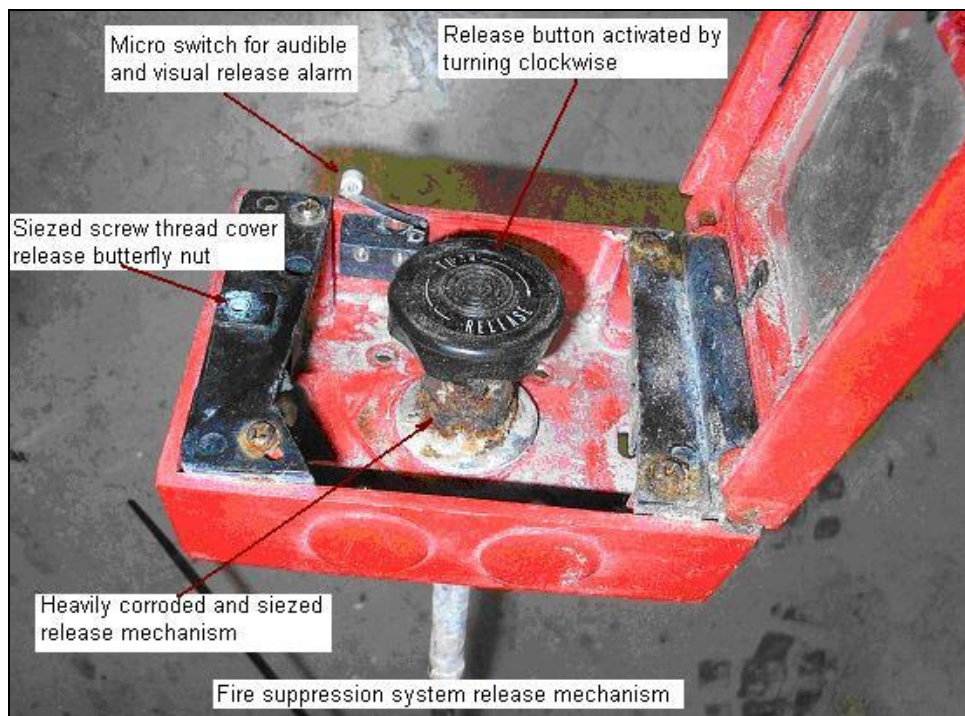
Figure 6 - Fire suppression system release mechanism

The engine room fire suppression system was not released as the system release mechanism was not operational and the release knob and the release cable were seized. The investigation concluded that no inspection or testing of the fire suppression system has been carried out since 2003 and the deterioration of the release mechanism has occurred since the last service carried out in 2003.

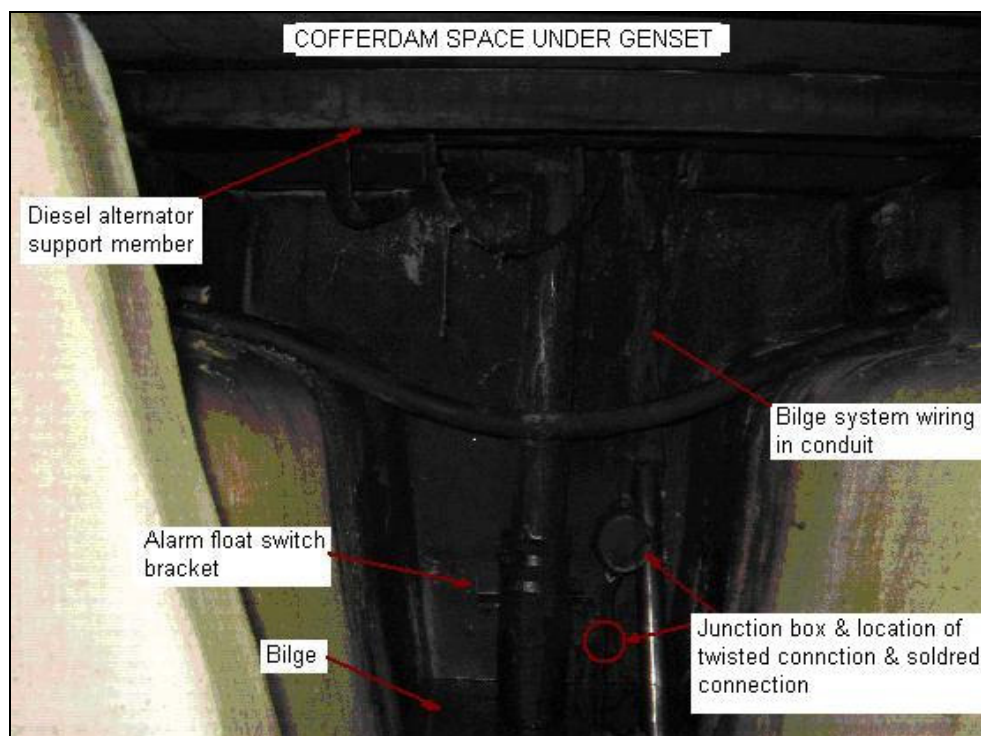
Figure 8 - Cofferdam space under Genset

Based on the area of the most intensive and lowest burning, it is most probable that the fire started in the area of the cofferdam space under the Genset.

The underside of the plywood platform supporting the Genset and the underside of the plywood battery support were both heavily charred, further indications that the seat of the fire was below both these units. The burn pattern of the bilge pump activating float switch indicates that the fire was external to this switch.

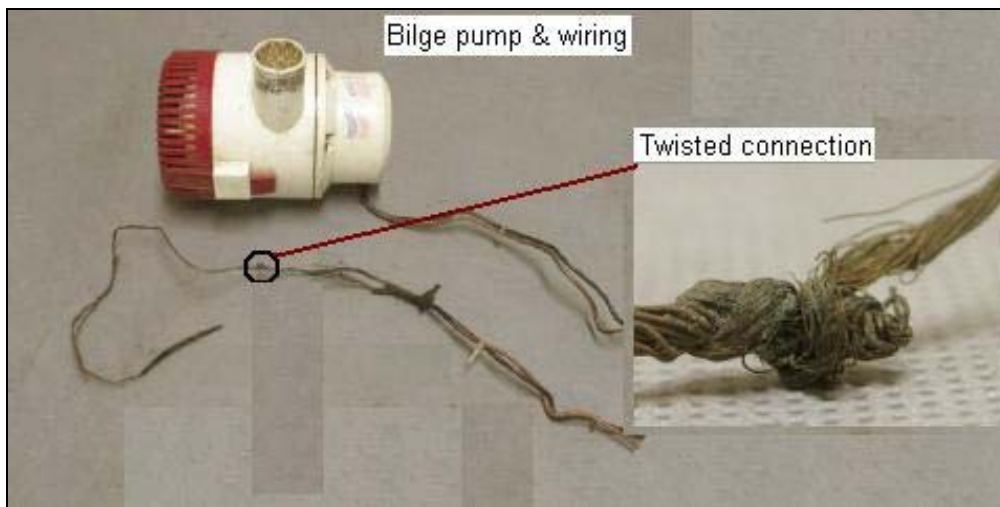
Figure 9 - Bilge pump wiring (positive lead connection)

Inspection of the junction boxes and the wiring loom revealed traces of diesel fuel. Although the junction boxes showed fire damage most of the wiring was in good condition with the insulation intact. An open twisted joint was found in the positive supply wire to the bilge pump (Figure 9). The connection was made by twisting two wires together without a connector providing mechanical compression to the joint. This connection showed evidence of copper oxidation. The connection also showed evidence of arcing and over heating.

The connection made by twisting two wires together to join the vessels wiring harness to the bilge pump positive conductor showed oxidation, signs of arcing and overheating (Figure 9). Inadequately compressed connections can become resistive¹⁰ over time, thereby increasing the power dissipation within the joint. Traces of diesel oil were found on the wires and the connection was in close proximity to the bilge where approximately 5 litres of diesel oil was found.

It is reasonable to conclude that the heat generated by this connection could have been sufficient to increase the temperature of the diesel oil to its flash point of 79 °C. It is probable that at this temperature the diesel oil ignited due to a spark occurring at this connection.

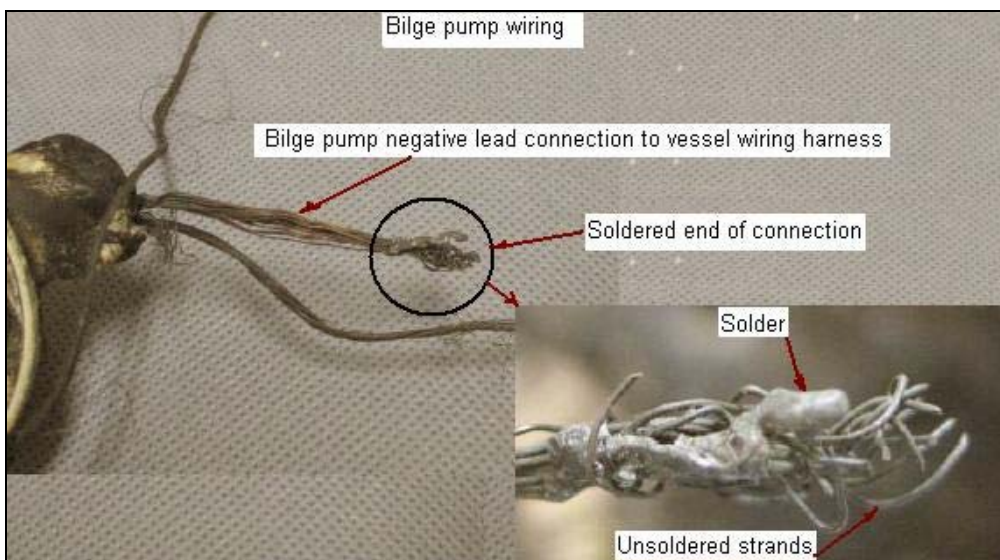
Figure 10 - Bilge pump wiring (negative lead connection)

The negative supply wire from the vessels wiring harness to the bilge pump also showed an inadequately soldered connection (Figure 10). The wire consisted of approximately 20 strands of which only four strands appeared to be connected by solder.

The negative supply wire from the vessels wiring harness to the bilge pump also showed a poorly soldered connection (Figure 10). The loom with the soldered connection consisted of approximately 20 strands of copper wire. Only four of these wires appeared to be connected by the solder. The reduced cross sectional area due to the reduction of connected strands increases the resistance in the wire loom. This results in increased power generation and dissipation. The darkened ends of the wire strands indicate severe overheating. The solder used in this connection appears to be common electrical grade tin-lead solder which normally has a melting temperature of around 200°C. Examination and laboratory analysis of the connection indicate that it is unlikely that external flames caused the melting of the soldered connection. It is reasonable to conclude that this connection could have been another source of ignition as the power dissipated at the connection could have been sufficient to heat the diesel oil to its auto ignition point.
