Office of the Chief Investigator
Transport and Marine Safety Investigations

**Rail Investigation
Report No 2008/11**

**Infrastructure Failure
Connex
Kensington/North Melbourne
6 November 2008**

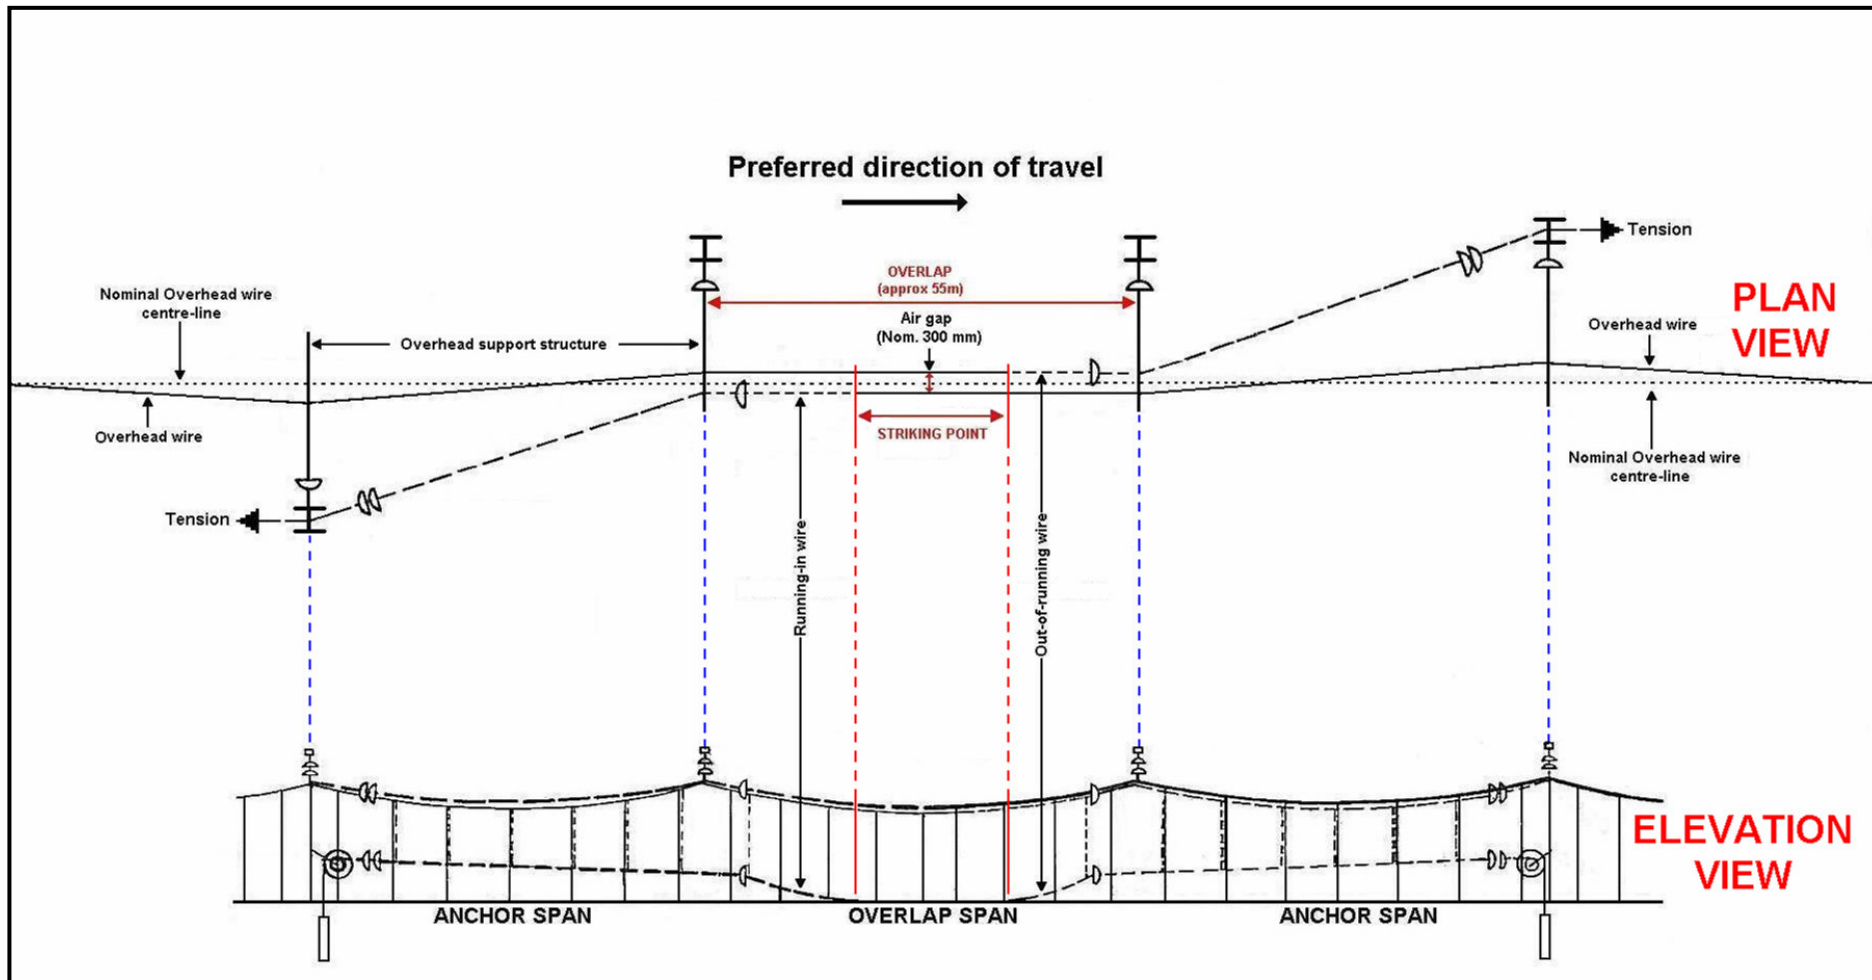
Figure 2 Diagram – Electrical Overhead Section Break (Air Gap) – Plan and side elevation view.

Arising from the problem with the Kensington № 12 points, train R463 — running empty from Flinders St to Flemington Racecourse — was halted at № 23 Down Home signal on the Broadmeadows Suburban (BS) line. By chance, the third of four pantographs⁸ on this stationary train was situated within the *overlap* (but not within the 'striking point': refer to Figure 2). This condition caused the pantograph to be in good contact with one of the wires within the overlap but either just out of, or in superficial contact with the other.

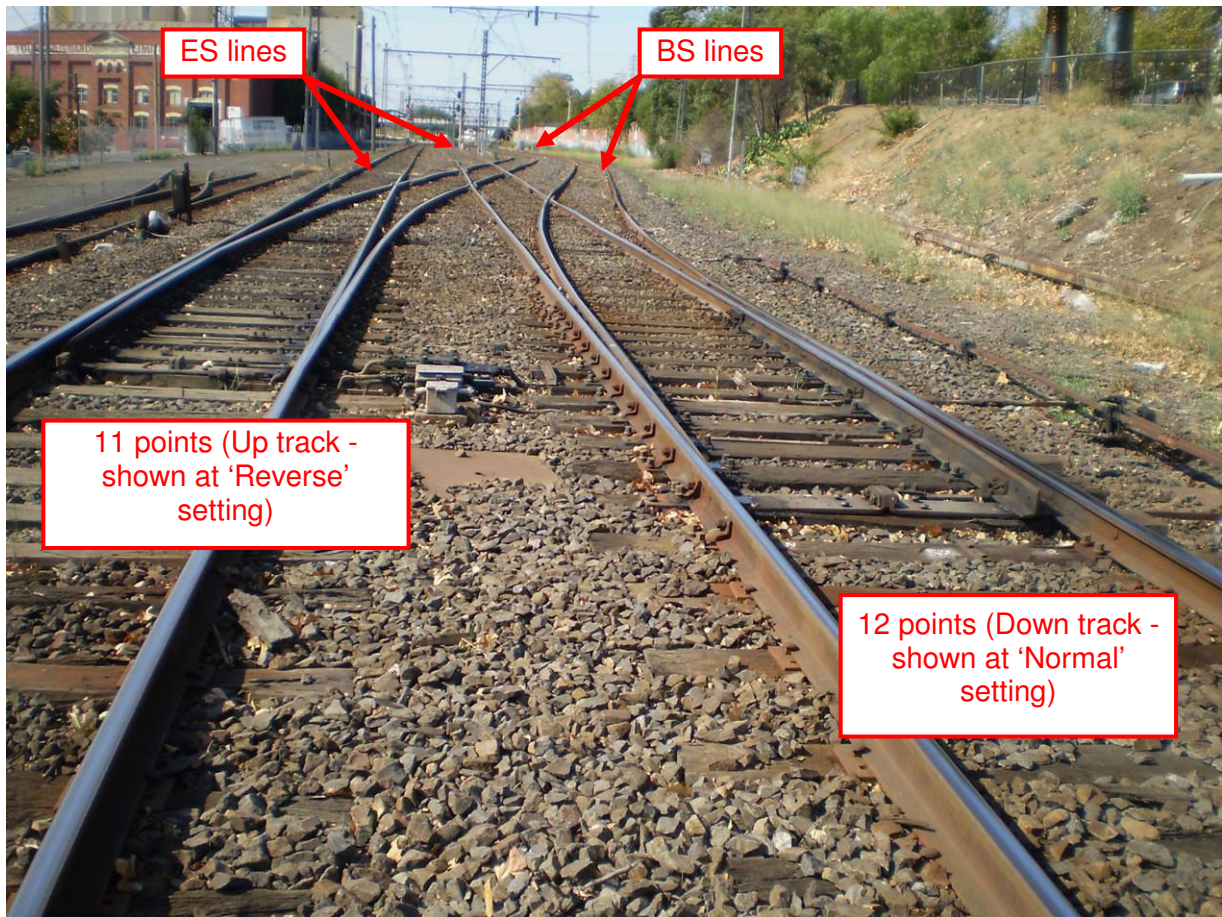
As the technician was preparing to depart, the signaller reported trouble with № 12 points (loss of detection in Normal position). The technician checked the points and found them not properly positioned (blade not against stock rail). All other relevant equipment was checked and no fault found. The technician concluded the problem had been a 'soft-pull'⁶ by the signaller on the № 12 points lever and that the signaller had not checked for detection before 'pulling signals'. He stated that this is a recurring issue at the Kensington signalbox.

Figure 6 Kensington interlocking showing 11 and 12 points (looking towards Melbourne). See Figure. 7 for signalbox points detection indicators.

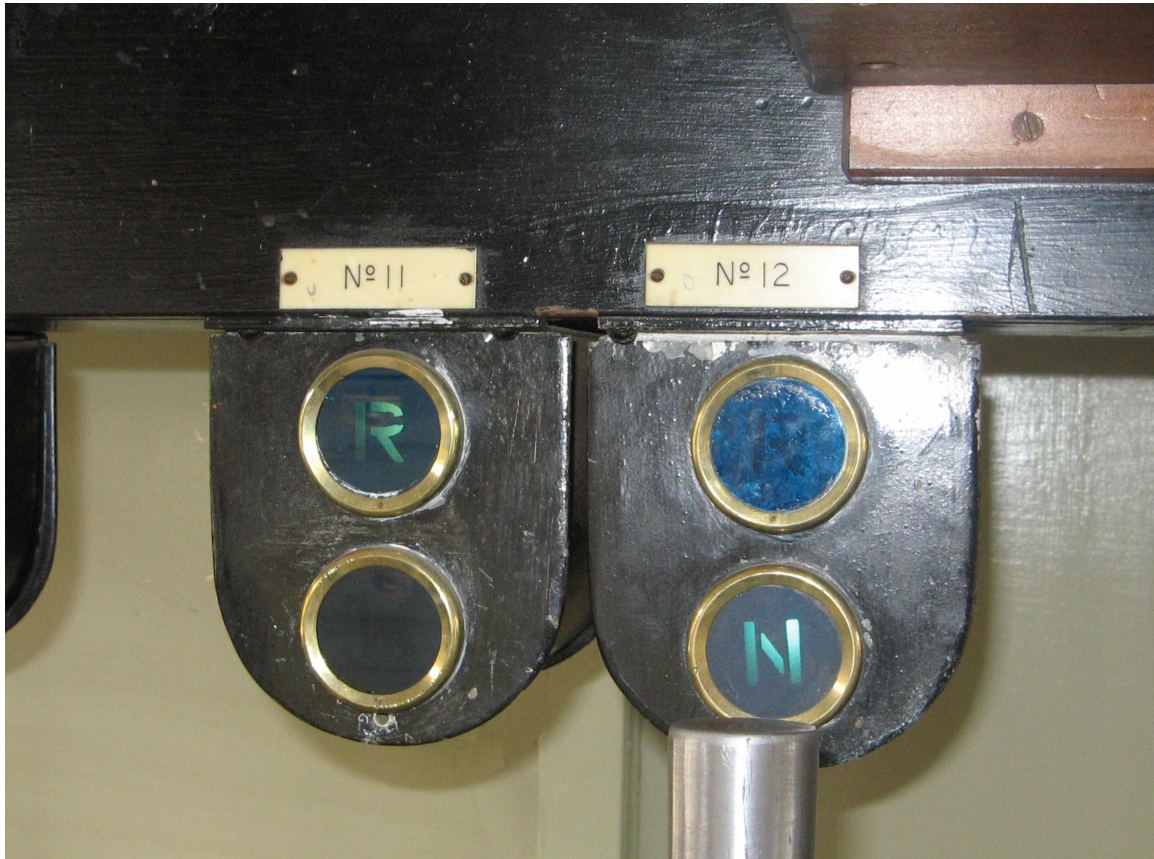
Figure 8 Kensington signalbox 11 and 12 points detection indicators displaying the points settings shown in Figure. 6.

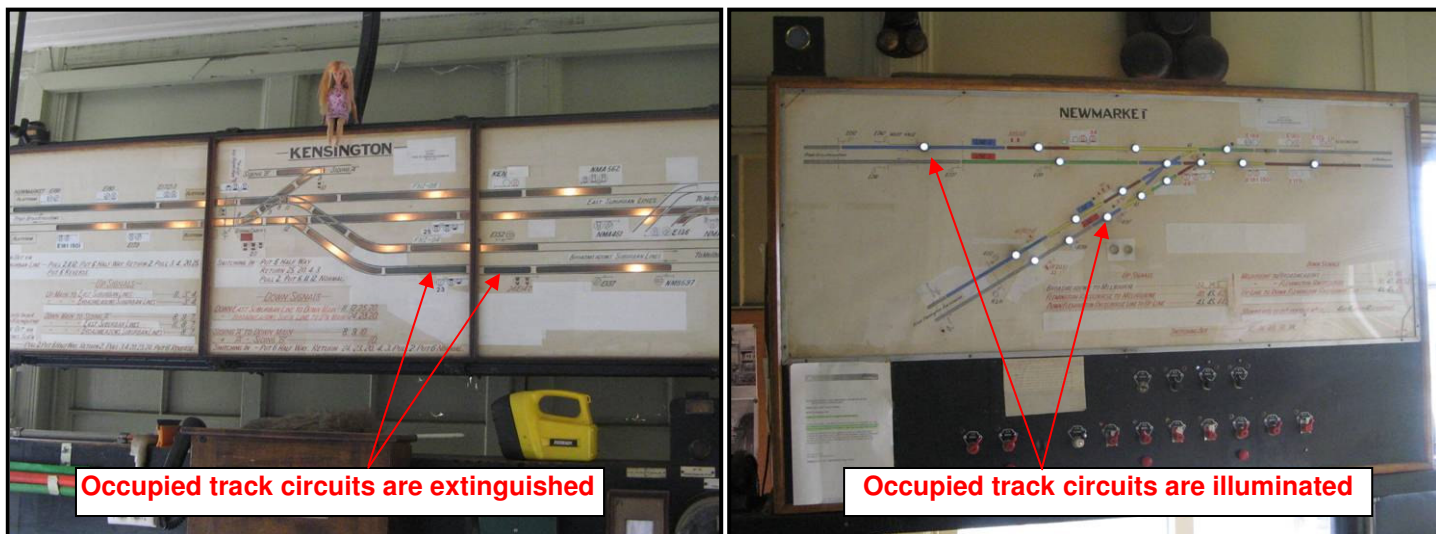
The Kensington illuminated diagram and co-located Newmarket control panel present conflicting display protocols to the signaller. While the older Kensington illuminated diagram graphically displays track circuits that are lit when the track is *not* unoccupied, the opposite is the case for the diagrammatic Newmarket panel which displays track sections via an illuminated lamp when the track *is* occupied (see Fig. 10).

Figure 10 Kensington Signalbox track indication display panels depicting opposite display logic.

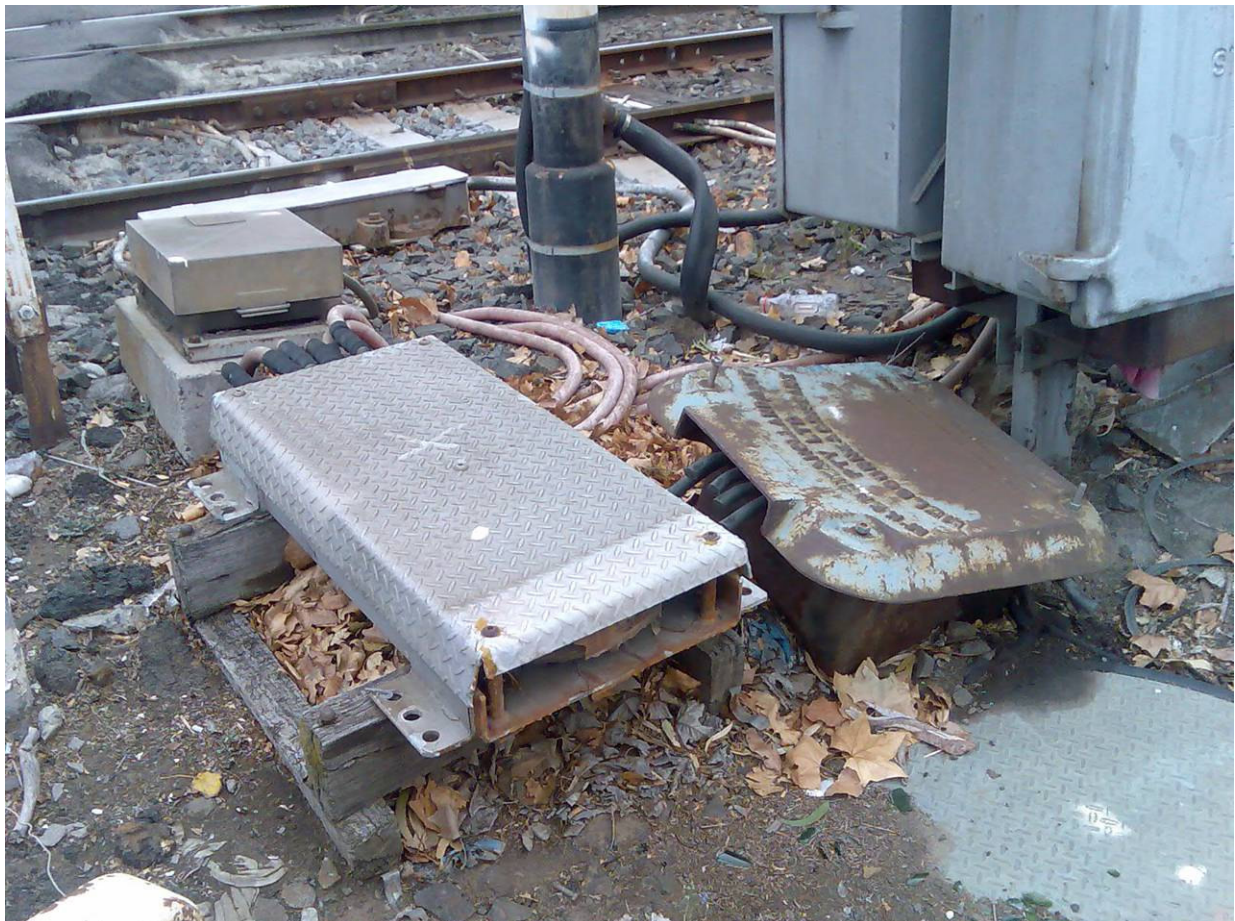
Figure 12 New impedance bond installation on original timber mounting at Kensington. The old impedance bond lies, discarded and disconnected, on the right.

The investigation was advised that within the Craigieburn corridor many impedance bonds date to the commencement of suburban railway electric signalling in 1923 and were designed to carry approximately 500A of current. Over the years, internal deterioration due to ageing as well as the increased performance and traction current requirements of newer trains has resulted in significant *current saturation* occurring within some impedance bonds. The potential for current saturation to occur at an impedance bond depends upon the co-occurrence of a degraded impedance bond at a key location, for example close to a substation, and the (usually random) existence of a heavy current draw by a train or trains at or near that location.

One result of return current saturation is that the AC impedance characteristic of the device is diminished, permitting a premature 'short' of the track circuit across the two rails. In such cases the track circuit will 'drop', presenting to the system (and the signaller) as a phantom track occupation which means that the signal(s) protecting the block revert to Stop and no train can be admitted into it. This has severe implications for reliable train running and the investigation received information that the incidence of such impedance bond failure across the network was recurrent. Because of its nature, identifying the exact location of such a fault can be time-consuming. As faulty impedance bonds are identified they are replaced with modern devices of around 2000A capacity.

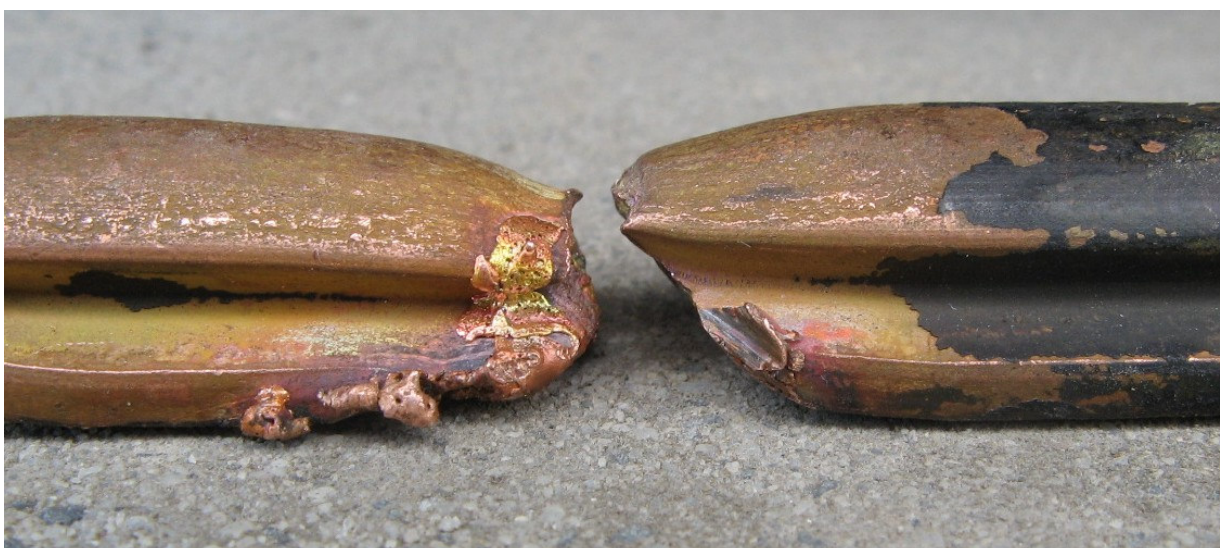
Figure 13 ‘Necking’ shape of contact wire evidences the tensile failure and consequent pull-apart.

Figure 13 displays the parted ends of the Section 37 contact wire, and shows the result of tensile pull-apart consequent to annealing. Adhered ‘splatter’ damage to the end depicted at left is consistent with it having been in live contact with and shorting through the train structure after parting.

The disarranged overhead wire on the Down BS line was repaired temporarily and power restored to all lines. This repair consisted of splicing the two ends of the contact wire together.

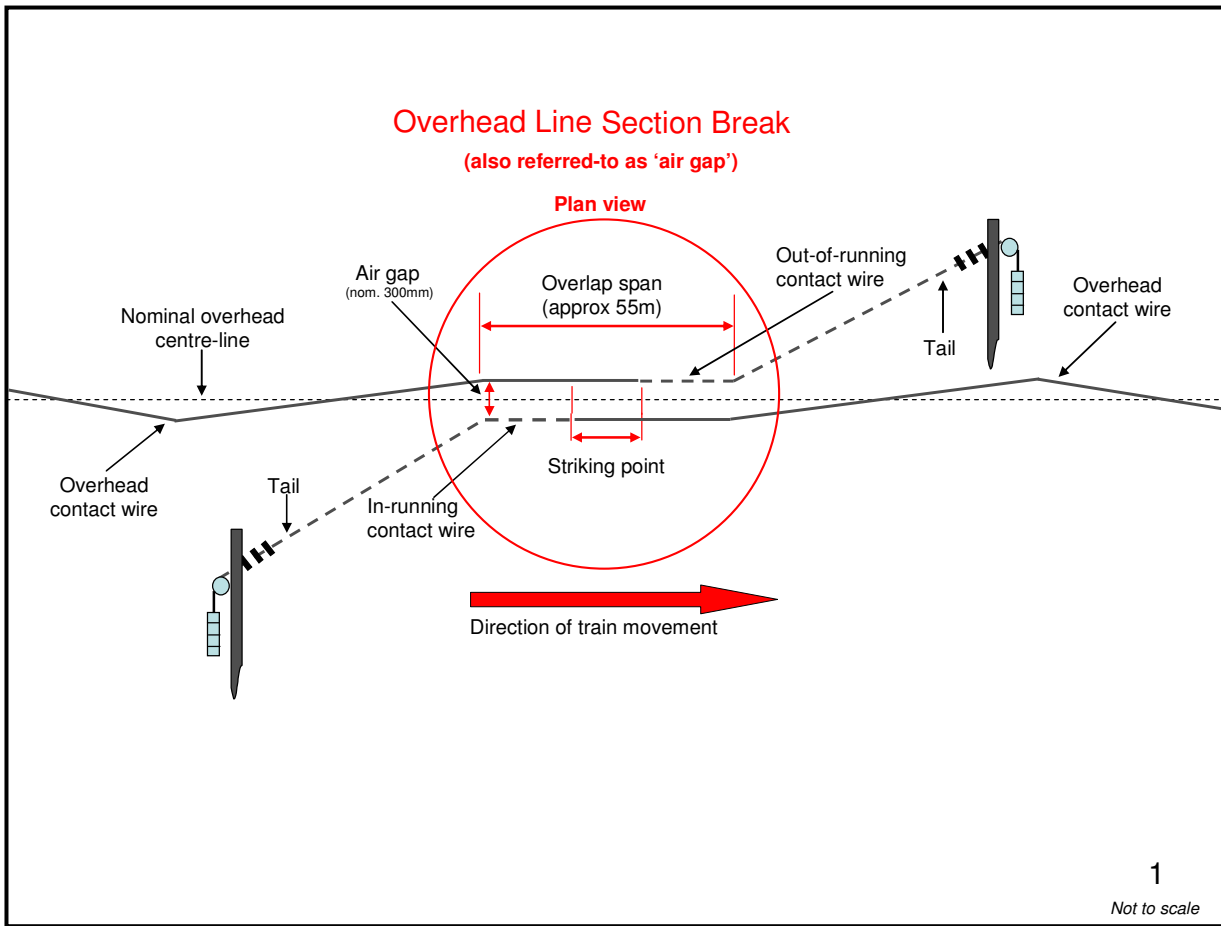
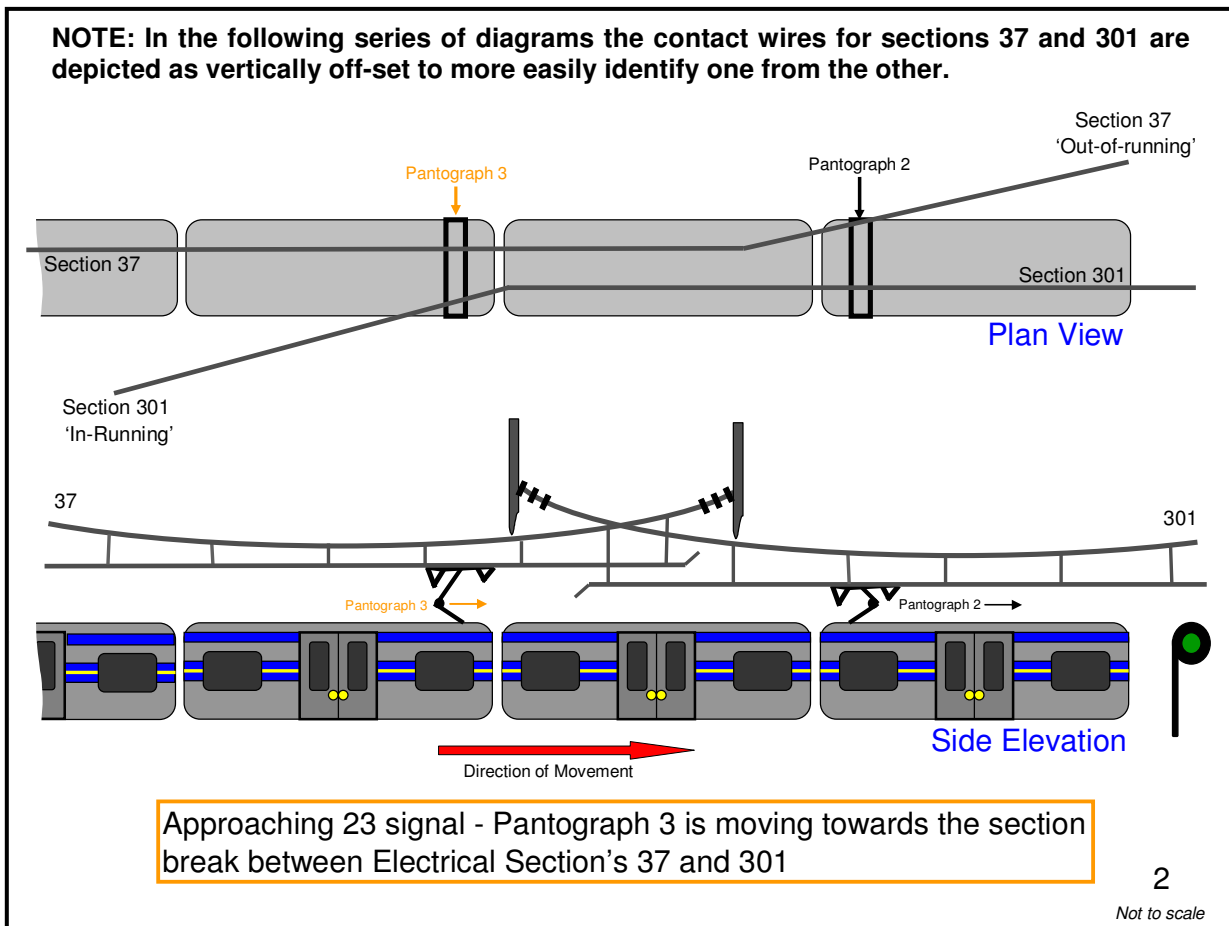
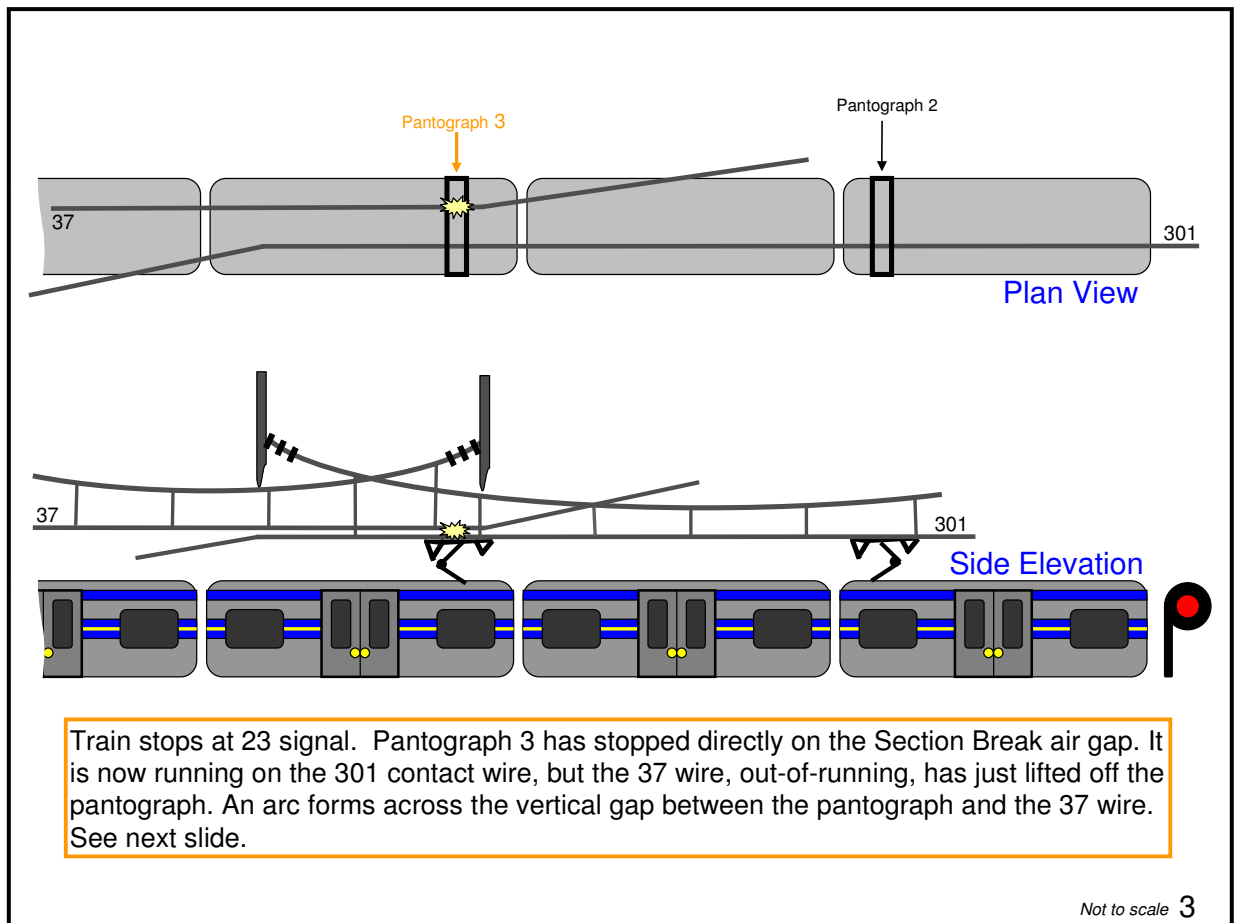
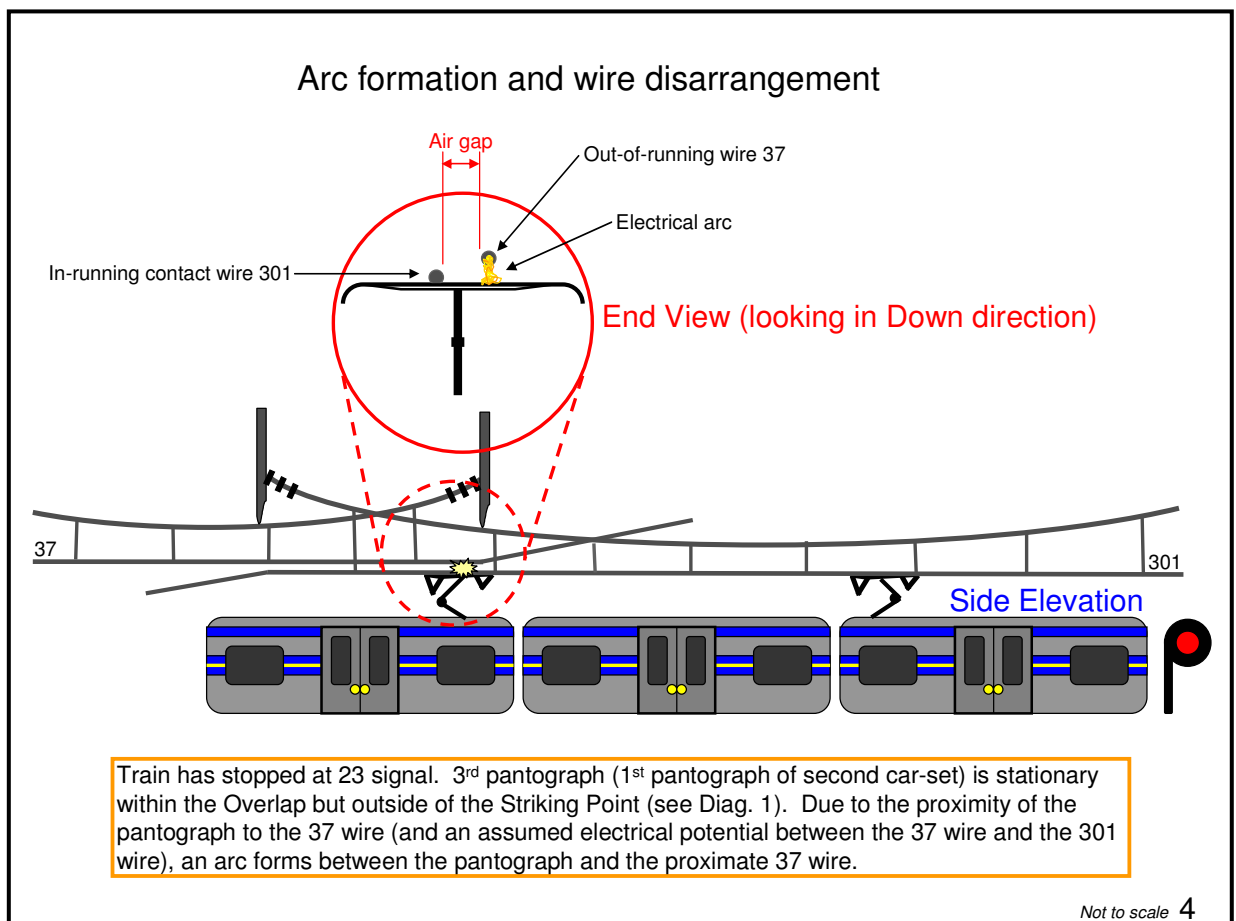
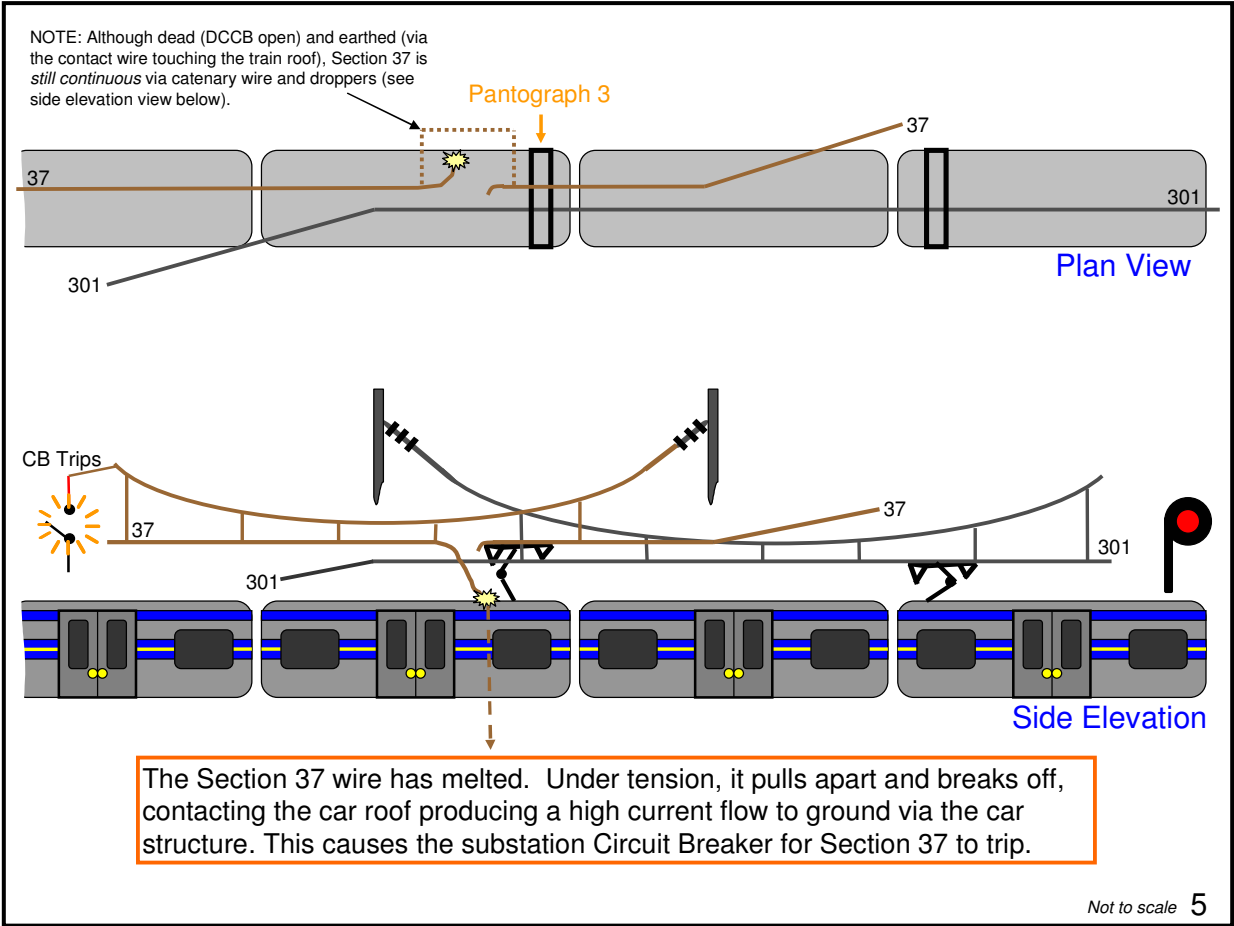
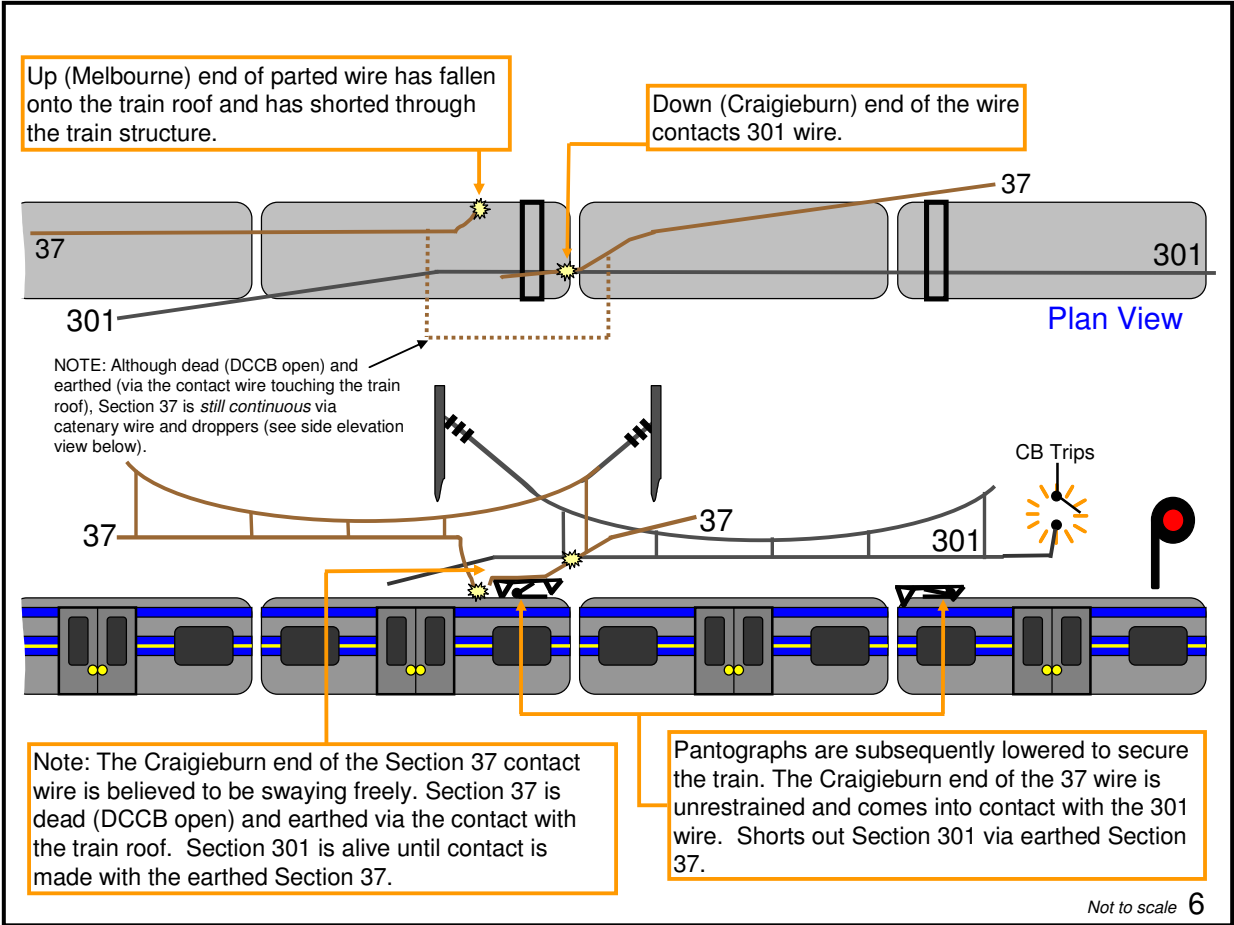
Appendix E: Overhead wire burn-down sequence

Due to the position of the third pantograph of train R463, mentioned in point 6, an electrical arc (refer to Section 2.3.3, p30) that formed between one of the overhead wires and the train's pantograph burned through the wire. The wire then fell and contacted the train's roof. This condition caused an automatic substation cut-off that disrupted power to the overhead wires of Sub-section 37/2 ['37-over-Two'] on the Down Through Suburban (TS) line, Branch-section 37/2/1 ['37-over-Two-over-One'] on the Down BS line, and momentarily to Sub-sections 301/1 and 301/2 on the Down East Suburban (ES) lines (refer to Appendix C for diagram). The circuit breaker for this latter disruption was reset remotely from Electrol. At this point, some trains were stranded in mid-section between Newmarket and Kensington and between North Melbourne and Kensington while others were held behind stopped trains or were deliberately halted by Metrol⁹ at suburban platforms where available, otherwise at various signal locations.
