**Marine Safety Investigation
Report No 2009/12**

**Breakaway from Berth
MT Leyte Spirit
Gellibrand Pier Melbourne
21 August 2009**

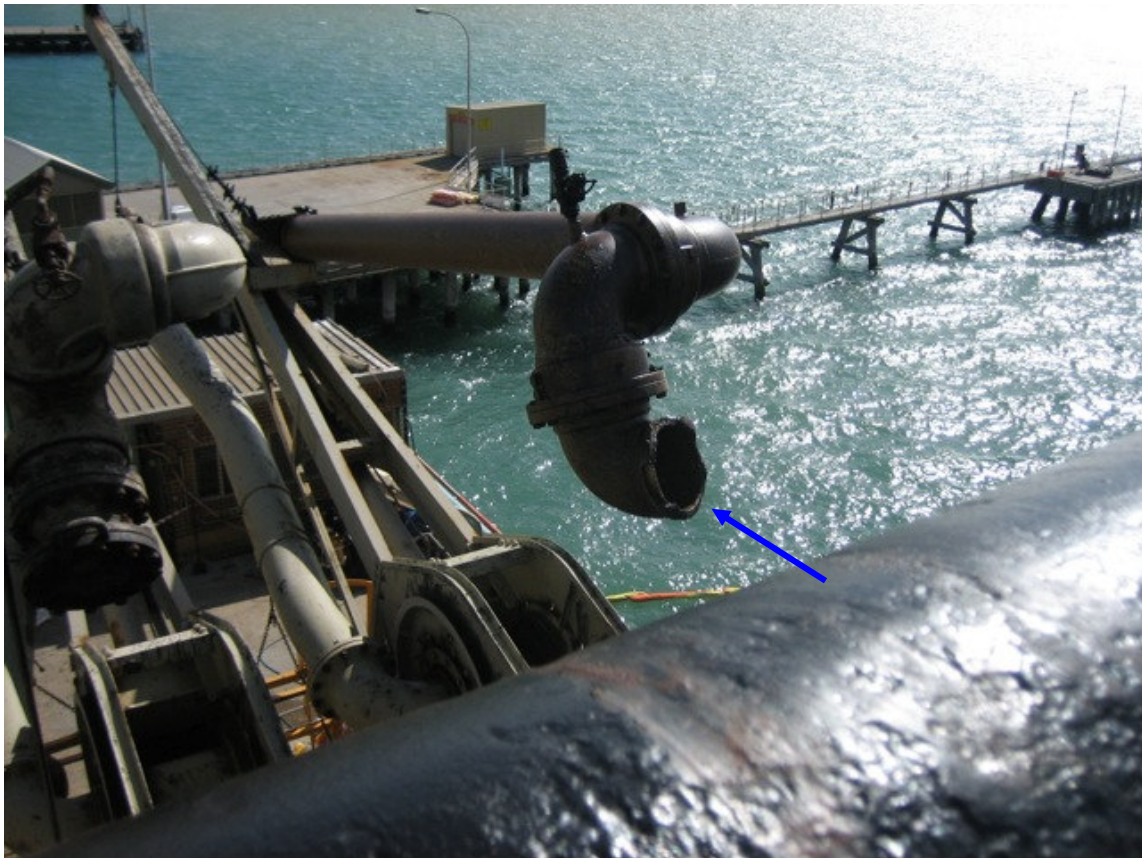
When the vessel had moved about 10 metres off the wharf the cargo arm, which was bolted to the vessel's manifold, fractured at the connecting flange (Figure 3). The wind at that moment was observed by the vessel to be north-westerly at 68 knots. The vessel reported that the oil dripping from its severed manifold was caught in the vessel's drip

tray. About 100 litres of crude oil that dripped from the cargo arm onto the deck was contained by the vessel however, about 40 litres of crude oil from the cargo arm spilled directly into the water.

Figure 3 – Fractured shore cargo arm as seen from the vessel

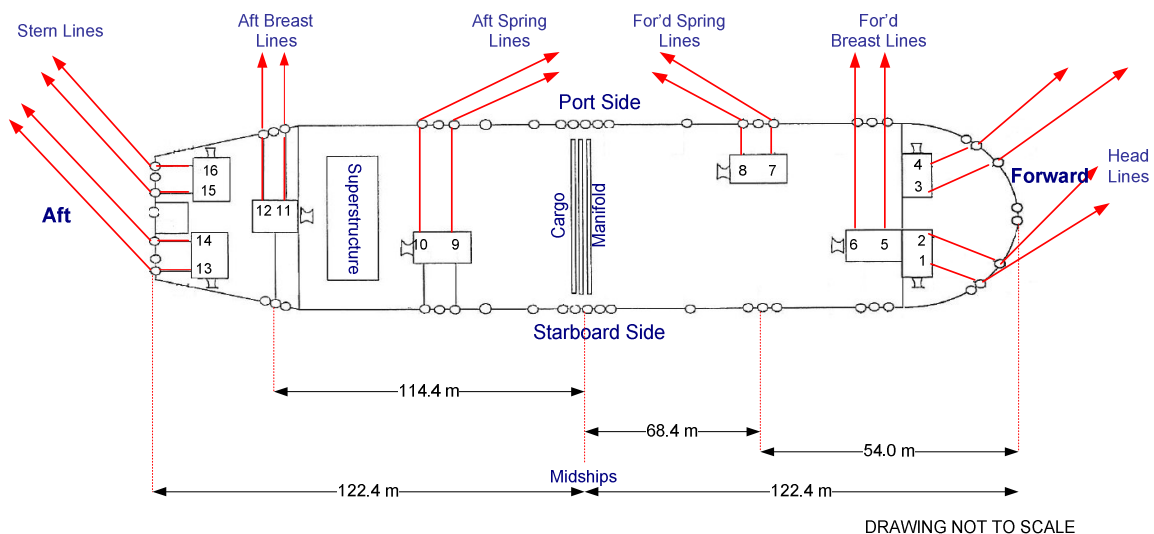
MT Leyte Spirit arrived at Gellibrand Pier at about 0900 on 19 August 2009. The vessel was made fast to the pier by eight mooring lines forward and eight mooring lines aft; in accordance with the terminal's requirements and the vessel's mooring plan for a routine berthing operation.

Figure 4 – Mooring diagram for vessels at Gellibrand Pier

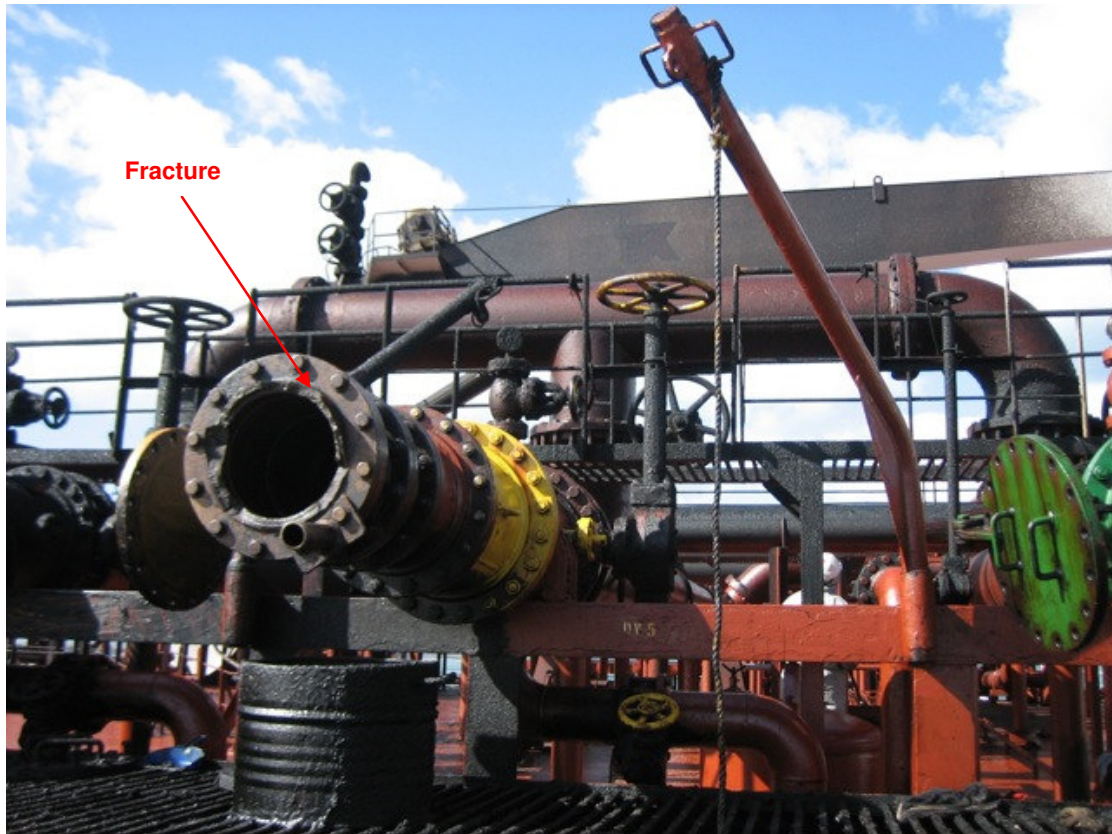
The terminal's 300 mm diameter cargo arm was connected to the vessel's manifold with 12 bolts (Figure 5). The bolts were tightened by a pneumatic impact wrench but final tightening was by manual hammering. In accordance with the terminal's policy, cargo arm connection was carried out by an independent contractor for the terminal.

Figure 5 – Vessel cargo manifold. The flange of the fractured shore cargo arm is still connected to the manifold.

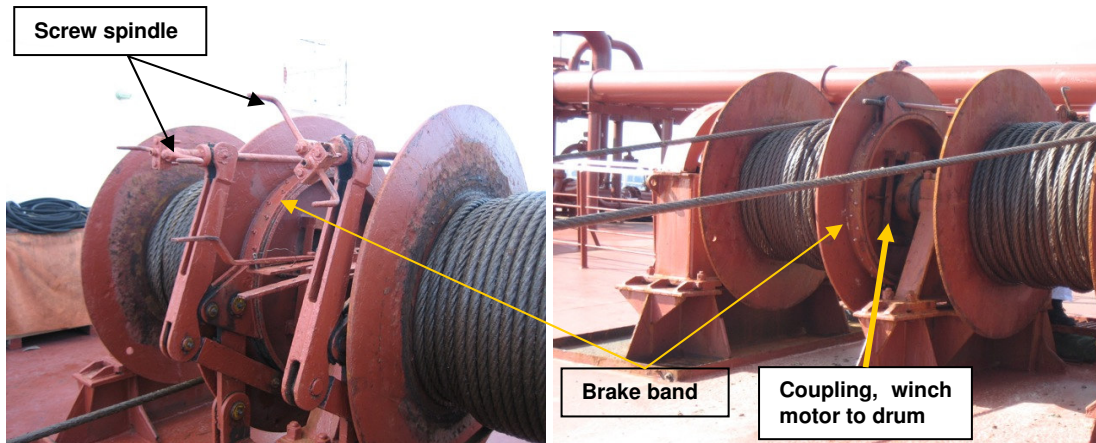
Each drum is held by a band brake, the brake is tightened by manually turning a screw spindle (Figure 7). The brake linings of all drums were renewed in October 2007 except for No 3 winch, which was replaced in July 2009. The design brake holding power of each winch drum was 48 tonnes. They were last tested in accordance with the vessel's continuous survey cycle in July 2009 and were recorded to have rendered at between 50 and 53 tonnes.

Figure 7 – Typical mooring winch on MV Leyte Spirit (front view and reverse view)

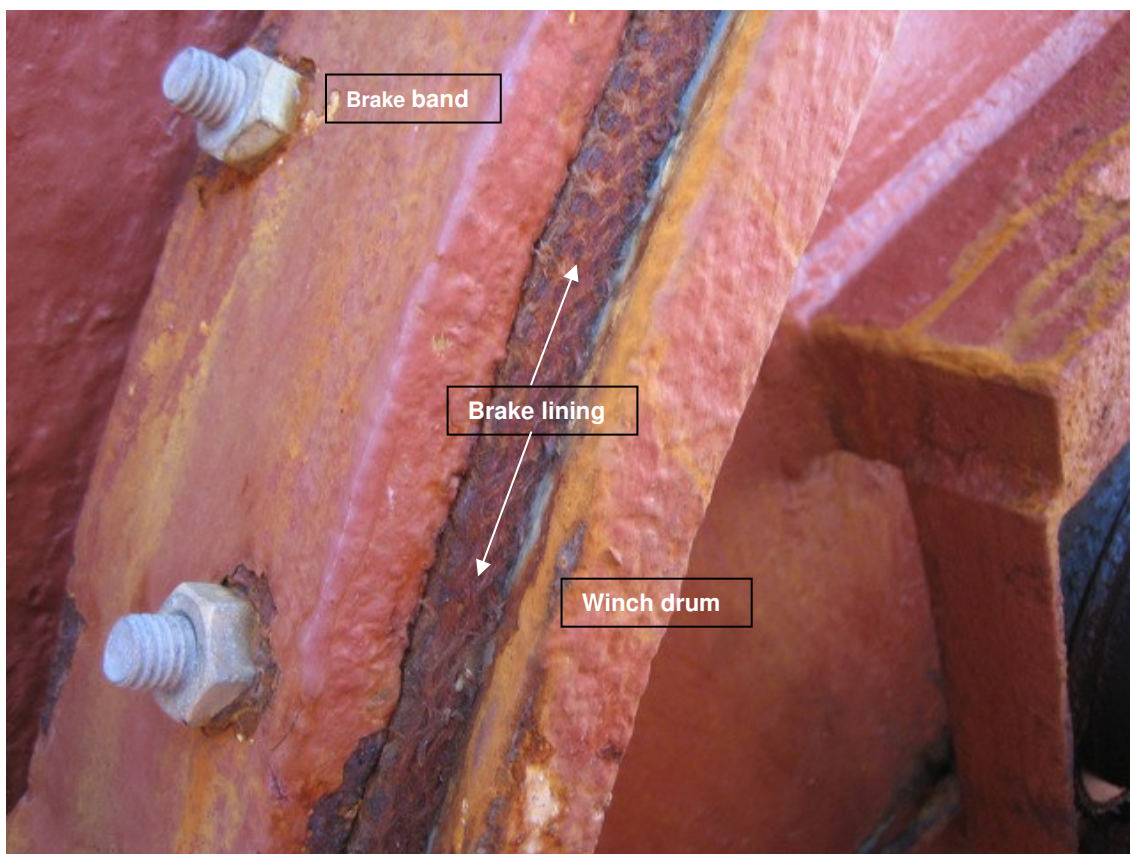
After the incident the mooring winches were independently inspected by surveyors from Lloyds Classification Society, AMSA (Australian Maritime Safety Authority) and the terminal, all of whom found that the winches and their brake drums were in a satisfactory condition and that the brake lining had not suffered wear or 'burn out' (Figure 8).

Figure 8 – Close-up of winch brake assembly post incident

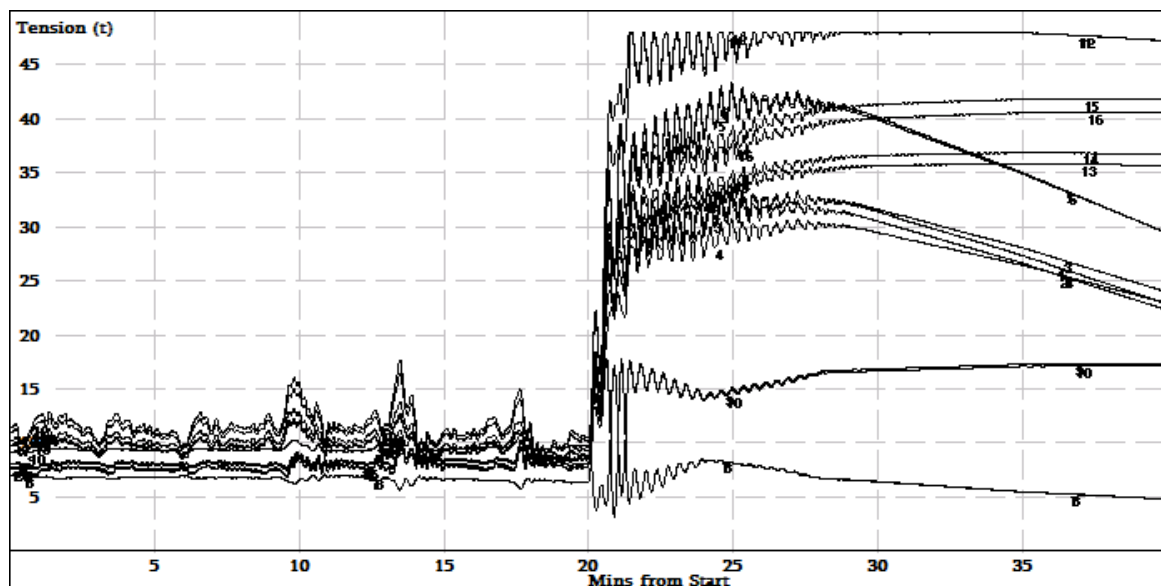
It was found that at the 21.5 minute mark, the tension in aft breast lines (11 and 12) reached 48 tonnes and they started to render (Figure 12). Once these lines started rendering, the strain on the other lines was increased. The stern lines rendered next (15 and 16, then 13 and 14), followed by the aft springs and then the forward lines.

Figure 12 – Mooring line load dynamic response
