Office of the Chief Investigator
Transport and Marine Safety Investigations

**Marine Safety Investigation
Report No 2007/13**

Sinking
MV Maheno
River Yarra
13 December 2007

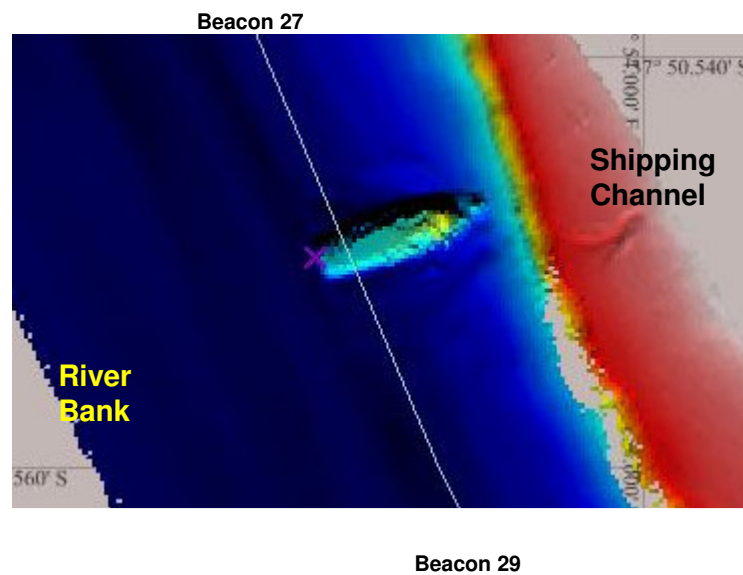
MV Maheno sank in GPS position³ 37°50.564'South 144°54.015'East in about seven metres of water. The sunken position was just outside the south side of the dredged shipping channel between beacons 27 and 29. The vessel was later declared a total loss.

Fig 1: Sonar image of Maheno's sunken position

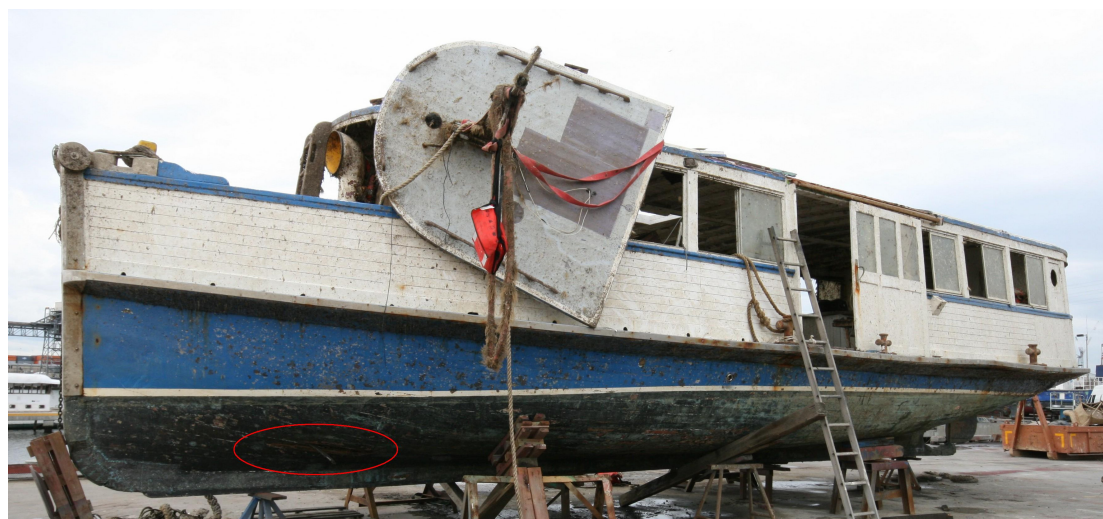
Maheno was found to be holed on its port side, about 1700 mm from the stem and 460 mm above the keel. The hole was about 910 mm long and 80 mm at its widest point. The holed planking would have been about 420 mm below the water line when the hull was intact and under the bottom boards in the forward locker. The holed timbers were not visible to anyone looking over the side or looking into the forward hatch through the hatch opening.

Fig 2: Location of damage on hull

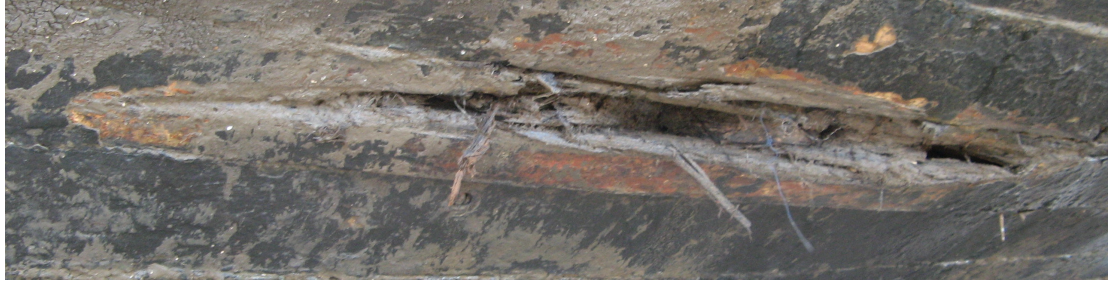
Fig 3: Close up of damage
