Office of the Chief Investigator
Transport Safety

**Marine Safety Investigation
Report No 2013/02**

**Passenger Fatality
MV Moonraker
Port Phillip Bay
13 December 2013**

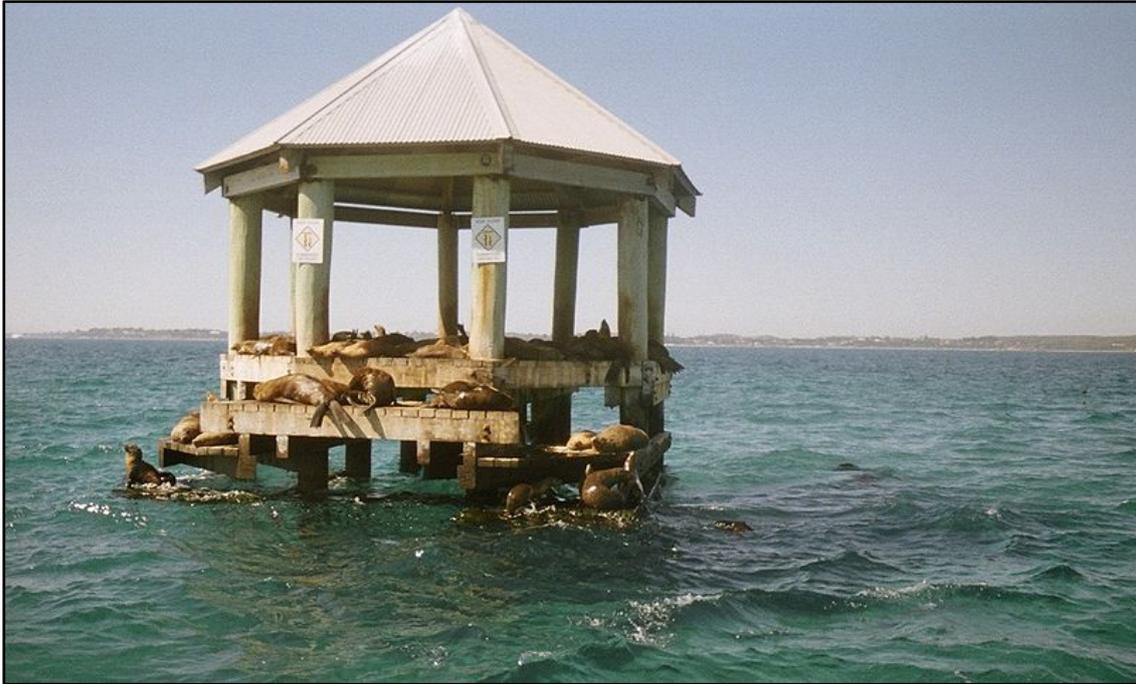
Figure 2: Chinaman's Hat

The structure and the surrounding waters are managed by Parks Victoria². There are no fixed mooring points or platforms near the site, and visiting vessels can either drift or drop anchor. There are no anchoring restrictions in the vicinity of the structure.

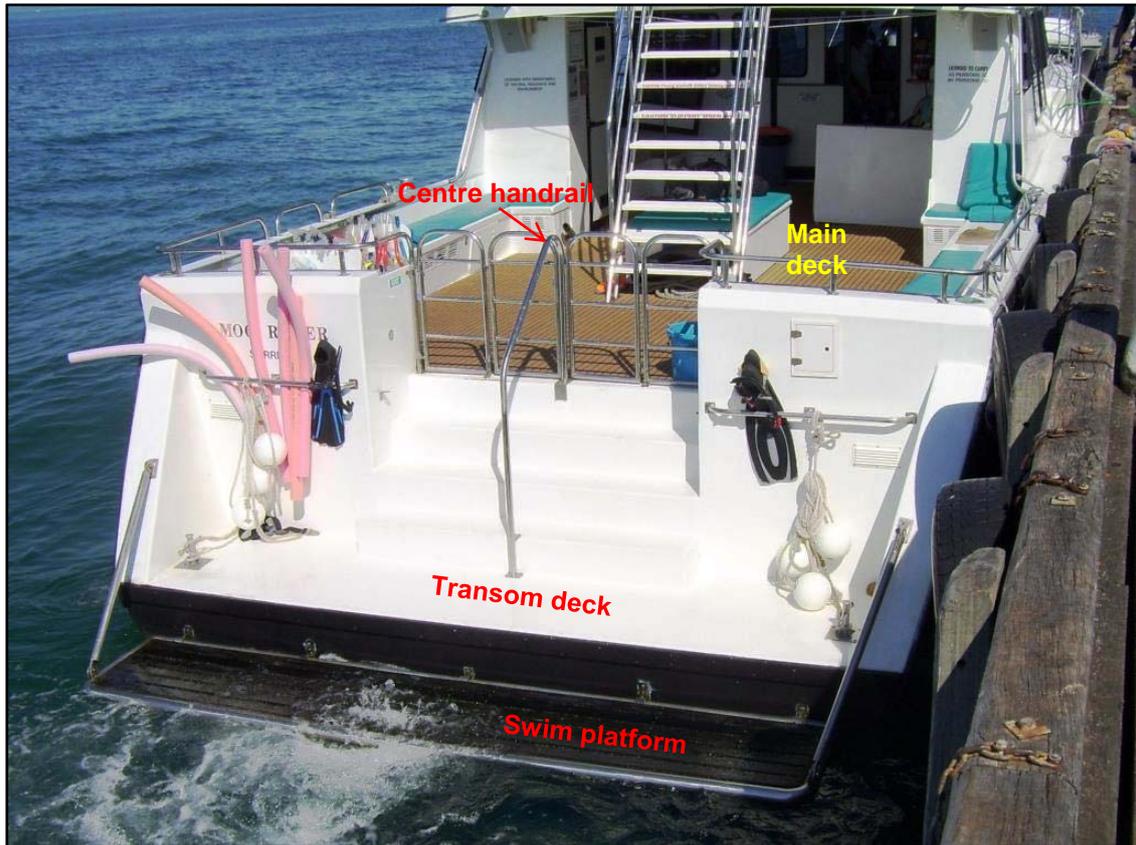
Figure 3: Aft section of MV Moonraker

The third crew member assisted passengers into the water at the swim platform and then was stationed on the main deck adjacent to the centre handrail (Figure 3) acting as the look-out. The Master was operating the vessel from the main conning position inside the wheelhouse.

The Master returned to the wheelhouse and engaged the starboard engine to astern propulsion and the vessel started moving slowly astern towards the swimmers. Witnesses recalled noticing the change in the deck vibration and the wash over the swim platform.

As the boat was manoeuvring astern and after the look-out had taken a photograph of the passenger standing on the starboard side of the swim platform, the same passenger asked if the look-out could take a photo of him in the water, to which the look-out replied 'yes'. The passenger then immediately jumped into the water.

With passengers located on the swim deck or transom deck, there existed the realistic potential for a passenger to fall or intentionally enter the water at an inopportune moment. Furthermore, although the procedures stated that the swim guides get into the water first and then signal the passengers to follow, in practice this was not enforced, increasing the potential of passengers getting into the water without permission. The operator did not document this hazard and had not implemented appropriate controls to guard against the associated risks. One possible control measure was to have passengers return to the main deck and close the access handrail between the main and transom decks prior to engaging propulsion and manoeuvring the vessel.

Moonraker Charters has modified its practices for swim operations and passengers are no longer permitted to remain on the swim deck while the vessel is manoeuvring. The safety management system has also been updated to identify 'propeller strike' as a hazard. A number of instructions have been created to document vessel practices including the use of the auxiliary (aft) conning position during a swim activity, passenger oversight, passenger briefing and the requirements for master-crew communication.

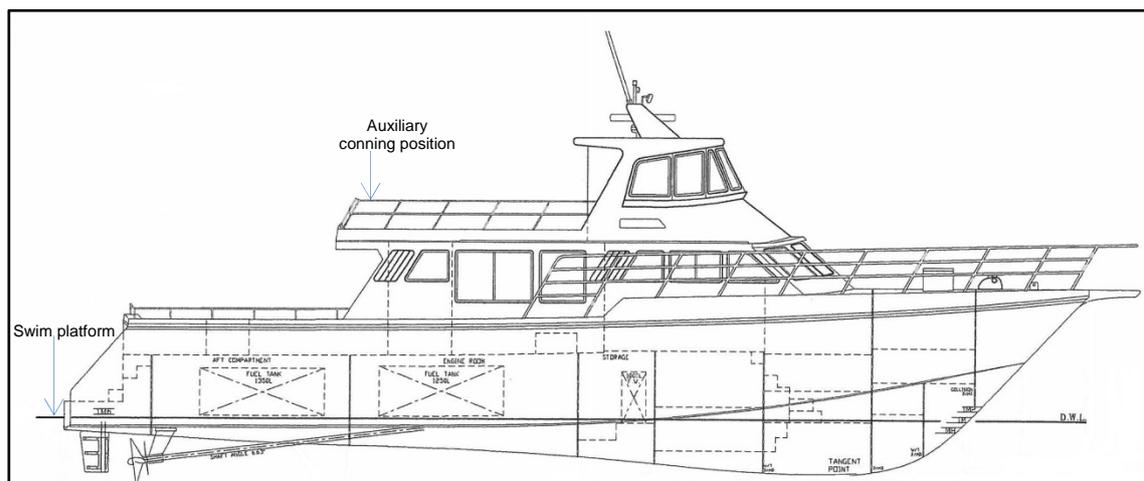
Figure 4: MV Moonraker profile

There were three conning positions on the vessel. The main conning position was located on the port side of the wheelhouse and adjacent to the vessel's navigational equipment. A secondary conning position was located on the starboard side of the wheelhouse and was used mainly when berthing the vessel starboard side to the wharf. A third (auxiliary) conning position was located outside the wheelhouse at the aft, port corner of the upper deck (Figure 4).

From the auxiliary conning console located aft on the upper deck there was a clear view of the swim platform and the swimmers and there was easy two-way communication (verbal and visual) between the Master and a deck look-out located on the main deck. In contrast, the conning positions in the wheelhouse afforded limited visibility aft and the potential for effective communication between Master and deck look-out was limited.
