Office of the Chief Investigator
Transport Safety

**Rail Safety Investigation
Report No 2019/01**

Collision
Tram No 3535 and Tram No 3532
St Kilda Junction, Melbourne
13 February 2019

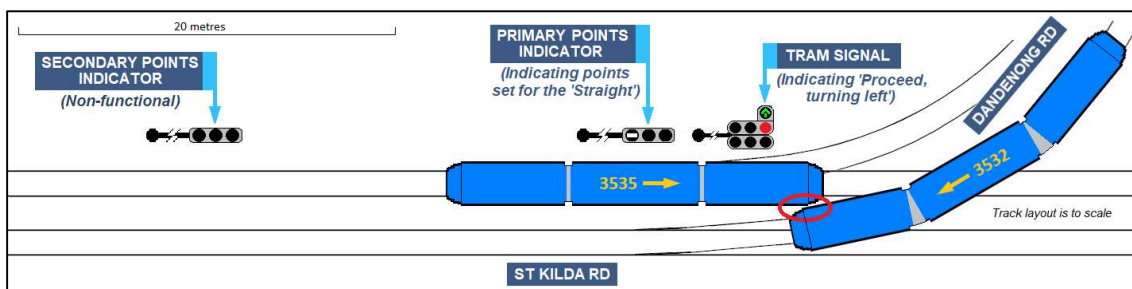
Figure 2: Diagram depicting the points and signal displays at the time of the tram collision

Facing a green left-turn arrow, Tram 3535 then departed the stop, the driver expecting the tram to turn left at the facing points. However, instead of turning left as required, Tram 3535 continued straight and collided with the inbound Tram 3532, that had commenced its right-hand turn from Queens Way into St Kilda Road (Figure 2).

The collision occurred at low speed, with only the outbound tram in motion at the instant of impact as the opposing tram had stopped when its driver became aware of the imminent collision. Both vehicles were conveying around 20 passengers and there were no reported injuries. Both trams sustained minor leading-end right-hand panel and mirror damage.

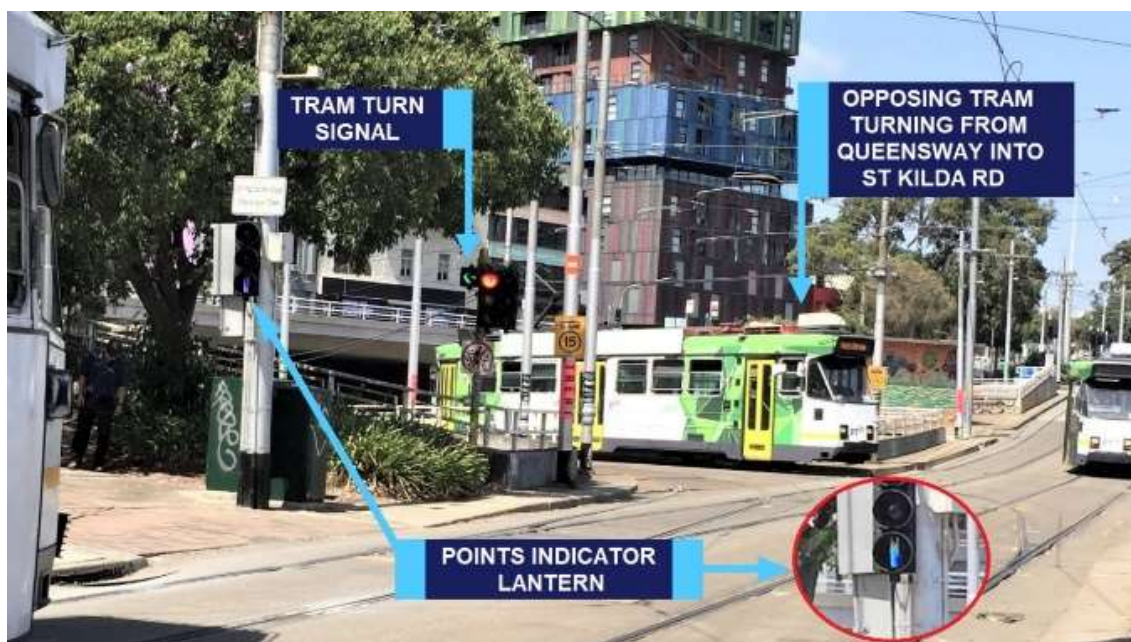
Figure 5: St Kilda Junction intersection with signals as they were for the incident

It was also found that the design configuration of signals meant that the traffic signal at the intersection presented a green left-turn arrow to the driver, even though the points were set for the straight. This was probably a factor in the driver proceeding and not correctly perceiving that the points were set for the straight. This junction was a designated 'off route hot spot', and there had been 14 off-route incidents at this location in the previous two years.

For outbound traffic travelling through this junction, the tram signal for the straight was predominately set for green, and the left-turn arrow extinguished. This signal condition permitted all outbound traffic to proceed, whether that be proceeding straight or turning left onto Queens Way. The trigger for a change to the traffic lights controlling outbound movements was when a city (inbound) Queens Way tram approached the junction. When the inbound Route 5 or 64 was detected, the outbound straight movement (for Routes 3, 15 and 67) was halted with a red traffic signal, and the green left-hand arrow was illuminated, providing continued permission for Route 5 and 64 trams to turn left onto Queens Way (Figure 5). In this signal configuration, outbound and inbound trams were permitted to pass while taking the curve.

Accordingly, it is recommended that Yarra Trams undertakes a full human factors review of several hotspot locations including the tram and road traffic signals that a driver is expected to interpret and respond to and develop improvements to reduce collisions caused by off-route trams.

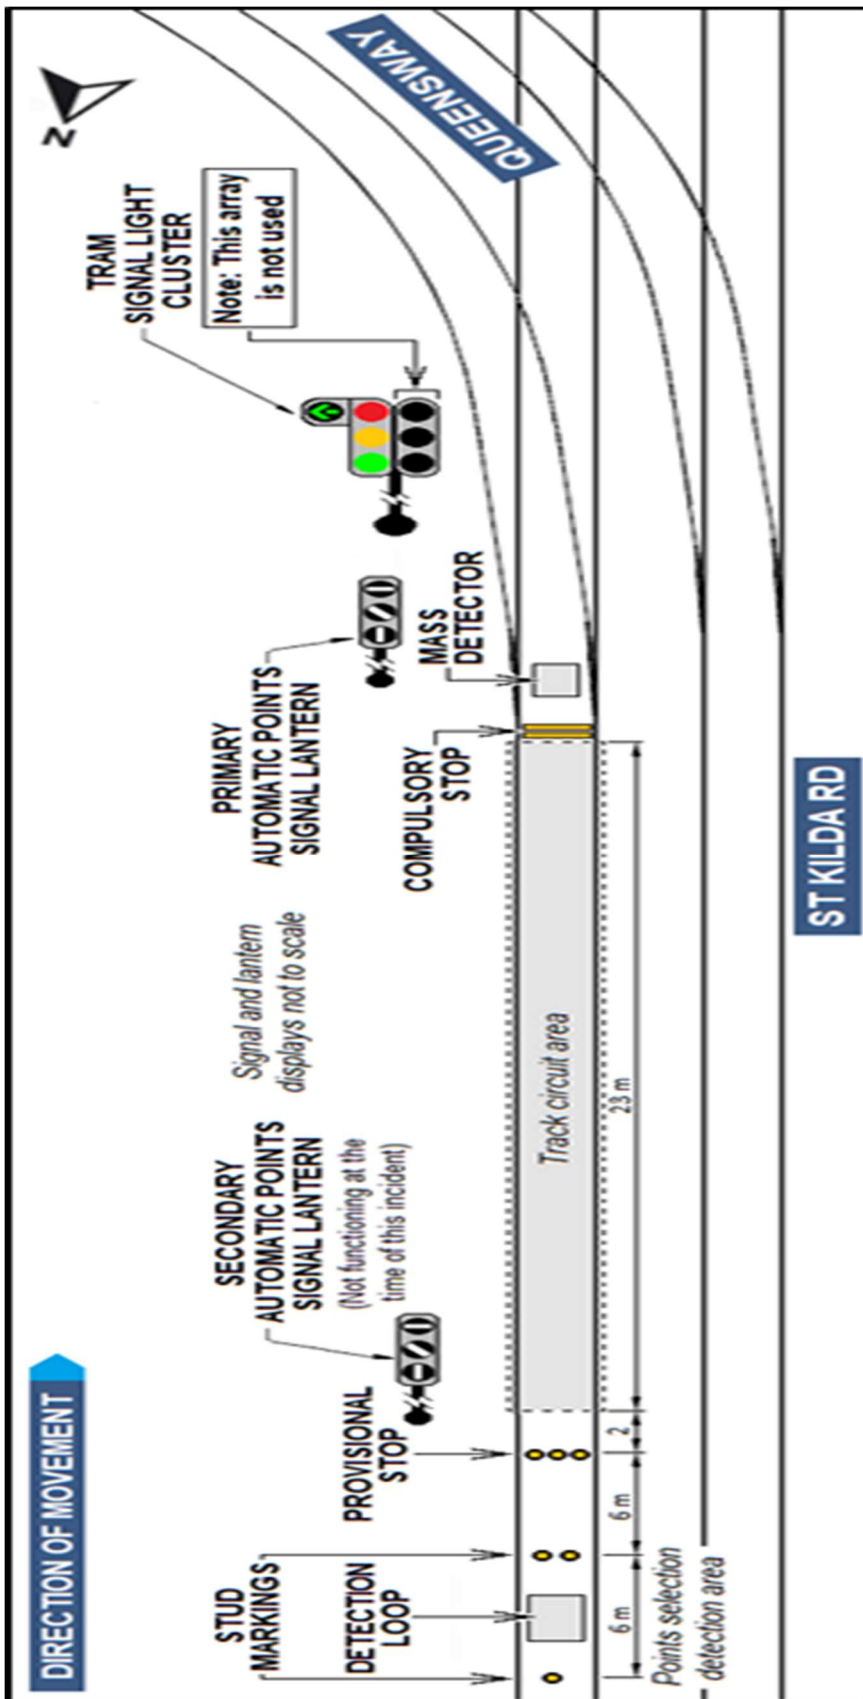
Figure 6: Track infrastructure and signal arrangement at St Kilda Junction

St Kilda Junction was fitted with an automatic points system that was comprised of track and trackside infrastructure (Figure 6). From the single-stud marker to the compulsory stop line is about 37 m.

This in-ground loop received the turn call from tram transponders and was in turn connected to the points controller located in a cabinet. At St Kilda Junction, the centre of the detection loop was around 34 m before the points.

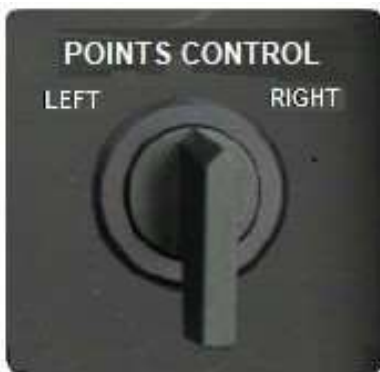
Figure 7: Points selector switch

When the tram entered the 'detection loop' section (between the one and two stud markers) the driver if turning, was required to turn and hold the points selector switch to the desired direction of turn. In the case of Tram 3535 at St Kilda Junction, the switch was required to be turned to the left position.

The default position of the switch was straight, and should the driver not make a turn selection, straight ahead was selected and the points, if set for the Queens Way turn, would move to straight-ahead.

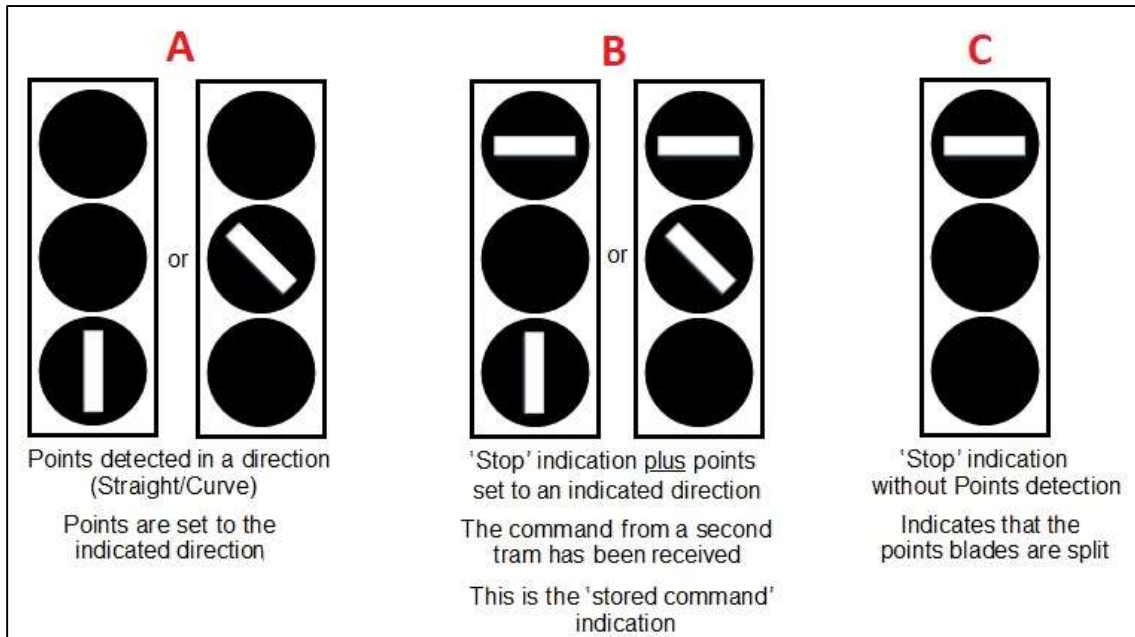
Figure 8: Indication of the points settings on the points lantern

The normal state of automatic points was to lie for the direction set by the previous tram through the location. If there was no tram ahead at the stop, the points lantern would display the setting of the points via an illuminated bar: vertical for straight-ahead; or 45 degrees for a turn (in the direction of turn) (Figure 8, Image 'A').

Should there be a tram ahead, stopped or not clear of the mass detection section, and the approaching tram wished to travel in a different direction to the tram ahead, the points lantern would mimic Image 'B' in Figure 8. That is, a horizontal bar meaning stop; and identifying the command from the following tram has been stored. In this instance, the tram must be stopped at the provisional stop until it was clear to proceed to the compulsory stop at the toe of the points.

If the points were not correctly set, a single white horizontal bar (Image 'C') would be illuminated, indicating a possible fault.

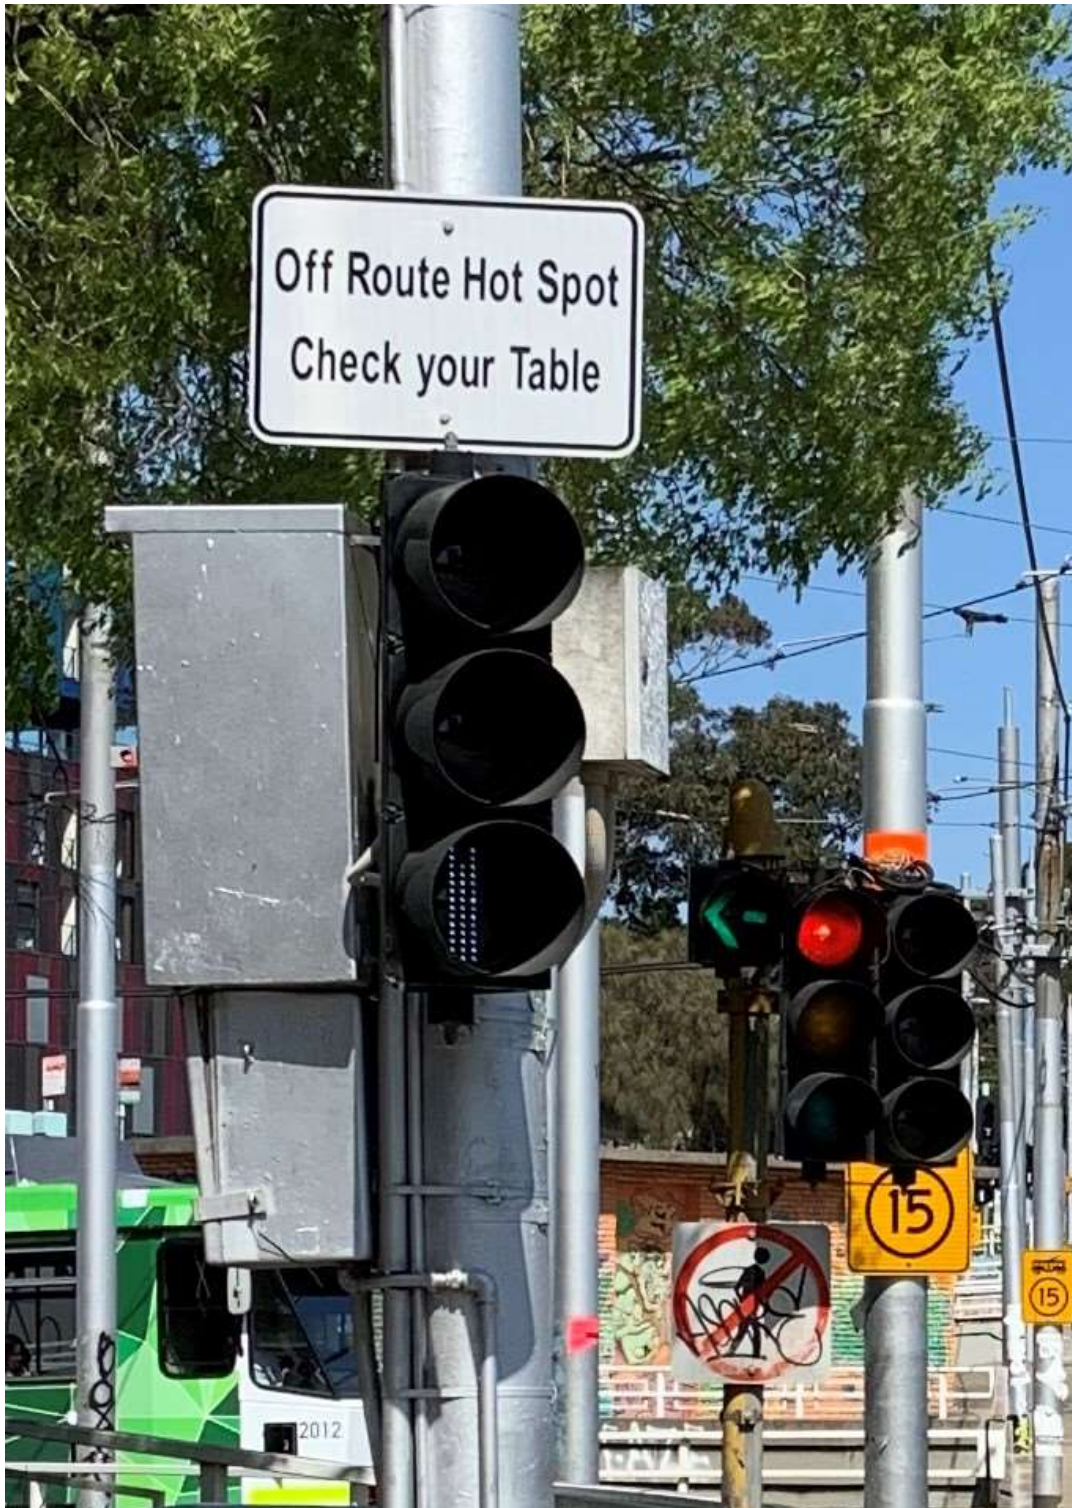
Figure 9: The points set for the straight, with the traffic signal indicating a left turn green arrow

The tram traffic signals control system was independent of the tram automatic points system. This meant that the traffic signal could indicate a green left-turn arrow while the points were set for the straight direction (Figure 9). This system independence was common on the Melbourne network.

Accordingly, it is recommended that Yarra Trams undertakes a full human factors review of several hotspot locations including the tram and road traffic signals that a driver is expected to interpret and respond to and develop improvements to reduce collisions caused by off-route trams.
