Office of the Chief Investigator
Transport and Marine Safety Investigations

**Marine Safety Investigation
Report No 2006 / 04**

Near Grounding
Passenger Vessel MV Statendam
Port Phillip Heads
6 December 2006

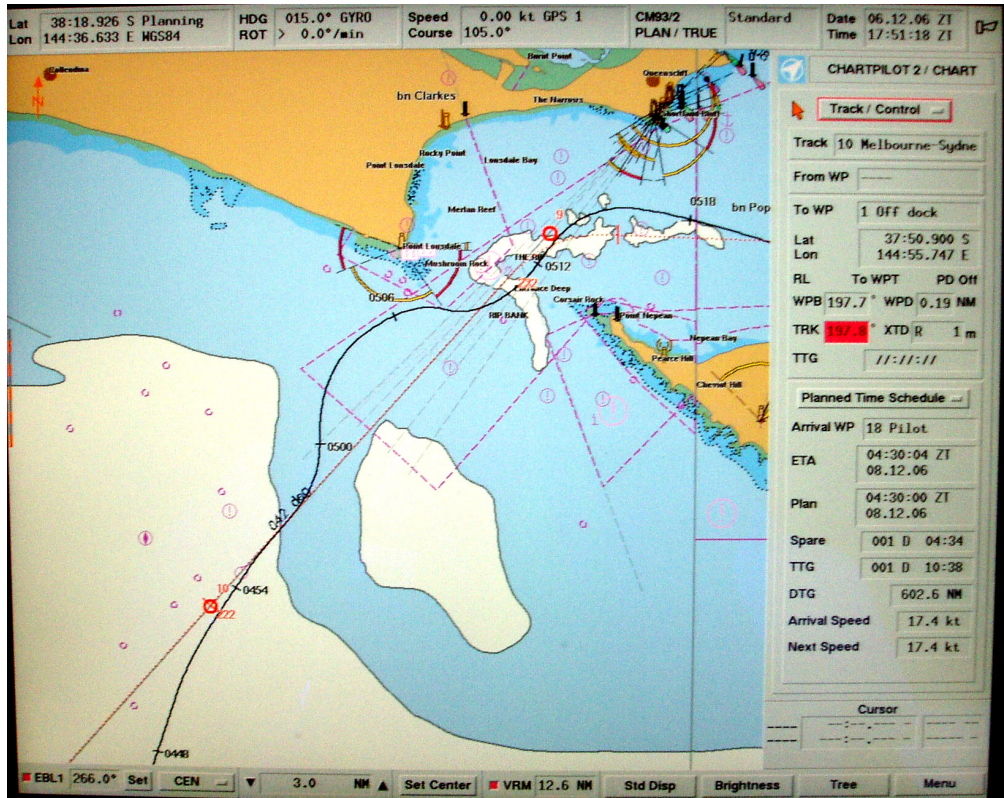
The investigation found that Statendam was travelling over the recommended speed limit when it picked up the pilot well inside the pilot boarding ground and applied a slow rate of turn to get back on track causing it to enter shallow water.

An overview of Statendam's progress through the Heads, as observed on it's Voyage Data Recorder (VDR). Appendix A tables the sequence of events.

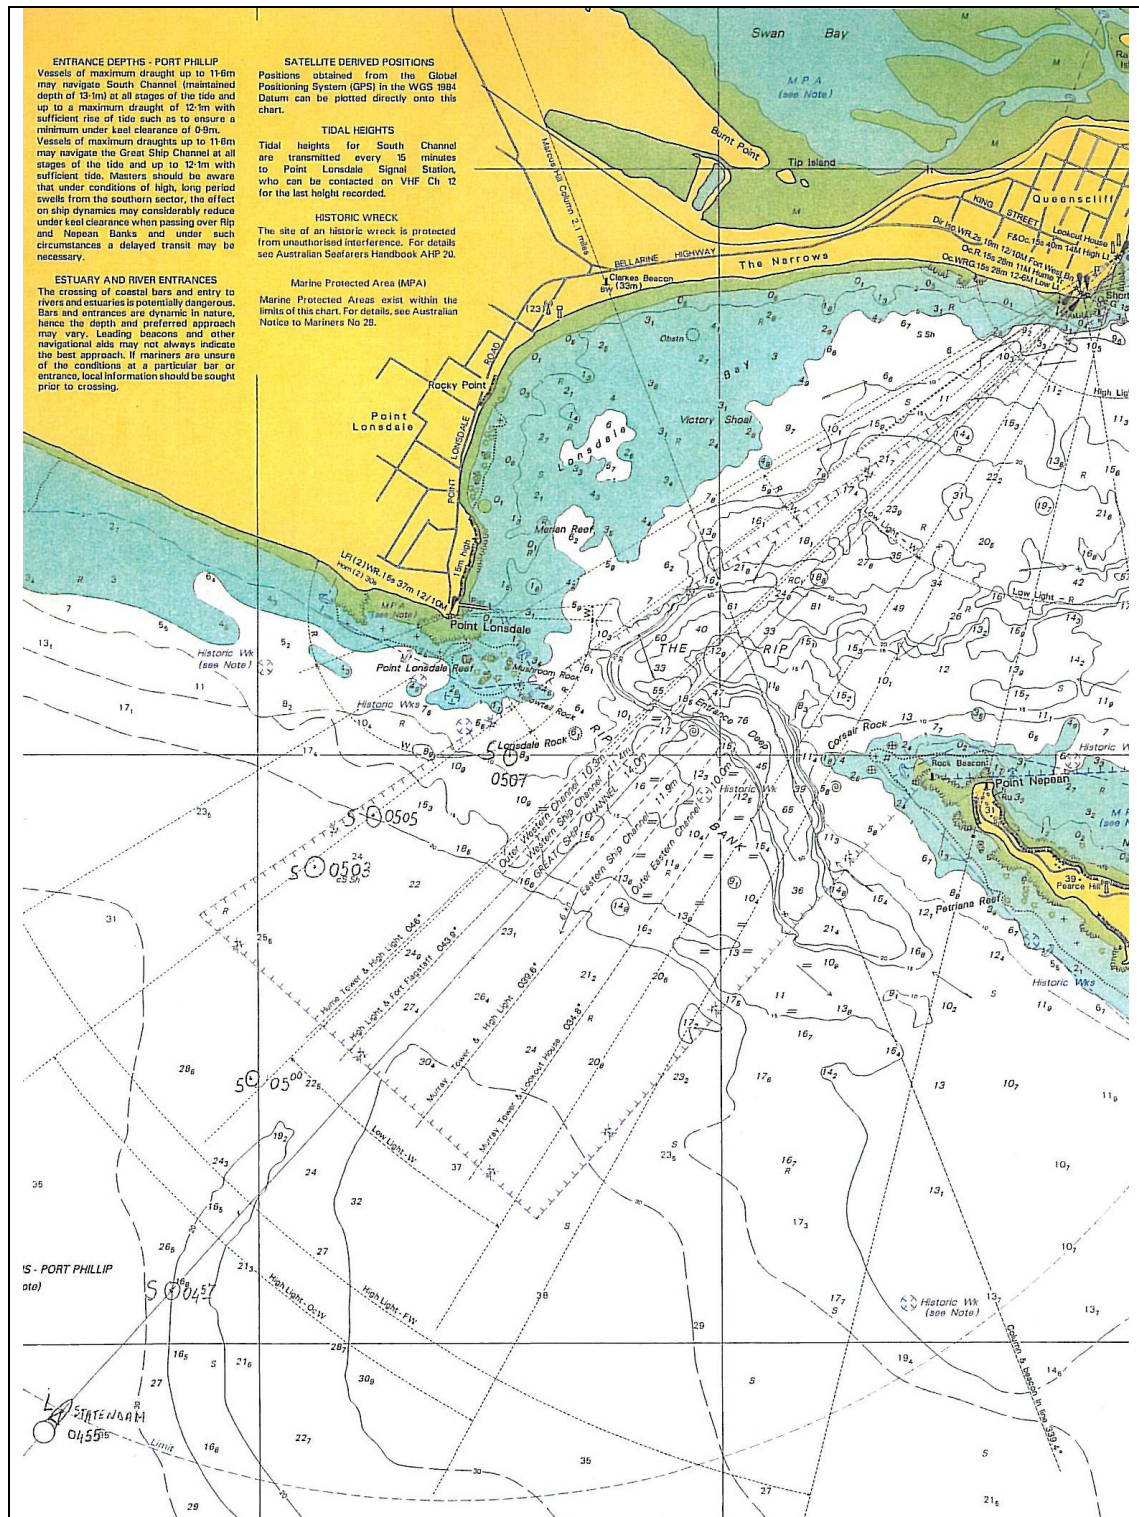
Appendix B - Port Phillip Heads

The VDR and AIS recordings indicate that just after 0505, whilst still outside the channel, Statendam appeared to steady on course 060⁰ (see Statendam's position in Appendix B), the course the helmsman was ordered to steer. At about the same time, the pilot recommended an alteration of course to 090⁰.

The investigation found that Statendam entered shallow waters with a minimum charted depth of 8.3 metres off Point Lonsdale prior to proceeding through the Heads.

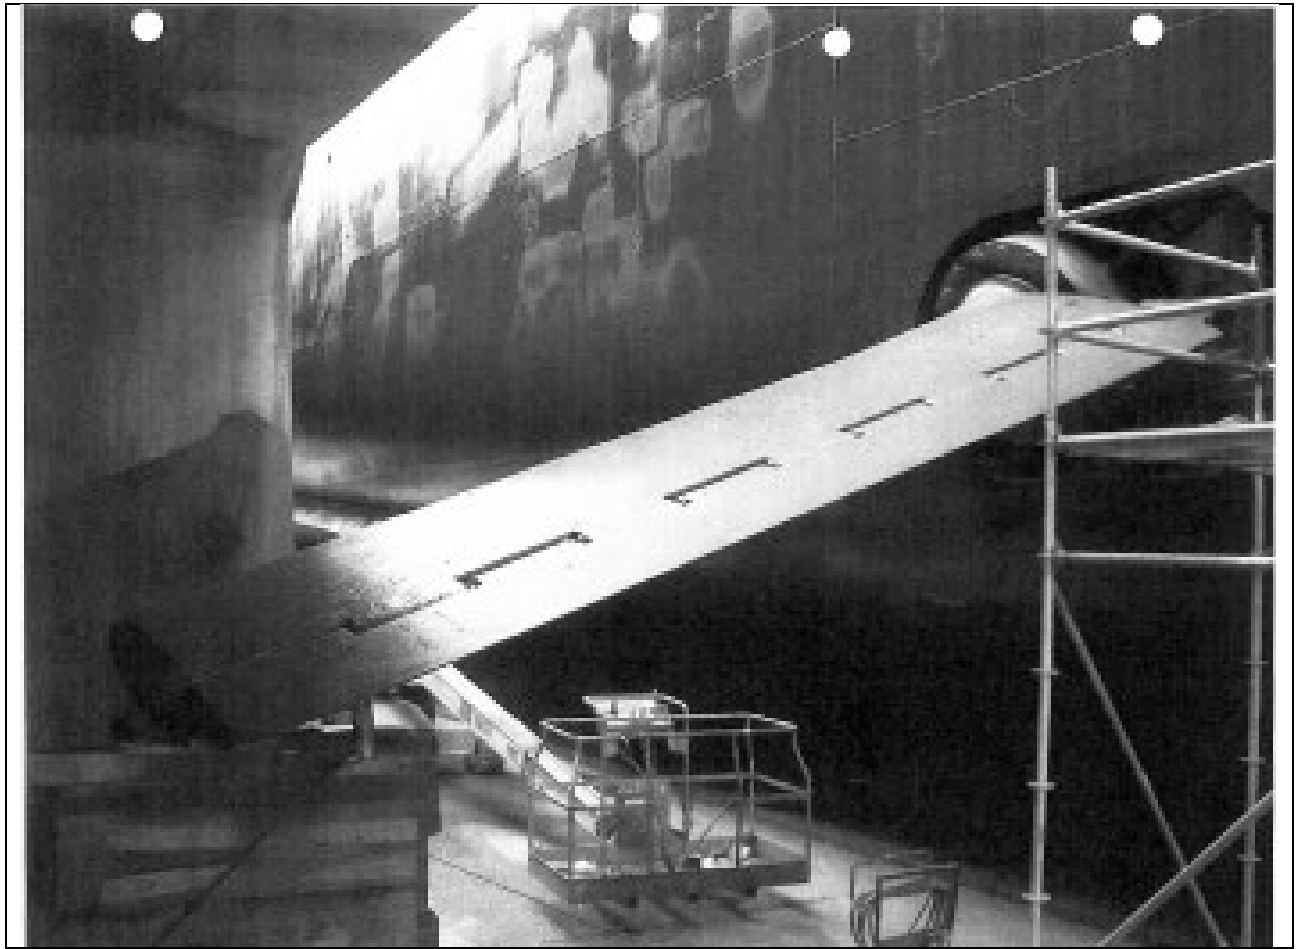
Appendix D - Statendam Stabiliser

An underwater inspection revealed that the outer tip of the port stabiliser fin suffered minor paint abrasion. The inspection also revealed that some fin holding bolts on the upper side of the shipside housing had broken, causing the stabiliser to misalign in its mounting.

The stabiliser fin (see Appendix D) is five metres in length, housed two metres above the keel and when extended is inclined 20° below the horizontal. When extended, the fin has a linear horizontal extension of about 4.70 metres from the shipside and the tip lies at a height of about 0.30 metres above the keel.

On the balance of evidence provided, it is likely that Statendam's port stabiliser fin made contact with some object on or near to the seabed. This conclusion is further supported by the physical evidence of scraping at the fin tip, failure of the stabiliser housing bolts and the report of a knocking sound being heard from within the hull.
