Office of the Chief Investigator  
Transport and Marine Safety Investigations

## Rail Safety Investigation

# Brief Report

Tram to Tram Collision

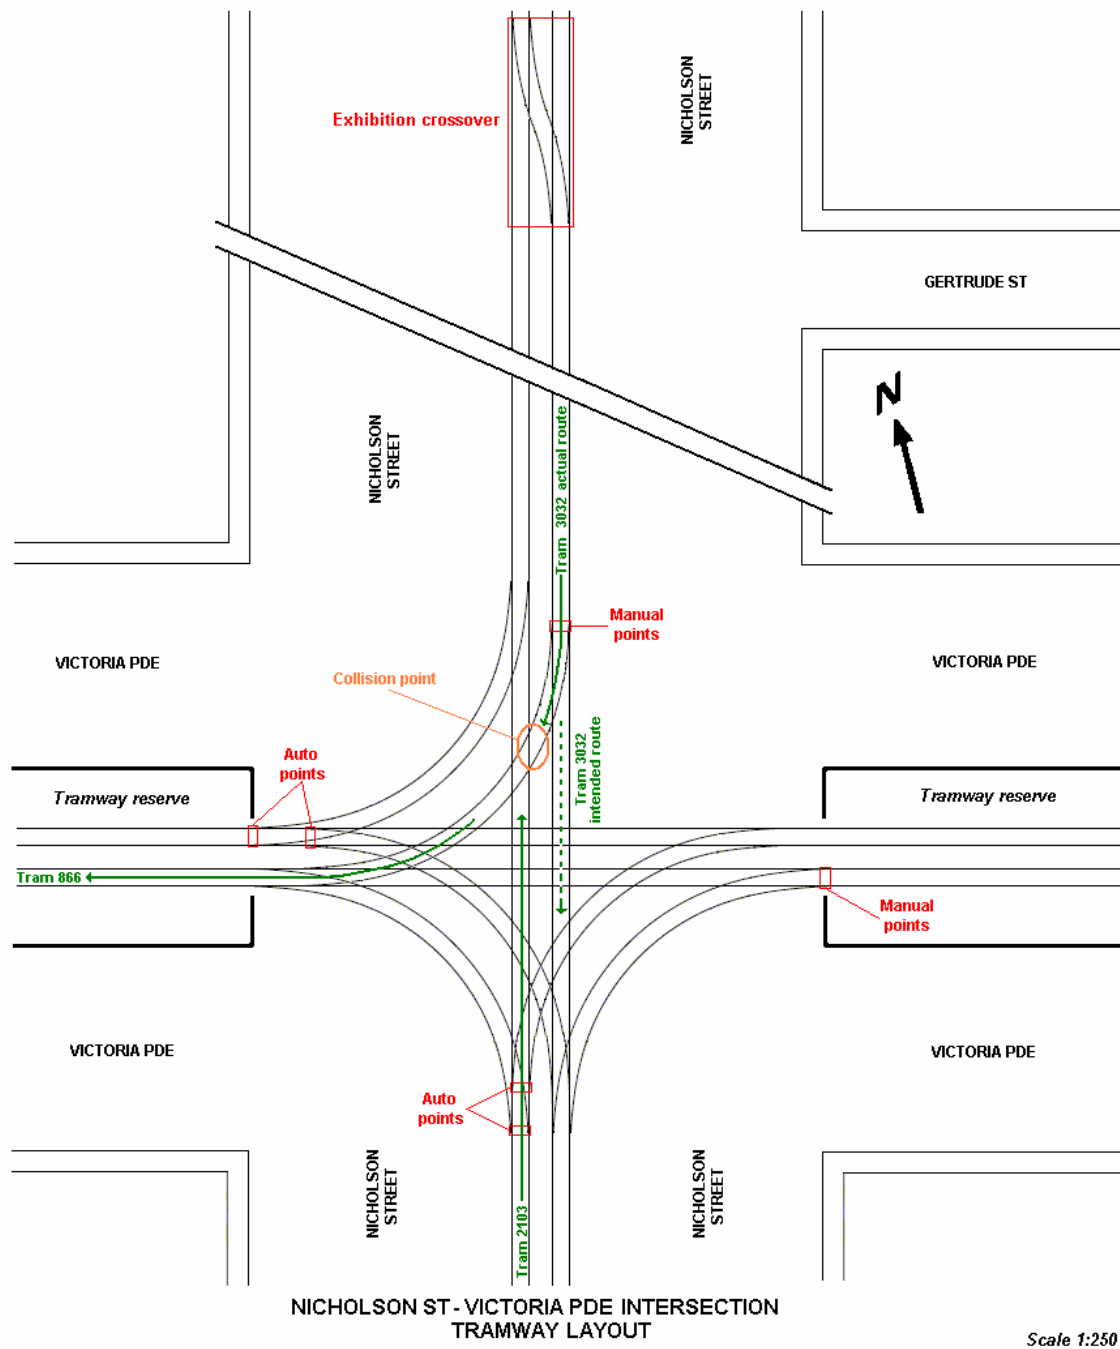
Figure 3. Schematic of intersection.

As tram 3032 entered the intersection the driver observed an opposing northbound movement (tram 2103) about three quarters of the way into the intersection. When both trams were passing, tram 3032 diverged to the right and collided with the side of tram 2103. The point of contact was about eight metres from the rear of Tram 2103 and resulted in superficial damage to the side panels. As a consequence of the impact tram 3032 was derailed and also sustained superficial panel damage.

Tram 3032 was brought to a stand with the leading bogie on the route leading towards Victoria Parade 8.7 metres from the toe of the facing points in Nicholson Street. Tram 2103 continued across the intersection coming to a stand opposite stop 11. The speed of tram 3032 at impact was about 10 km/h

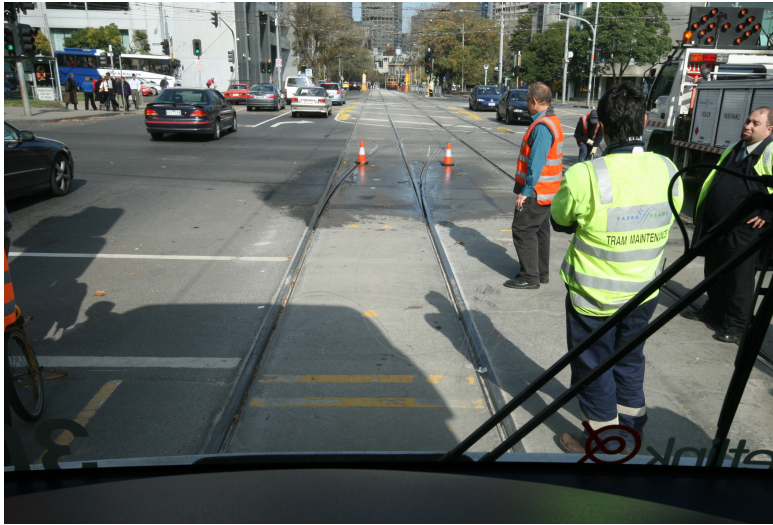
At about 1048 southbound Tram 3032 arrived at the intersection of Nicholson Street and Victoria Parade - Stop 11. While at this stop the driver reported that he observed the points and believed them to be set for the straight to continue along Nicholson Street across the Victoria Parade intersection.

Figure 4. View of facing points from driving position of tram 3032.

The driver of Tram 3032, although stopping tram 3032 in accordance with section 83 at Stop 11, failed to recognise, for whatever reason, that the facing points were set for the diverge route before proceeding.

That Yarra Trams review their Safety Management System with respect to the adequacy of risk mitigations provided to prevent side or head-on tram collisions at locations where facing points lead to a diverging movement which conflicts with opposing tram traffic.

Yarra Trams have issued a safety notice and conducted safety briefings to raise driver awareness of the requirements when stopped at facing points.

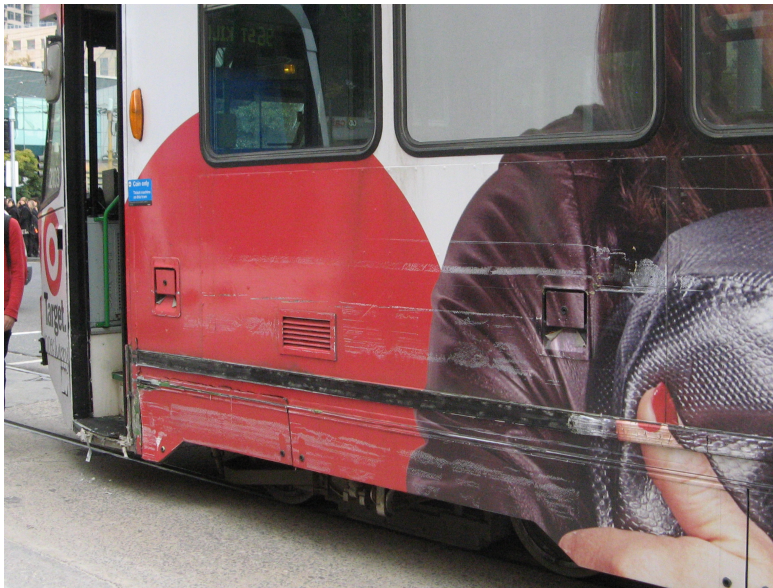
The incident resulted in a low speed side collision and derailment of Tram 3032. There were no injuries to passengers or tram crews. Both trams sustained minor panel damage.

Figure 5. View of side panel damage to Tram 2103.

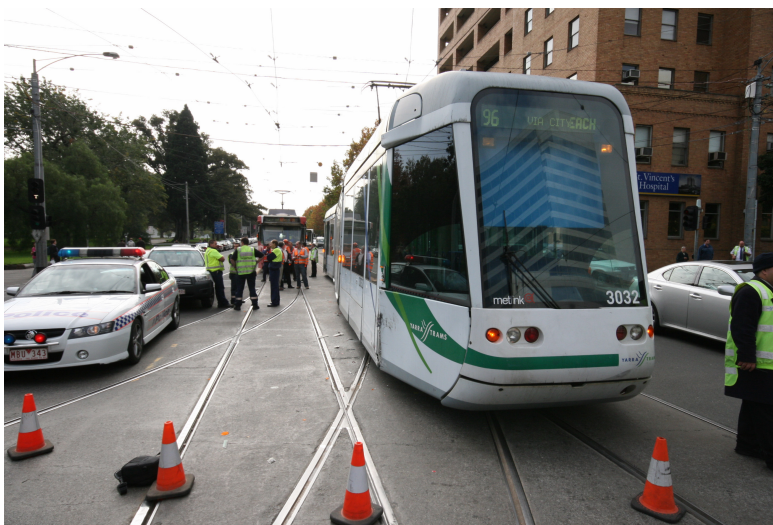
Figure 6. View looking north showing final position of tram 3032.
