Office of the Chief Investigator  
Transport Safety

**Rail Safety Investigation  
Report No 2010 / 07**

**Tram to Tram Collision  
The Arts Centre, Stop 14  
St Kilda Road, Melbourne  
2 June 2010**

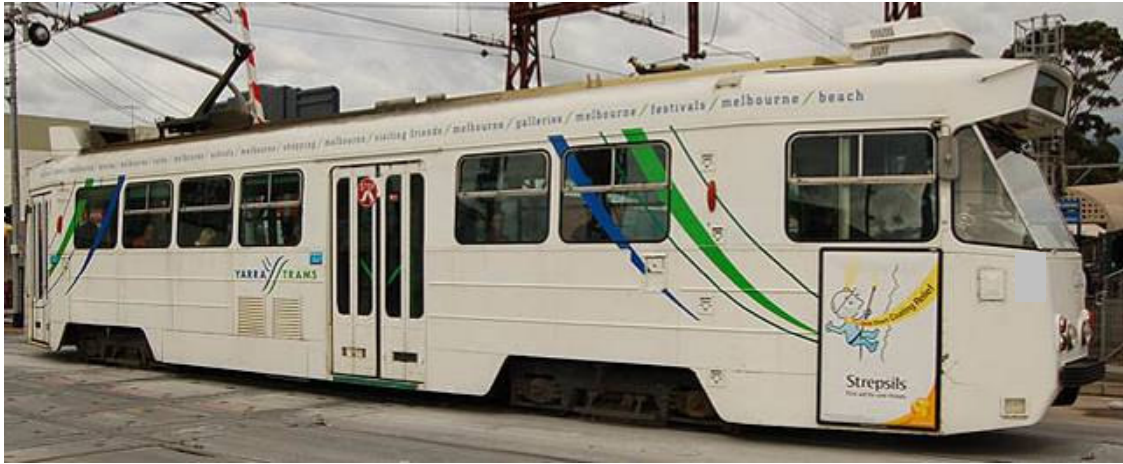
Figure 1 Tram 133

The rear end of Tram 133 suffered broken panels and windscreens and the driving console was pushed in.

Tram 133's brake was released at the time of collision, which probably reduced the force of impact and therefore the damage suffered by both trams.

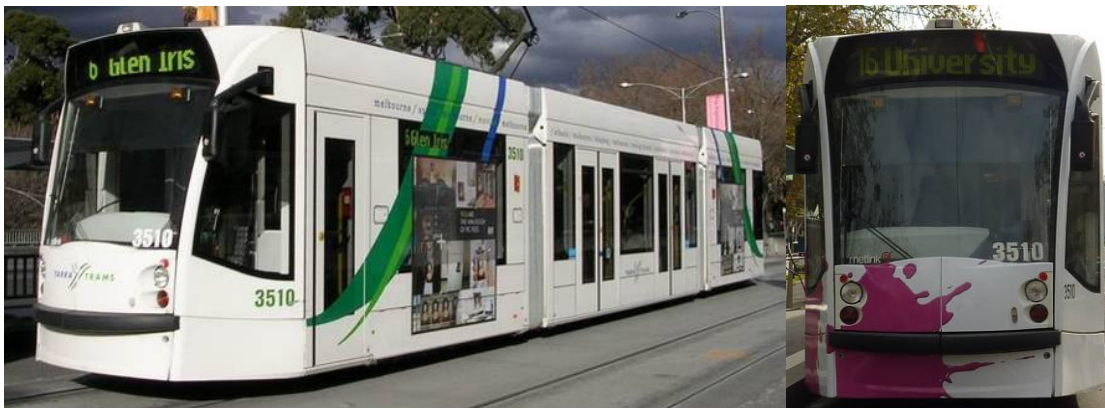
Figure 2 Tram 3510 side view and front view, photographed at different times during its lifespan.

Tram 3510 suffered damage to its front panel and windscreen.

Post incident, the data logger was downloaded and its diagnostic memory statistics were retrieved. The data indicated that the tram's driving, braking and general operating systems were operating normally until the time of the incident.

The data logger also identified that as Tram 3510 approached Stop 14, the driving throttle was put into 'neutral' and the tram kept moving forward under its own (built-up) momentum at 23 km/h. The service brake was activated a few seconds before collision and just after the collision the emergency brake was activated.

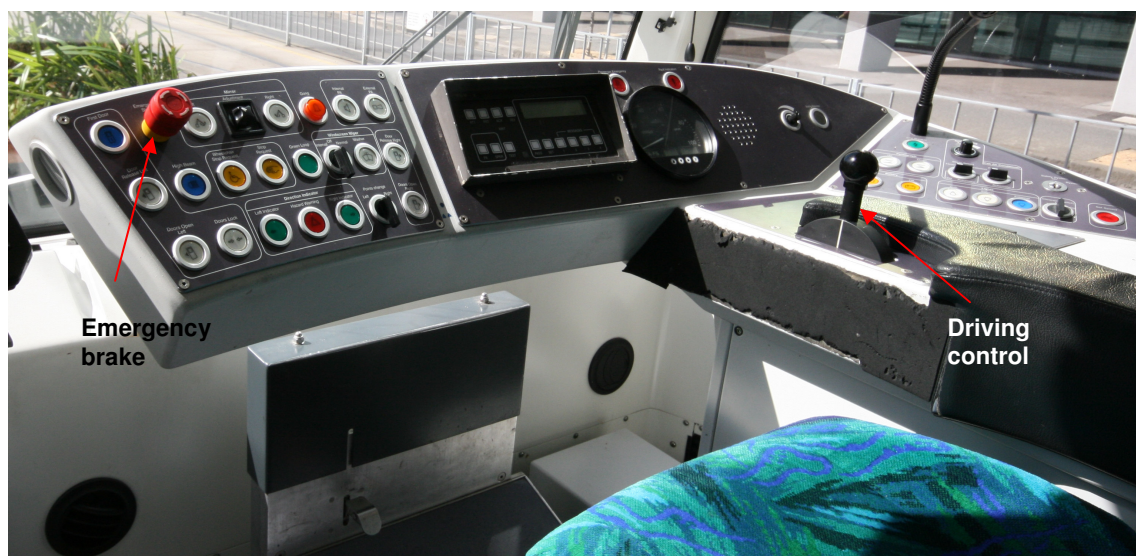
Figure 3 Tram 3510 Driving console

The service braking system is engaged when the control is pulled backwards from the upright position. The braking effect is commensurate with the amount of movement

applied to the control. The service brakes have an average deceleration rate of 1.35 m/s<sup>2</sup> and a maximum of 1.61 m/s<sup>2</sup>.

When the driving control is pulled backwards to its extremity, the emergency brake is applied. The emergency brake can also be applied by depressing the red button on the main operating console. When in emergency braking mode, the deceleration rate is 3.40 m/s<sup>2</sup>.

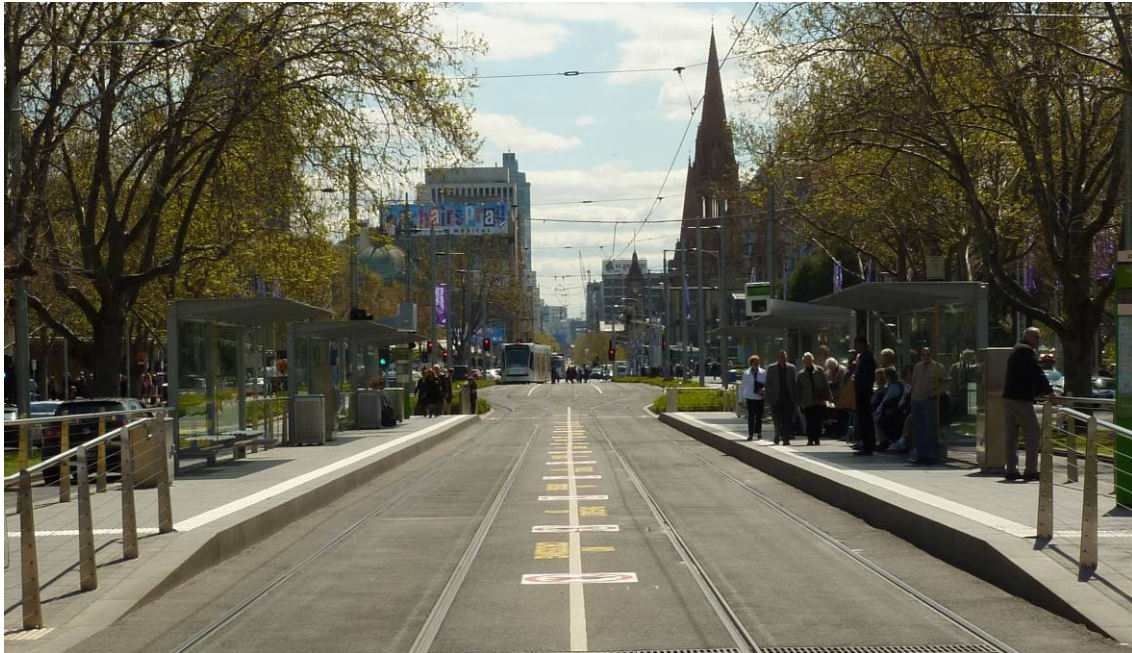
**Figure 4 Stop 14**

Tram Stop 14 on St Kilda Road (see Figure 4) is opposite the Melbourne Arts Centre, about 156 metres north of the Southbank Boulevard intersection. This tram ‘superstop’ was built in June 2008. The tram track runs in a straight line from Stop 17 to Stop 14 (about 600 metres) and continues in a straight line to the next stop at Flinders Street. The track in this section slopes upwards by about 150 mm from the Southbank Boulevard intersection and is level across the ‘safety zone’ and tram platform stop.

The length of the ‘safety zone’ on the inbound track is about 83 metres and is separated from the road by a protective metal fence on a concrete barrier. The length of the platform on this track is about 63 metres.

An inspection of the track infrastructure found that it was in a satisfactory condition for the operation of trams, at the time of the incident.
