Derailment of freight train 9204V

Sims Street Junction, West Melbourne, Victoria | 4 December 2013

ATSB Transport Safety Report
Rail Occurrence Investigation
RO-2013-027
Final – 13 January 2015

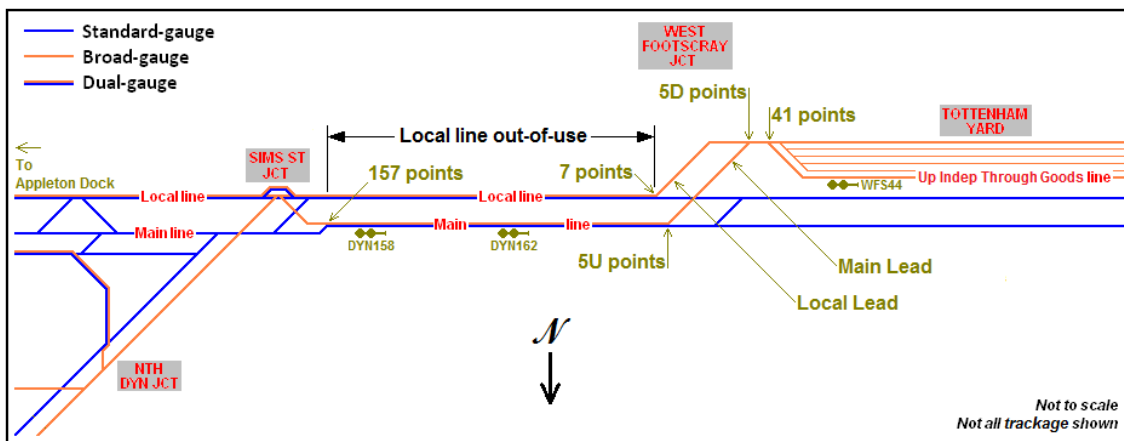
Figure 1: Simplified area diagram

Train 9204 would normally have been routed via the Local line (accessed from Tottenham Yard by the ‘Local lead’), however on this occasion the damage to № 7 points precluded this, and the NCO established a route via the Main lead and Main line. The locomotive crew received a Signalman’s Caution Order⁵ to proceed past signal WFS44, a pointsman hand-wound the 5U and 5D points to provide a route for train 9204 to the Main line, and shortly after 0125 train 9204 departed Tottenham Yard for the Port of Melbourne.

The damage resulting from the previous derailment had also affected the operation of ‘gauge detection’⁶, therefore there was no input to the Train Control System (TCS) of the track gauge of trains moving on the Main line through that area.

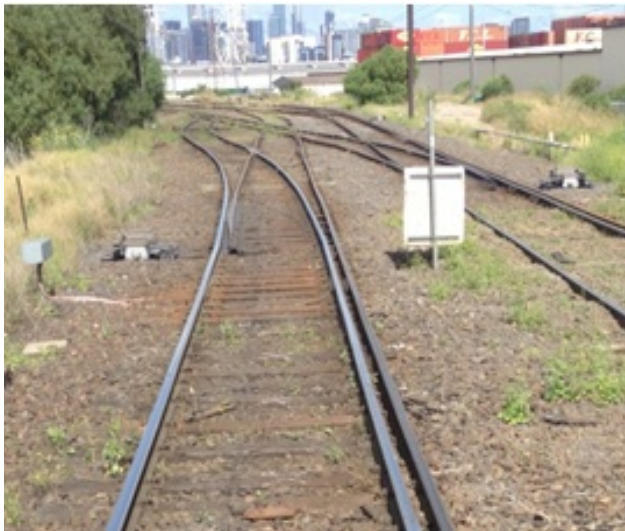
Figure 2: 157 points – dual-gauge separation

At about 0141, the NCO issued the Caution Order for train 9204 to pass signal DYN158. The train was then taken past the signal and travelled approximately 130 metres before it encountered the № 157 point blade set for the standard gauge track, whereupon the train derailed as the broad-gauge and common rails diverged.

Figure 2 shows the dual-gauge Main line separation at Sims Street Junction. The standard-gauge diverges to the left and continues as the Main line while the broad-gauge track extends directly ahead to connect with the Local line (seen in parallel to the right).

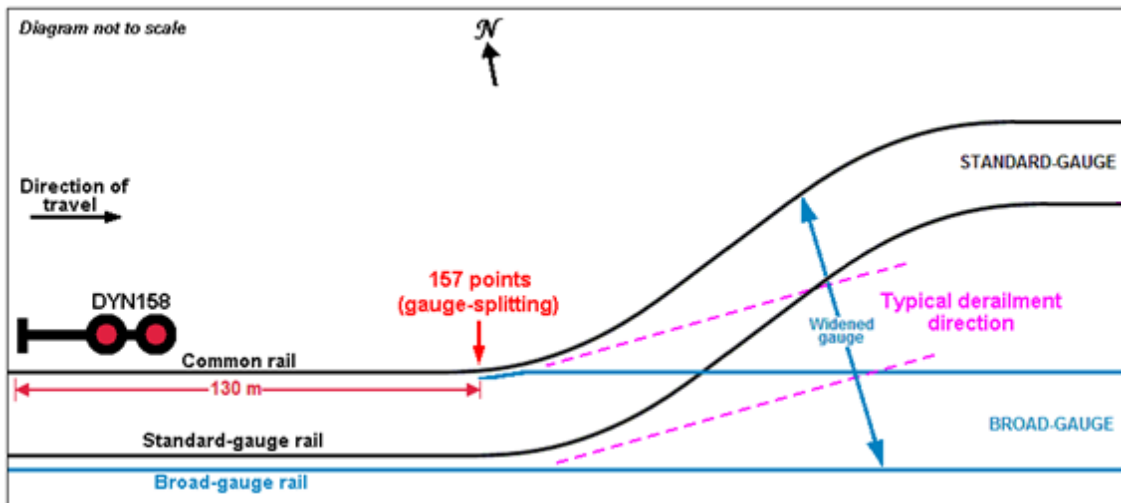
Figure 3: Diagram of derailment scenario at Sims Street Junction

Dual-gauge track comprises three running rails; one being common to both gauges. Gauge-splitter points consist of a single point blade that switches the common rail for either the broad- or standard-gauge direction. At locations—such as Sims Street Junction—where the diversion is achieved via the standard-gauge track turning away from the broad-gauge, the broad- and standard-gauge rails diverge and the common rail becomes a separate running rail for each track according to the setting of the point blade. From this arrangement, it follows that if a broad-gauge train should proceed into a standard-gauge route set in this manner, it will derail by dropping into the 'centre' as the available rail gauge widens due to the broad-gauge and common rail divergence (Figure 3).

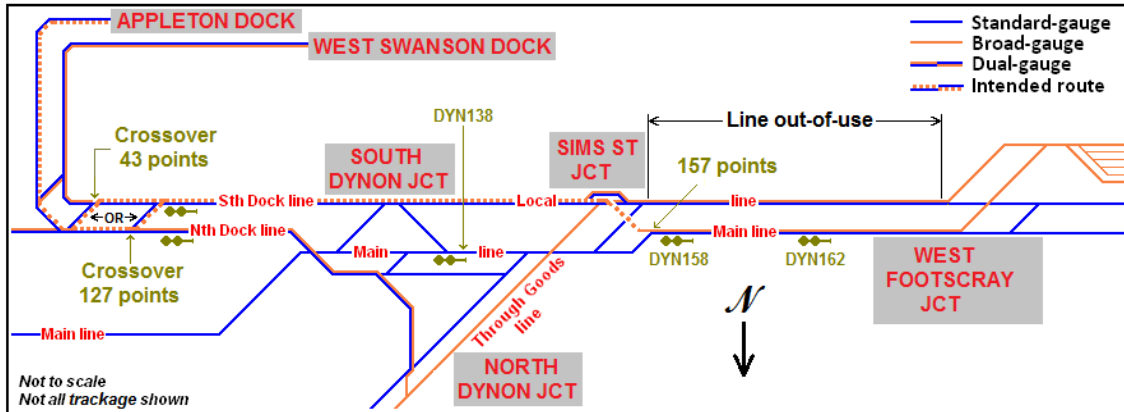
Figure 4: Simplified area diagram showing the correct route for train 9204

About a week earlier, on 29 November 2013, a broad-gauge freight train had derailed at the No 7 points (the Local lead) at West Footscray Junction, damaging approximately 100 metres of track. This rendered the Local line between West Footscray Junction and Sims Street Junction unusable and caused the gauge detection system and track circuits at this location to be unserviceable. This, in turn, resulted in signals affected by these track circuits being unable to assume a Proceed indication.

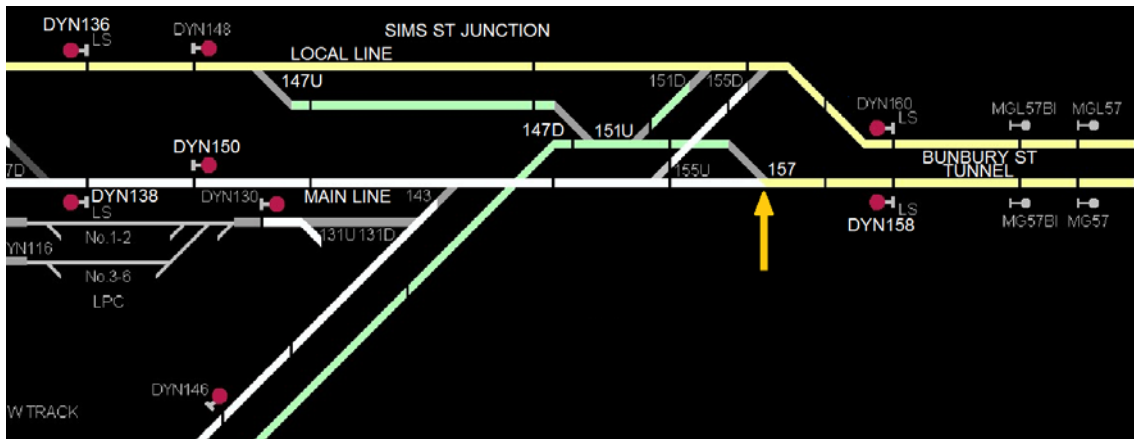
Figure 5: Portion of NCO’s screen display showing Sims Street Junction

Figure 5 shows the track layout at Sims Street Junction as viewed by an NCO on their TCS screen. Yellow depicts dual-gauge track, green is broad-gauge, and white is standard-gauge. Reading from right-to-left, the Main (lower) and Local lines are depicted approaching from Footscray toward Sims Street Junction. The two track gauges comprising the Main line diverge at No 157 points (arrowed). The intended and correct route for train 9204 was via 157 and 151U points, then the 147 crossover (147D/147U points) to access the Local line. Note that in diagrammatic form, the graphic presentation lacks spacial context. As a result, the screen display of network trackage at the 157 points represents the broad-gauge as diverging (to the right in the direction of travel) and the standard-gauge Main line continuing straight ahead when in reality the opposite is the case (refer to Figure 3).

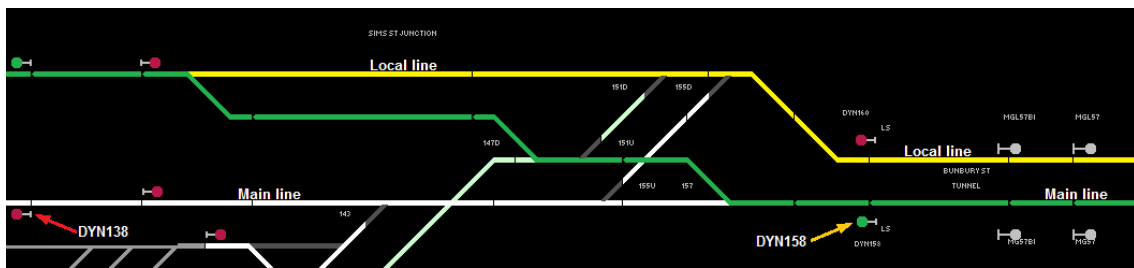
Figure 6: Screen display showing correct broad-gauge route

Figure 6 depicts the Sims St Junction location as it would appear on the TCS screen with the route correctly set for broad-gauge access from the Main line to the Port.

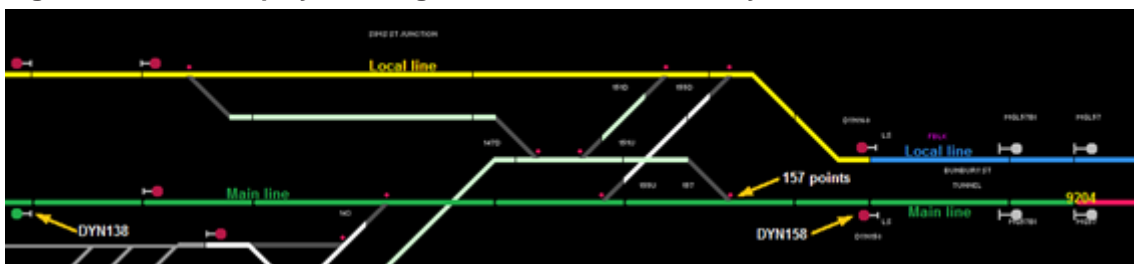
Figure 7: Screen display showing the route as inadvertently set for train 9204

Figure 7 replicates Figure 6 but depicts conditions at the time of the incident and the route set by the NCO for train 9204 (seen depicted in red as it approaches from the right). Although this route is unviable for train 9204 beyond the 157 points, the train control system does not prevent it from being selected and set, since it includes a valid standard-gauge component throughout.

The NCO reported having believed they had set the route for the train to run from the Main line across to the Local line and recalled that the screen display was showing a green viable route but that the signals had not cleared. When setting a route on the train control system, an NCO's route-setting¹⁵ actions with respect to cursor control require precision; otherwise an unintended route can easily be established. In this instance, in establishing the entry point for movement of train 9204 from the Main line at signal DYN158 to the port, the NCO unintentionally 'clicked' beyond signal DYN158 instead of before it, and in consequence established a route along the standard-gauge Main line instead of via broad-gauge crossover № 147.
