Level crossing collision between passenger train and semi-trailer

near Lake Charm, Victoria | 12 February 2013

ATSB Transport Safety Report
Rail Occurrence Investigation
RO-2013-008
Final – 7 October 2014

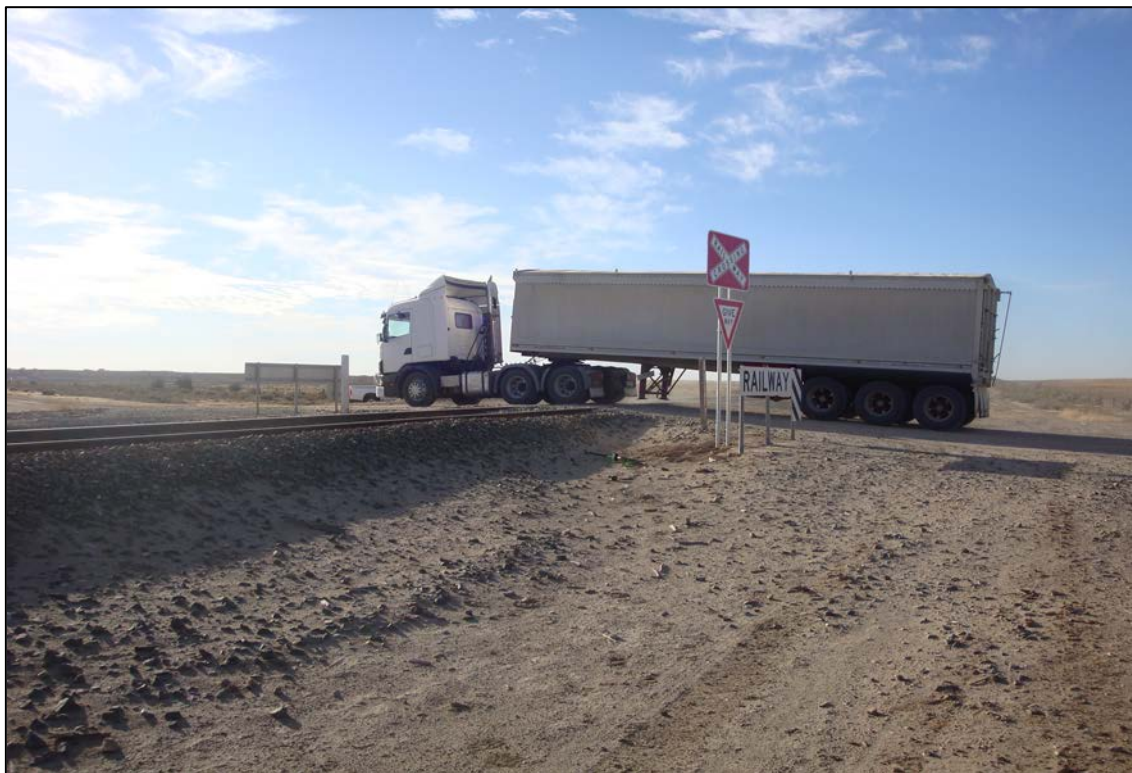
Figure 2: A semi-trailer negotiating the level crossing, looking southeast

The driver then returned to his normal driving posture, selected first gear, and proceeded slowly towards and across the level crossing at a speed of around five km/h. The approach to the crossing was on an incline (Figure 2), that resulted in reduced acceleration from the stopped position and added to the time taken to traverse the crossing.

With the truck in motion and the driver in his normal driving posture, there was no further opportunity to view the track to the north beyond a short distance due to the truck's angle of approach and the sighting angle limitations through the truck's left-side cab window. The train did not come into the truck driver's view at any point during this transit.

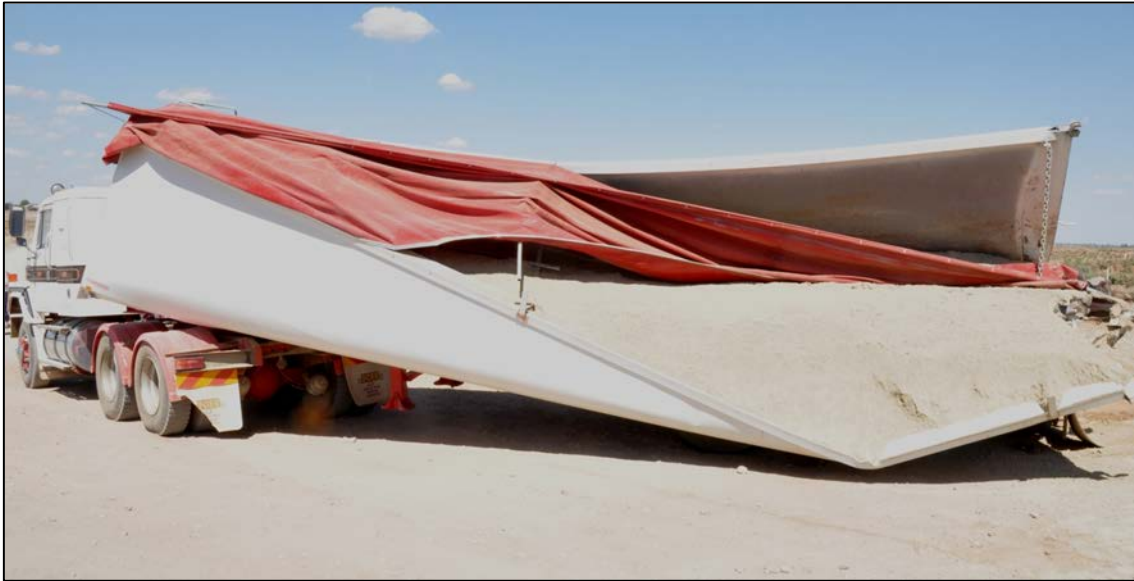
Figure 3: Damage to the truck's trailer

The trailer had almost cleared the crossing when it was struck in the rear left-hand corner resulting in the loss of load and the destruction of the trailer. The speed of the train at the time of the collision was 84 km/h and it came to a stand under the emergency brake application about 248 m beyond B. McCann Road. The collision occurred at about 1320.

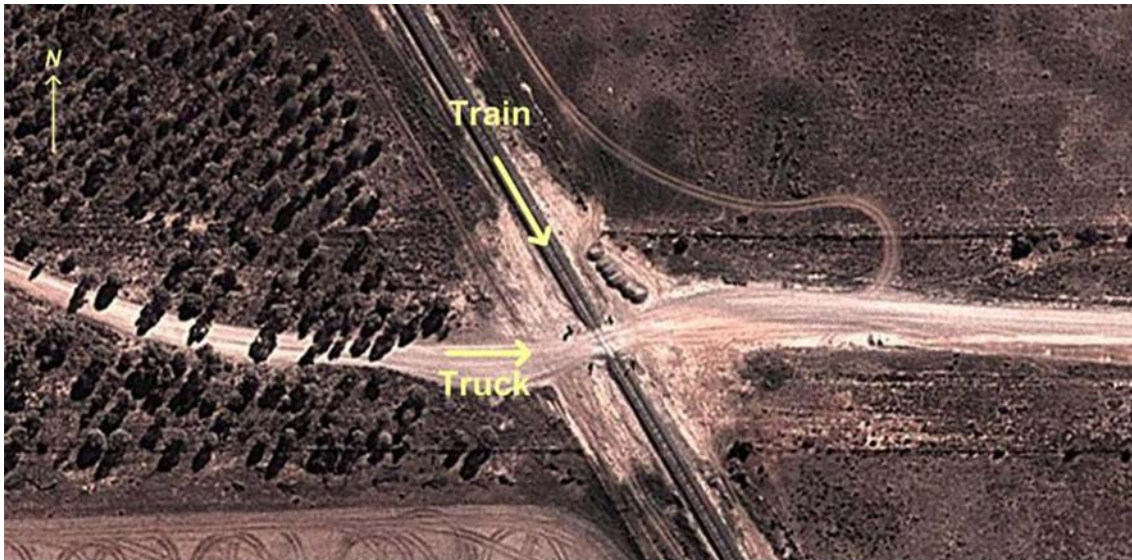
Figure 5: Aerial view of B. McCann Road level crossing.

The B. McCann Road level crossing was situated on the V/Line Broad-Gauge network 303.095 rail kilometres from Melbourne, between Kerang and Swan Hill. When approaching from the mine, vegetation on the left-hand side prevented road users from viewing the railway line towards Swan Hill until they were within about 35 m of the crossing. Once clear of the vegetation, the view to the north was affected by an earth embankment created by a shallow railway cutting.

- Option 1 – Retain the give-way signs, realign the roadway and level out the road approaches in close proximity to the level crossing, cut back the embankment and reduce the road speed to 20 km/h.
- Option 2 – Level out the road approaches in close proximity to the level crossing, change the protection type from give-way to stop signs and reduce the rail speed to 60 km/h.
- Option 3 – Retain the give-way signs, realign the roadway and level out the road approaches in close proximity to the level crossing, cut back the embankment, remove vegetation and reduce the road speed to 30 km/h.

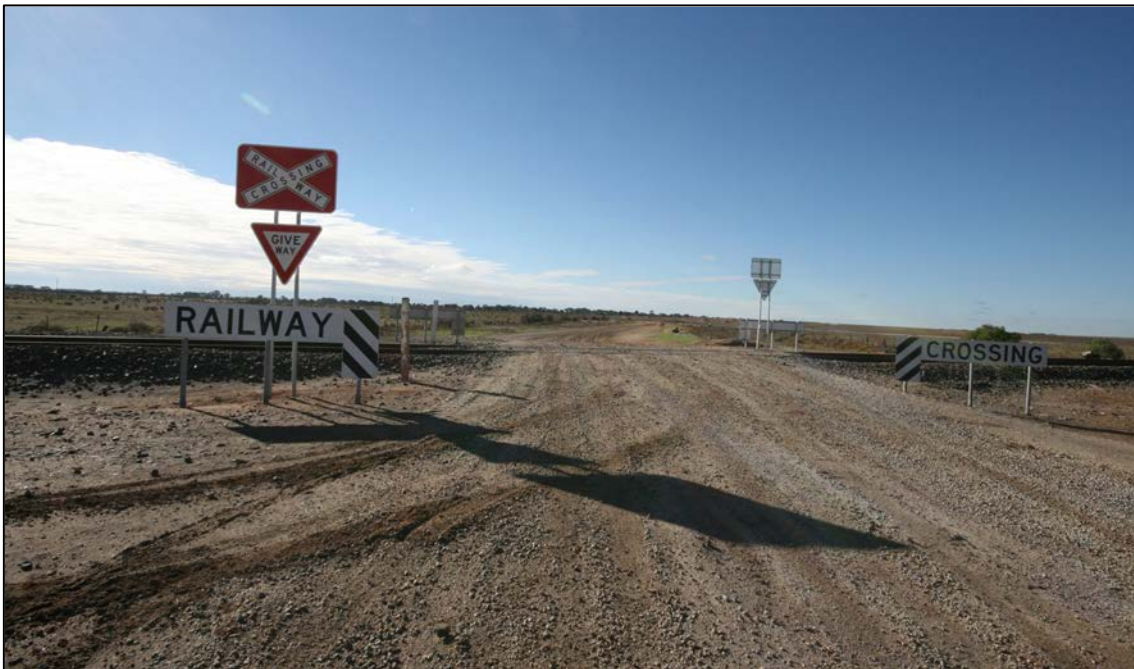
Figure 6: Crossing signage, approaching from the gypsum mine

All signage installed at the crossing was in good condition and clearly visible. Give-way signage was provided as the control treatment for road users and included the Railway crossing give-way assembly (RX-1) and the Railway crossing width marker assembly (RX-9) as detailed in AS1742.7 Manual of uniform traffic control devices, Part 7: Railway crossings.

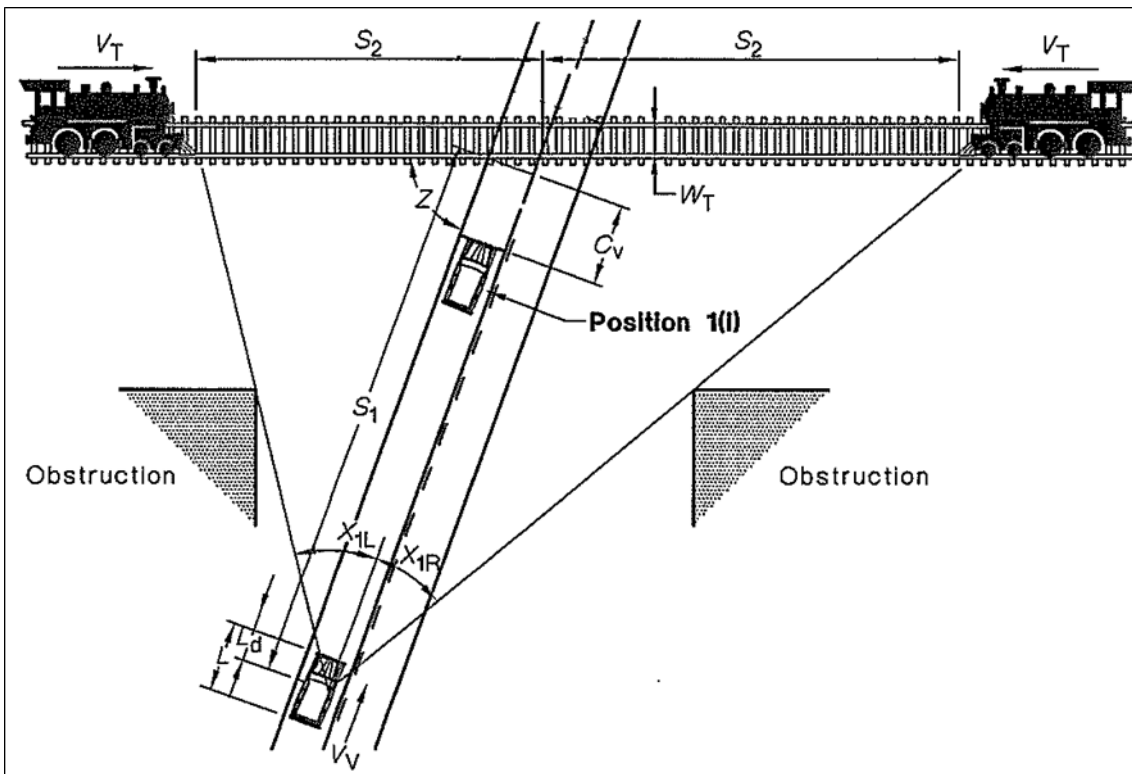
Figure 7: Definition of S2 distance for road vehicles approaching a give-way sign

The more critical finding of the assessment was the identified non-compliances with the S2 sighting requirement applicable to give-way protection (Figure 7). This measurement is an indicator of whether a motorist has sufficient time to observe and give way to an approaching train. The ALCAM assessment assumed a vehicle approach speed of 50 km/h and concluded that for eastbound road traffic, the S2 distances (looking both north and south) were less than 50 per cent of that required. The assessment also identified an S2 deficiency for westbound road traffic.

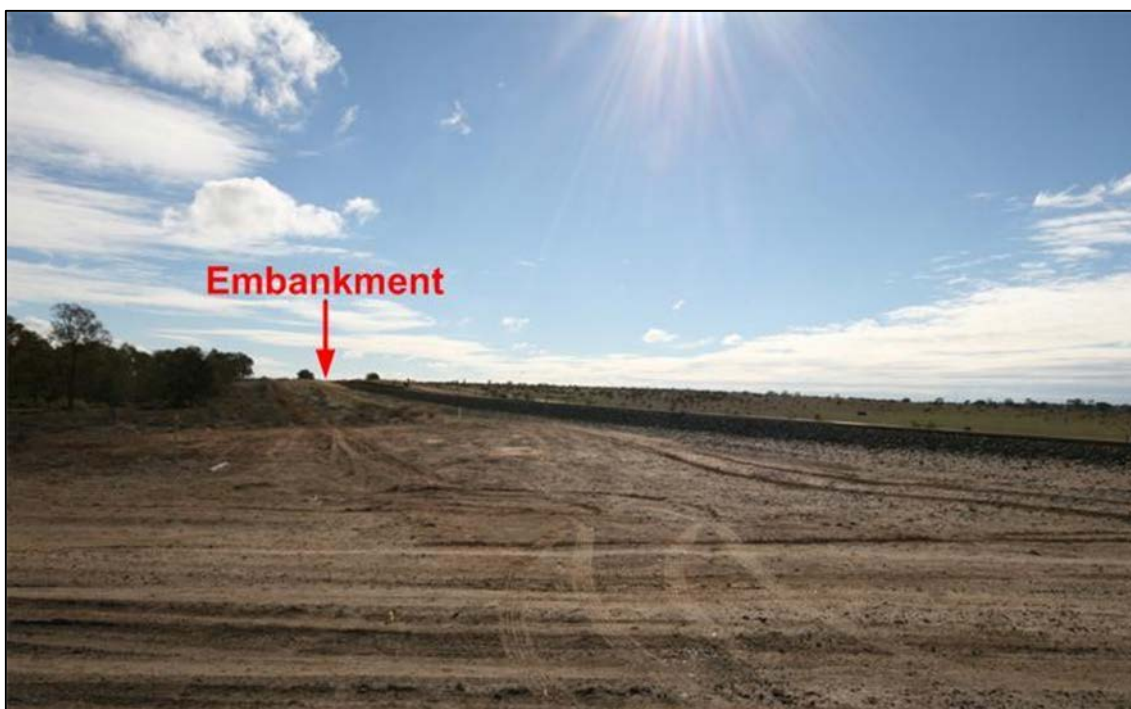
Figure 8: View looking north, about 20 m from the crossing

An examination of the eastbound road approach to the crossing (travelling from the gypsum mine) found that sighting to the north was affected by a number of factors. On the approach to the crossing, there was no sighting to the track due to vegetation until about 35 m from the track. Once clear of the vegetation, the view to the north was affected by an embankment (Figure 8) formed by a shallow rail cutting. The embankment did not completely block an approaching train from view, although the view was diminished.

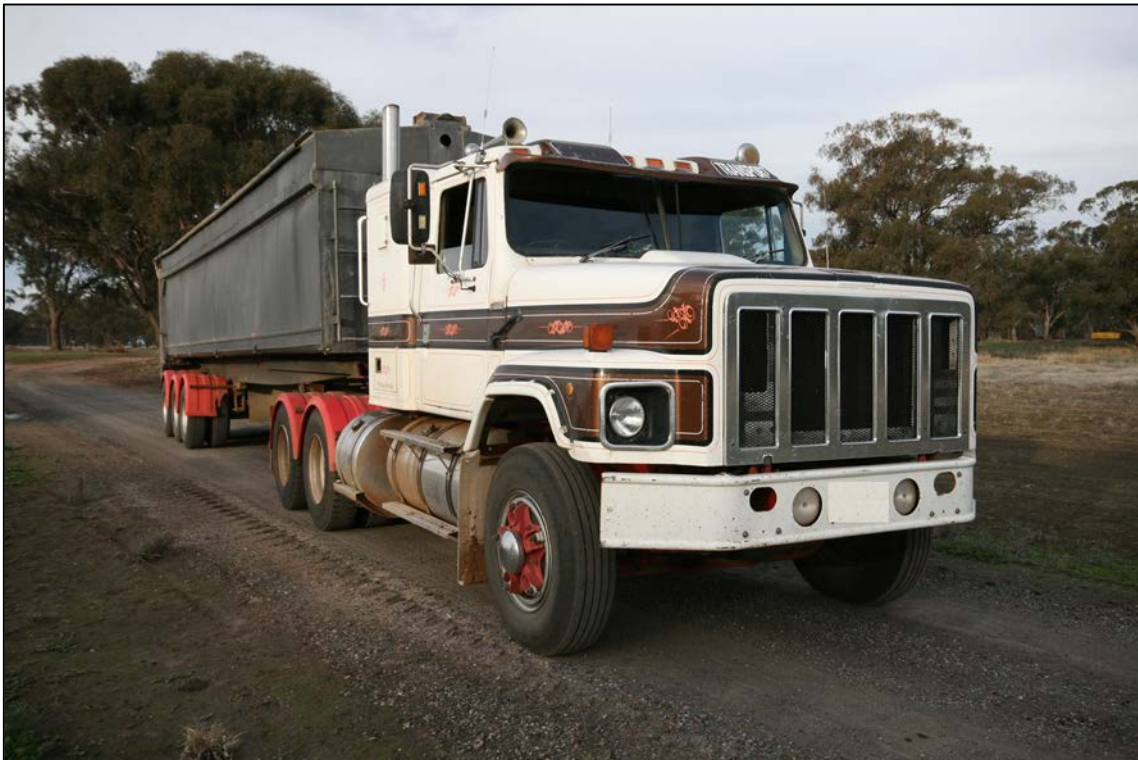
Figure 9: The semi-trailer configuration, with the prime-mover and a similar trailer

The prime-mover was a dual axle 1982 White International with sleeper cab (Figure 9). The trailer was a Freightmaster semi-tipping type with a capacity of 27 t. The total length of the semi-trailer was 14.9 m and its total mass was about 43 t after departing the gypsum mine on the day of the incident. The truck's mechanical condition did not have a bearing on the event.

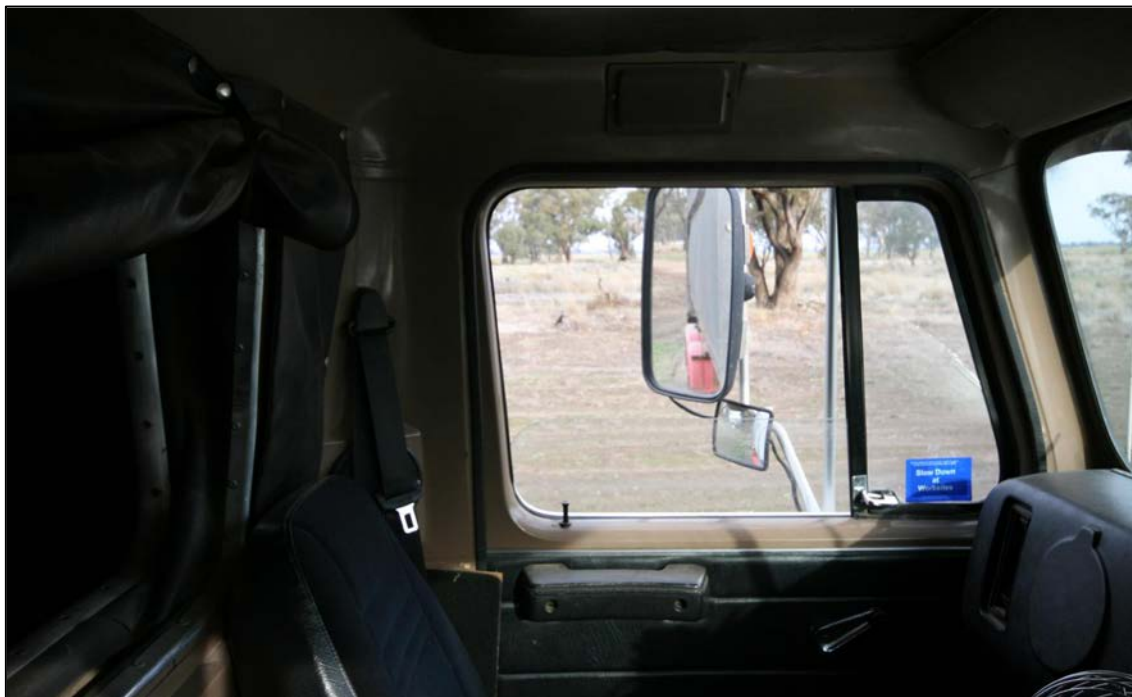
Figure 10: View through truck cab side window from the driving position

A driver's view to the left of the truck was restricted by the cab and sleeper configuration (Figure 10). Viewing left was limited to the small passenger-side window as there were no windows further to the rear.

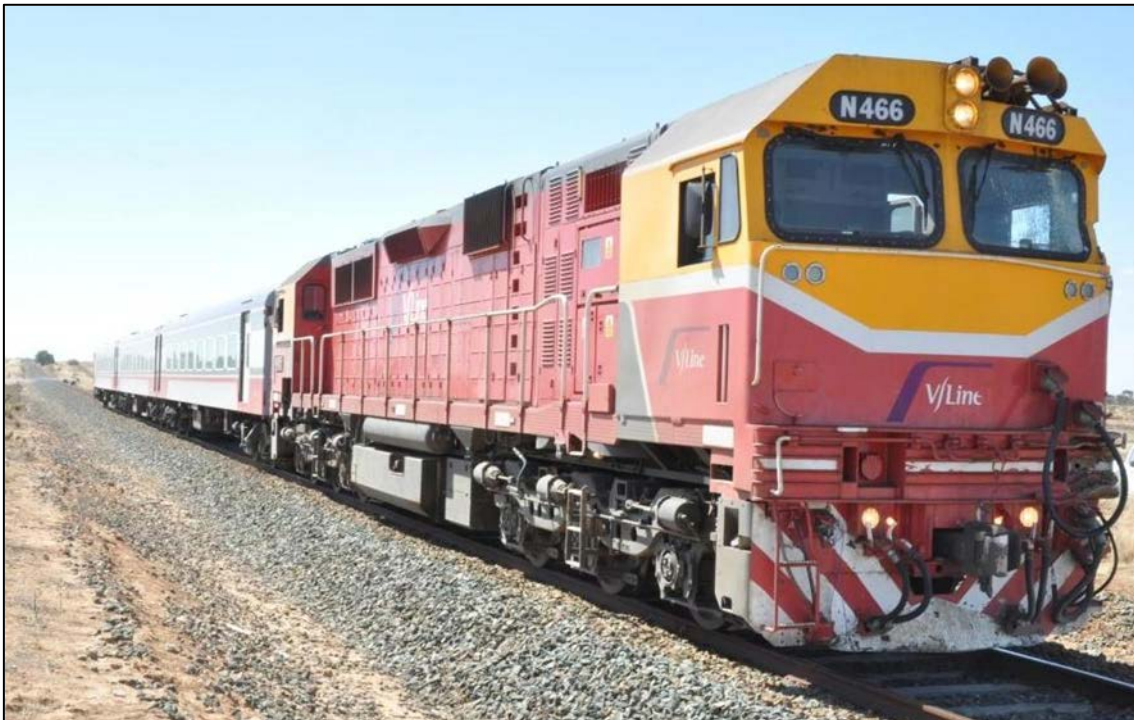
Figure 11: Train 8042 following the collision

Train 8042 consisted of locomotive N466 and three passenger cars. It was about 87 m in length and had a mass of 254 t. Aboard were the driver, two conductors and about 40 passengers. No aspect of the mechanical condition of the train contributed to the incident. The train's headlights were examined after the incident and found to be functional.

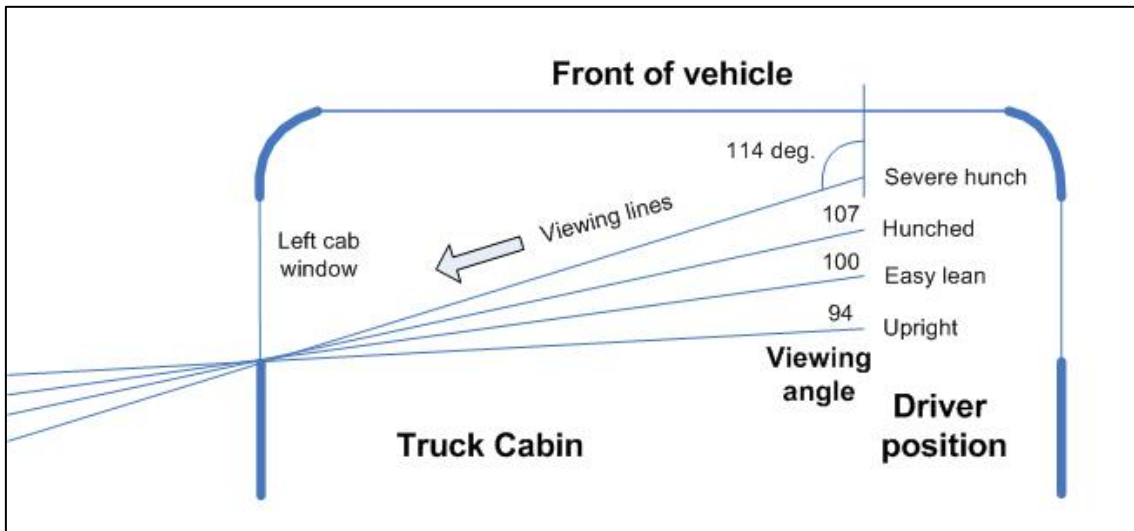
Figure 12: Measured maximum driver viewing angle for a range of driver postures

Measurement of the truck involved in this incident confirmed the viewing limitations when attempting to view to the left behind the perpendicular to the direction of travel. With the driver in a typical upright position, the furthest rearward view was about 94 degrees from the direction of travel. With an easy lean forward, this angle could be increased to 100 degrees, with a more extreme hunch forward to 107 degrees and at the most extreme forward position over the steering wheel, to about 114 degrees (Figure 12).

With the driver in a 'hunched' position (107 degree view angle), the truck approaching at an acute angle of 65 degrees to the track and the driver 20 m back from the crossing, the driver's view along the track would have been limited to about 140 m. With the driver hunched slightly more forward and achieving the Australian Standard specified maximum (at stop) view angle of 110 degrees, this distance could be increased to about 220 m. The precise extent to which the driver leant forward to look for trains is unknown. However, based on these estimates, it is likely that when stopped on the left-hand side of the road, the driver's view was limited to less than 220 m along the track as a result of the acute road-rail angle. The train is estimated to have been in excess of 500 m from the crossing when the observation was made and therefore out of the truck driver's view.
