Level crossing collision between truck and passenger train 8753

Phalps Road, Larpent, Victoria | 13 July 2016

ATSB Transport Safety Report
Rail Occurrence Investigation
RO-2016-009
Final – 28 June 2019

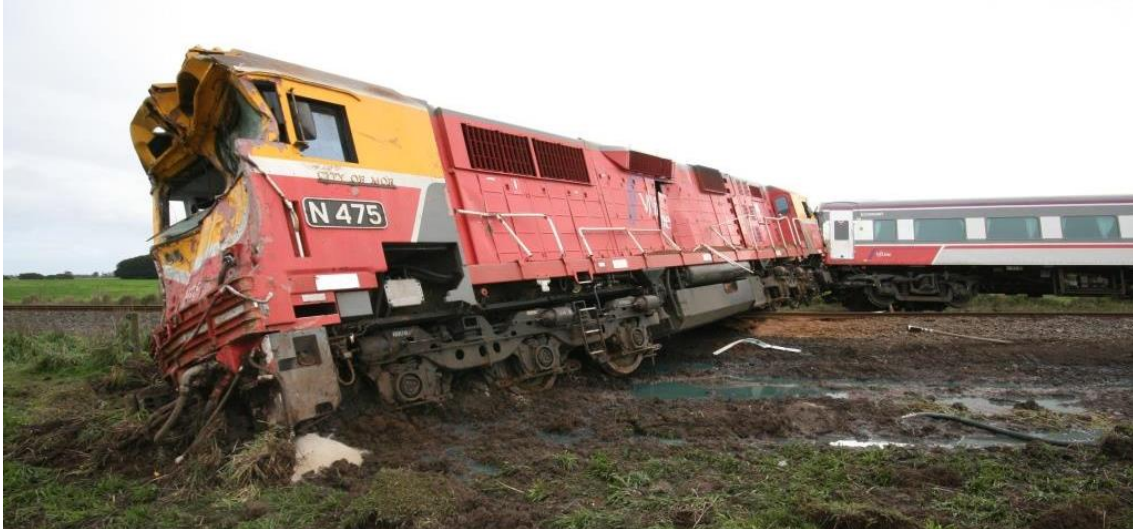
Figure 3: The damaged locomotive following the collision

The locomotive sustained significant damage and came to a rest about 120 m beyond the crossing (Figure 3). The collision resulted in severe damage to the prime mover and the semi-trailer (Figure 4).

The image shows the resting position of the locomotive, its angle of around 45 degrees to the longitudinal direction of the track and the severe impact damage to its leading end. The locomotive and passenger cars remained upright.
Source: Chief Investigator, Transport Safety (Vic)

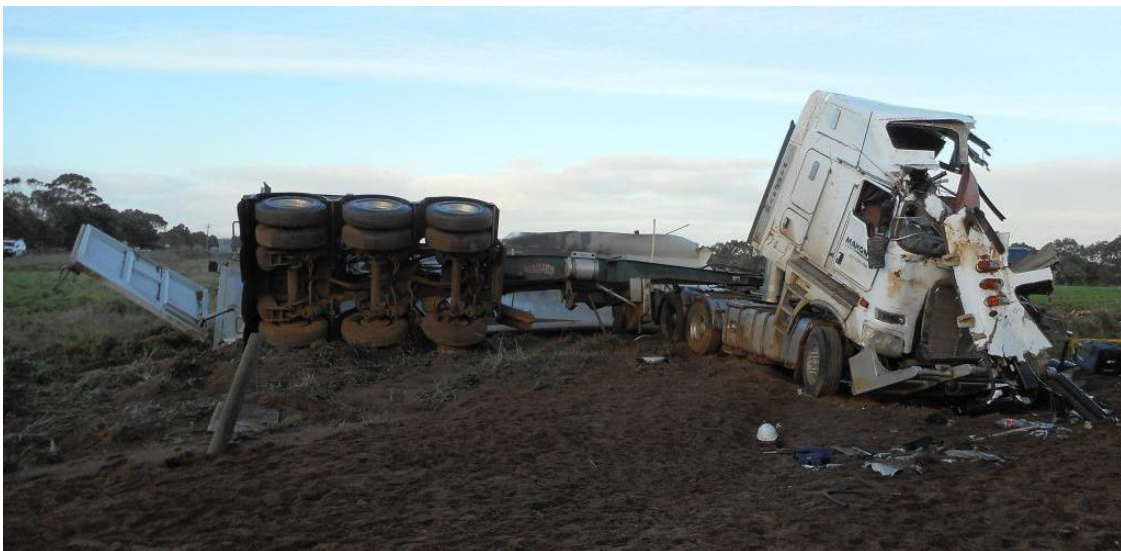
Figure 4: The damaged prime mover and semi-trailer following the collision

The image shows the severe damage to the prime mover and semi-trailer. The damage to the driving cab was most severe on its left side and the left-front corner.
Source: Chief Investigator, Transport Safety (Vic)

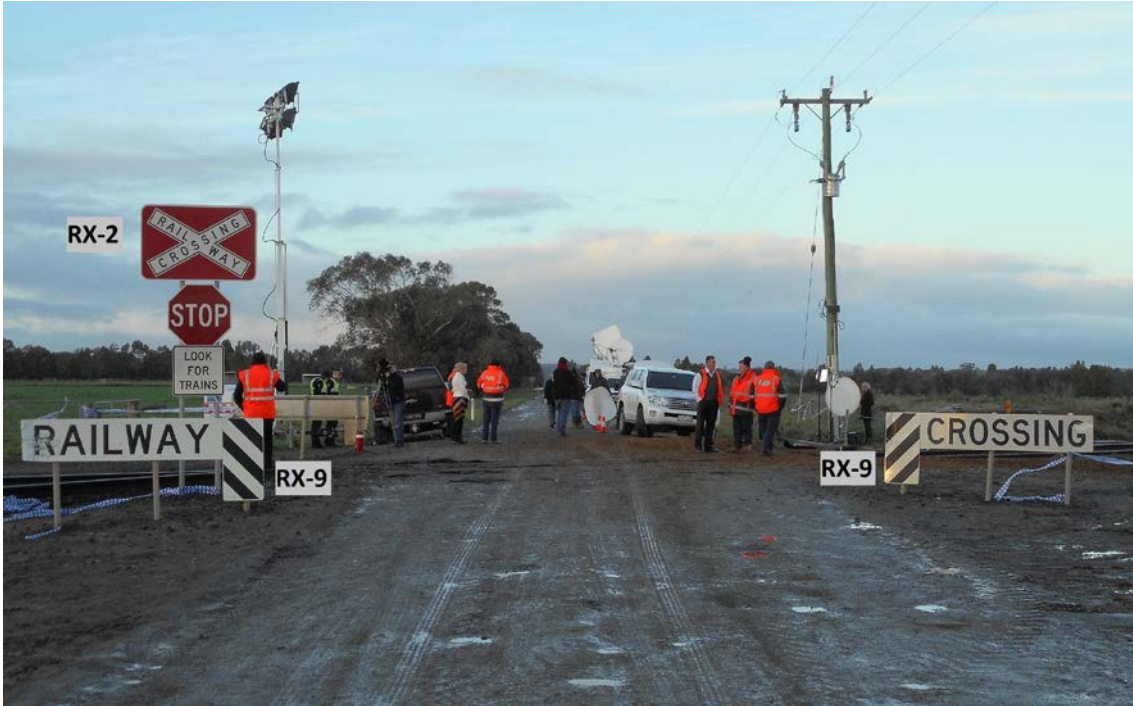
Figure 7: Signage at the crossing when approaching from the north

Signage at the crossing was in good condition. It included a *Railway Crossing Stop Assembly (RX-2)* and *Railway Crossing Width Marker Assembly (RX-9)* located a short distance in advance of the crossing (Figure 7).

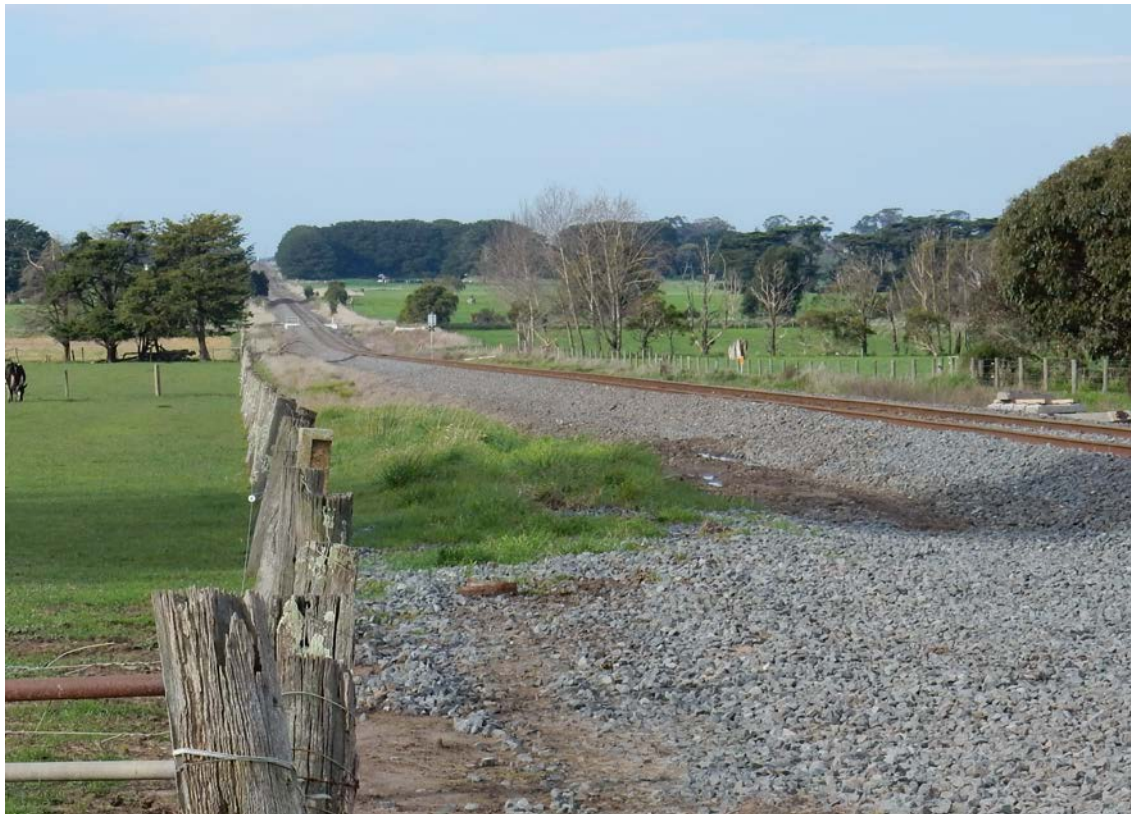
Figure 10: The view to the track when not encumbered by the road vehicle structure

When outside a vehicle, there was a clear view along the track (Figure 10).

The image shows the view from Phalps Road along the track in the east. When not restricted to the specified maximum viewing angle, or the structure of the road vehicle, the view along the track exceeded 500 m.
 Source: Chief Investigator, Transport Safety (Vic)

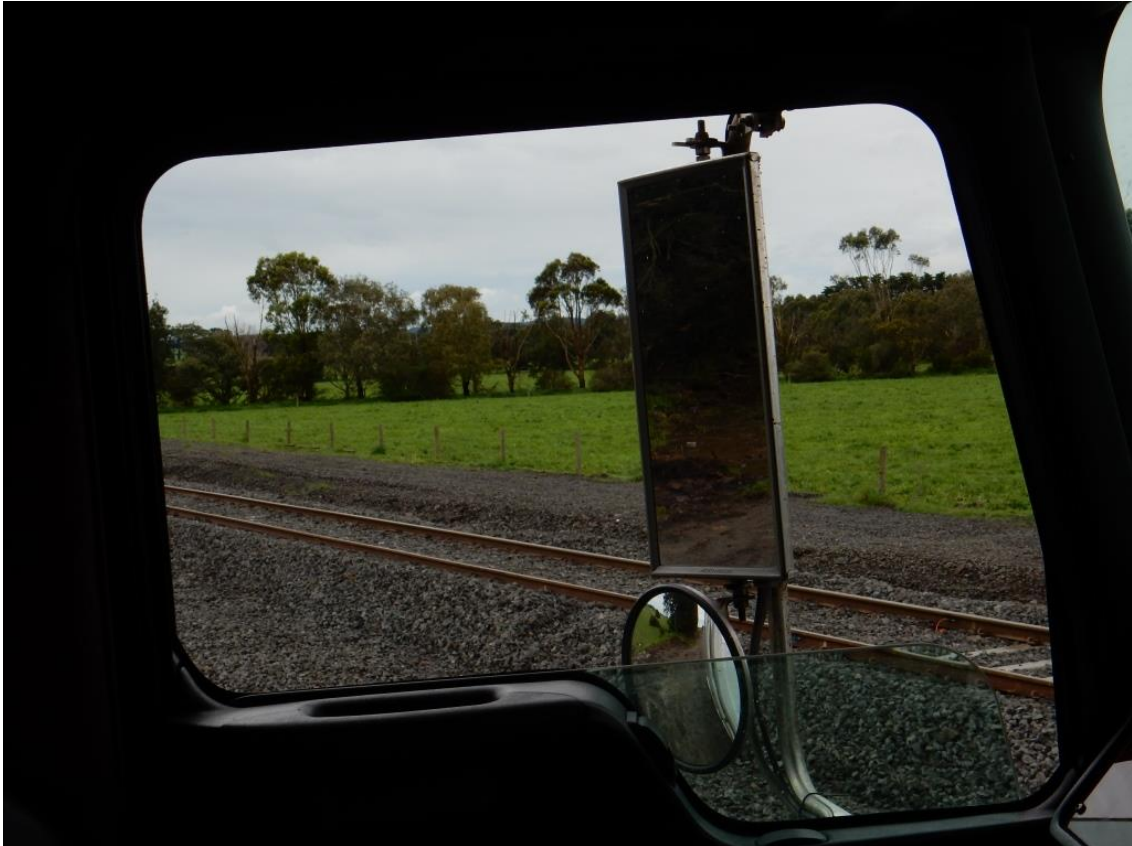
Figure 14: The restricted view along the track with the truck stopped 10 m from the track

The general finding of the trials was that the view along the track was restricted by the structure of the cab, and the absence of windows rearward of the driver (Figure 14).

The image shows a typical view from the truck driving position, taken during the trials. It shows a severely restricted view towards the track. The view is limited to the size and location of the cab's passenger-side window.
Source: Chief Investigator, Transport Safety (Vic)

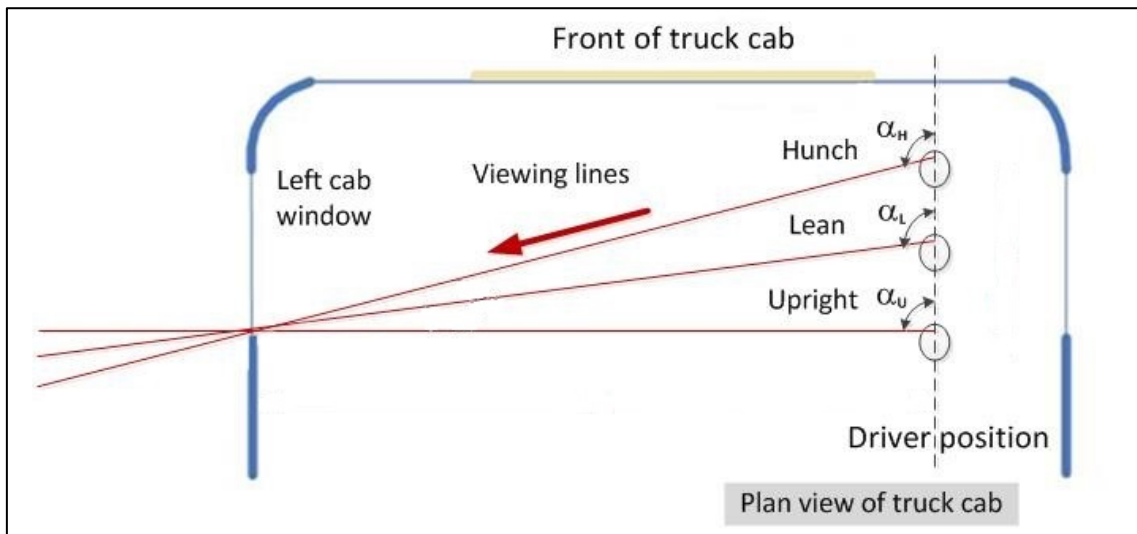
Figure 15: Plan view showing driver viewing angles for a range of driver postures

With the truck at its stopped location, achievable sighting distances (along the track to the left) and the viewing angles (of the driver towards the track) were determined using laser measuring equipment. The measurements were taken for the driver upright (α_U), leant forward (α_L) and hunched forward (α_H) (Figure 15).

For these three driver positions, the achievable sighting distances ranged from 29 to 60 m, and the achievable viewing angle from 90 to 104 degrees (Figure 16). The maximum distance and viewing angle achieved were with the driver hunched forward over the steering wheel. The rear edge of the passenger-side window was the limit of the view towards the track.

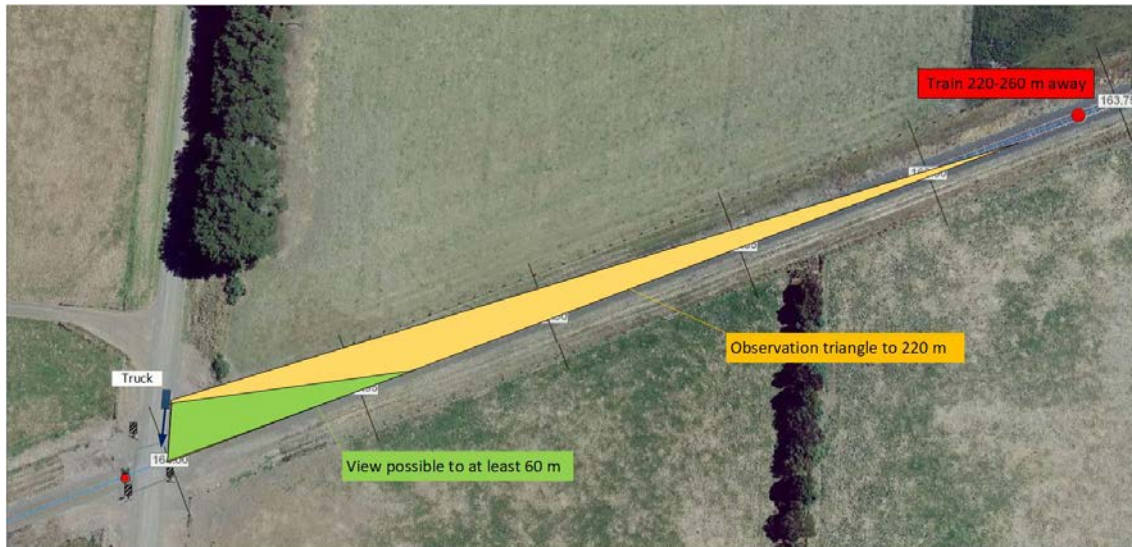
Figure 17: The position of the train when the truck started moving towards the crossing.

The implications of the restricted view was that the driver did not observe the approaching train when stopped prior to moving towards the crossing. The view along the track was significantly less than that required to observe the train, probably at least 60 m but no further than 220 m (Figure 15).

The figure is an aerial view of the level crossing and the track to the crossing’s east. The figure depicts the estimated position of the train at the time the truck started moving from its stopped position, the minimum distance of 60 m that the truck driver could probably see, and the observation triangle to a distance of 220 m. The train was 220-260 m from the crossing, and is shown at 240 m. Source: Pass Assets, Public Transport Victoria, annotated by Chief Investigator, Transport Safety (Vic)
