Collision between passenger train and truck

Woodvale, Victoria | 19 December 2014

ATSB Transport Safety Report
Rail Occurrence Investigation
RO-2014-024
Final – 25 September 2015

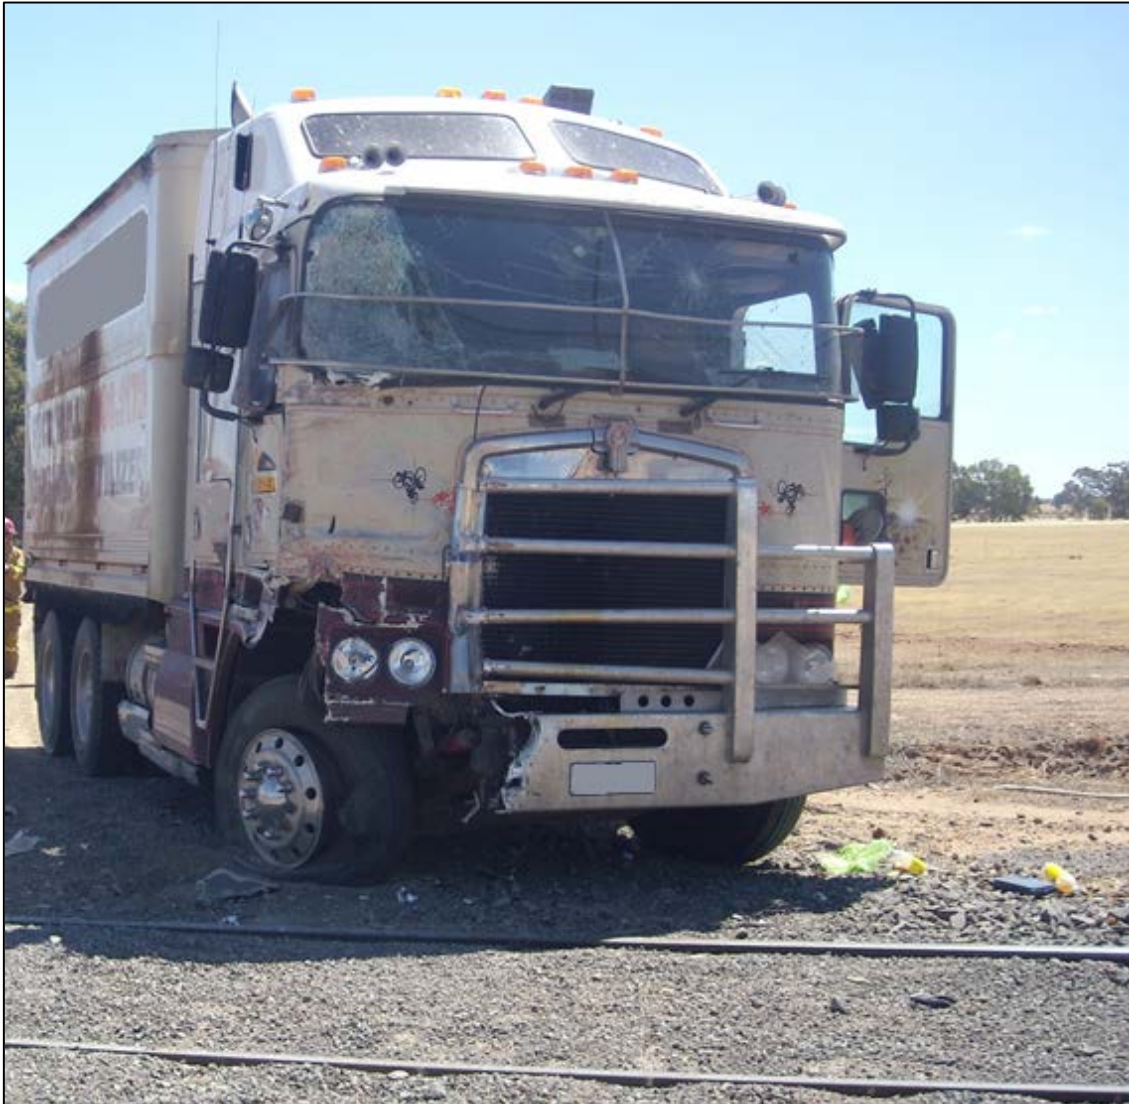
Figure 2: The truck immediately after the collision

The truck was turned to the left—as the train occupied the crossing—and collided with the adjacent level crossing signage and the train.

This last-second avoidance manoeuvre by the truck driver presented the front right-hand corner of the truck’s cab to the train. As the train passed in front of it, this corner of the cab and the roo-bar struck the side of the first passenger car. This impact caused the derailment of that car’s trailing bogie, inflicted deep impact scars to its side panels (Figure 3) and tore through its exterior skin over approximately a two-metre length (Figure 4).

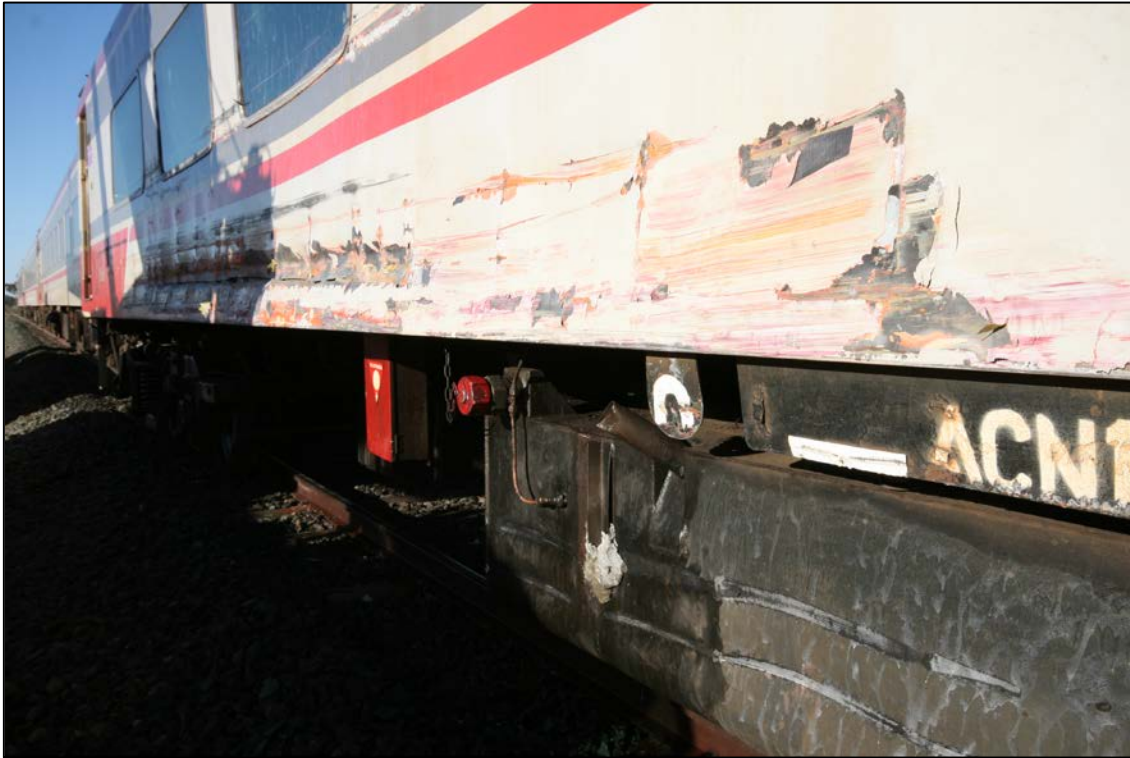
Figure 3: Damage sustained by the first car at the initial impact point

The impact also breached the underslung diesel generator fuel tank—precipitating an outflow of fuel—and destroyed some bogie-mounted brake equipment. The train consist then continued to scrape along the right-hand corner of the truck’s cab causing abrasion damage to the side panelling of most of the cars. The locomotive was not impacted. Track damage caused by the derailed passenger car required V/Line to replace approximately 200 sleepers.

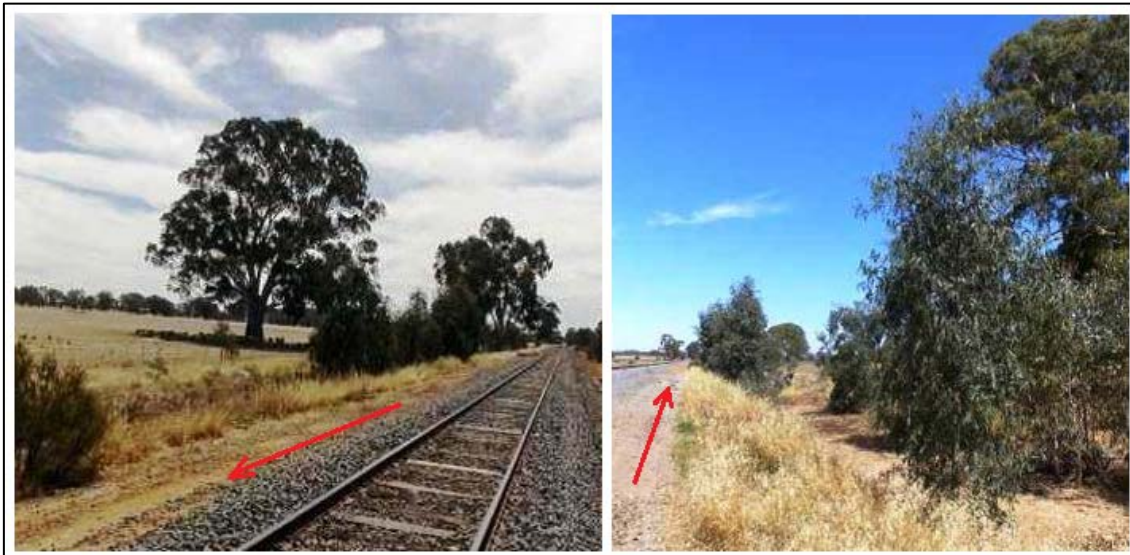
Figure 5: Lineside tree growth. Arrows show direction of train

Several mature trees were growing near the railway fence line in the adjacent paddock to the north of Rileys Road, and a number of juvenile self-sown trees nearby were growing sporadically along a drainage ditch within the railway reserve. For the driver of a vehicle approaching the level crossing from the direction of the Loddon Valley Highway, this growth partially obscured from view a train approaching from the north until the train was about 200 m from the crossing.

Arboricultural advice was sought in relation to the trees growing in the rail reserve (Figure 5). The River Red Gum trees (*eucalyptus camaldulensis*) were in a group of around 40-50, growing in an area approximately 300 m long and 30 m wide. The stand of trees displayed height (1-9 m)¹ and 'breast-height'² trunk diameter characteristics consistent with ages of between 1 and 8 years. Situated along a drainage line subject to areas of seasonal standing water, the trees were judged to be in good condition and displaying vigorous growth. Expected growth rates of juvenile-to-young (1-15 years) River Red Gum growing in an ideal situation with good conditions is 1 to 1.5 m per year, and in most conditions the annual juvenile height growth rate will slow as the tree matures. If left standing, the trees in their current position can be expected to thrive and add good annual diameter and height.

Considering a normal growth rate of 1 to 1.5 m per year the taller of the self-seeded trees within the rail reserve would have been around 3 to 5 m (and therefore projecting from 1.5 to 3 m above rail level) when the last ALCAM survey was conducted in October 2010. The trees would most likely, therefore, not have presented as a sighting obstruction at that time.

- Is engaging the services of a vegetation management contractor to undertake hazardous tree assessment—including of predicted growth—that could impact rail, staff, or customer and neighbour safety.
- Has revised the inspection frequency for Level Crossing Line-of-Sight inspections from an annual requirement to a 3-monthly inspection via a foot patrol.
- Is revising the vegetation/hazardous trees inspection from annually to monthly via a foot patrol.
- Is instigating a Plan-Do-Review (PDR) cycle that is expected to improve the management of faults identified from inspections. The outcomes are expected to be implemented by 1st July 2015. This includes the inspections outlined above for Level Crossing Line-of-Sight and Hazardous Trees/Vegetation Management.
- Is introducing weekly PDR meetings after every set of inspections, and developing a rolling 4-weekly corridor-by-corridor plan.

- Initiated a discussion with the City of Greater Bendigo on the subject of a reduction to 60 km/h of road speed on the approach to railway level crossings. This has resulted in the commencement of a trial program on both gravel and sealed roads.
- Requested the Victorian Level Crossing Committee to upgrade the Rileys Road level crossing to active protection. This is scheduled for 2016-17, but may be delayed to 2017-18
- Cleared trees and vegetation from the rail reserve.

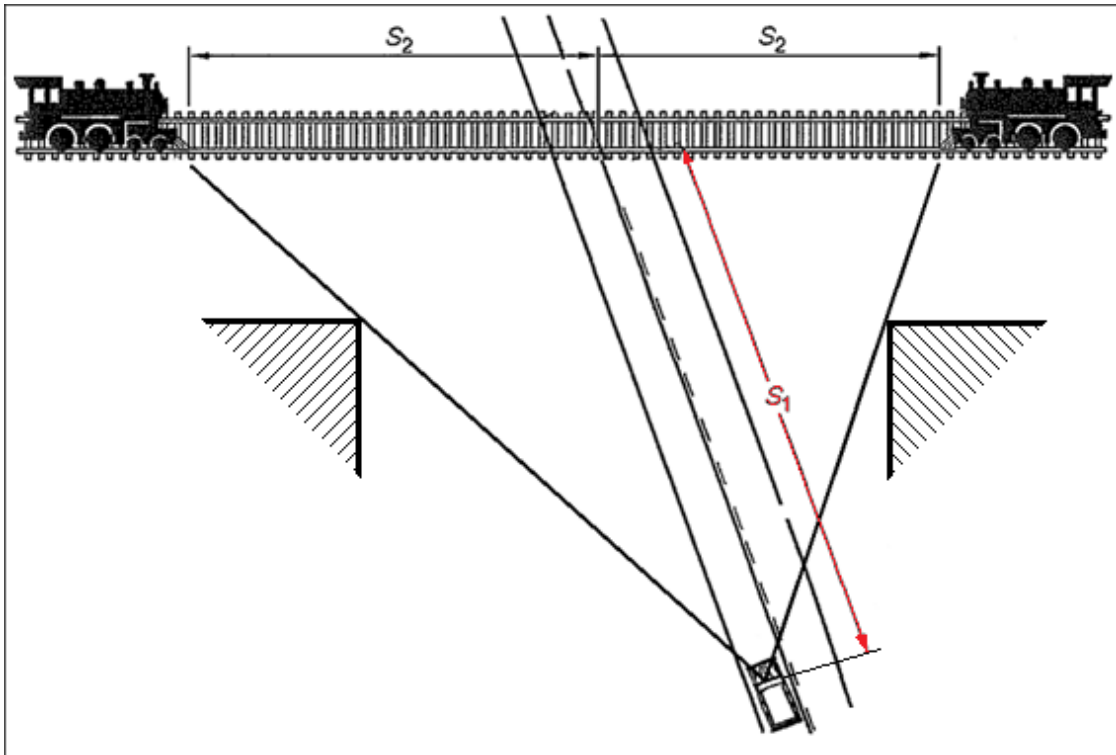
Figure 7: Approach visibility at ‘Give-Way’ passive-control level crossing – Rileys Road

Values for S1 and S2 (Figure 7) were evaluated as part of this ALCAM assessment. S1 is defined as the minimum distance of an approaching road vehicle from the nearest rail at which the driver of that road vehicle must be able to see an approaching train in time to stop if necessary before reaching the crossing. S2 is defined as the minimum distance of a train from the crossing at which a road vehicle driver at distance S1 from the crossing can proceed and safely clear the crossing ahead of the train.

To evaluate sighting distances at the Rileys Road level crossing, the ALCAM assessment assumed a road vehicle approach speed³ of 70 km/h. For a train approaching from the North (from the vehicle driver's left – the train direction in this instance), the assessment provided a required S_2 value (left-hand side) of 240 m. A field survey measurement taken in 2010 indicated that the vehicle driver's view in this quadrant was unobstructed and this S_2 value satisfied.

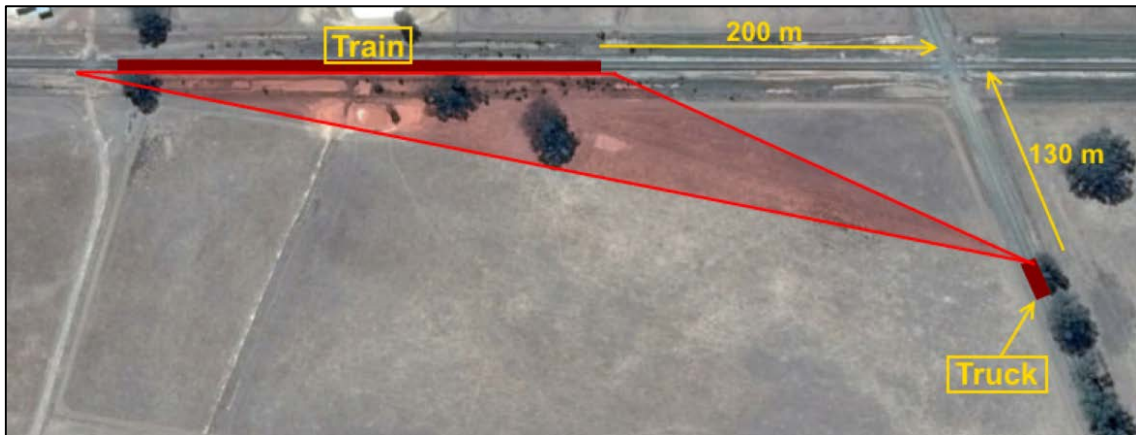
Figure 8: Vehicle driver's field of view, through foliage, of the approaching train

Drivers of vehicles approaching the Rileys Road level crossing from the direction of the Loddon Valley Highway had a clear northerly view across an adjacent paddock toward the railway line, however the conspicuity of rail traffic approaching from that direction was diminished due to it being partially obscured by the merging of lineside foliage as viewed at an angle from the road (Figures 8 and 9).

- A line of self-sown trees of varying heights were growing within the railway reserve. When viewed at an angle from the road this growth partially concealed the presence of an approaching train.
- V/Line's process for the inspection of level crossing sighting did not provide explicit instructions for the identification and removal of problem vegetation. [Safety issue]

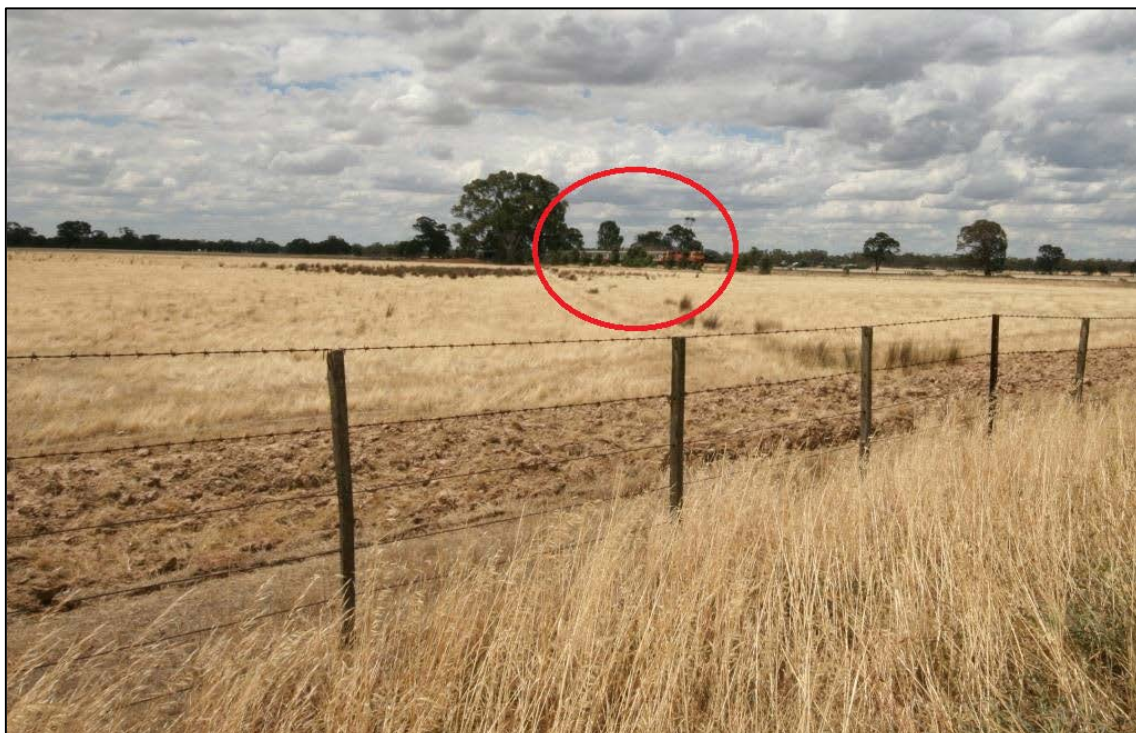
Figure 9: View of approaching train from the road 100 m back from the level crossing. Train is approximately 200 m from the crossing

The ATSB inspection at the date of this incident identified that sight lines in the relevant direction were 40 m less than the required 240 as specified in the ALCAM assessment and used by V/Line. In October 2010, though—when the most recent ALCAM survey of the Rileys Road level crossing was completed—the string of River Red Gum trees along the lineside ditch would not have been as high and would probably not have presented as a sighting obstruction.
