# Derailment of passenger train ST23

Wallan, Victoria on 20 February 2020

**ATSB Transport Safety Report**

RO-2020-002

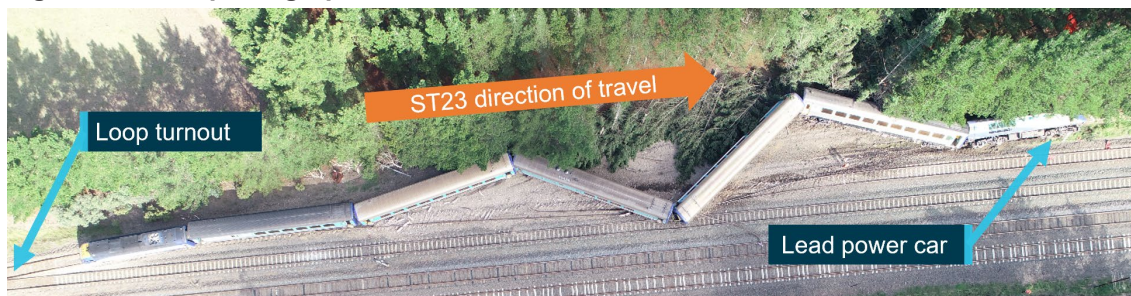
**Figure 4: Aerial photograph of derailment site**

The speed of ST23 then increased towards the line speed of 130 km/h as the train approached Wallan. At about 1943, ST23 was approaching the northern end of Wallan Loop when an emergency brake application was made. Brake cylinder pressure was recorded as commencing to rise when ST23 was between 153 and 50 m from the turnout.<sup>26</sup> This slowed the train a small amount before it entered the turnout travelling at a speed estimated to be between 114 and 127 km/h. The train was not able to negotiate the turnout to the No.2 track (loop) at this speed and derailed (Figure 4). The leading power car rolled onto its left side. The trailing 5 passenger cars remained upright although tilted by varying amounts, and the rear power car remained upright on the track.

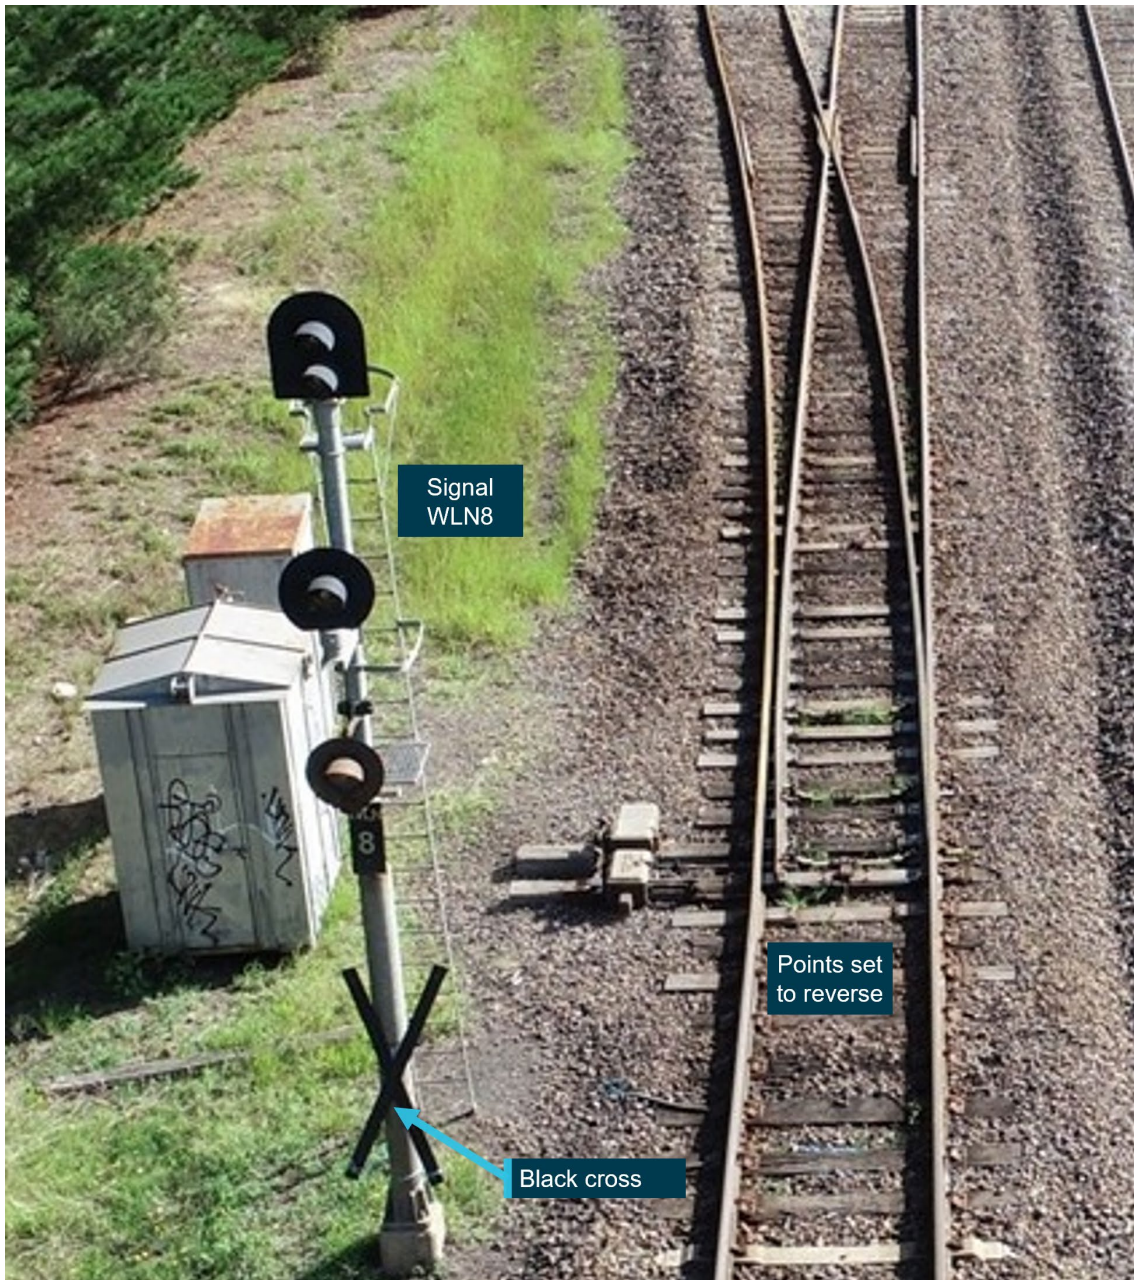
**Figure 8: Elevated view of northern turnout to No. 2 track at Wallan Loop**

*The photograph shows the turnout and signal WLN8 on 21 February 2020 after the passage of train ST23 and its derailment. The points are set for the No.2 track as they were at the time of the derailment.*  
 Source: ATSB

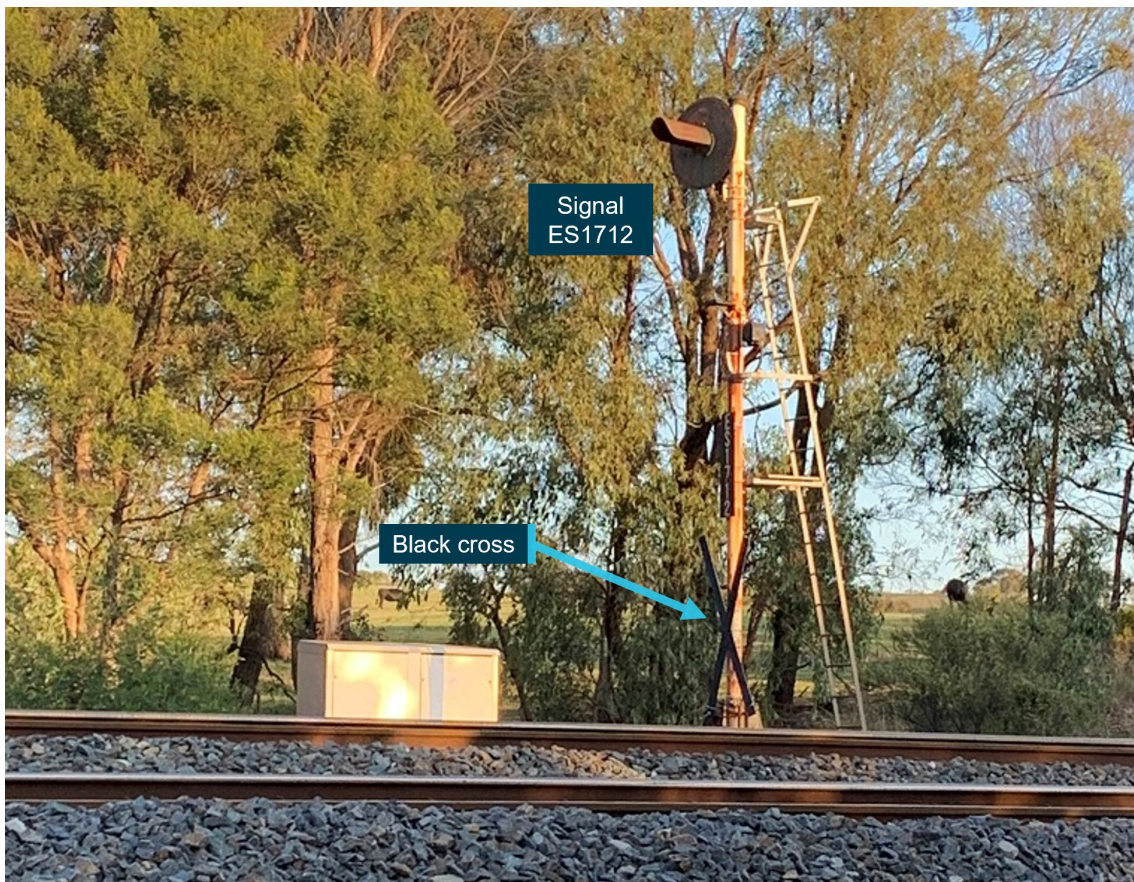
**Figure 10: Signal ES1712 following derailment, non-operational and with cross affixed**

Approaching from Kilmore East, the first signal to advise of the state of the turnout at Wallan Loop was signal ES1712 located about 2.7 km prior to the northern turnout to Wallan Loop.<sup>49</sup> At the time of the derailment, signal ES1712 was extinguished and was fitted with a black cross near its base to indicate that it was not functioning (Figure 10).

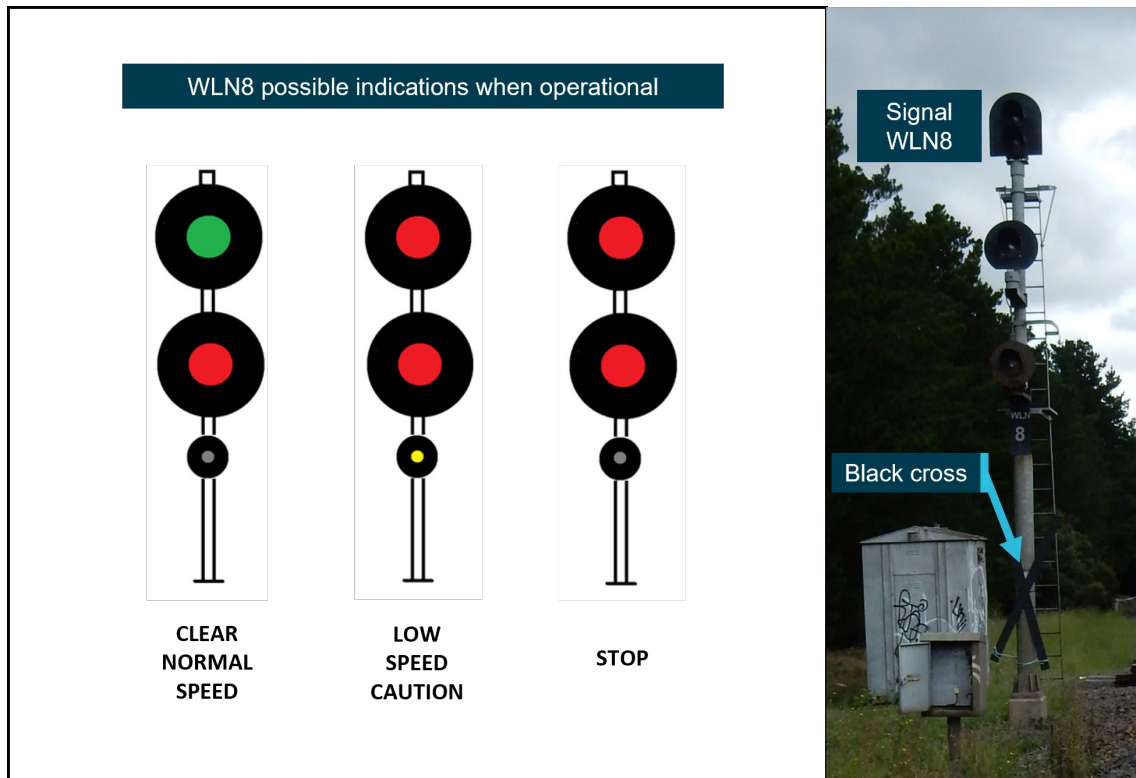
**Figure 11: Signal WLN8 possible indications (left) and on day of occurrence (right)**

*The figure shows the possible indications of signal WLN8 (when operational), and a photograph of the signal extinguished. The photograph of signal WLN8 also shows the black cross that was attached to the signal post.  
Source: CITS*

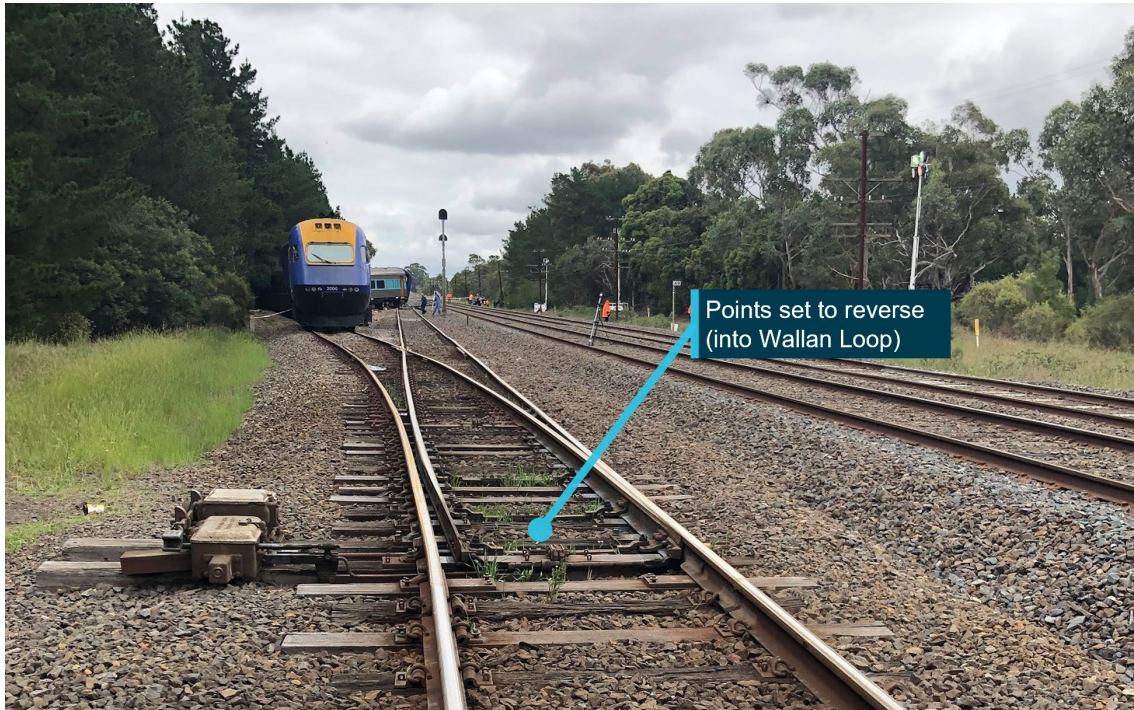
Figure 14: No. 7 points at the northern entrance to Wallan Loop set to reverse

There was no evidence of derailment prior to the turnout. Inspection identified evidence of derailment within and beyond the turnout. Track damage, including to rail and track formation, was extensive within No.2 track.

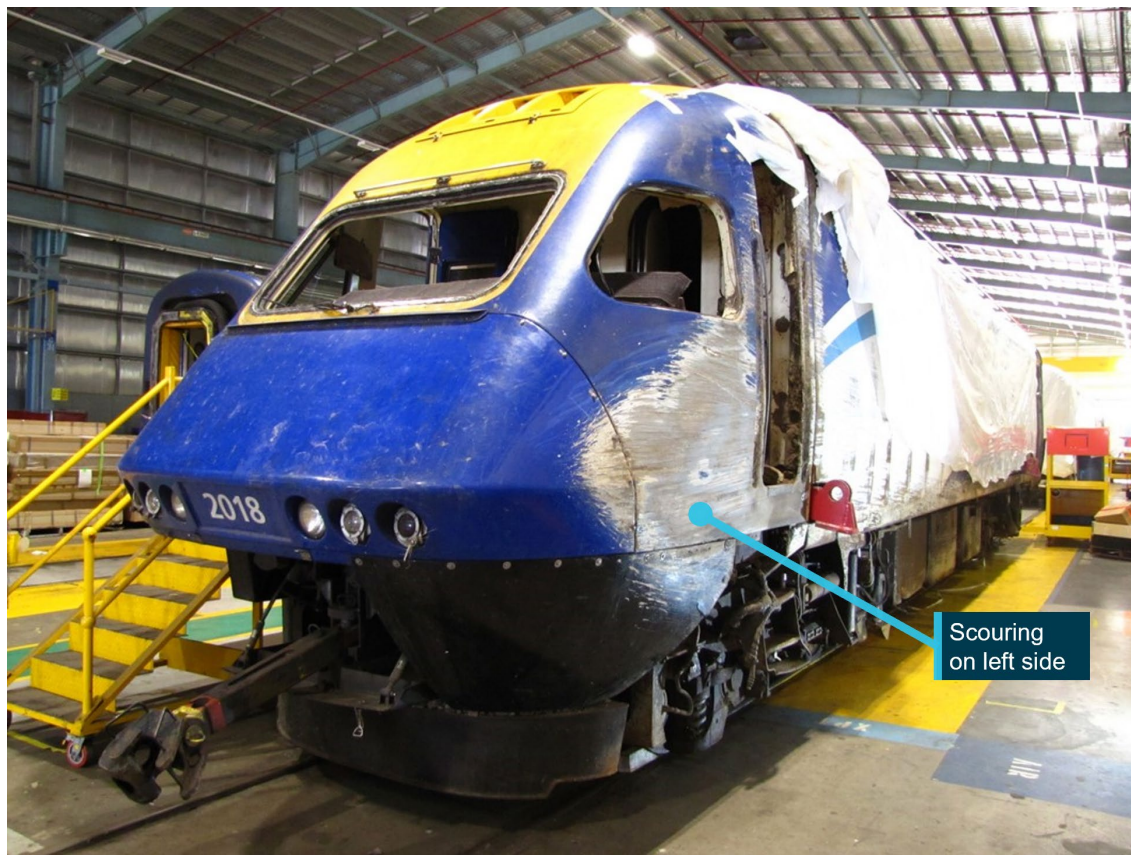
Figure 17: Power car XP2018 at Auburn workshops on 10 March 2020

Scouring damage was present along the full left side of the power car that suggested the car had slid on its side for a significant distance. The car had retained its whole-body structural integrity, however both doors on the left side had been dislodged. There was evidence of a significant amount of ballast and earth having entered the driver's cabin through the left-side driver's cab door opening. Instruments, control panels and interior fittings were mostly intact.

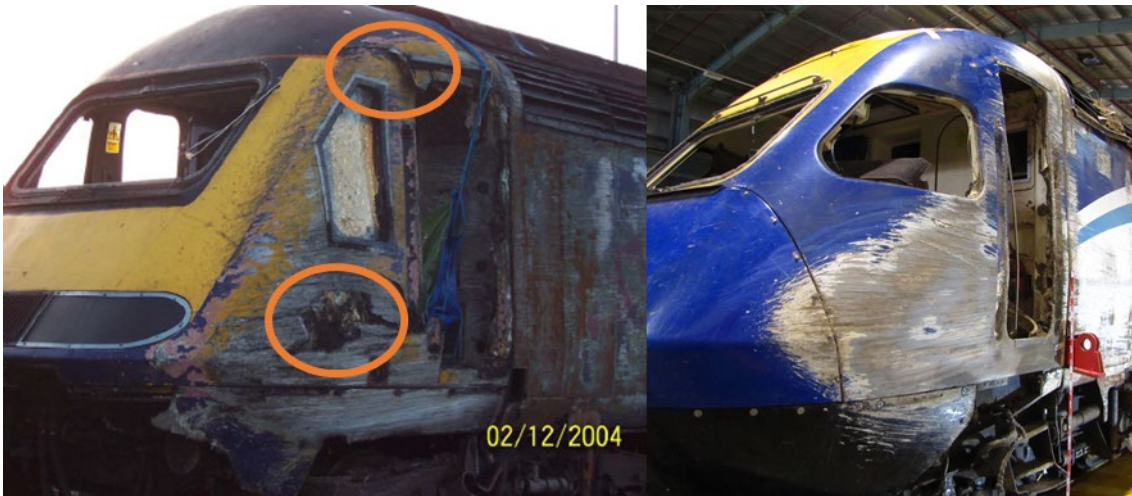
**Figure 21: Ufton Nervet cab side damage (left) and Wallan cab side damage (right)**

In the Ufton Nervet derailment, the leading power car came to rest on its left side with severe abrasions down the side of the car but with the whole-body structure substantially intact. There was structural failure at the top of a left leading pillar, this being the frame to which the left-side driver’s cab door was latched (Figure 21). The cab door had separated from the door frame and earth and ballast had entered the cab through the door aperture. In both the Ufton Nervet and Wallan derailments, the loss of the side cab door (when the power car overturned) resulted in material entering the cabin and impacting the occupants.

*Skin penetrations are circled on the HST damaged at Ufton Nervet. The windscreens and windows have been removed on both trains.*  
 Source: RSSB and ATSB.

The RSSB final investigation report into the Ufton Nervet derailment did not make a direct recommendation on the ingress of materials into the driver’s cab and referred the matter to the RSSB (2007) research project into cabin design and driver protection. The scope of this research project, which had already commenced at the time of the Ufton Nervet accident, was amended to include aspects of that accident; specifically, protecting the driver’s cab occupants from ingress of debris. The released report from this research project acknowledged that the door would open in such an accident and suggested the installation of partitions or reorientation of the door opening to screen the driver from the incoming debris.

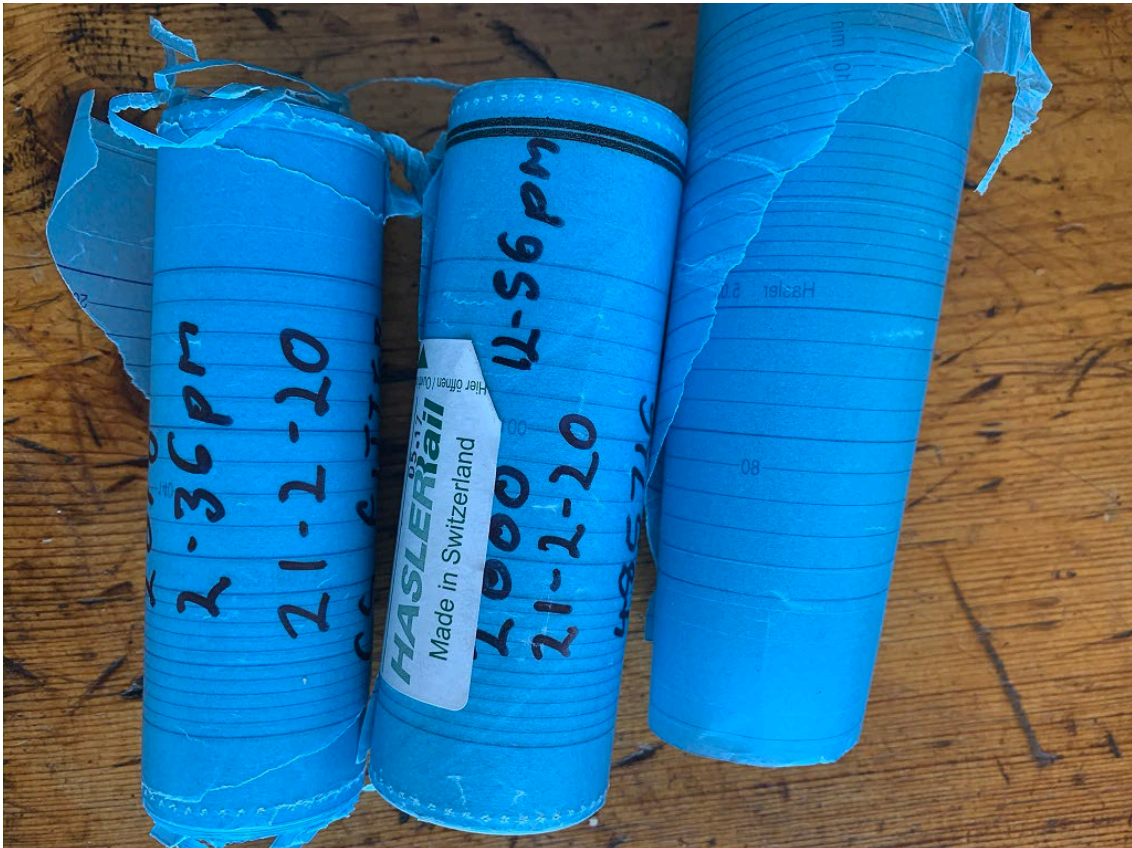
**Figure 23: Hasler waxed paper rolls removed from power cars XP2018 and XP2000**

The photograph shows the recovered waxed tapes. The centre roll is the tape from power car XP2000. The left and right rolls are the tape from power car XP2018 that jammed during its removal and was torn at one location.  
Source: CITS

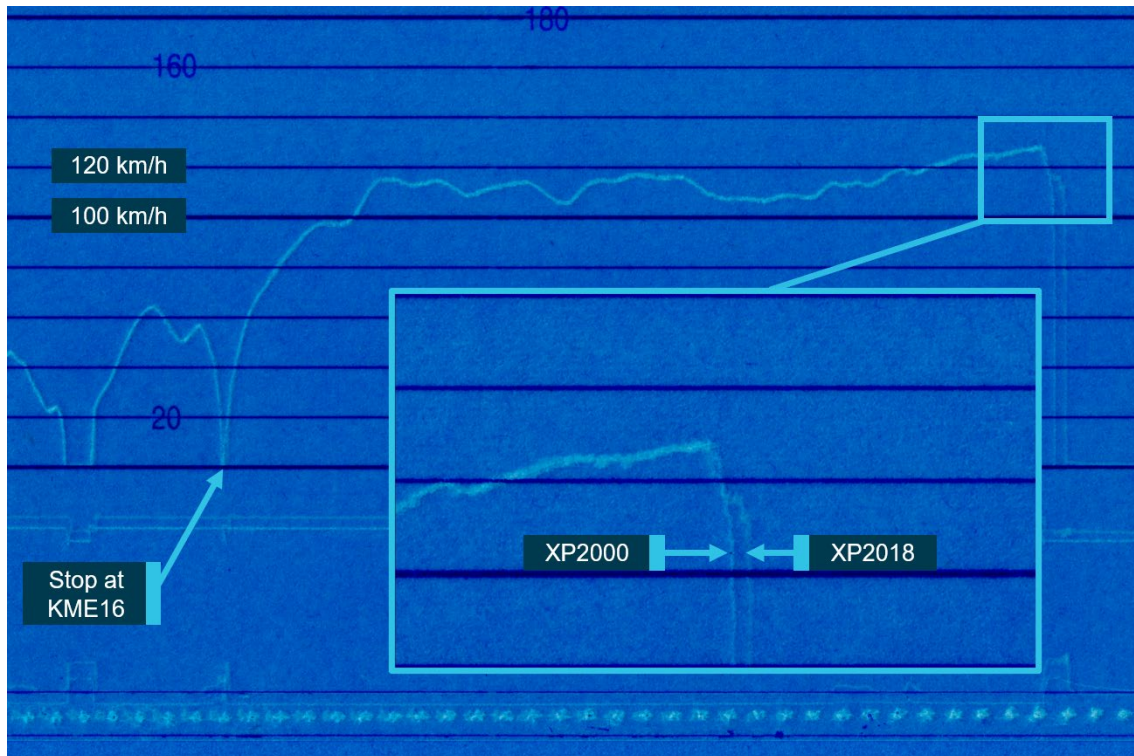
**Figure 24: Overlay of data recordings from XP2018 and XP2000**

The image shows an overlay of speed records from power cars 2018 and 2000. It indicates consistent speed records after departing Kilmore East, then a consistent initial sharp deceleration of both cars followed by diverging speed records during the derailment. Source: ST23 Hasler recordings annotated by the ATSB

There were also potential inaccuracies in the XP2000 data in the latter stages due to uncertainty in the measured wheel rotation being an accurate measure of train speed during this phase.

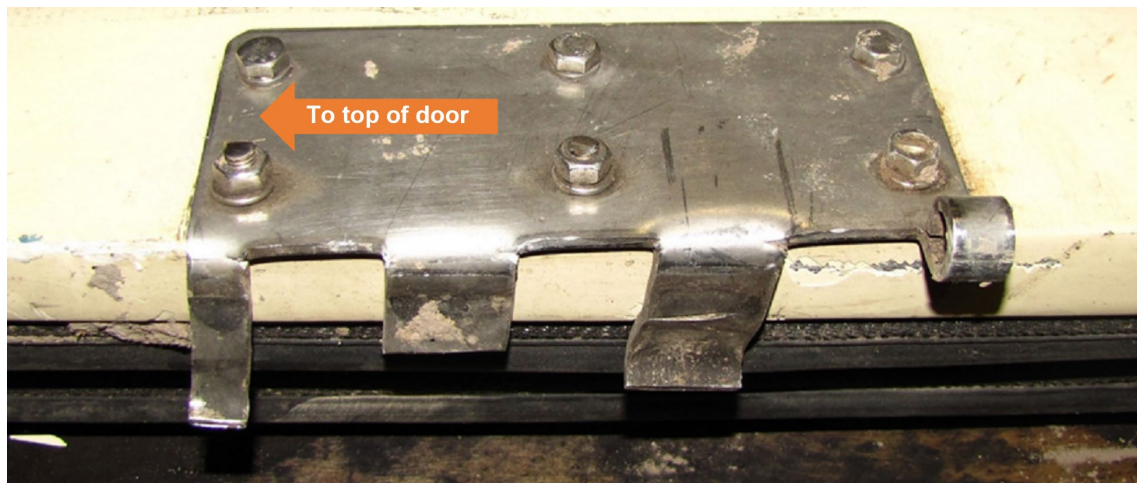
**Figure 27: Failed hinge knuckles (upper hinge)**

The mechanism of the failure of the upper hinge provided a specific failure mode for assessment. Loading of the 3 knuckles that unfurled was assumed for the estimation of material stresses in specified loading scenarios and compared against material yield strength. Dimensional assumptions were also made for the unfurling sequence (Figure 28).
