# Fatality at Heyington Railway Station

Toorak, Victoria | 22 February 2014

**ATSB Transport Safety Report**  
Rail Occurrence Investigation  
RO-2014-005  
Final – 27 April 2016

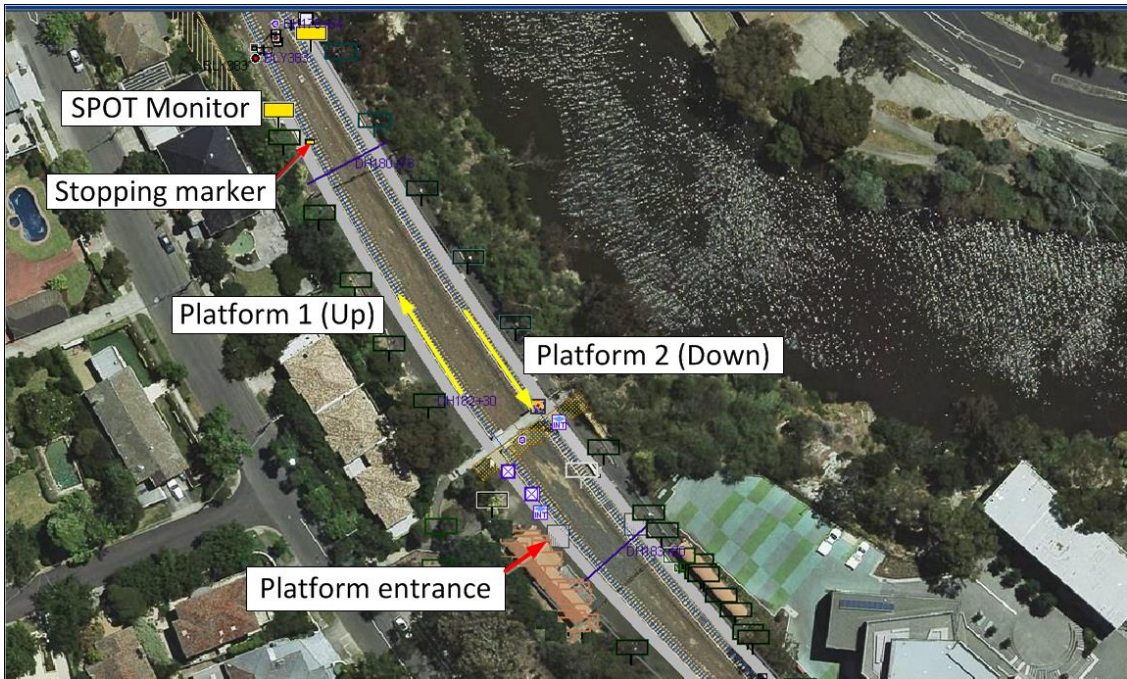
Figure 3 – Heyington Railway Station platform configuration

The Up line track followed the curve of the concave platform 1 and transitioned into the straight section at the Up end of the platform (Figures 3 & 4). The curve of platform 1 had a radius of approximately 380 m.

Single Person Operations Television (SPOT) monitors were located about 1.3 m from the end of the platform. The 6-car stopping marker was about 6.0 m before the SPOT monitors. The passenger entrance to the platform was about 93 m from the Up end of the platform.

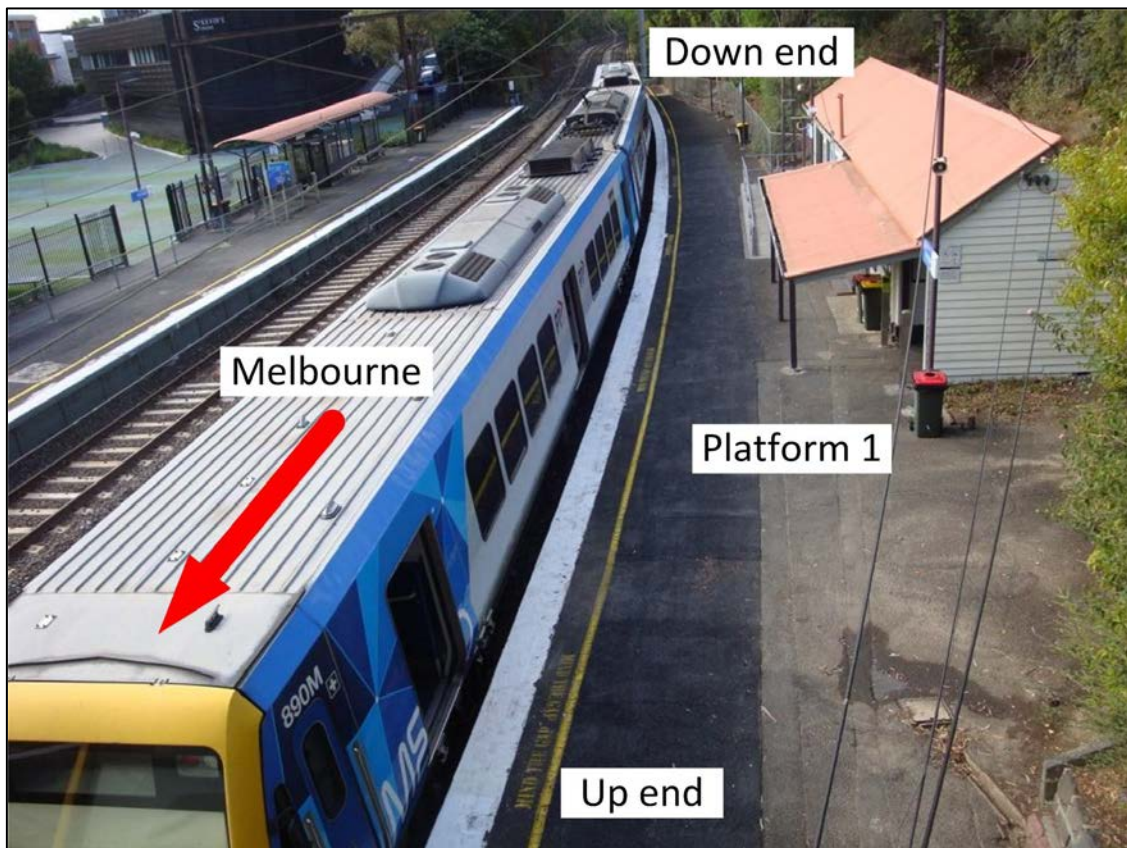
Figure 4 – Platform 1 of Heyington Railway Station (3-car set at platform)

Heyington Railway Station is on the Glen Waverley Line and is located in a cutting (Figures 3 & 4). The station was opened in 1890 and has two side platforms connected by a footbridge. Access to the platforms was via stairs and the footbridge. Both the Up<sup>4</sup> and Down<sup>5</sup> platforms were about 158 m in length. The height of platform 1 from the design rail level ranged from 1070 mm to about 1140 mm.

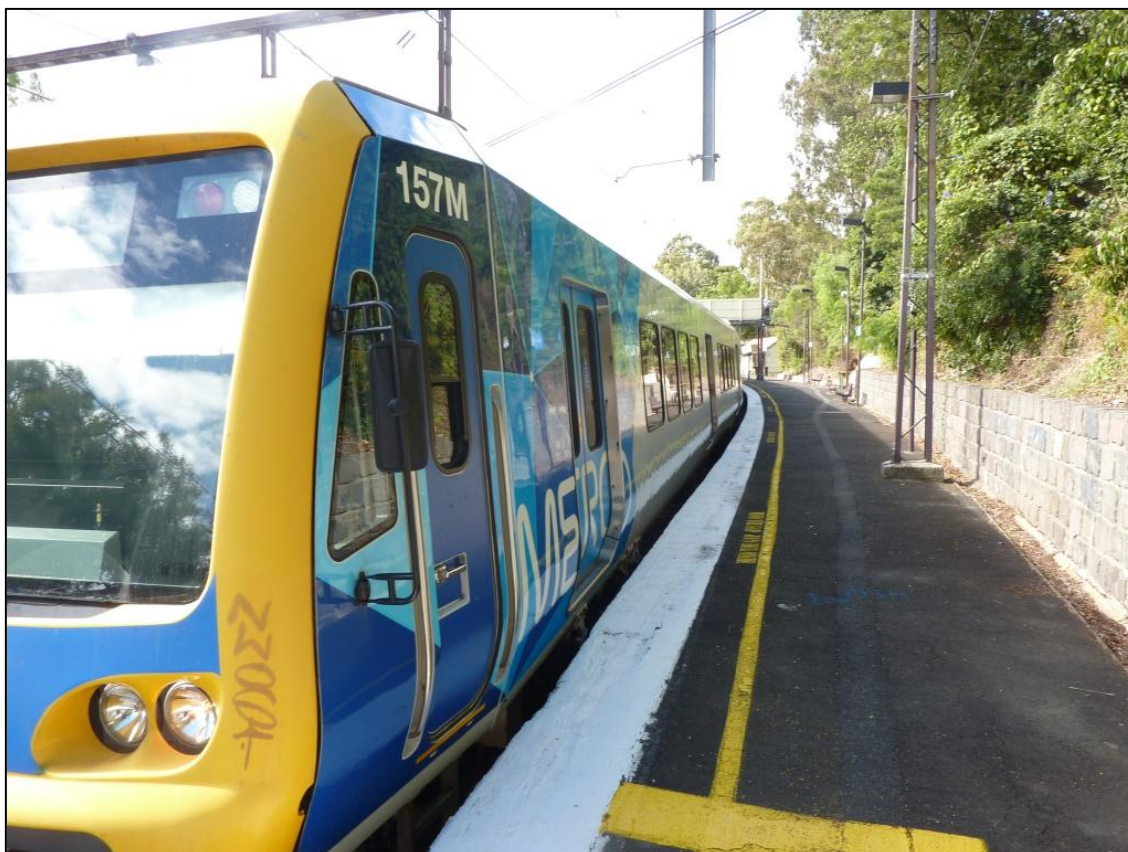
**Figure 5 – Sighting of platform from front of train**

Platform 1 at Heyington Railway Station is a concave platform and the driver is unable to view the platform in its entirety along the length of the train using the train mirrors (Figure 5). This platform was equipped with four CCTV cameras that displayed sectors of the platform on four SPOT monitors. The SPOT monitors are located on the platform such that the driver is able to view the four monitors when stopped at the 6-car stopping marker. SPOT Monitor cameras were located to show the view along the train/platform length, on curved platforms rather than individual doors.

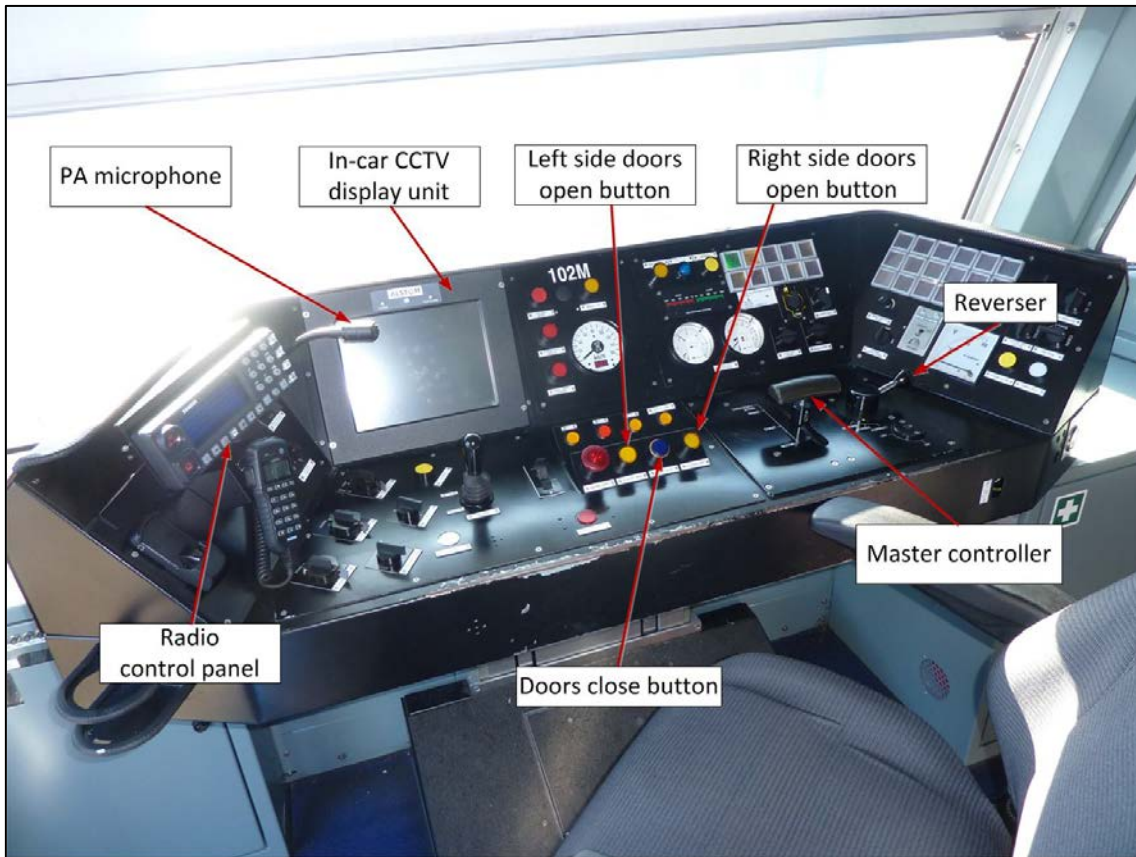
**Figure 6 – Driver control console of X'Trapolis EMU**

Post incident testing found that the door open indication light on train TD 2100 functioned as designed and changed from 'flashing' to 'steady' only when the doors were closed. Although the flashing state of the indication light identified that the doors may be open it did not provide warning to the driver of the deactivation of the traction interlock control. Where the design of a safety system such as a traction interlock times out automatically, it would be prudent to have additional indications/alerts to warn a driver of a change of state in the vehicle controls, particularly during passenger boarding at a station. Further, formally documenting the operation of the traction interlock override systems in the MTM training manuals would increase driver awareness of the risks associated with these systems.

- **The train door open/close indicator on the driver's control console was inadequate as a warning device once the traction interlock had deactivated. (Safety Issue)**
- **The existing standards stipulated minimum clearances between trains and platforms but did not consider the effect of the resulting gaps with respect to safe accessibility. (Safety Issue)**

The ATSB recommends that MTM consider incorporating an additional warning device to heighten driver awareness that the train doors have not closed, if automatic deactivation is retained.

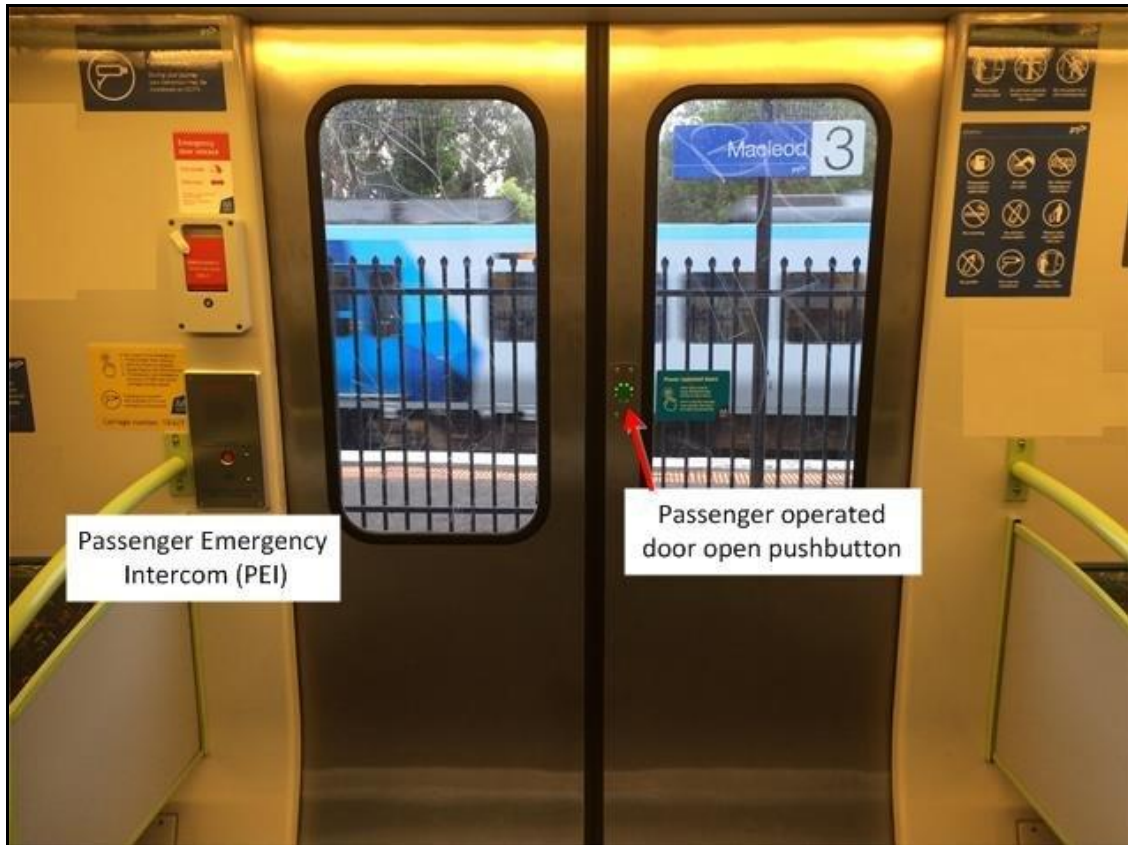
**Figure 7 – X'Trapolis doors**

Each door is equipped with an obstacle/obstruction detection device. During the door closing sequence if an obstruction is detected, the doors will open once and then make three further attempts to close at three second intervals. If unable to close, the doors will then revert to the obstructed/open position. The blue pushbutton lamp on the driver’s console will continue flashing, to indicate to the driver that a door is detected open and unlocked. The yellow pushbutton lamp stays extinguished during this sequence.

Pressing the blue pushbutton at the console initiates door closing and a 60 second time delay for traction authorisation. Detection of all doors closed and locked before the 60 seconds elapse, activates traction authorisation. Should the doors fail to close and lock after 60 seconds, the system is designed such that traction is authorised, despite the possibility that the doors have not closed. Once traction is authorised and applied the train will move. In this situation the blue pushbutton lamp will continue to flash. When the train speed exceeds three km/h and should the door obstruction be removed, the door closing mechanism activates and the doors will close, with the blue pushbutton lamp then displaying a steady blue light.

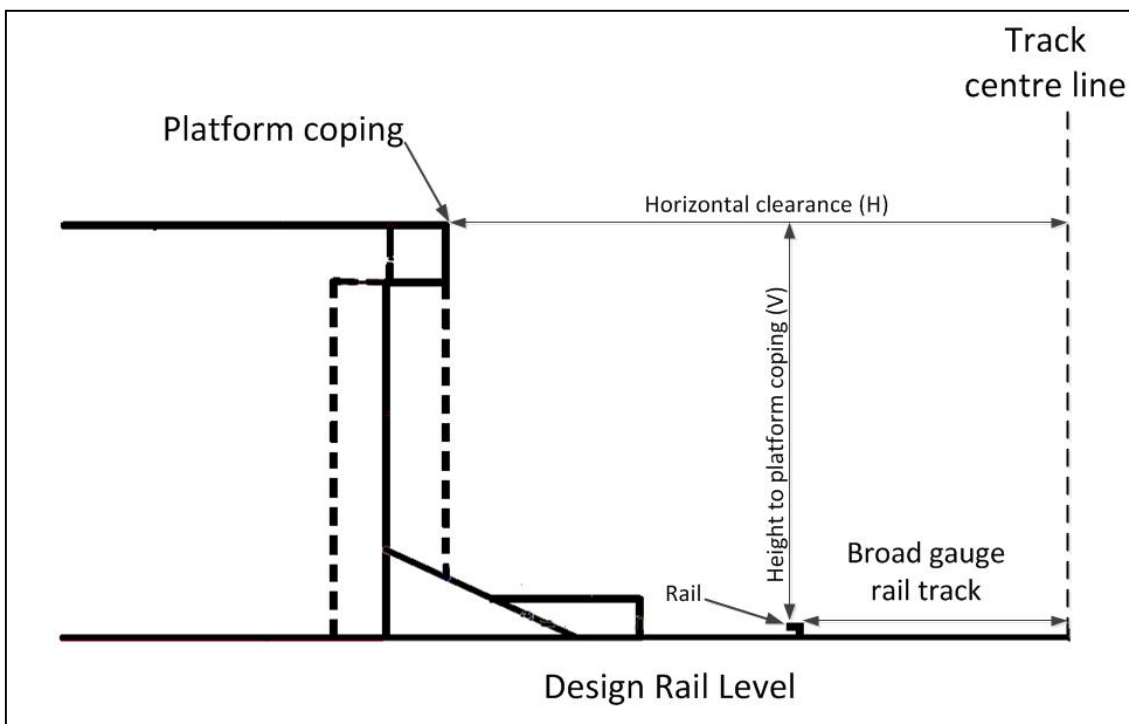
**Figure 8 – Horizontal and vertical clearances between platform and track**

The VRIOG standard *VRIOGS 001 - Structure Gauge Envelopes* issued in June 2012 specifies the minimum clearances required to safely separate rolling stock from trackside infrastructure. The standard specifies the horizontal distance from the track centre line to the platform edge (H) and the vertical height from the design rail level to the top of the platform edge (V) [Figure 8]. For existing track infrastructure the standard specifies a horizontal distance of 1550 mm with a construction tolerance of +10 mm and vertical height of 1043 mm for tangent track.<sup>22</sup>

Where a platform is curved, extra horizontal clearance is required to allow for:

- the end throw of rolling stock
- the dynamic effects such as car body roll
- body displacement due to lateral deflection of suspension and wheel flange wear.

Further, track centre misalignment, gauge variations and rail wear are other factors that have to be allowed for during platform design and installation.

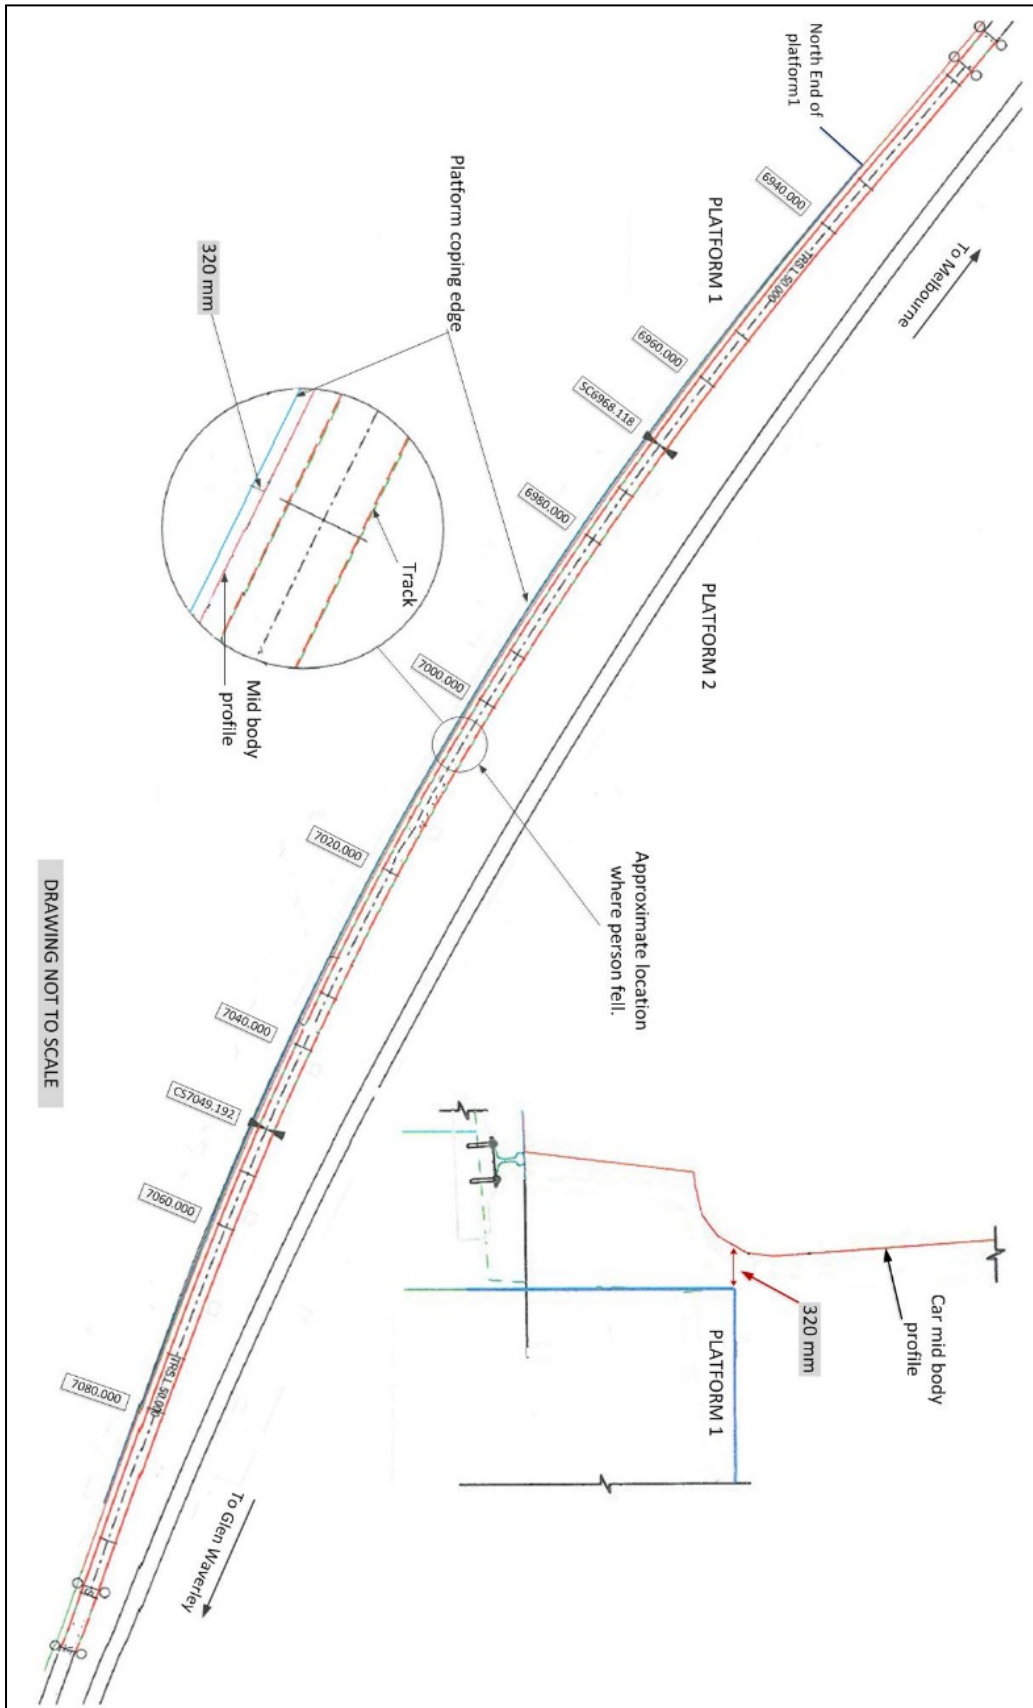
Figure 9 – Schematic showing clearance between platform and train

Due to the curvature of the track, a wide gap existed between the mid-body of the carriage and the platform.

In order to minimise the gap between the train and platform, MTM has realigned the track at Heyington railway station and a rubber finger coping has been installed along the entire edge of the platform face. Further, a barrier has been constructed at the platform entrance to deter passengers from running for the train.

The ATSB recommends that MTM expedite their plans to introduce additional risk mitigation measures (such as instituted at Heyington Railway Station), at the platforms that have been identified as presenting higher risks from larger platform-carriage clearances.

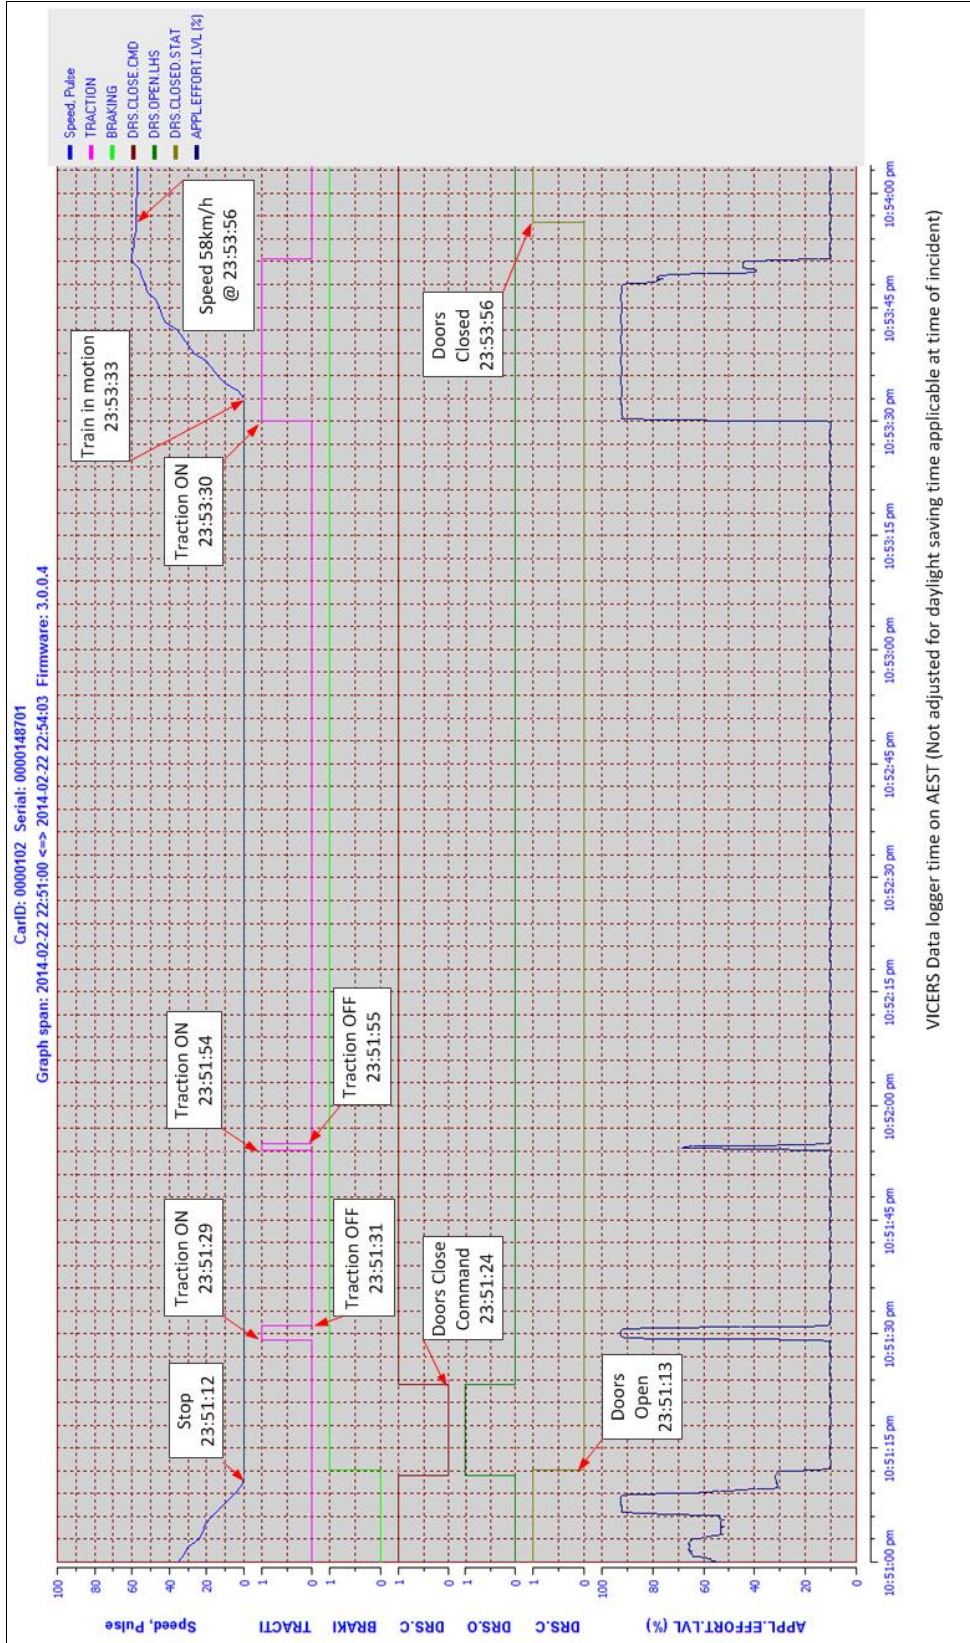
## Appendix A – VICERS Data logger analysis

The driver activated the door close command at 23:51:24 and shortly after made two attempts to apply traction. The train did not move as the traction interlock system had detected the open door and inhibited the application of power to the motors. The end doors of the fourth car and the doors on all the other cars had closed, but the centre doors of the fourth car were held open by the two youths. After a short delay, the driver made an announcement for passengers to keep the doors clear. During this period, as designed, the doors attempted to close several times, but were held open.

The driver then applied traction again at about 23:53:30 and the train commenced moving along the platform with the doors held open, as the traction interlock system had timed out as designed.
