Collision of passenger train 8185 with level crossing gates

Lydiard Street North, Ballarat, Victoria, on 30 May 2020

Rail Occurrence Investigation (Systemic)

RO-2020-007

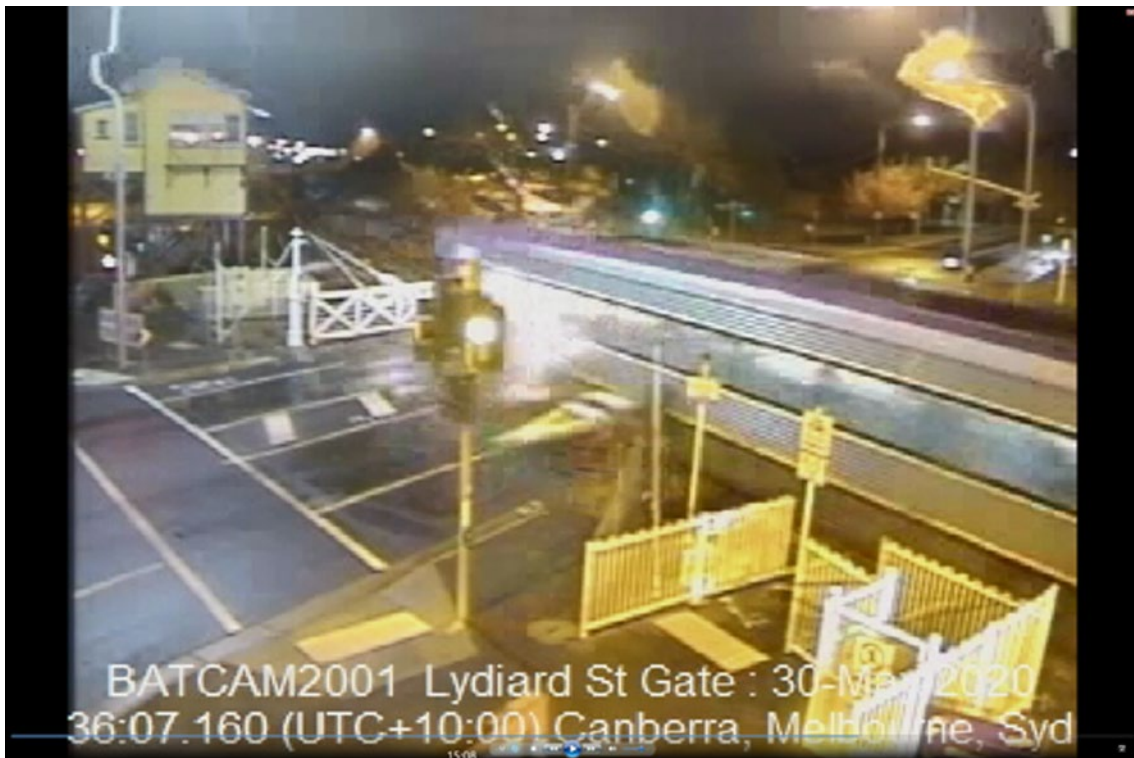
Figure 2: Train 8185 having impacted the first gate and about to strike the second.

*CCTV snapshot of train having entered the level crossing traveling from right to left.
Source: V/Line Corporation*

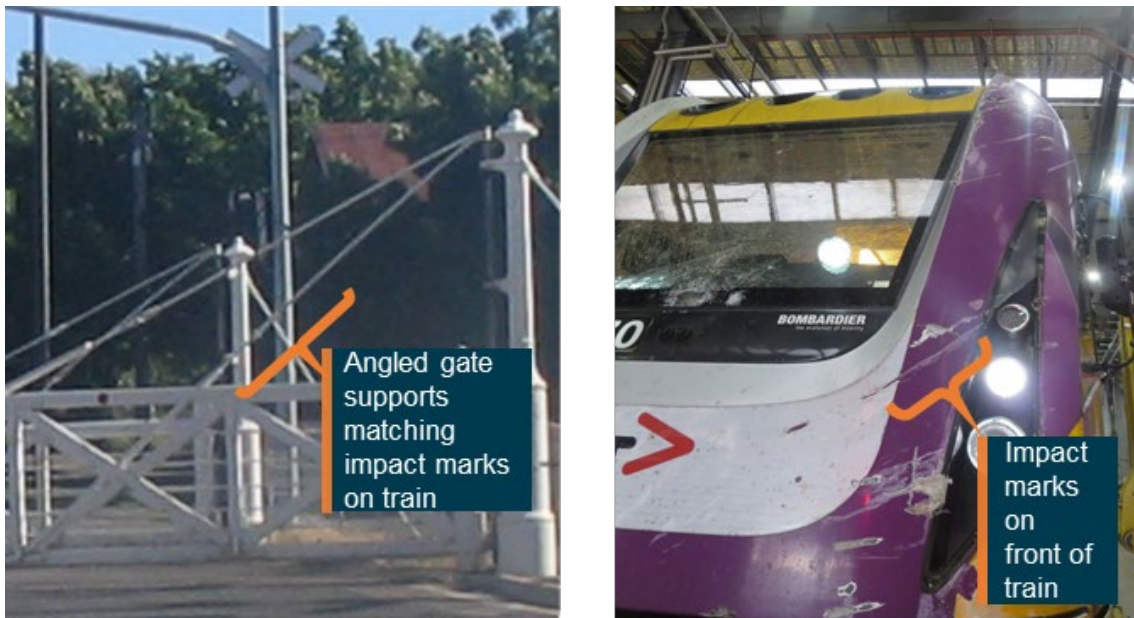
Figure 3: Impact damage to the front of train 8185, car 1270

The front of the lead car (1270) was significantly damaged as a result of impact with the heritage gates. The driver’s cab survival space was maintained and the windscreen was not penetrated.¹⁰ Impact marks on train front were consistent with portions of the gate support (Figure 3).

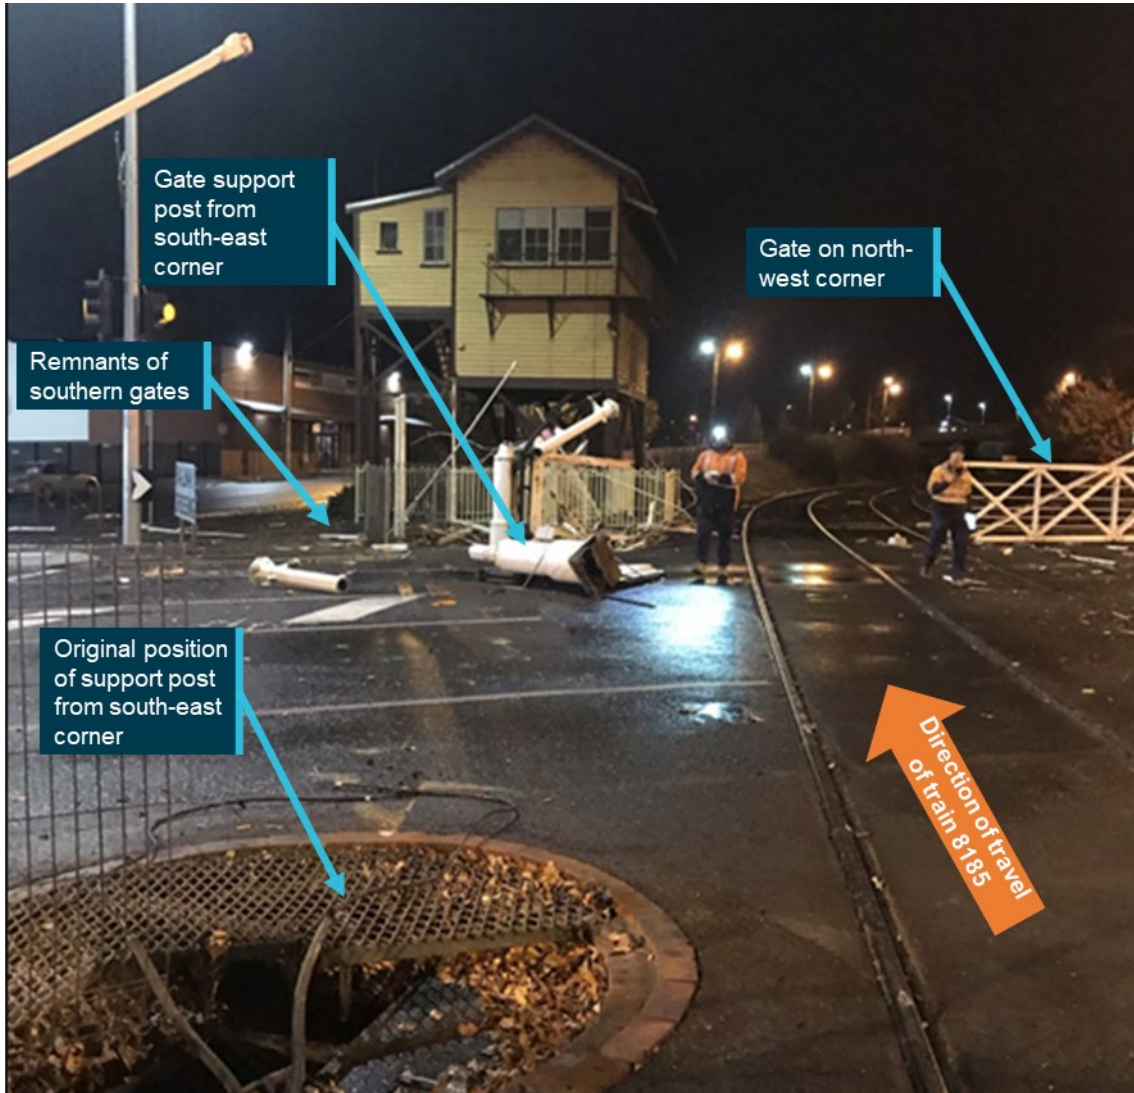
Figure 5: Remnants of the damaged gates on the southern side of the crossing

The impact destroyed the pair of southern gates, damaged the front and side of the train, and resulted in gate debris being scattered into the surrounding area. There were no injuries to members of the public from this debris.

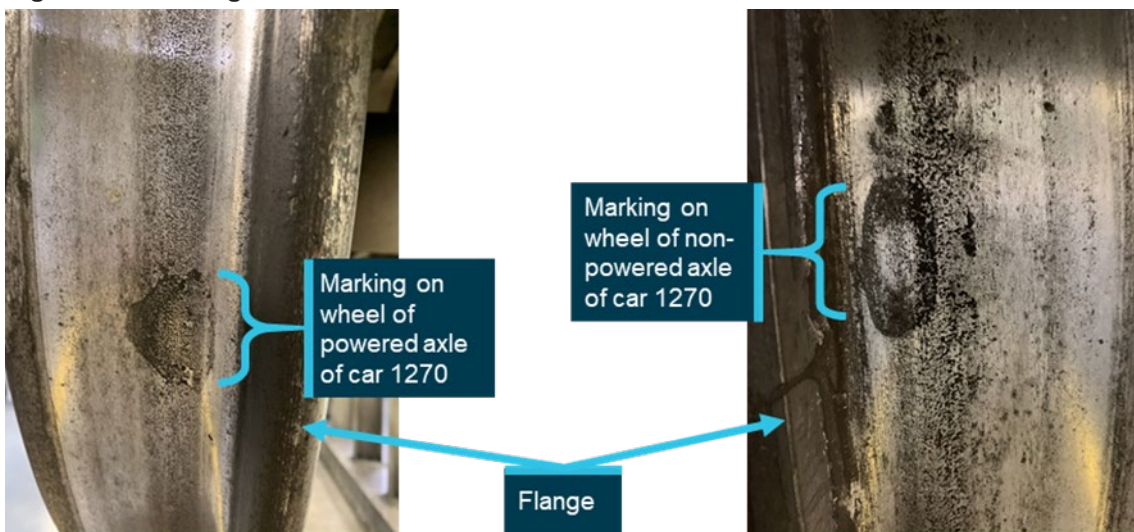
Figure 13: Markings on the wheels of car 1270

Post-incident inspection of train 8185 wheels identified some markings. The wheels of the leading car (1270) exhibited some minor marks approximately 25 mm long around the flange root of the wheels (Figure 13). It could not be determined whether these were caused by the slide incident or a previous event.

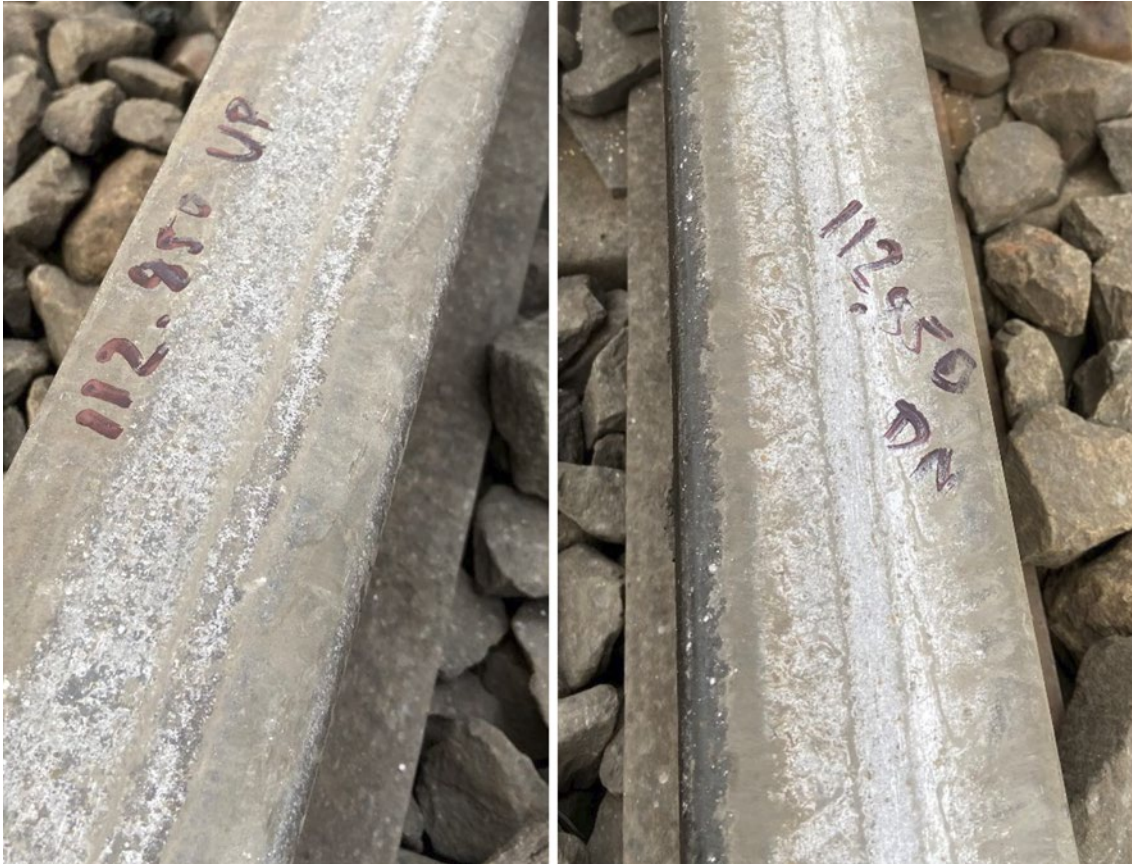
Figure 15: Rail surface condition at 112.850 km chainage, about 1.1 km from station stop

IRT reported that the surface condition at sites 1 and 2 showed relatively typical levels of contamination, consistent with the presence of normal oxides and dust/dirt. More significant contamination was observed at site 3, with what appeared to be dirt/dust on the surface of the rails (Figure 15). The particulates on the rail head were not tested for composition.

*The figure shows some surface dust/dirt on the rail head and grease on the gauge corner of the down rail, the left rail looking towards Ballarat. The source of the dust/dirt is not known.
Source: IRT (2020)*

Grease was also observed on the gauge corner of the down rail at site 3, which was likely to have been carried from the wayside lubricator located approximately 150 m from this site in the direction of Ballarat Railway Station. The lubricant had not migrated onto the top of the rail where wheel contact was likely to have occurred.

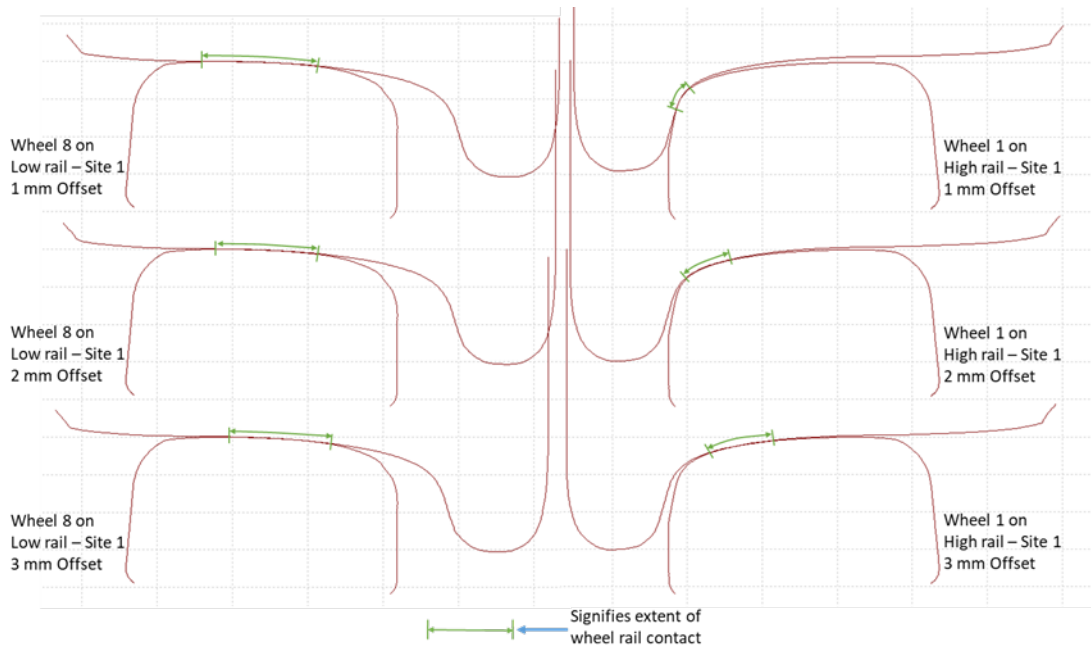
Figure 16: Site 1 profile overlays showing likely contact scenarios for the leading axle

On the high rail of the curve, a narrow band of contact was likely present for typical wheel positions,³⁸ localised on the gauge shoulder only. Narrow contact in this location was not ideal for promoting good adhesion conditions between wheel and rail. This was also away from the area of the rail targeted by sanding (the central crown) and toward a region of the wheel and rail that was more likely to be affected by any contaminant such as grease that could migrate from the wheel flange.

The figure shows the predicted wheel rail contact of the leading axle during curving at site 1. Three scenarios are shown; a 1mm offset, 2 mm offset and 3 mm offset from flange contact condition
Source: ATSB

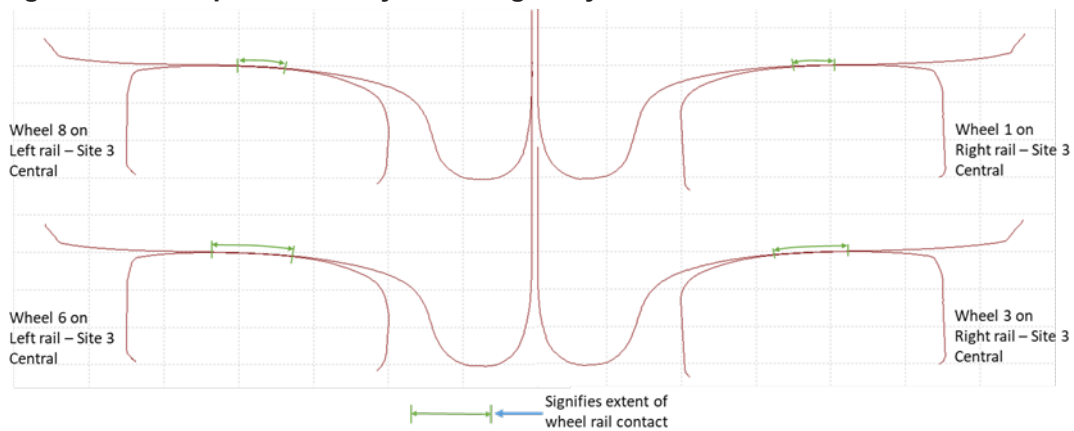
Figure 17: Site 3 profile overlays showing likely contact scenarios for two axles

The figure shows the predicted wheel rail contact of the leading axle and third axle of car 1270 at site 3, assuming centralised running.
Source: ATSB

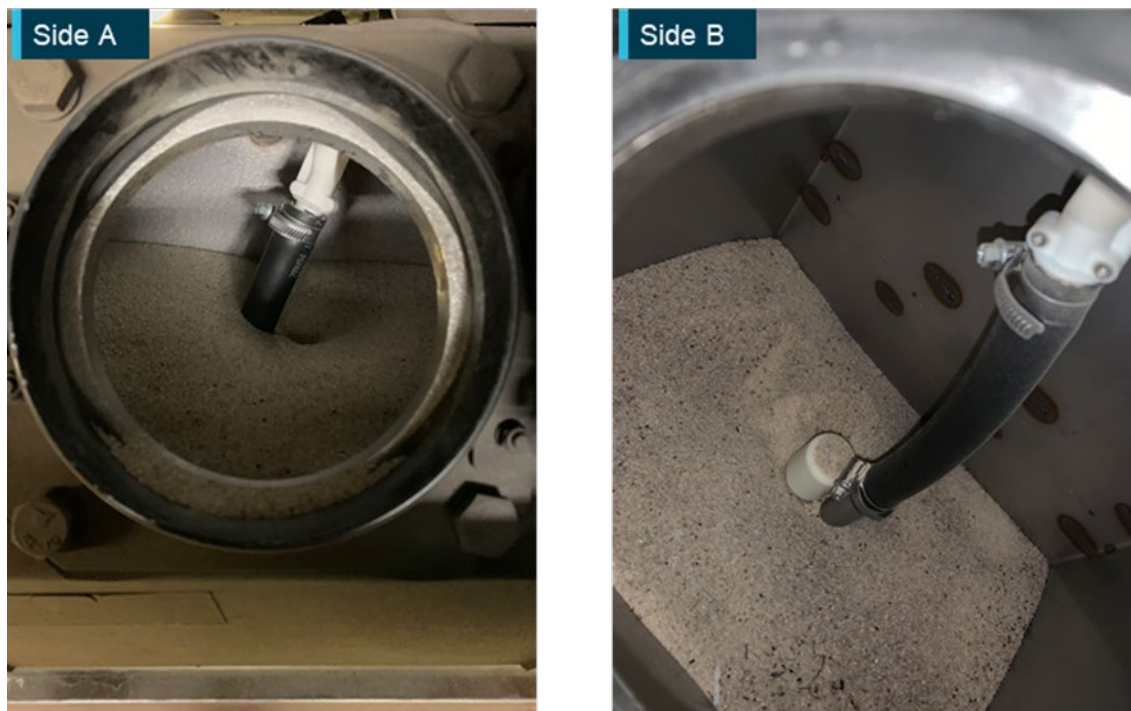
Figure 22: Sand boxes on car 1270 at Ballarat East depot, after the incident.

The sand box on side A (left side in direction of travel) contained approximately 21.6 kg of sand compared to the nominal capacity of 25 kg. The sand box on side B contained approximately 3.9 kg when measured and was effectively depleted.⁴⁴

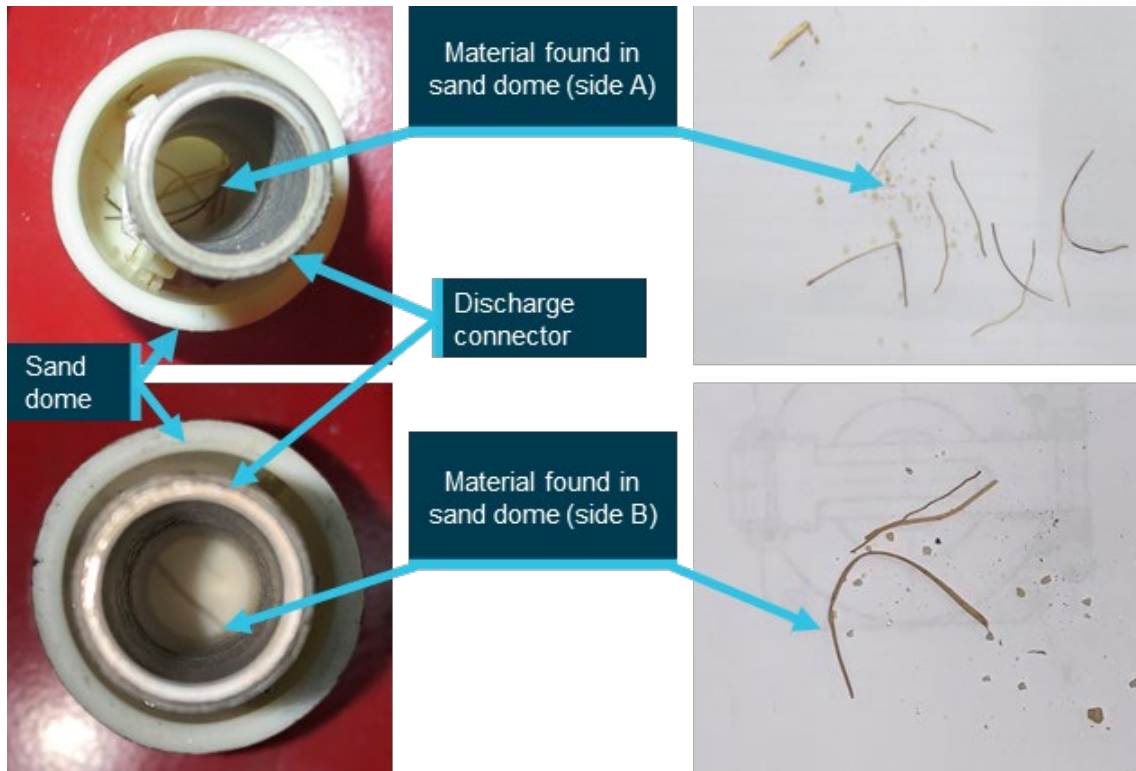
Figure 23: Vegetation in metering unit sand domes of car 1270

Other factors that increased the risk of diminished sander performance included vegetation contamination in sander mechanisms that reduced sand flow, and the depletion of sand in one sand box. These factors were associated with sander maintenance and train preparation processes. It was also noted that the strong crosswinds present that evening may have adversely influenced sand distribution.

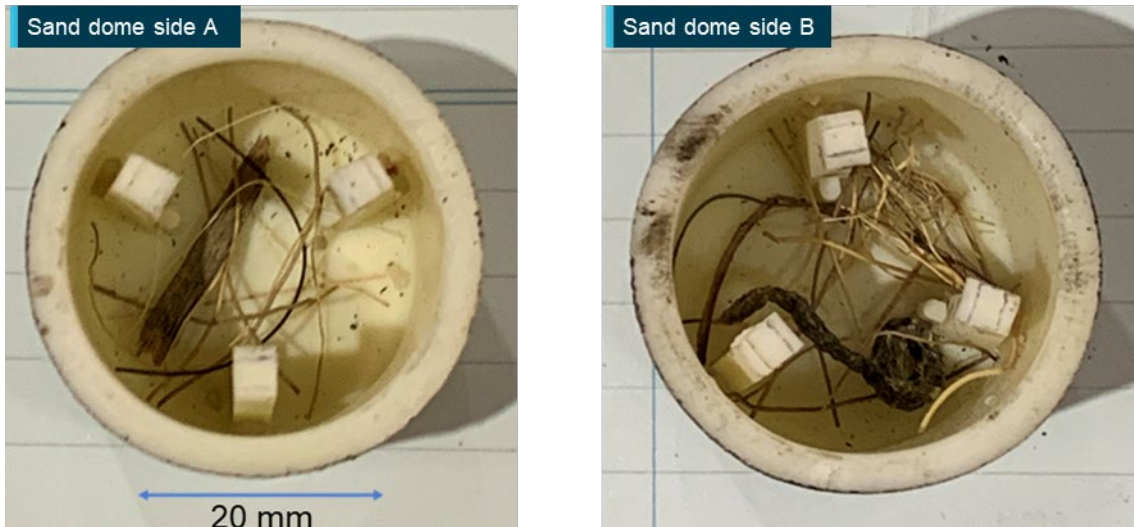
Figure 24: Vegetation in metering unit sand domes of car 1170.

Vegetation was also found in the sand domes of the metering units of car 1170 (Figure 24).

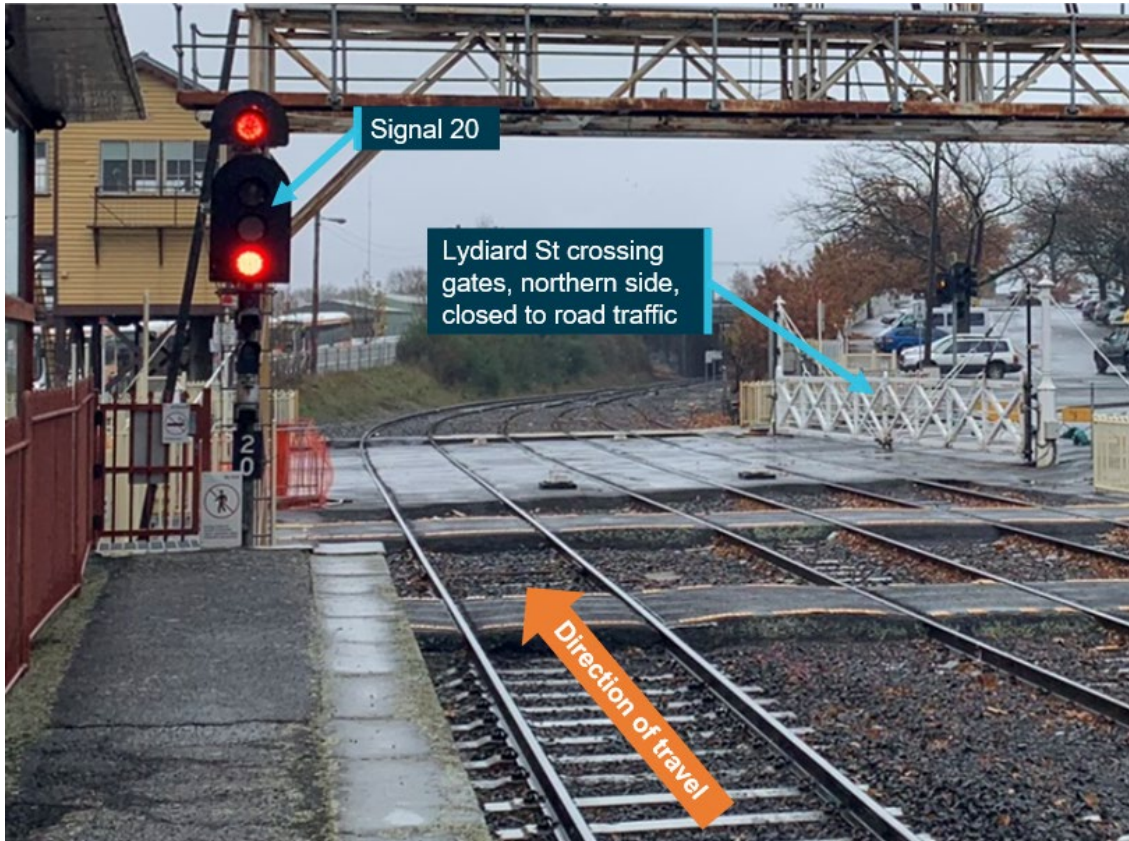
Figure 30: Departure signal 20 and the Lydiard Street North level crossing

*This photograph was taken after the event. The gates on the northern side of the crossing are shown closed to road traffic. The departure signal 20 is shown at stop, as it was when passed by train 8185.
Source: CITS*
