# Derailment of freight train 3XW4

Newport, Victoria | 30 October 2013

**ATSB Transport Safety Report**  
Rail Occurrence Investigation  
RO-2013-026  
Final – 13 January 2016

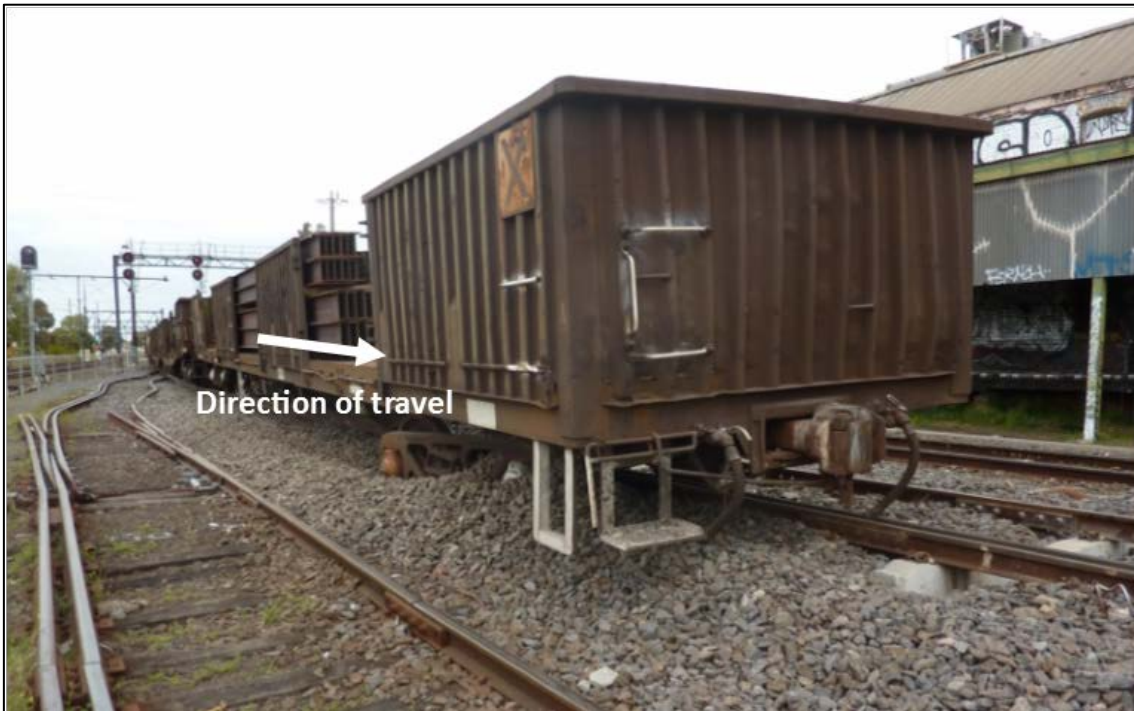
The leading left-hand wheel of the lead bogie had fallen inside the common<sup>2</sup> rail of the dual-gauge track. On reaching the next turnout, the wheel struck the toe of the common rail point blade. The train travelled about 100 m with the bogie derailed, causing damage to the mainline track and an adjacent siding (Figure 1).

**Figure 1: Derailed wagon RKOX 4072D and track damage to adjacent siding**

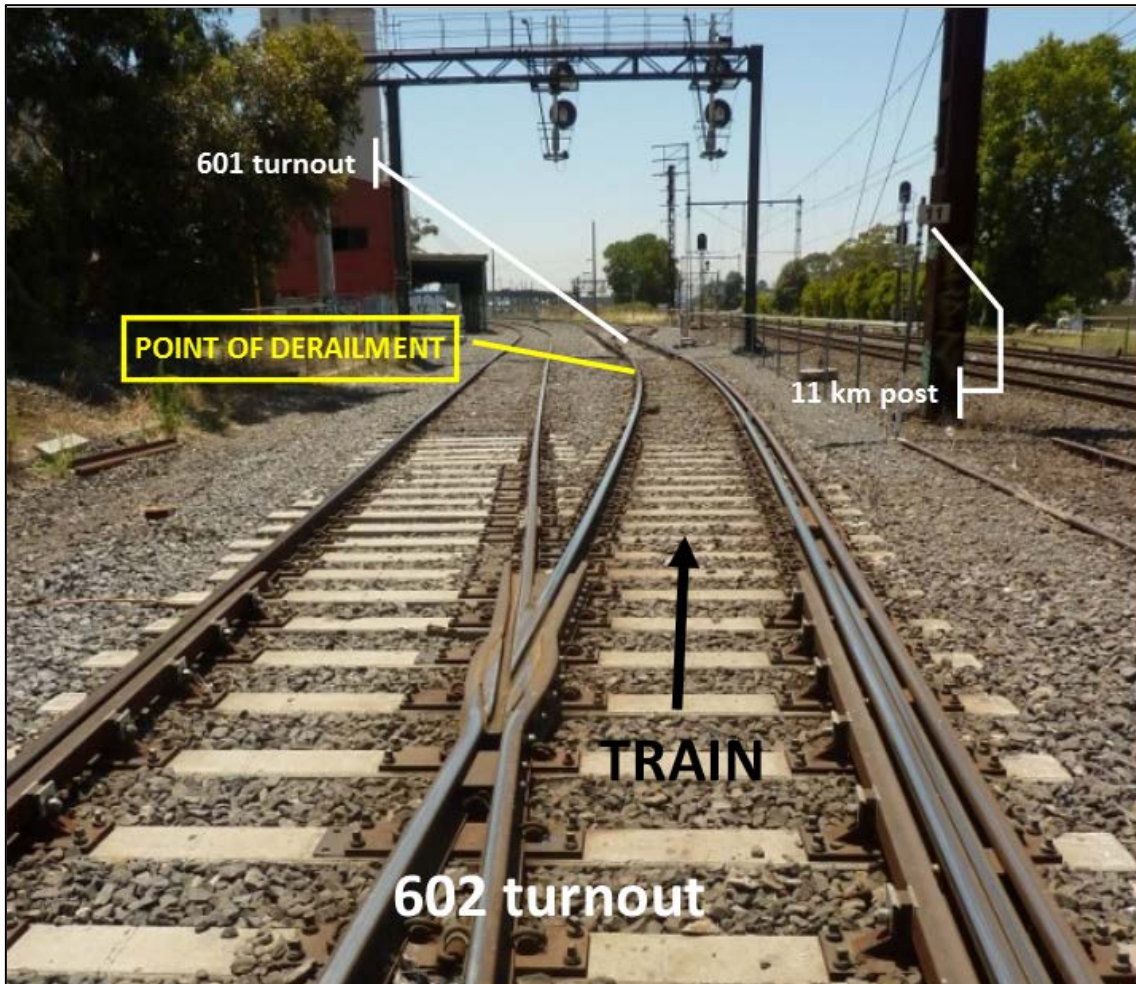
The track between turnouts 602 and 601 had a radius of about 200 m at the point of derailment (Figure 3). There was a mix of concrete and timber sleepers (Figure 4) and the standard-gauge rail was heavily worn.

**Figure 3: The approach to the left hand curve and the point of derailment**

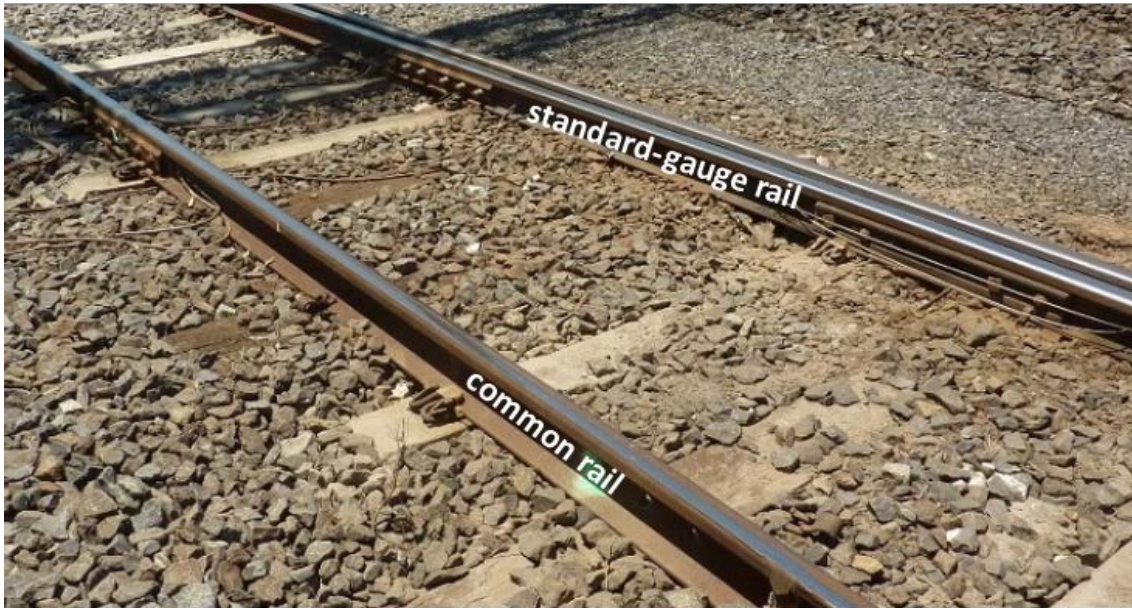
**Figure 4: Track construction at point of derailment**

At timber sleepers, rail was supported on double shouldered sleeper plates and fastened by dog spikes and screw spikes. Several dog spikes and screws were loose and 'working'.

At concrete sleepers, a mix of resilient fastening types were used. There was a history of damaged fixings and dislodged rail spacers through the location.

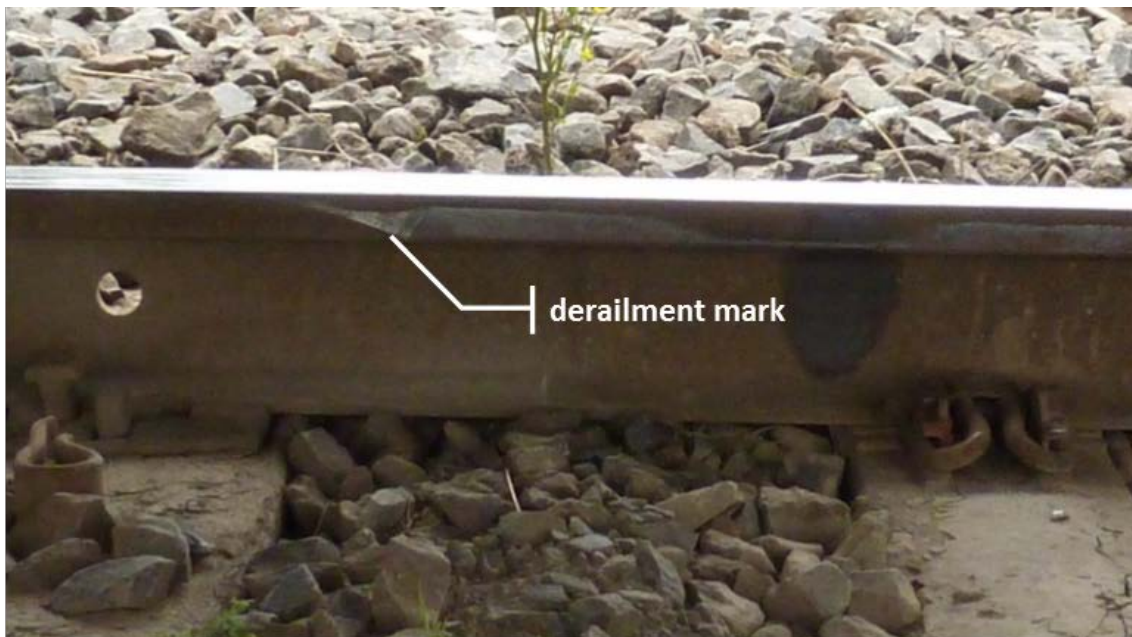
The point of derailment (PoD) was about 11 m before the toe of the 601 points blade. The leading left-hand wheel of wagon RKOX 4072D had dropped inside the common rail leaving a mark on the gauge face of the rail (Figure 5). The PoD was on 50 kg/m rail, just past a transition from 47 kg/m rail.

**Figure 5: Point of derailment where a wheel had dropped inside the common rail**

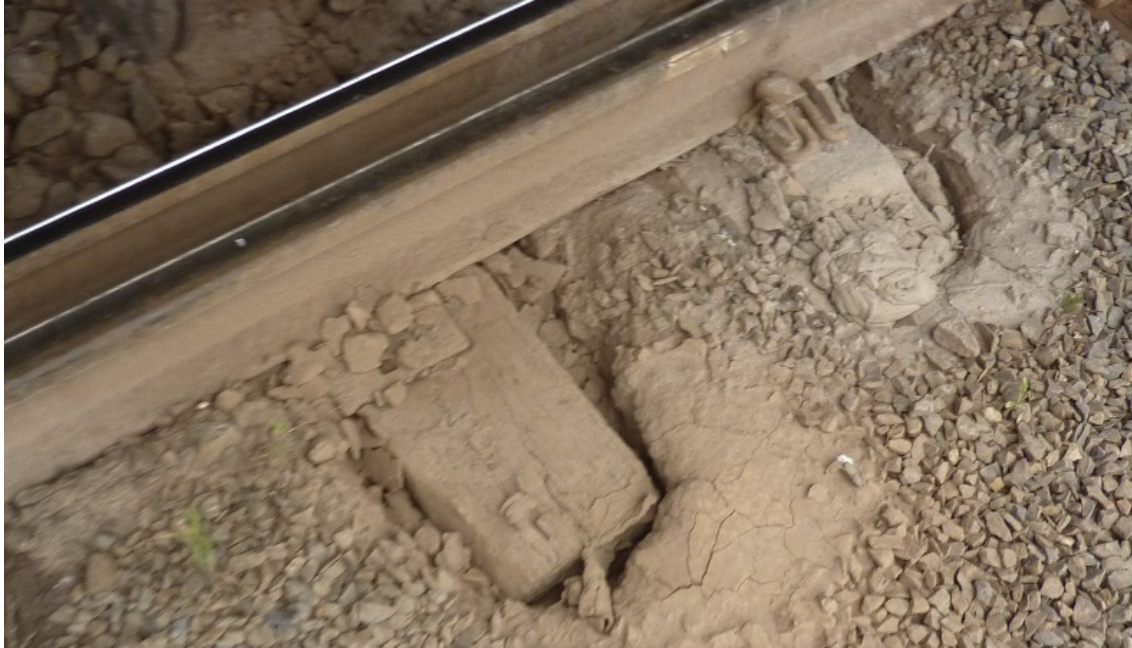
Around the PoD, the ballast was fouled and the track had been pumping (Figure 6).

**Figure 6: Track pumping at location of derailment**

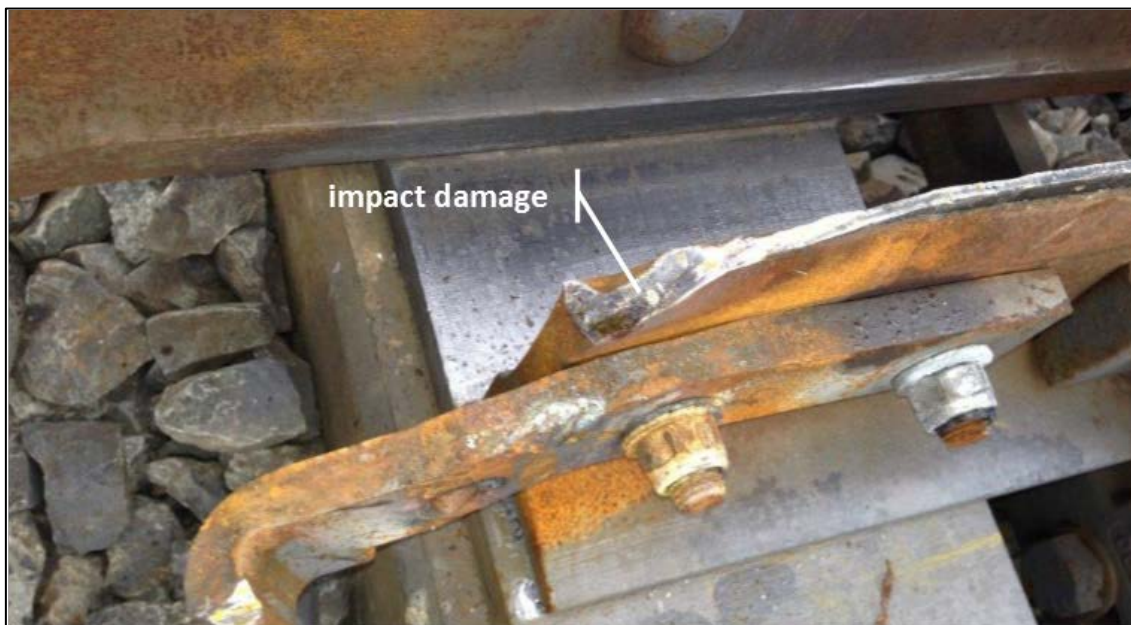
Beyond the point of derailment there were markings and fastener damage consistent with a derailed wheel travelling inside the common rail. The toe of the point blade at turnout 601 had been impacted by the wheel (Figure 8).

**Figure 8: Impacted toe of the point blade at turnout 601**

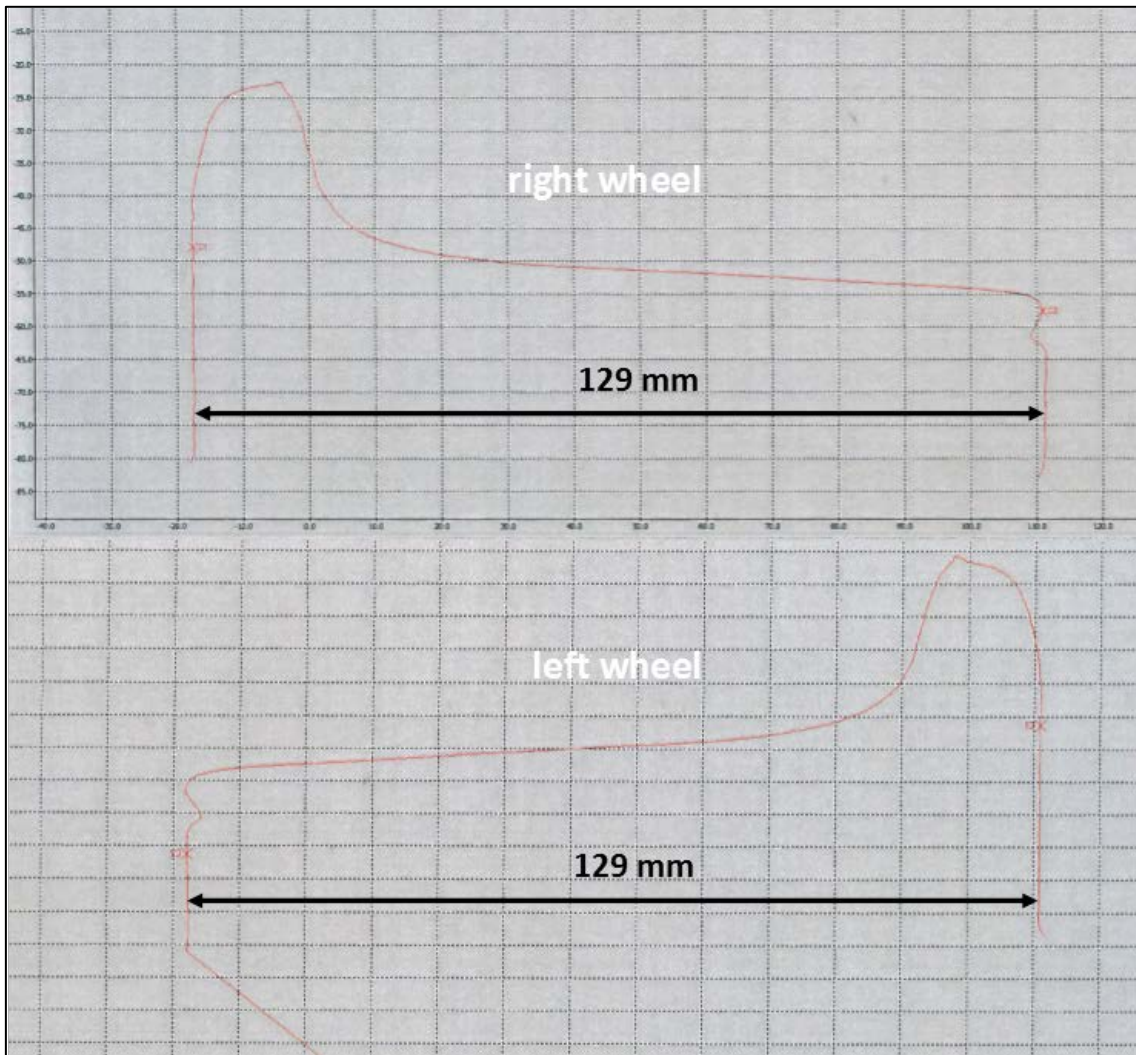
The leading wheelset of the derailed bogie was fitted with the narrower wheel type, with both wheels having a measured rim width of about 129 mm (Figure 10). Inspection of these wheels using the rolling stock operator’s field gauge found that they were more worn than others on the wagon, but that flange thickness and wheel profile met requirements. Flange thickness exceeded the operator’s permitted minimum of 19 mm.

**Figure 10: Leading axle wheel profiles, right wheel (top) and left wheel (below)**

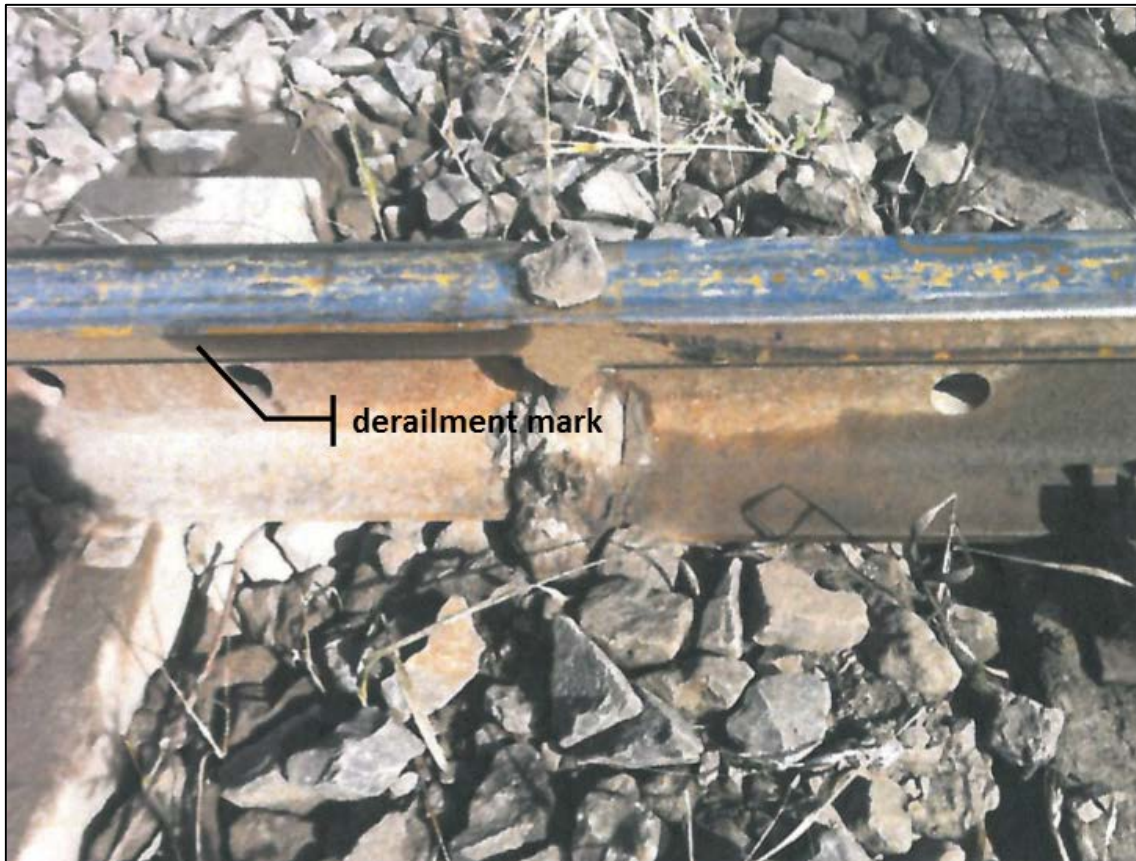
**Figure 11: Photograph from the 11 September 2013 derailment, showing marks on the rail gauge face consistent with a left hand wheel dropping inside the common rail**

The ATSB identified from photographic evidence that the point of wheel drop-in on 11 September was about 0.6 m before (to the south of) the point of derailment seven weeks later, on 30 October. In addition, inspection of the bogie that probably derailed first found that the wheels on that bogie were also of the 127-130 mm type.

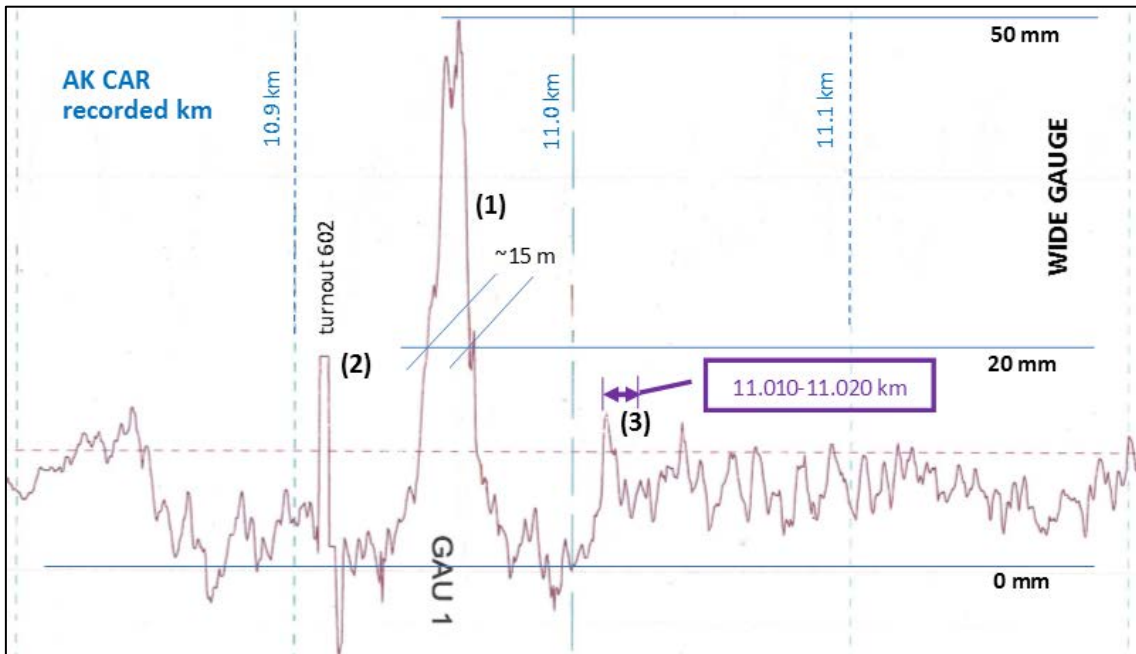
**Figure 12: Extract of AK Car chart from 2 October 2013 measurement showing:**

- (1) wide-gauge magnitude and extent consistent with that at the derailment site
- (2) a wide-gauge spike consistent with transition zone at turnout 602
- (3) no significant wide-gauge recorded between 11.010-11.020 km

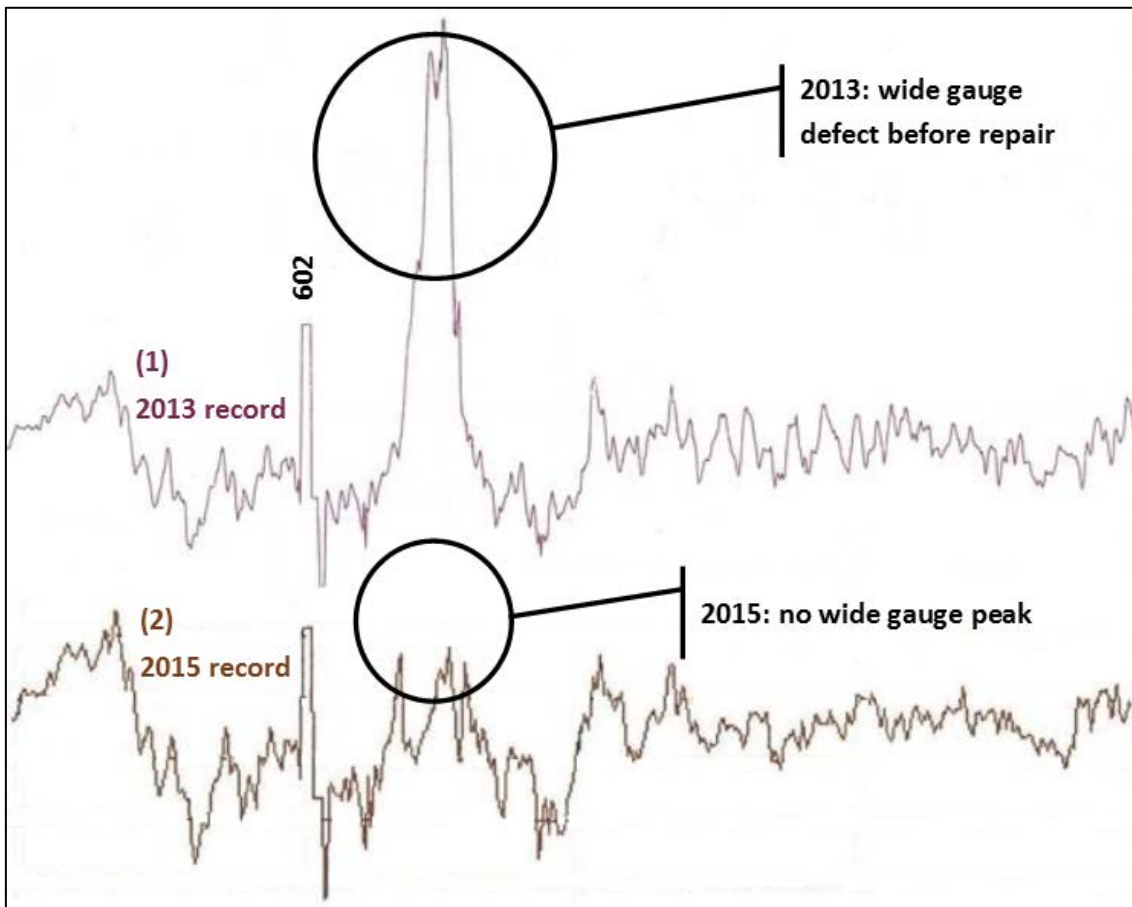
Once the track between 602 and 601 turnouts was renewed, the wide-gauge E fault and severe rail wear were no longer identified by the track geometry recording vehicle through the location. Comparison of charts shows that a wide-gauge peak is no longer present (Figure 14).

**Figure 14: Extract of AK Car charts of track gauge on similar vertical and horizontal scales from:**

- (1) 2 October 2013 (top) before repair to track between turnouts 602 and 601
- (2) 11 June 2015 (below)

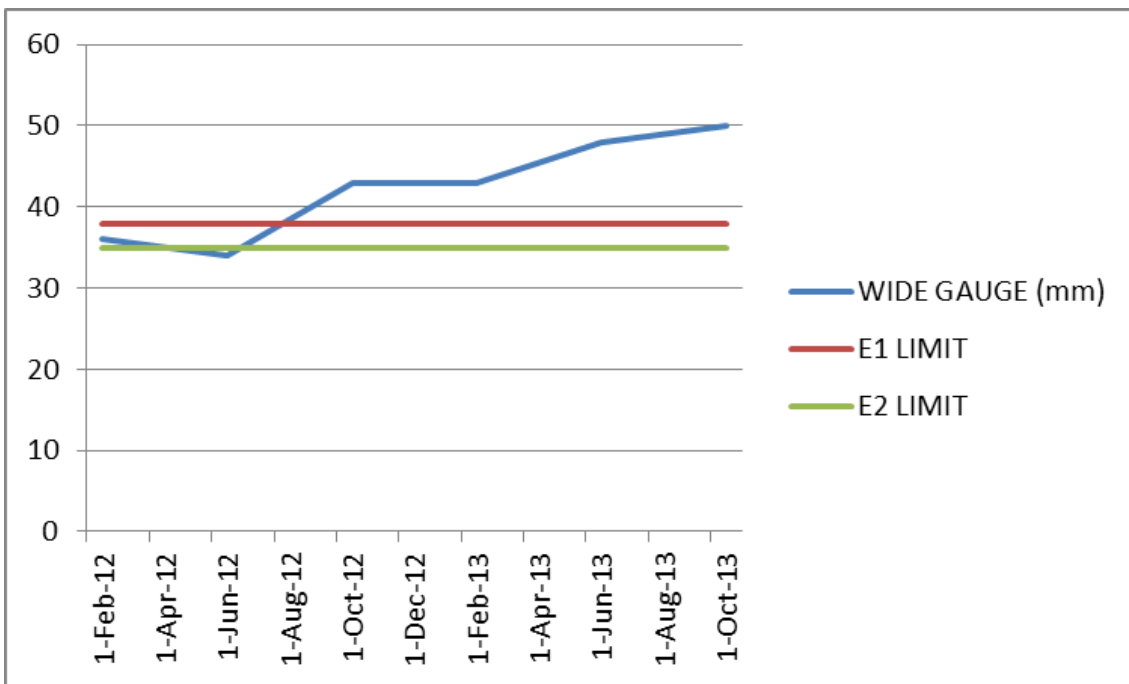
The network code specified a 38 mm wide-gauge limit under loaded conditions, above which an E1 (Emergency) response was required. This criterion was exceeded for both the static (no load) and loaded conditions.

The six AK Car track recordings prior to the derailment were examined. In all recordings, wide-gauge was identified by the track geometry recording vehicle for this track section. The wide-gauge exceeded the E1 limit for at least a year prior to the derailment and was trending upward (Figure 15). The track gauge was 50 mm wide when last measured by the track geometry recording vehicle on 2 October 2013, and so exceeded the 38 mm criterion.

**Figure 15: Trend in measured gauge shown against E1 and E2 limits**

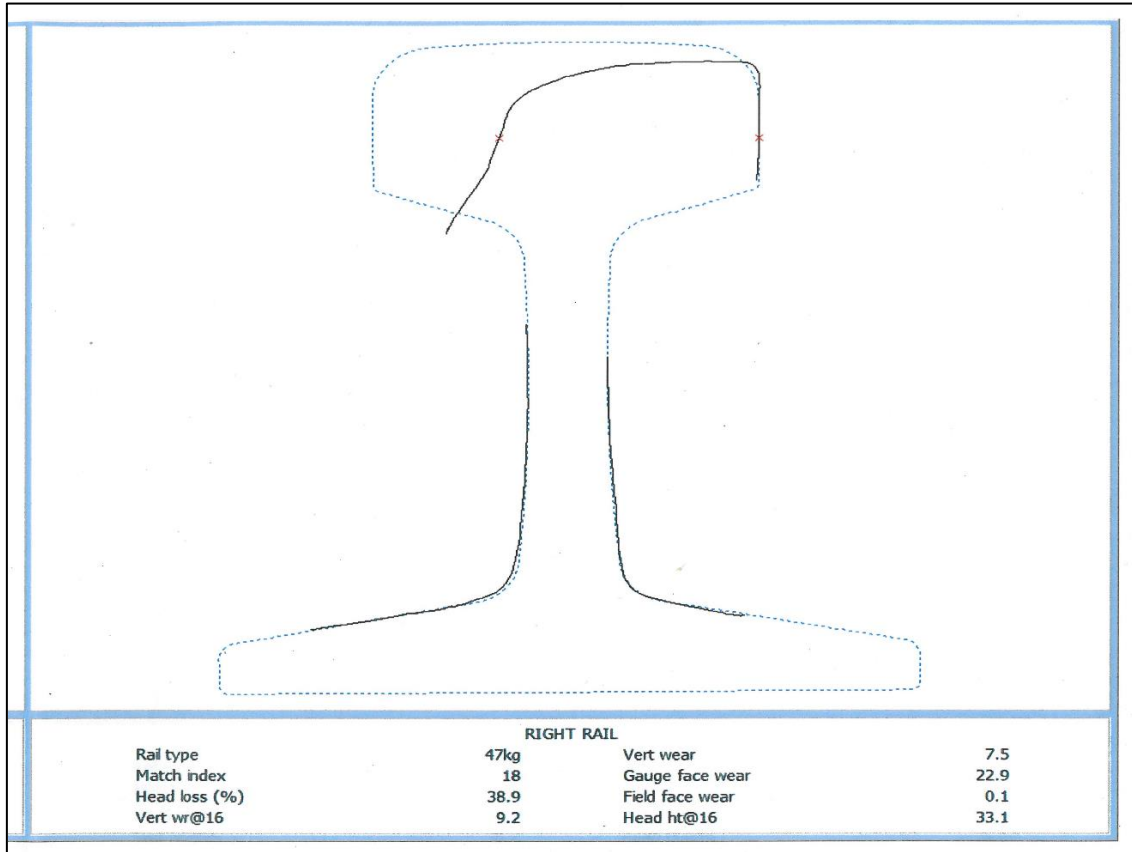
Rail wear leads to a loss of rail strength and rail head shape. As a result the network specifies limits on rail wear. The 47 kg/m rail near the point of derailment was worn beyond the network limits (Figure 16). Specifically:

- Head loss was 39 per cent, exceeding the 32 per cent criterion that triggered risk controls
- Gauge face side wear was 23 mm, exceeding the 15 mm condemning limit.

In addition, the gauge face of the standard-gauge rail was worn to an angle of about 27 degrees, exceeding the network criterion of 26 degrees. While only just exceeding the limit, high gauge-face angles increase the potential for flange climb.

**Figure 16: Rail head profile in heavily worn 47 kg/m rail, close to point of derailment**
