Derailment of freight train 7MC1

Wallan, Victoria | 4 November 2017

ATSB Transport Safety Report
Rail Occurrence Investigation
RO-2017-016
Final – 6 March 2019

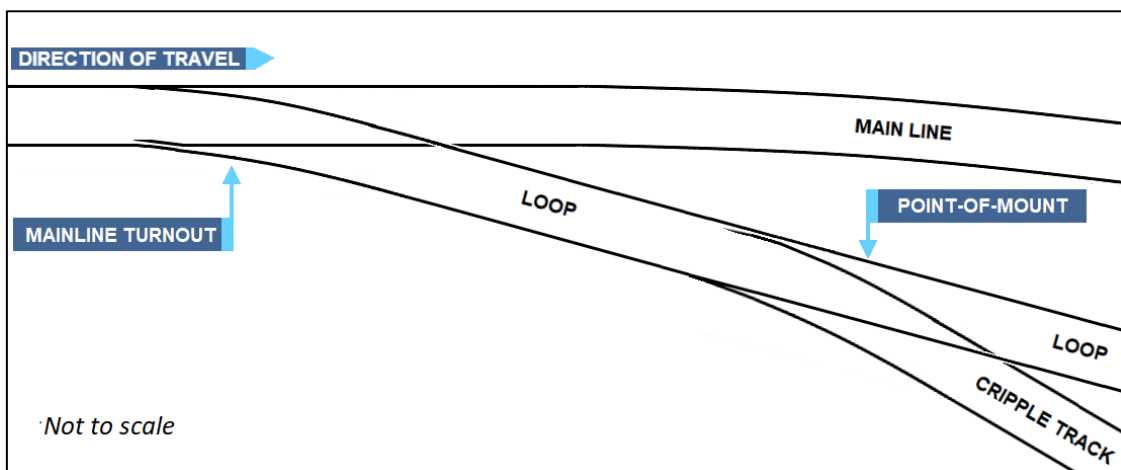
Figure 2: The location of the point of mount within the cripple track turnout

As 7MC1 was entering the loop, the leading wheelset of the 37th wagon (LQAY 00025D) derailed. The leading left-hand wheel of the wagon climbed³ the stock rail⁴ beyond the point blade in the cripple track turnout, ran along the railhead and dropped to the outside of the rail (Figure 2).

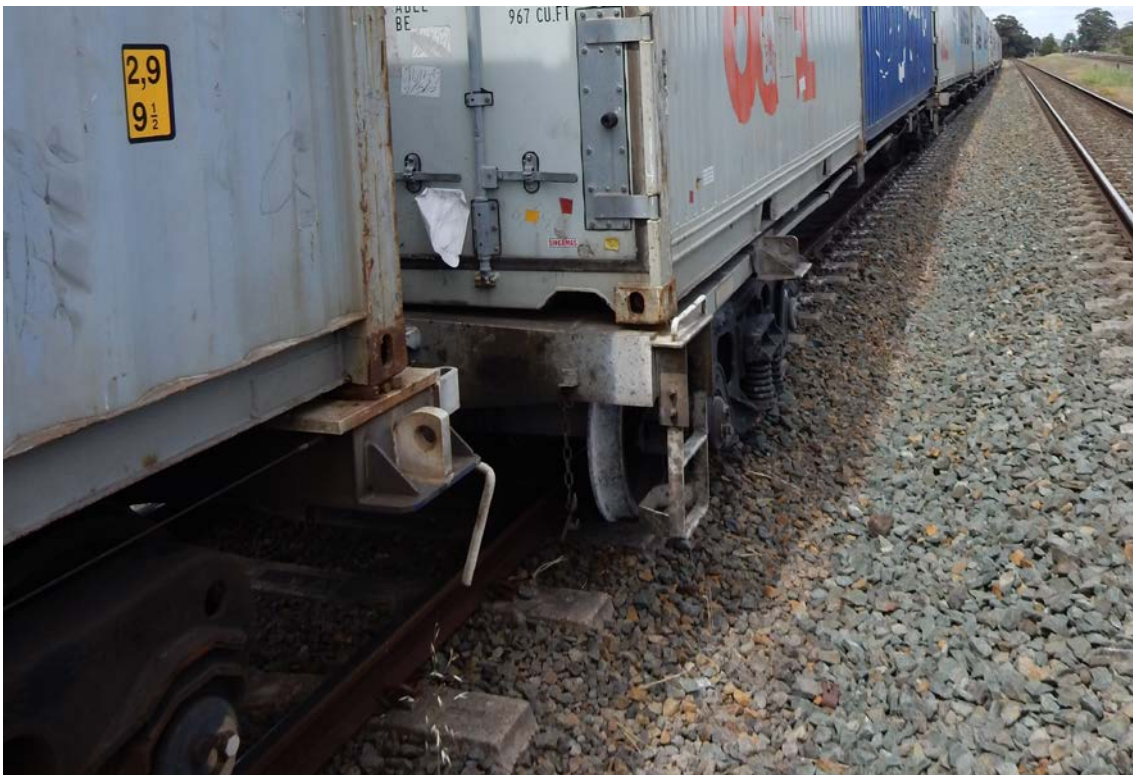
Figure 3: The derailed bogie (both wheelsets) after the train was brought to a stop

The train was brought to a stand. Damage to the train was limited to wagon LQAY 00025D that had derailed all wheels of its leading bogie (Figure 3).

*This picture shows the derailed wagon after the train was stopped when departing Wallan Loop.
Source: Chief Investigator, Transport Safety (Vic)*

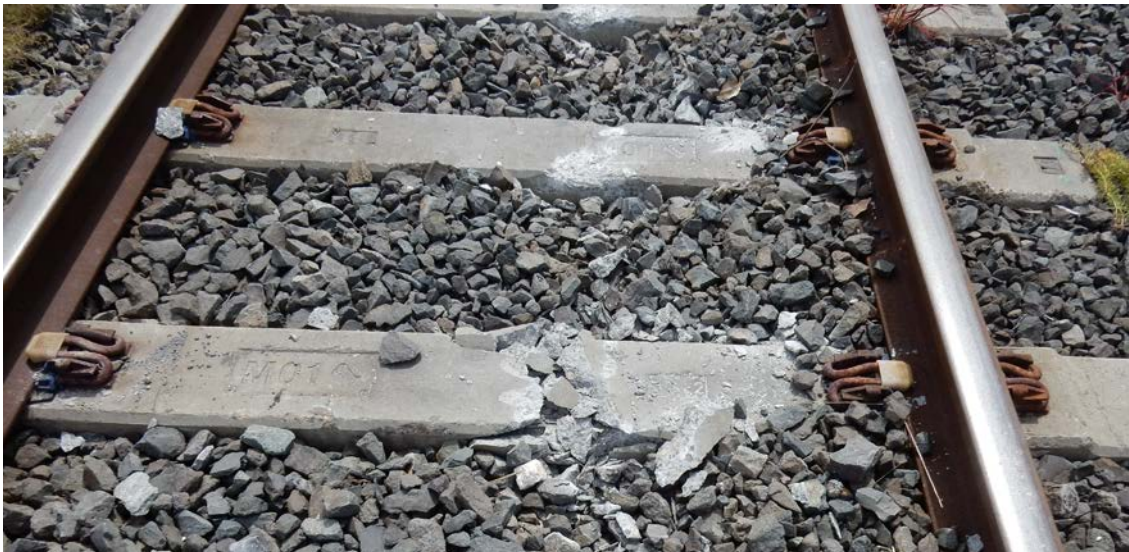
Figure 4: Typical damage to concrete sleepers within the crossing loop

The track sustained damage to sleepers over a distance of several hundred metres (Figure 4).

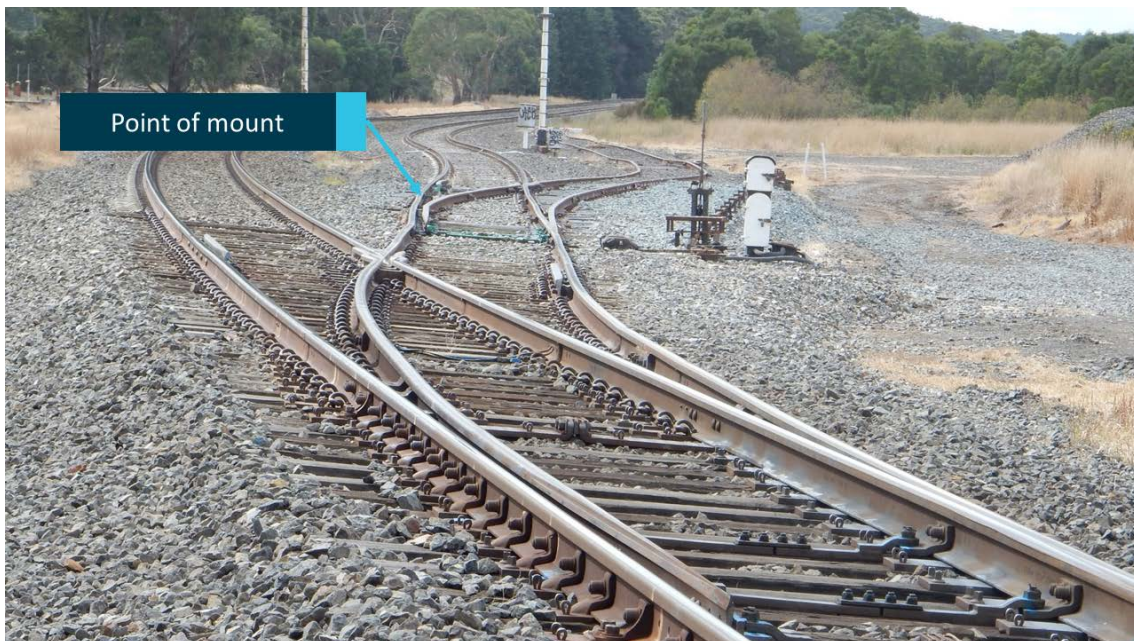
Figure 5: The southern entry from the mainline into Wallan Loop and the cripple track

The track at Wallan included the crossing loop and a cripple track for disabled rolling stock. The southern end of the loop consisted of a right-hand turnout from the main line and a second right-hand turnout to the cripple track. The Normal direction of this second turnout led into the crossing loop proper and to a short left-hand curve before the loop track curved right paralleling the main line (Figure 5).

The turnout at the southern entry to the crossing loop was located on a 1247 m radius main line curve with minimal gradient. The main line track has a superelevation⁸ of 100 mm that transitioned to the flat loop track over a distance of about 24 m.

The cripple track turnout was on timber sleepers. At the derailment location, sleepers were in degraded condition with an observable loss of effectiveness in the rail fastenings.

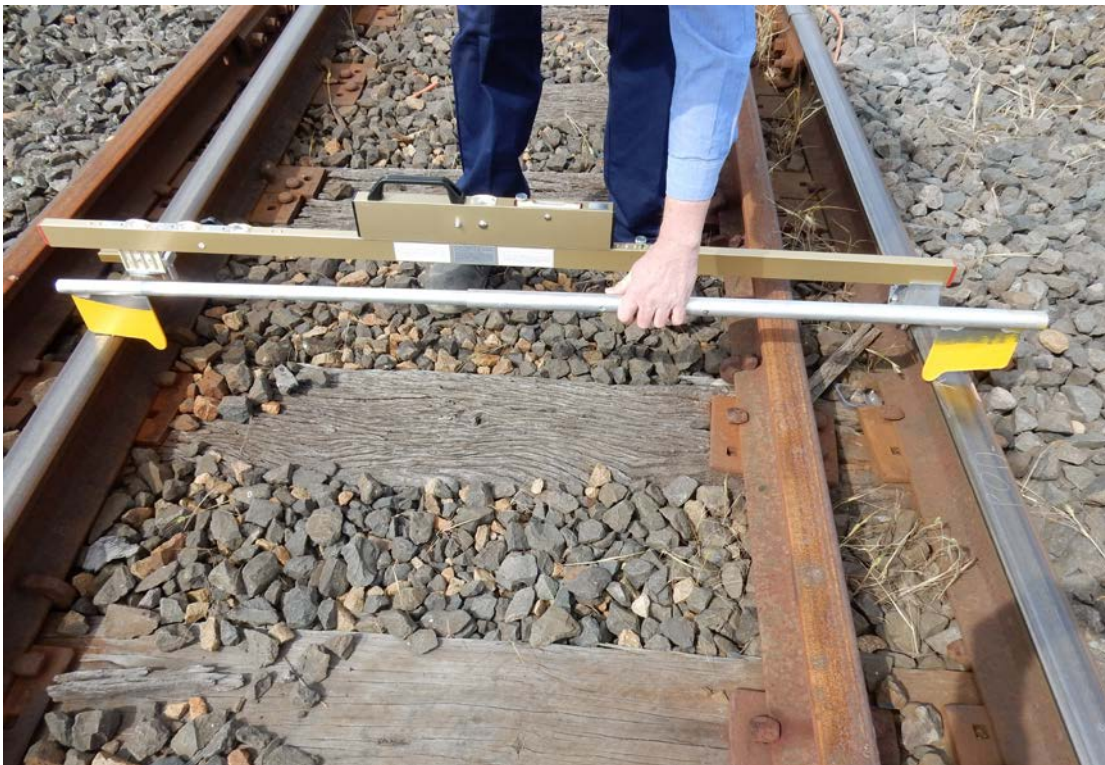
Figure 8: Point of wheel mount

Following the derailment, track gauge and cross level measurements were taken through the derailment location (Figure 8).

The PoM was at a chainage of approximately 47.316 km.¹⁴ Static twist measurements peaked around this location. A measured peak static long twist of 78 mm¹⁵ extended from 14 m before the PoM, up to the PoM. The measured peak static short twist¹⁶ was about 22 mm about 2 m ahead of the PoM. These values were comparable to the E-defects measured by the AK Car.

The maximum measured (no-load) wide gauge through the location was 20 mm at the PoM. This was within permitted maintenance tolerances. Review of the most recent AK Car data, measured under load, indicated a peak wide gauge of 31 mm at a chainage of 47.319 km. This falls within the P2 (Priority Class 2) defect category for this low speed track.

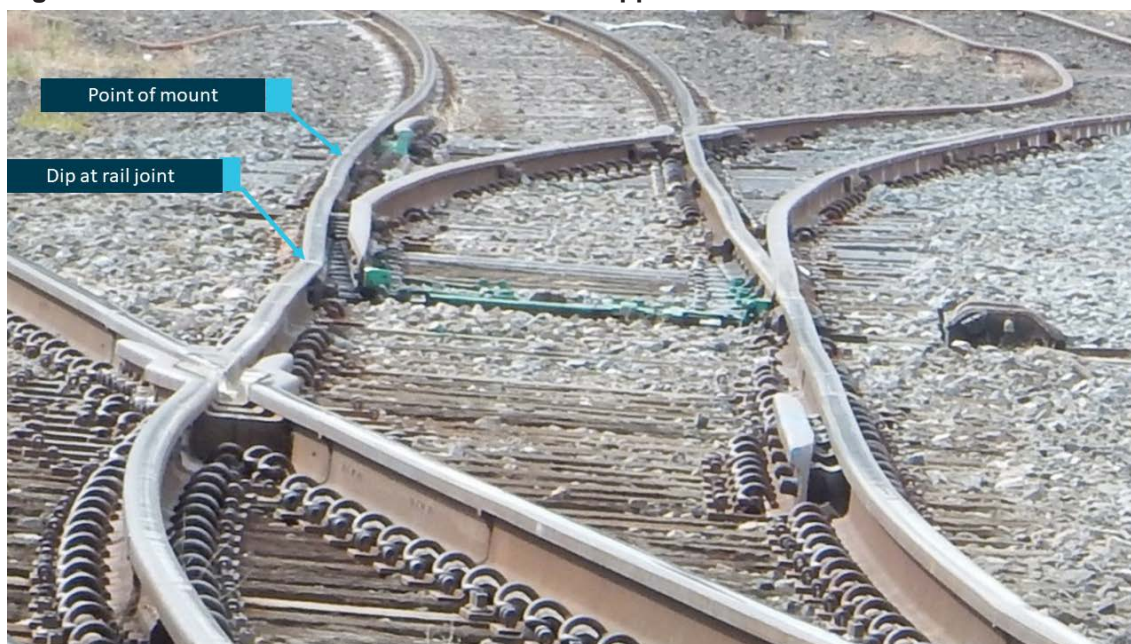
Figure 9: Transition from main line turnout to cripple track turnout

Track lateral alignment through the cripple track turnout was also sub-optimal and there was a significant dip in both rails at the transition (mechanical joint) from the main line turnout to the cripple track turnout (Figure 9).

This picture shows a close-up view of the track through the derailment location and shows the rail lateral alignment around the point of mount. The deviation in rail line is exaggerated by the telephoto effect.

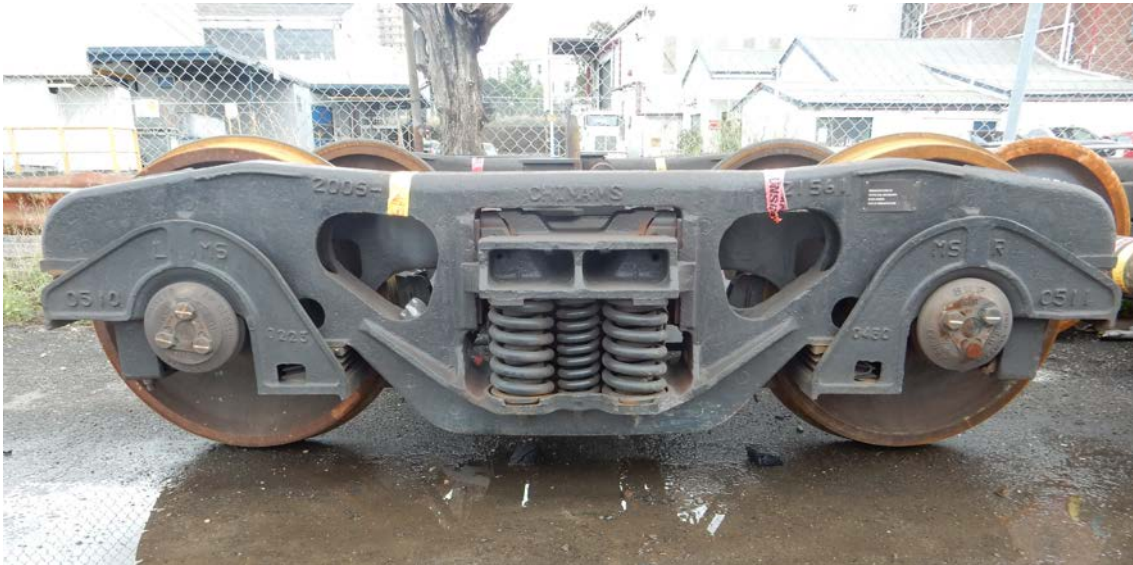
Figure 10: The derailed bogie after its transport to Melbourne

LQAY wagons are fitted with three-piece bogies with a steering arm mechanism linked to primary rubber pad arrangement between the side frame and axle box. They also have variable friction damping on the secondary springs and constant contact side bearers (Figure 10).

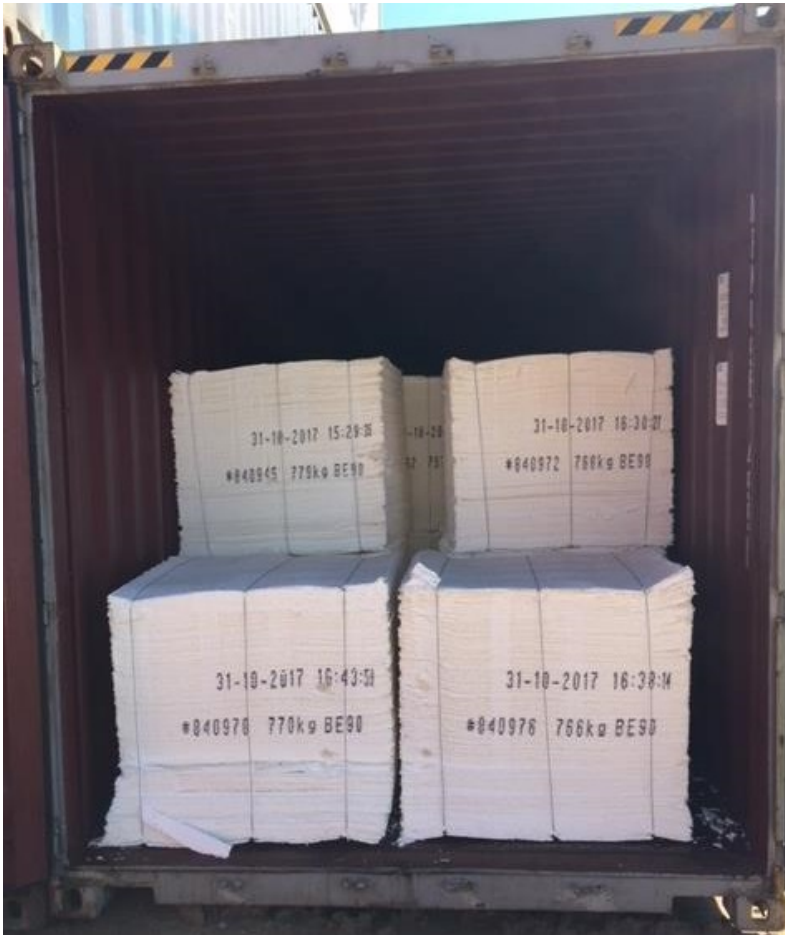
Figure 13: Paper bundles loaded in the 40-foot container

Wagon LQAY 00025D was loaded with two containers. At its leading end was an empty 20-foot refrigerated container with a reported mass of 3.2 t. Behind this was a 40-foot container loaded with strapped bundles of recycled paper and having a reported mass of 26 t (Figure 13). Wagon tare was 19.9 t, giving a total mass of 49.1 t. This compares with the train consist report that records a total mass of 69 t. The reason for this discrepancy is unknown.

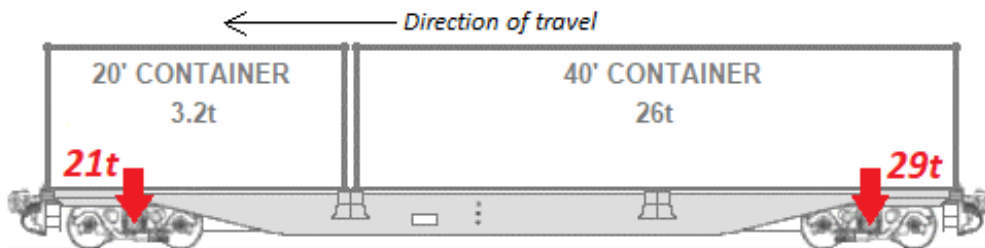
Figure 14: The container loads and the resultant mass at each bogie

The two containers wholly occupied the length of the wagon. The mass distribution of the containers and wagon tare resulted in an estimated 21 t at the leading bogie and about 29 t at the trailing bogie of (Figure 14).²¹ The difference of about 8 t was within the ARTC Route Access Standard²² requirement of no more than 20 t.

The mass at each end has been rounded up, resulting in a total rounding error of 1 t, and an apparent total mass of 50 t compared to the actual total mass of 49 t.

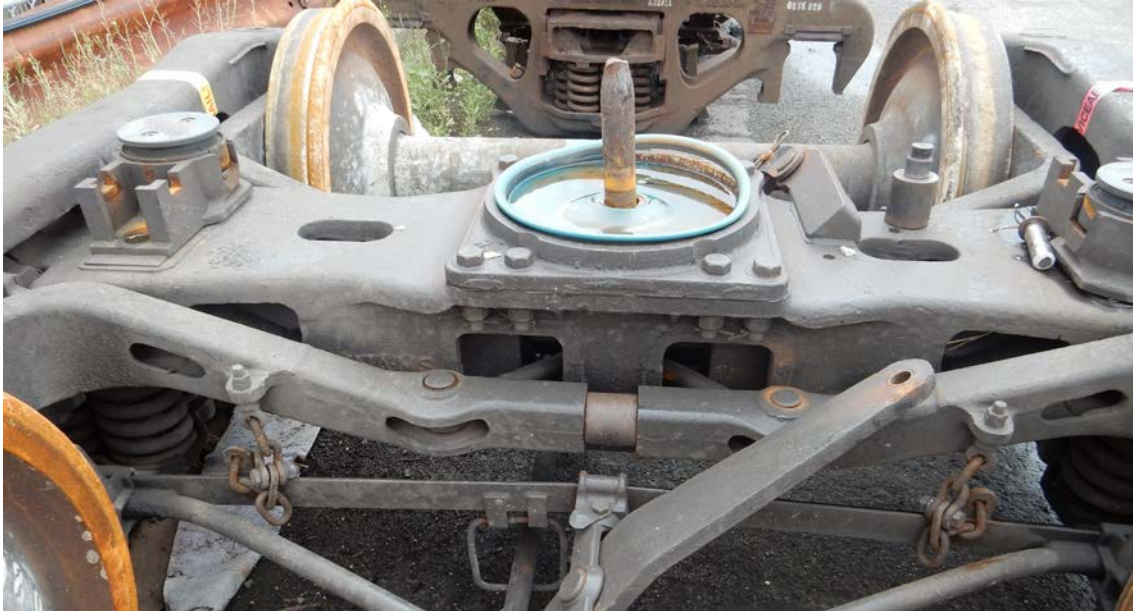
Figure 15: The derailed bogie at the post-incident inspection

A detailed inspection was conducted on both bogies of wagon LQAY 00025D. The derailed bogie was designated LHSY113 (Figure 15).

This picture shows the bogie that derailed. It shows damage to the centre bowl liner and some components, all believed to have occurred after the bogie derailed.

No wear or damage conditions were identified that were considered contributory to the derailment. Wear to both bogies was minimal and consistent with the recent December 2016 overhaul. In addition, surface condition of constant contact side bearers did not indicate any unusual behaviour.

Wheel wear was within the operating requirements and similar on both bogies. Wheel wear on the derailed bogie was relatively light and evenly matched from side to side indicating the bogie had been tracking well. Wear on the wheel flanges was more than expected for a steering bogie, but was within tolerance.
