Reaction to fire test report

Test standard: Ad-hoc test based off ISO 13785-1:2002

Test sponsor: Cladding Safety Victoria (CSV)

System: A cassetted aluminium composite panel wall system

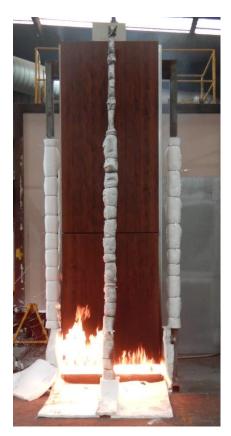
Figure 13 The specimen 3 minutes 58 seconds into the test (burner output at 100 kW)

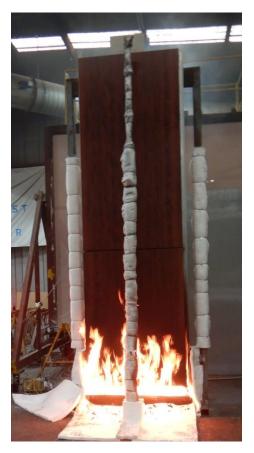
Figure 14 The specimen 8 minutes 49 seconds into the test (burner output at 100 kW)

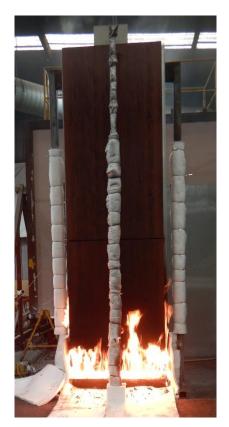
Figure 15 The specimen 12 minutes into the test (burner output at 100 kW)

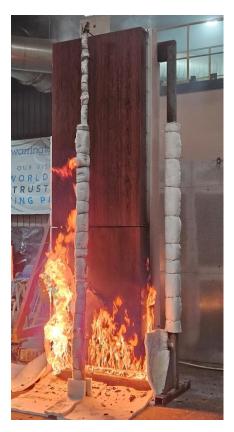
Figure 16 The specimen 16 minutes 12 seconds into the test (1 minute 12 seconds after burner output was changed to 300 kW)

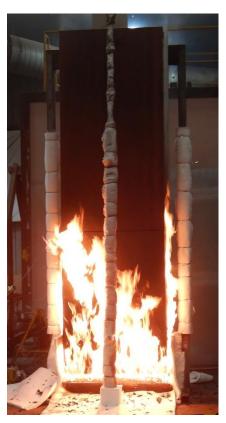
Figure 18 The specimen 21 minutes 40 seconds into the test (6 minutes 40 seconds after burner output was changed to 300 kW)

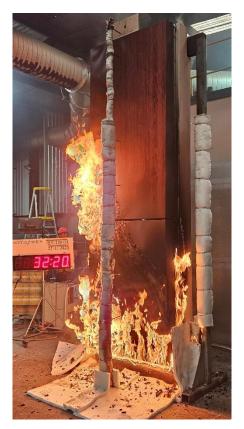
Figure 19 The specimen 32 minutes 20 seconds into the test (17 minutes 20 seconds after burner output was changed to 300 kW)

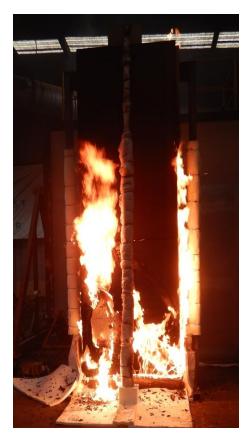
Figure 20 The specimen 36 minutes 37 seconds into the test (21 minutes 37 seconds after burner output was changed to 300 kW)

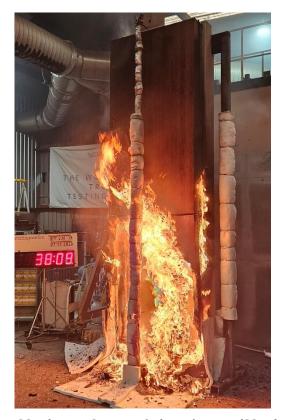
Figure 21 The specimen 38 minutes 9 seconds into the test (23 minutes 9 seconds after burner output was changed to 300 kW)

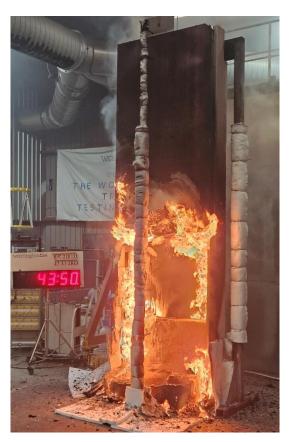
Figure 22 The specimen 43 minutes 50 seconds into the test (28 minutes 50 seconds after burner output was changed to 300 kW)

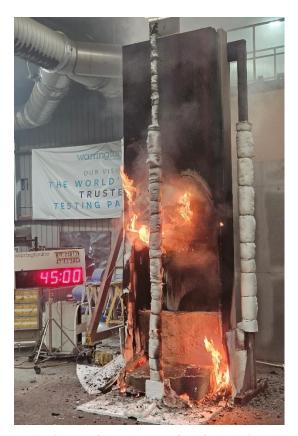
Figure 23 The specimen 45 minutes into the test (1 minute after burner was switched off)

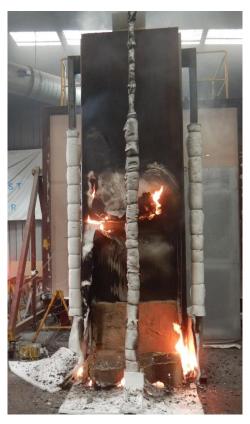
Figure 24 The specimen 47 minutes 58 seconds into the test (3 minutes 58 seconds after burner was switched off)

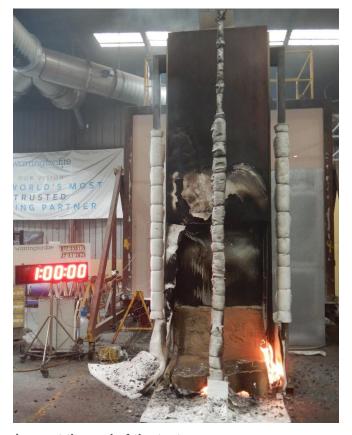
Figure 25 The specimen at the end of the test

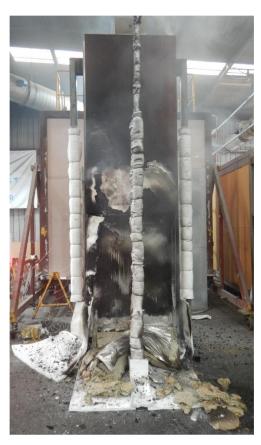
Figure 26 The specimen after the test, after being sprayed with water.

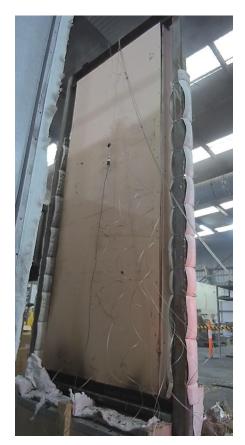
Figure 27 The specimen after the test – unexposed side.
