# Reaction to fire test report

Test standard: Ad-hoc test based off ISO 13785-1:2002 Test sponsor: Cladding Safety Victoria (CSV) System: A cassetted aluminium composite panel wall system Job number: RTF230111 Test date: 13 September 2023 Revision: R3.0

This report documents the findings of the third of three ad-hoc reaction to fire tests on a cassetted aluminium composite panel (ACP) external wall system - performed on 13 September 2023. The test was based on ISO 13785-1:2002.

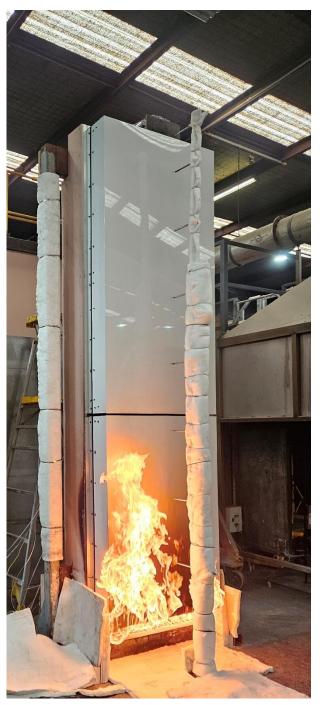
Figure 12 The specimen 1 minute into the test (burner output at 200 kW)

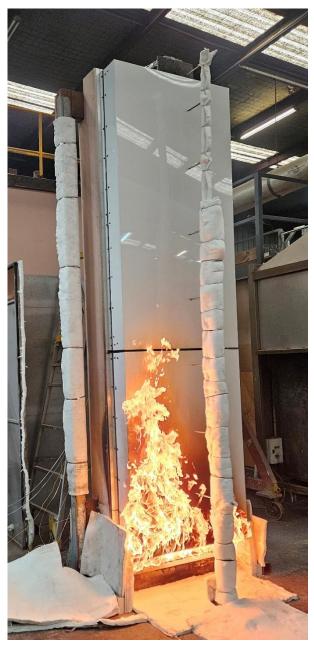
Figure 13 The specimen 2 minutes into the test (burner output at 200 kW)

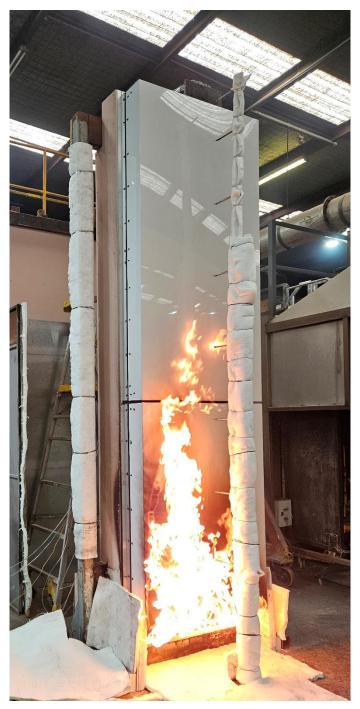
Figure 14 The specimen 3 minutes into the test (burner output at 200 kW)

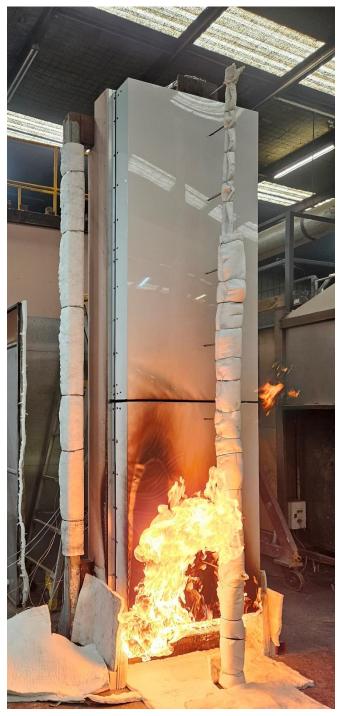
Figure 15 The specimen 4 minutes into the test (burner output at 200 kW)

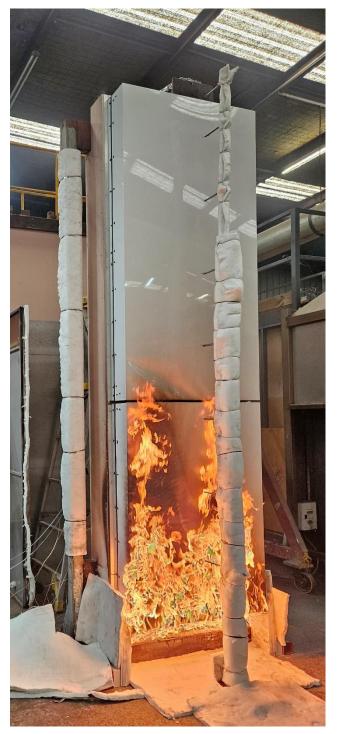
Figure 16 The specimen 5 minutes into the test (burner output at 200 kW)

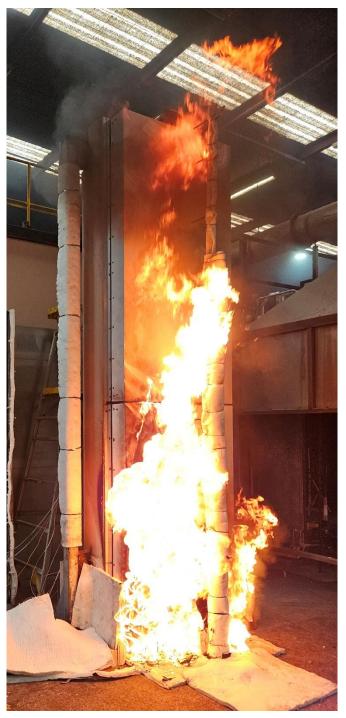
6	01	B3	Flames reached this section of the specimen.		
6	23	All	The panels have opened up and the core material is contributing to the fire.		
6	48	All	Flaming of the specimen was excessive. The power to the burner was cut and specimen was sprayed with water. The test ended.

Figure 17 The specimen 6 minutes into the test (burner output at 200 kW)

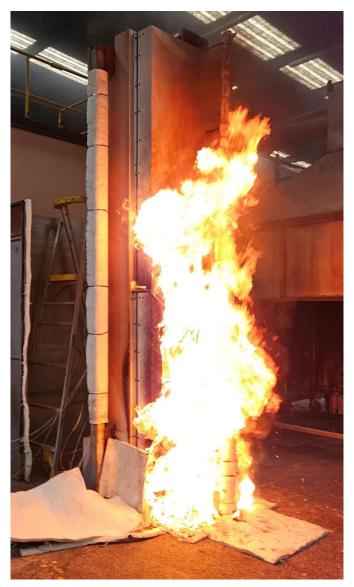
Figure 18 The specimen 6 minutes 17 seconds into the test (burner output at 200 kW)

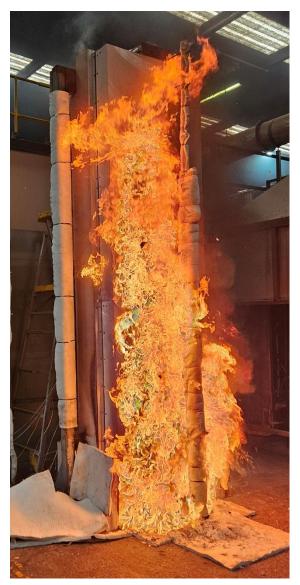
Figure 19 The specimen 6 minutes 22 seconds into the test (burner output at 200 kW)

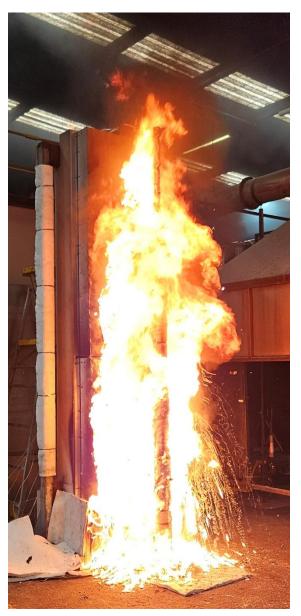
Figure 20 The specimen 6 minutes 37 seconds into the test (burner output at 200 kW)

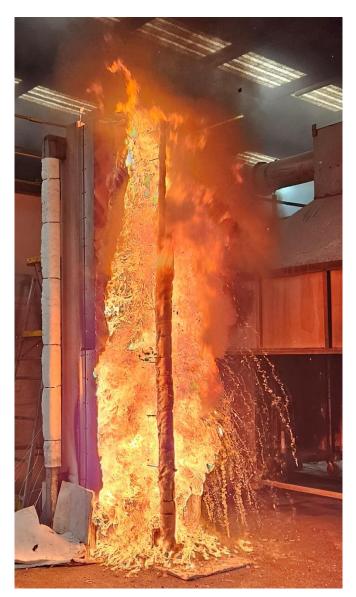
Figure 21 The specimen 6 minutes 46 seconds into the test (burner output at 200 kW) – 2 seconds before end of test.

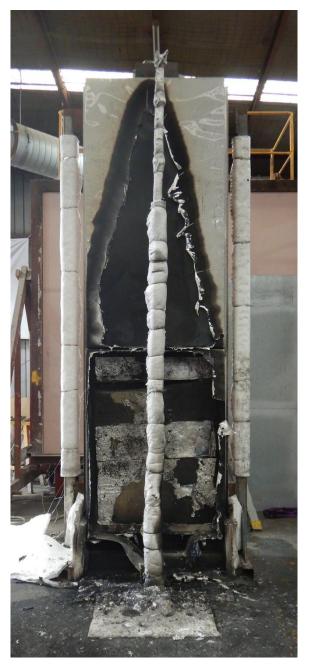
Figure 22 The specimen after the test
