Reaction to fire test report

Test standard: Ad-hoc test based off ISO 13785-1:2002

Test sponsor: Cladding Safety Victoria (CSV)

System: An aluminium composite panel (ACP) wall system and a mock balcony setup representative of an in-situ façade - [REDACTED]

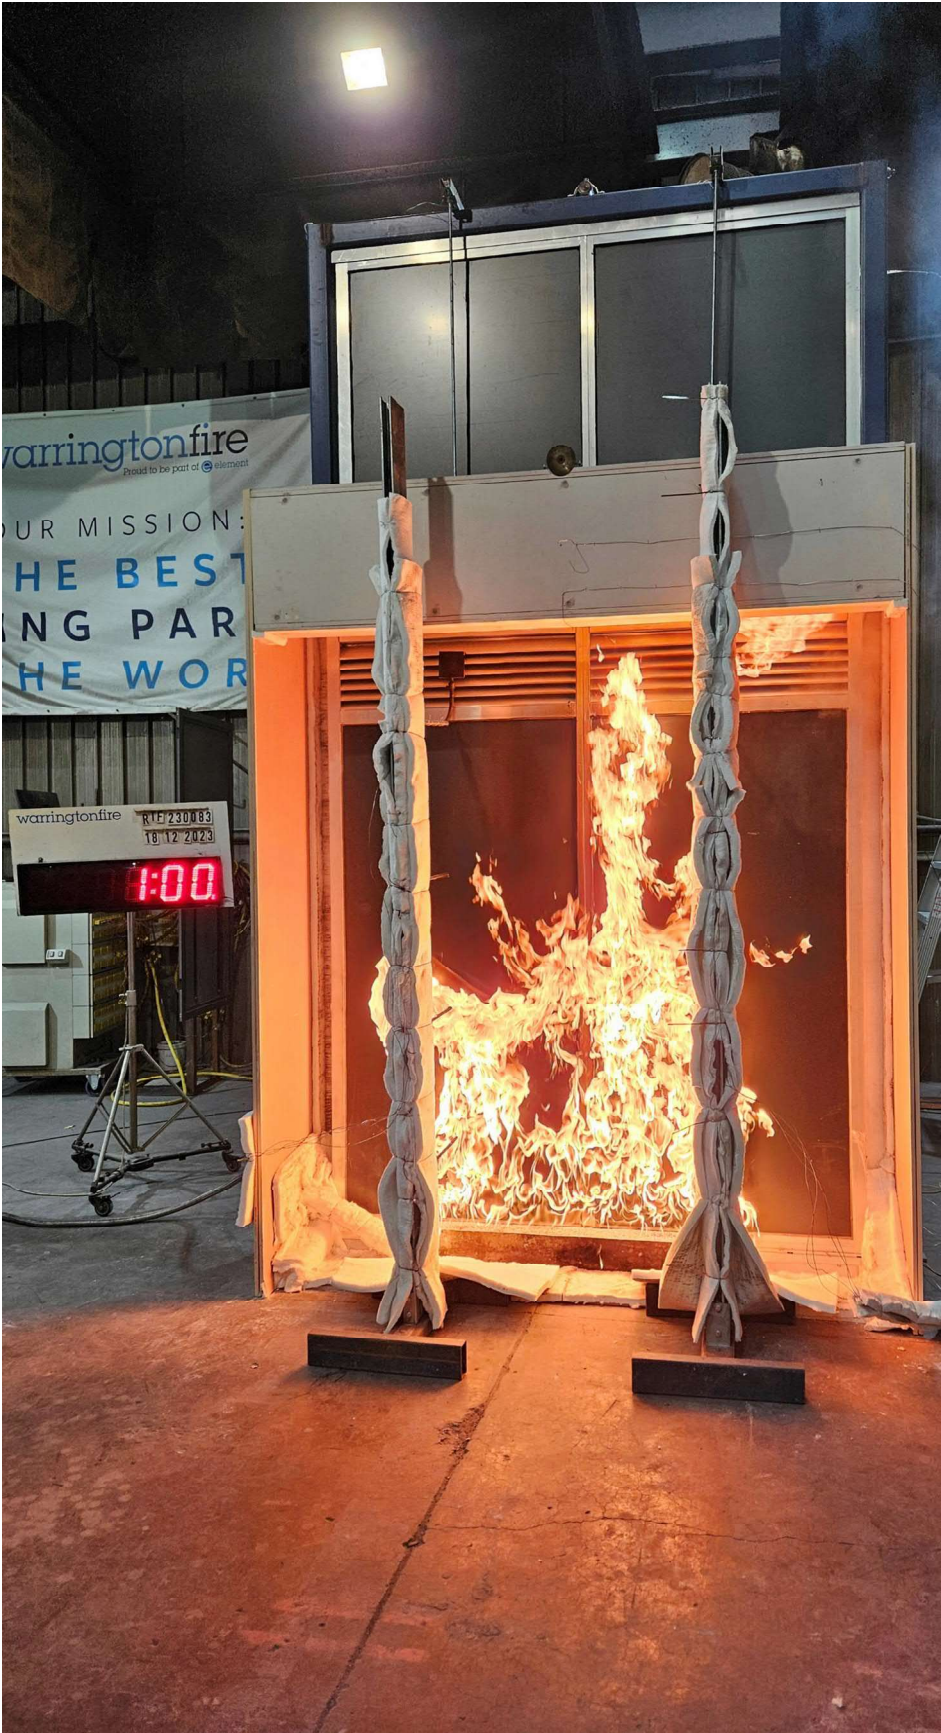
Figure 20 The specimen 1 minute into the test (burner output set to 300 kW for the duration of the test)

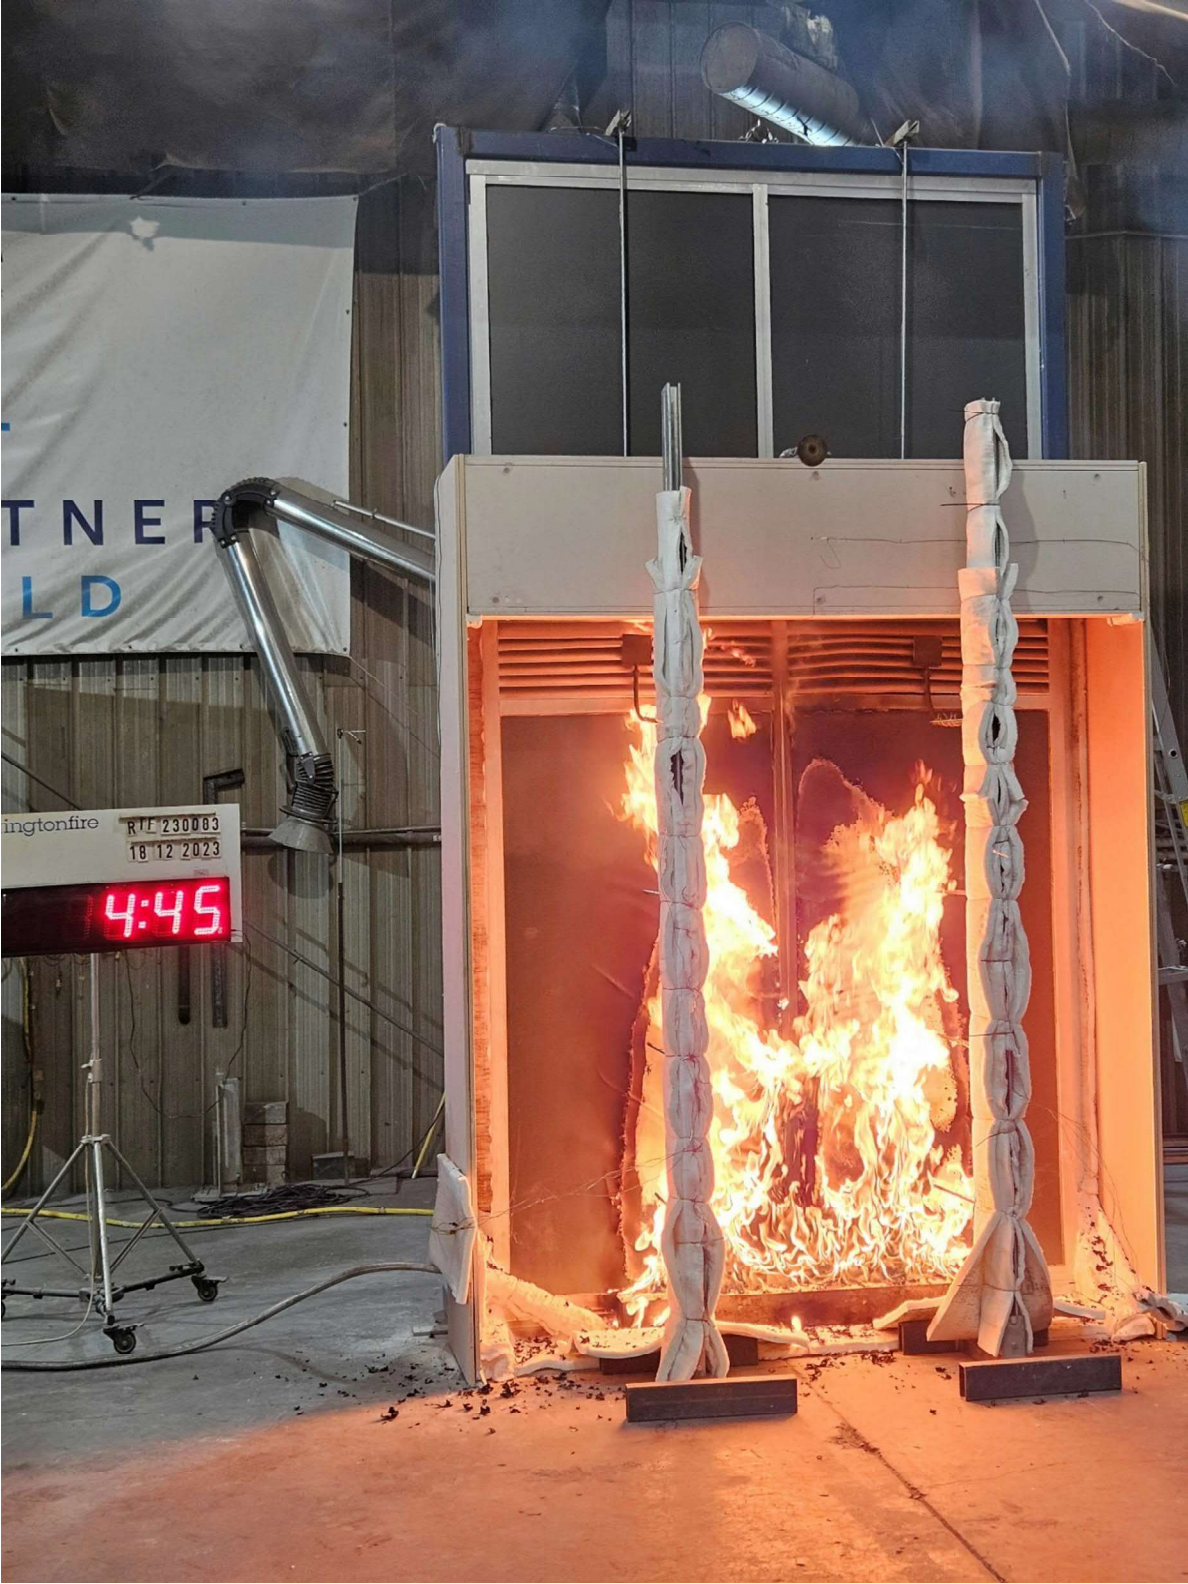
Figure 21 The specimen 4 minutes 45 seconds into the test

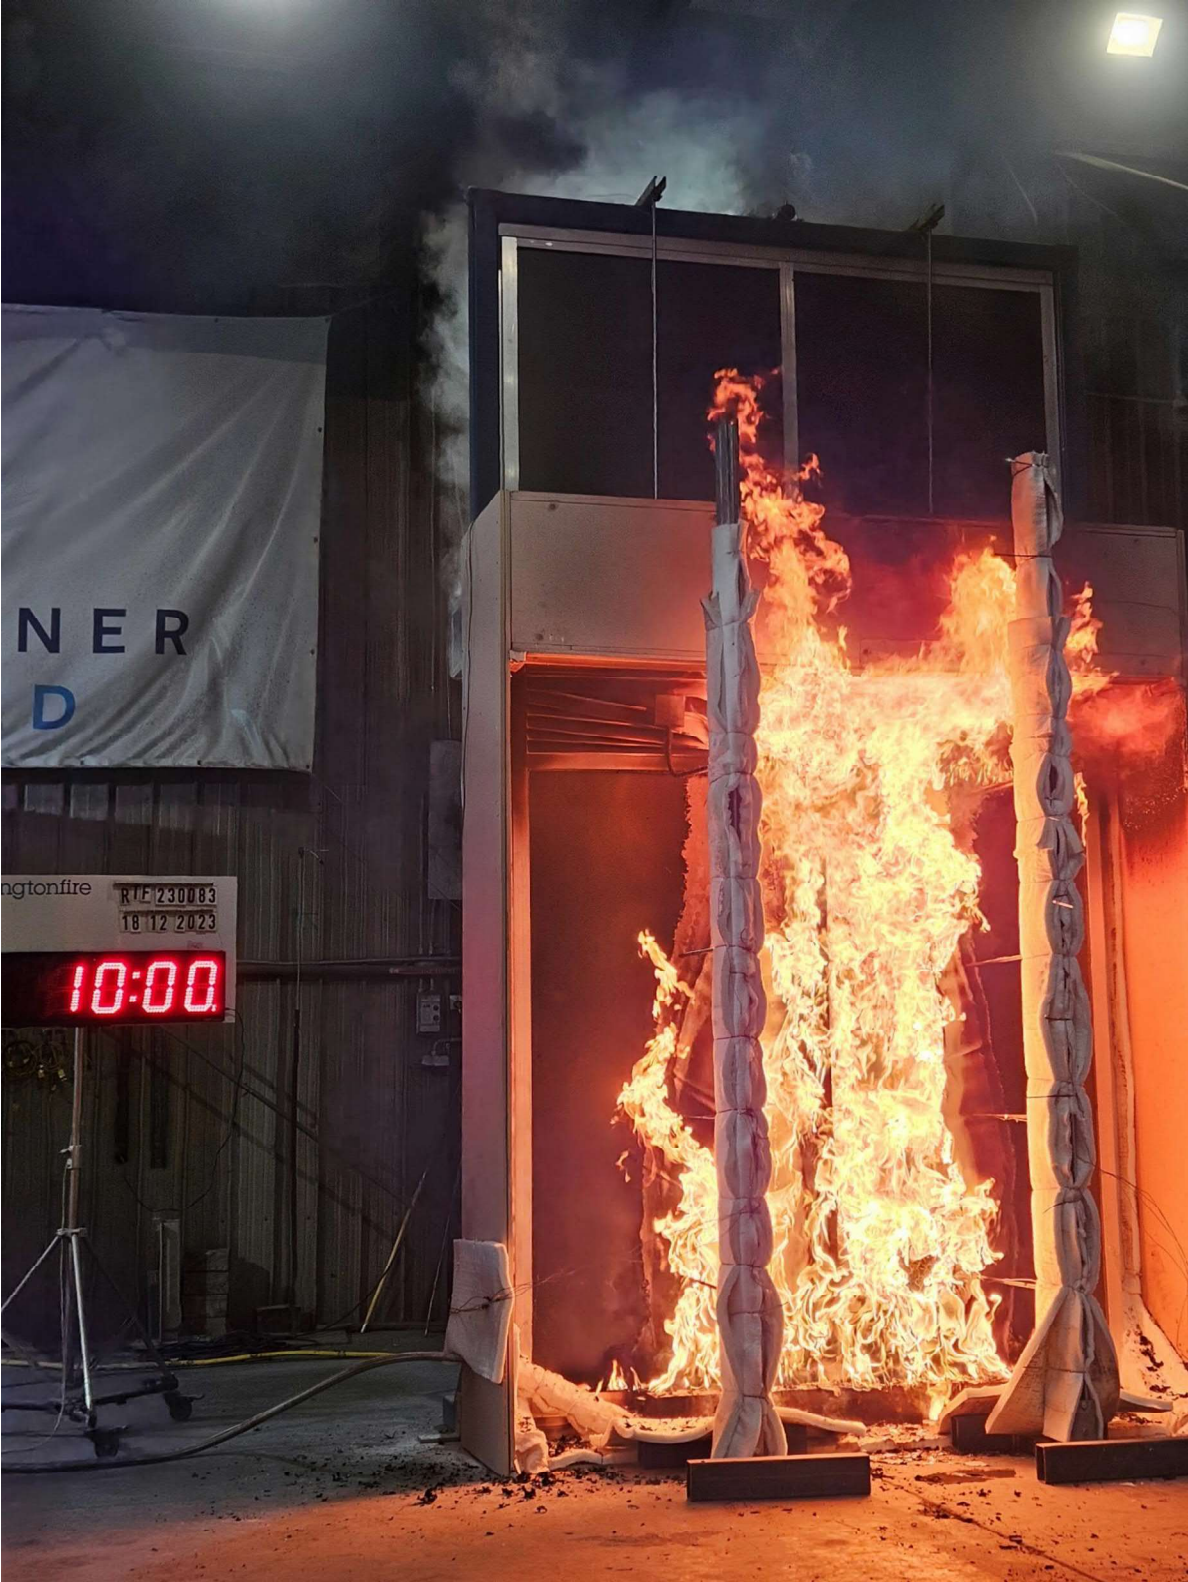
Figure 22 The specimen 10 minutes into the test

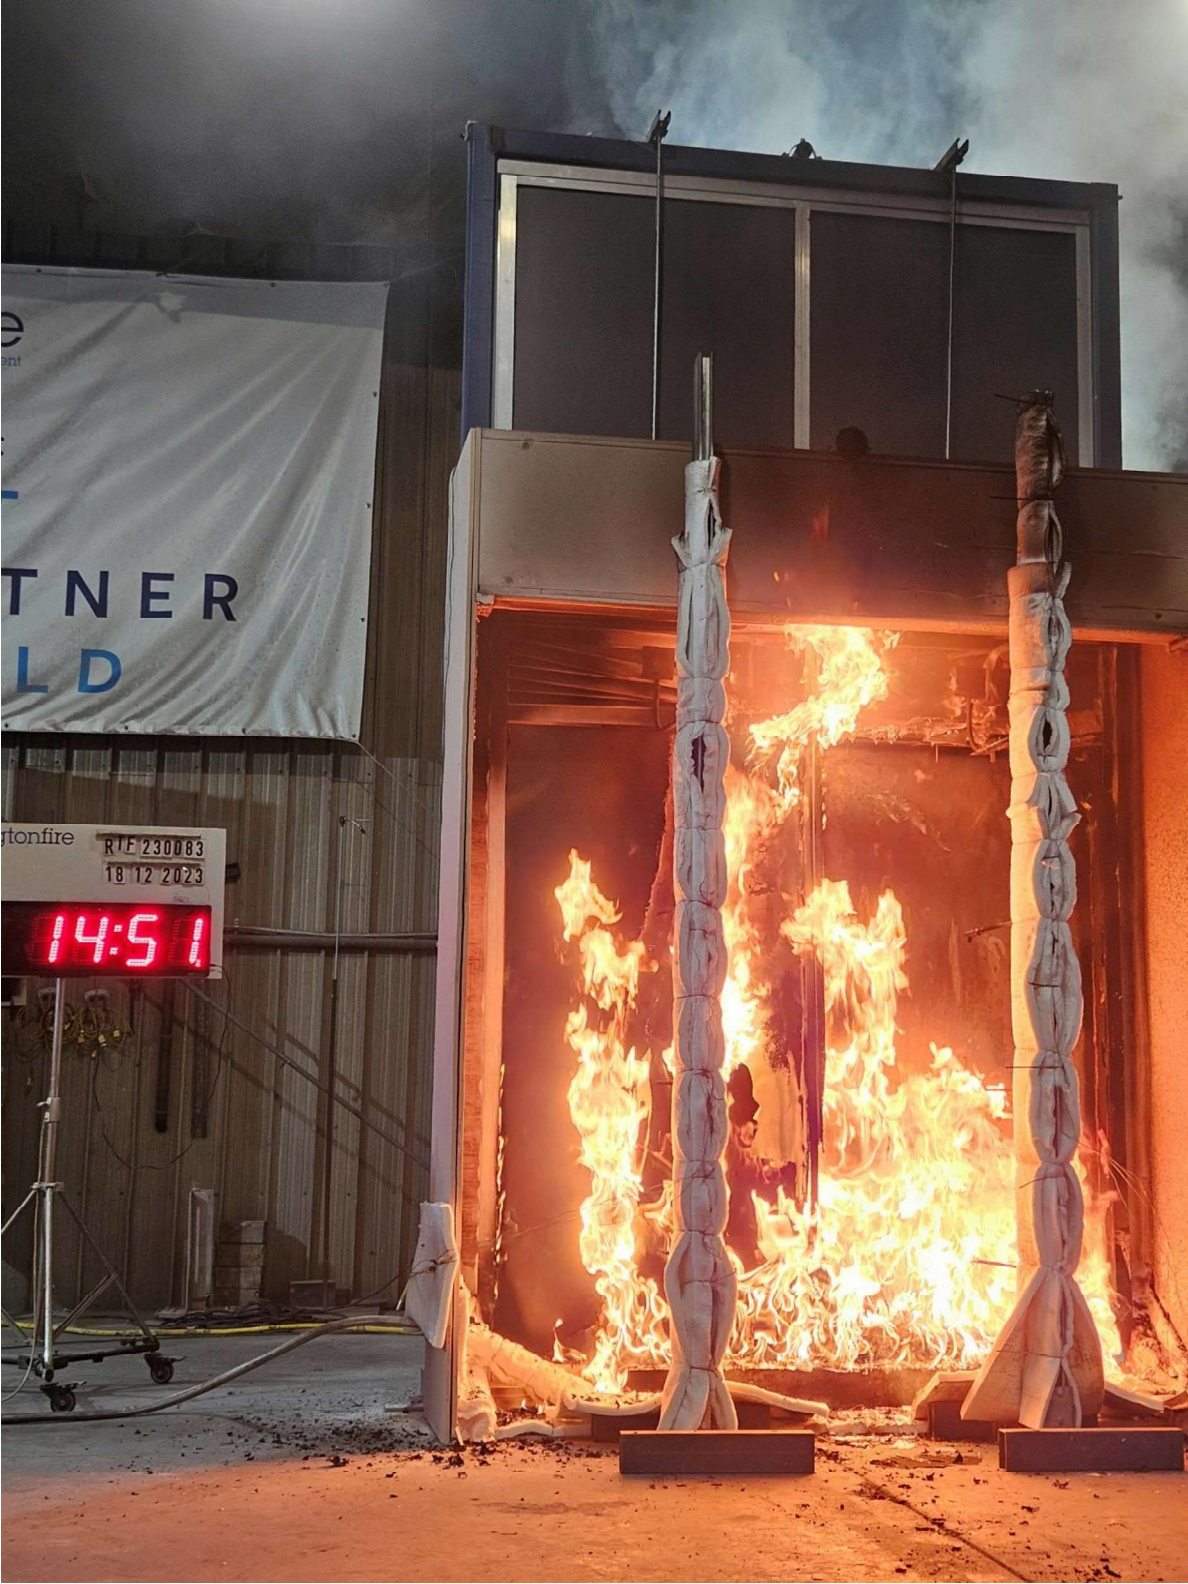
Figure 23 The specimen 14 minutes 51 seconds into the test

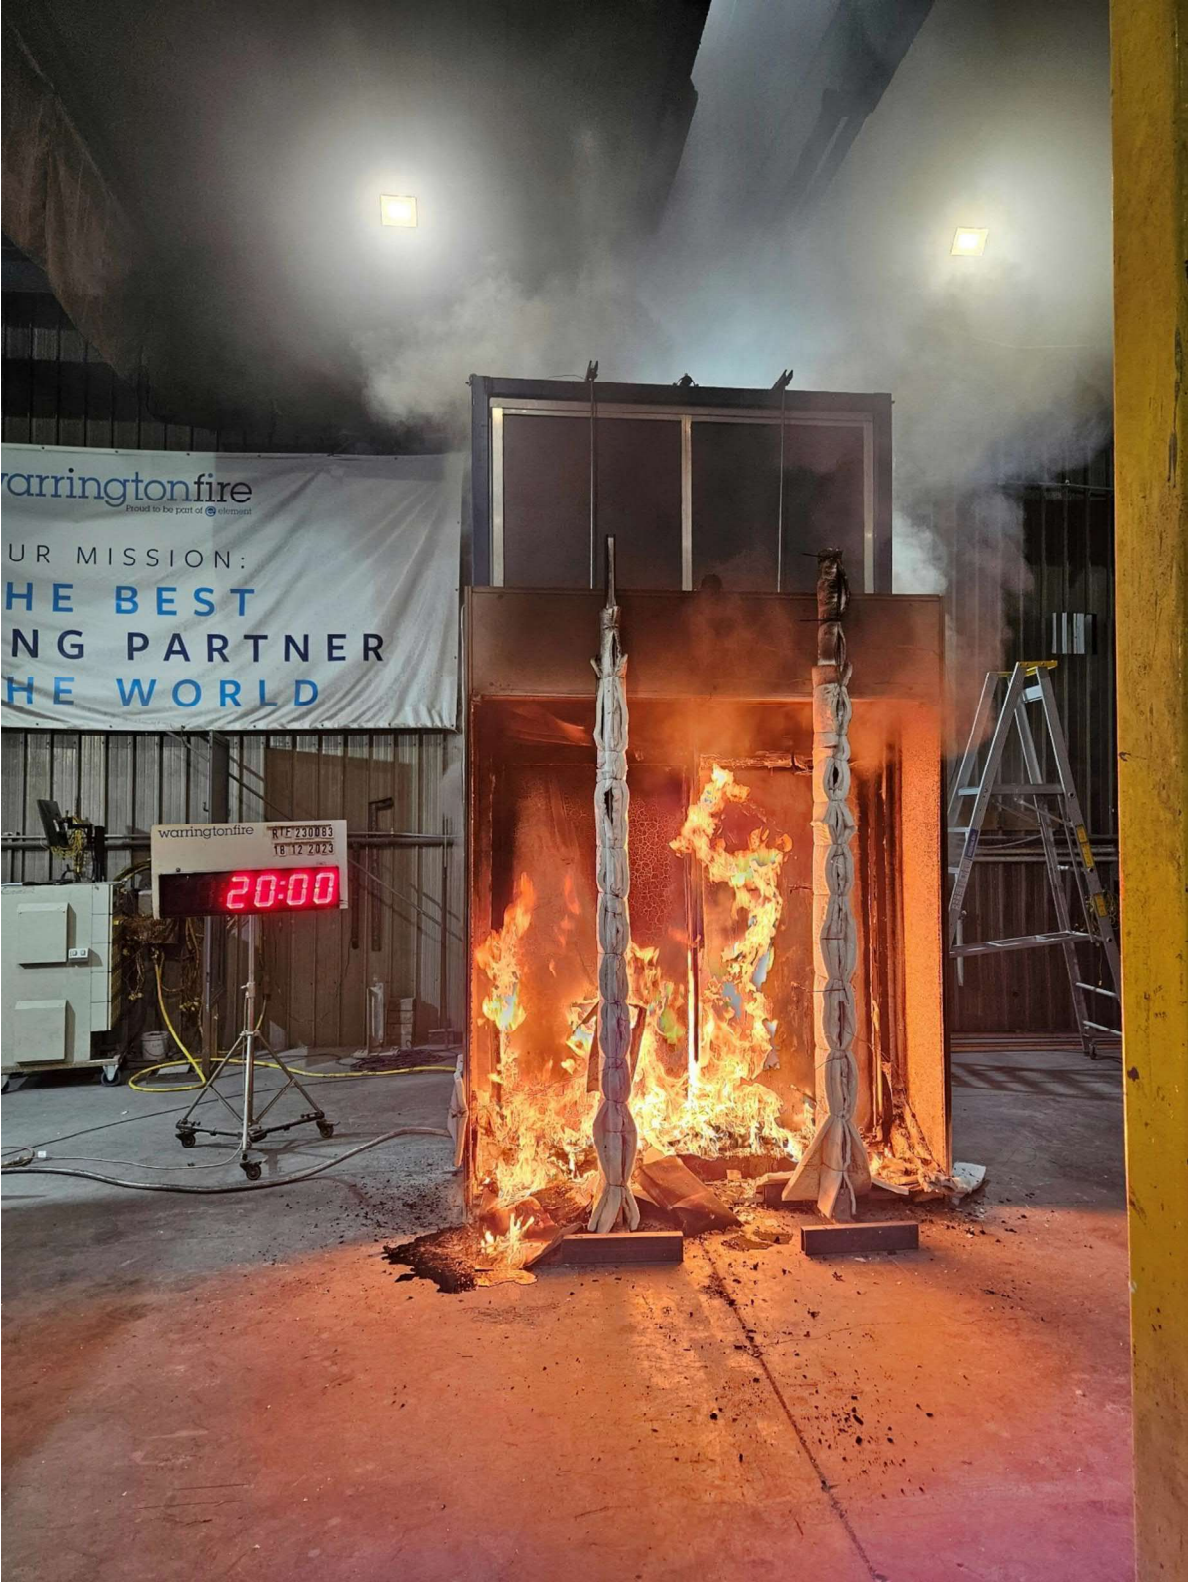
Figure 24 The specimen 20 minutes into the test

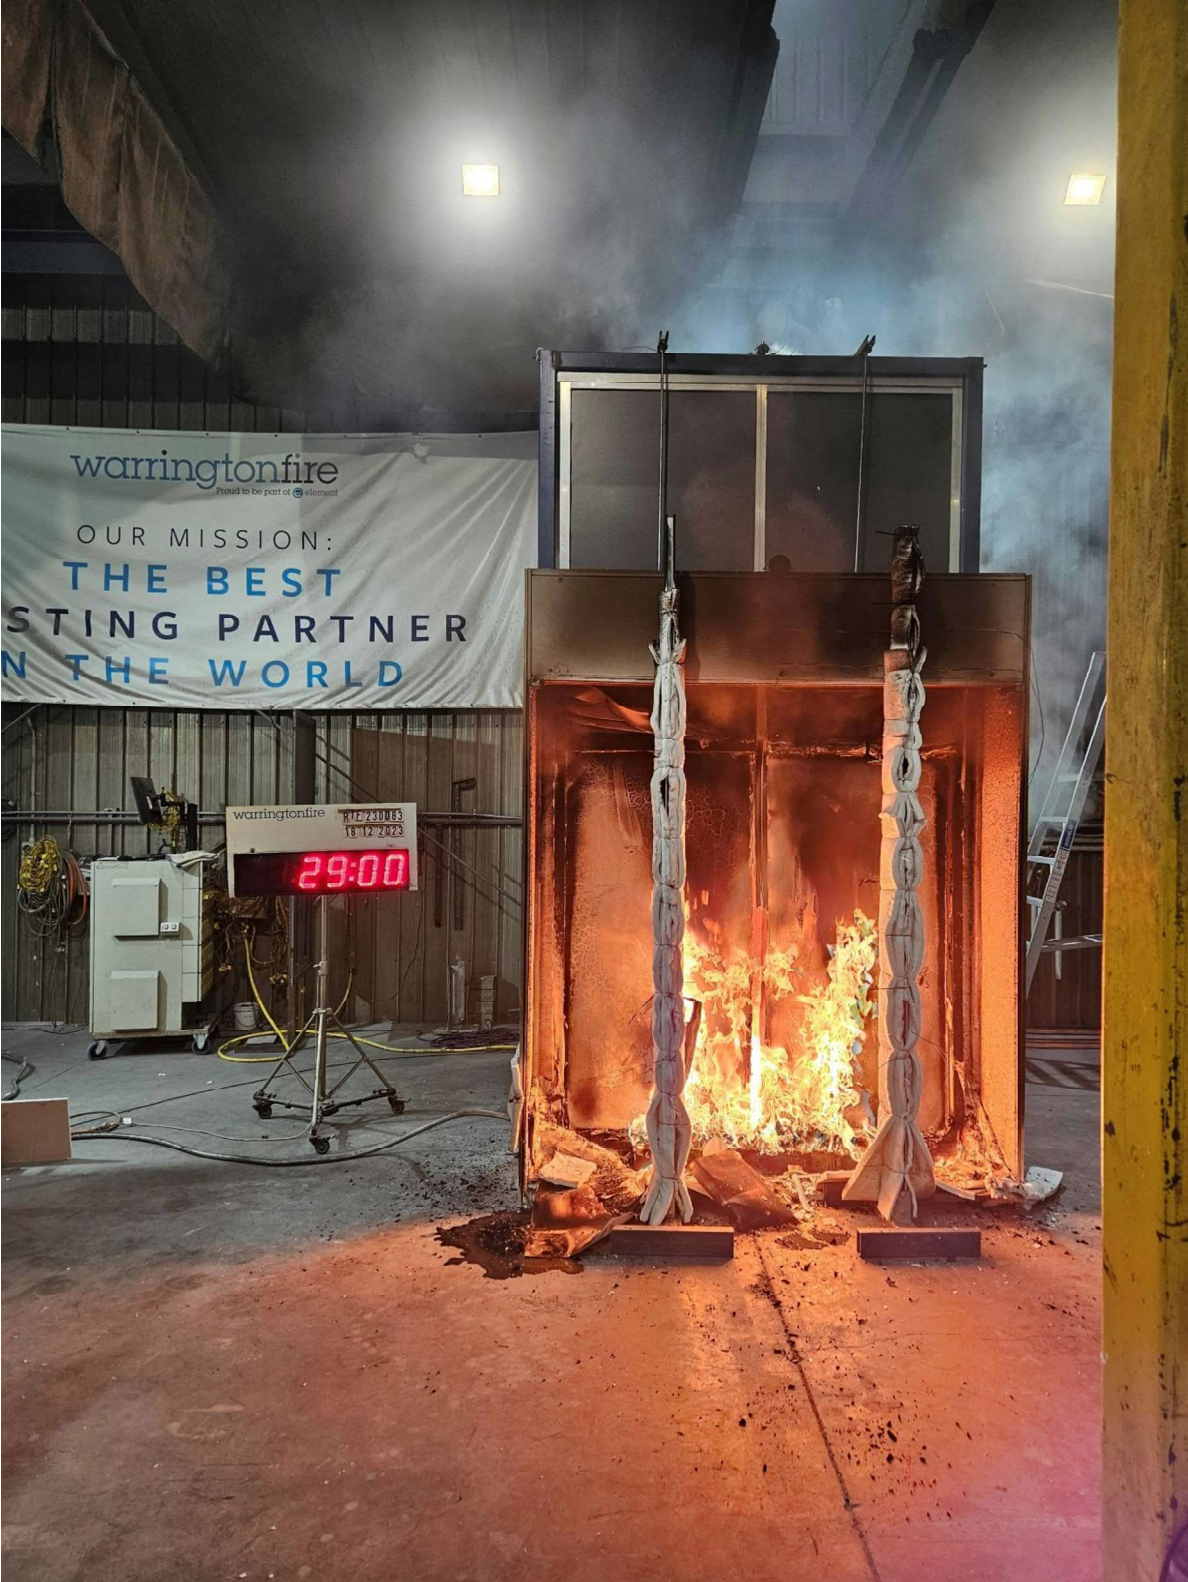
Figure 25 The specimen 29 minutes into the test

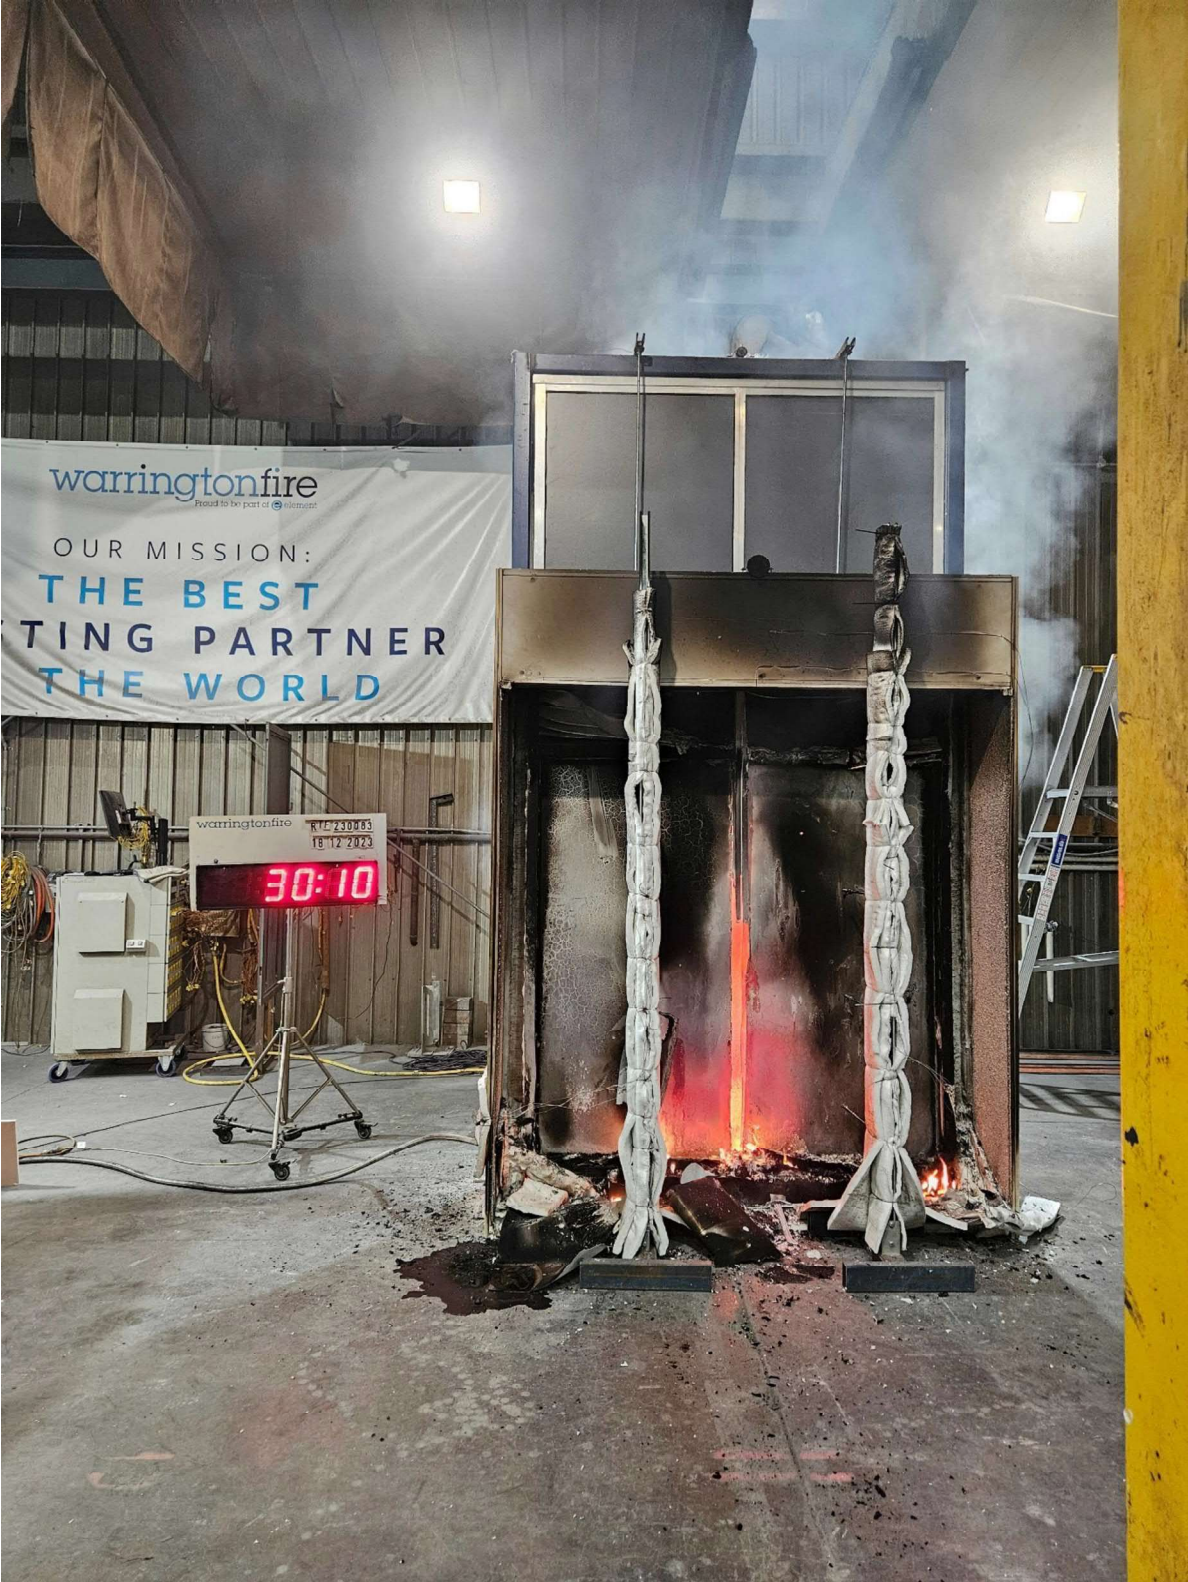
Figure 26 The specimen 10 seconds after the burner was turned off (30 minutes 10 seconds into the test)

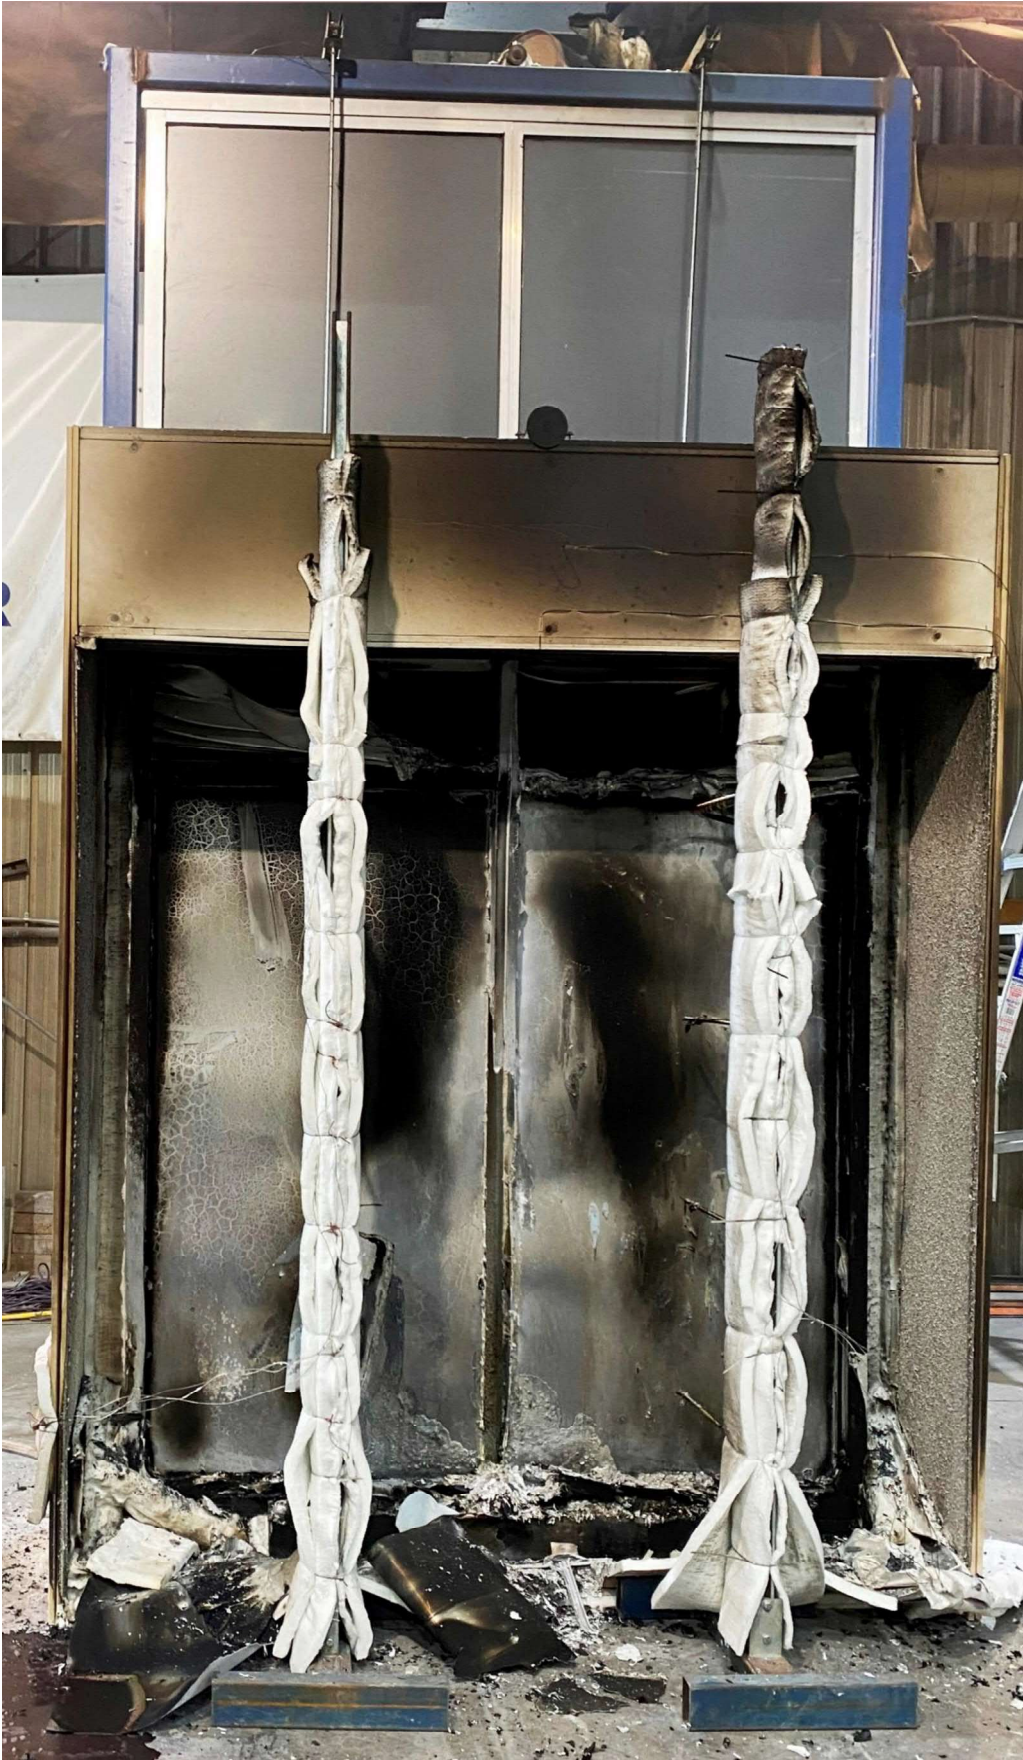
Figure 27 The specimen after the test.

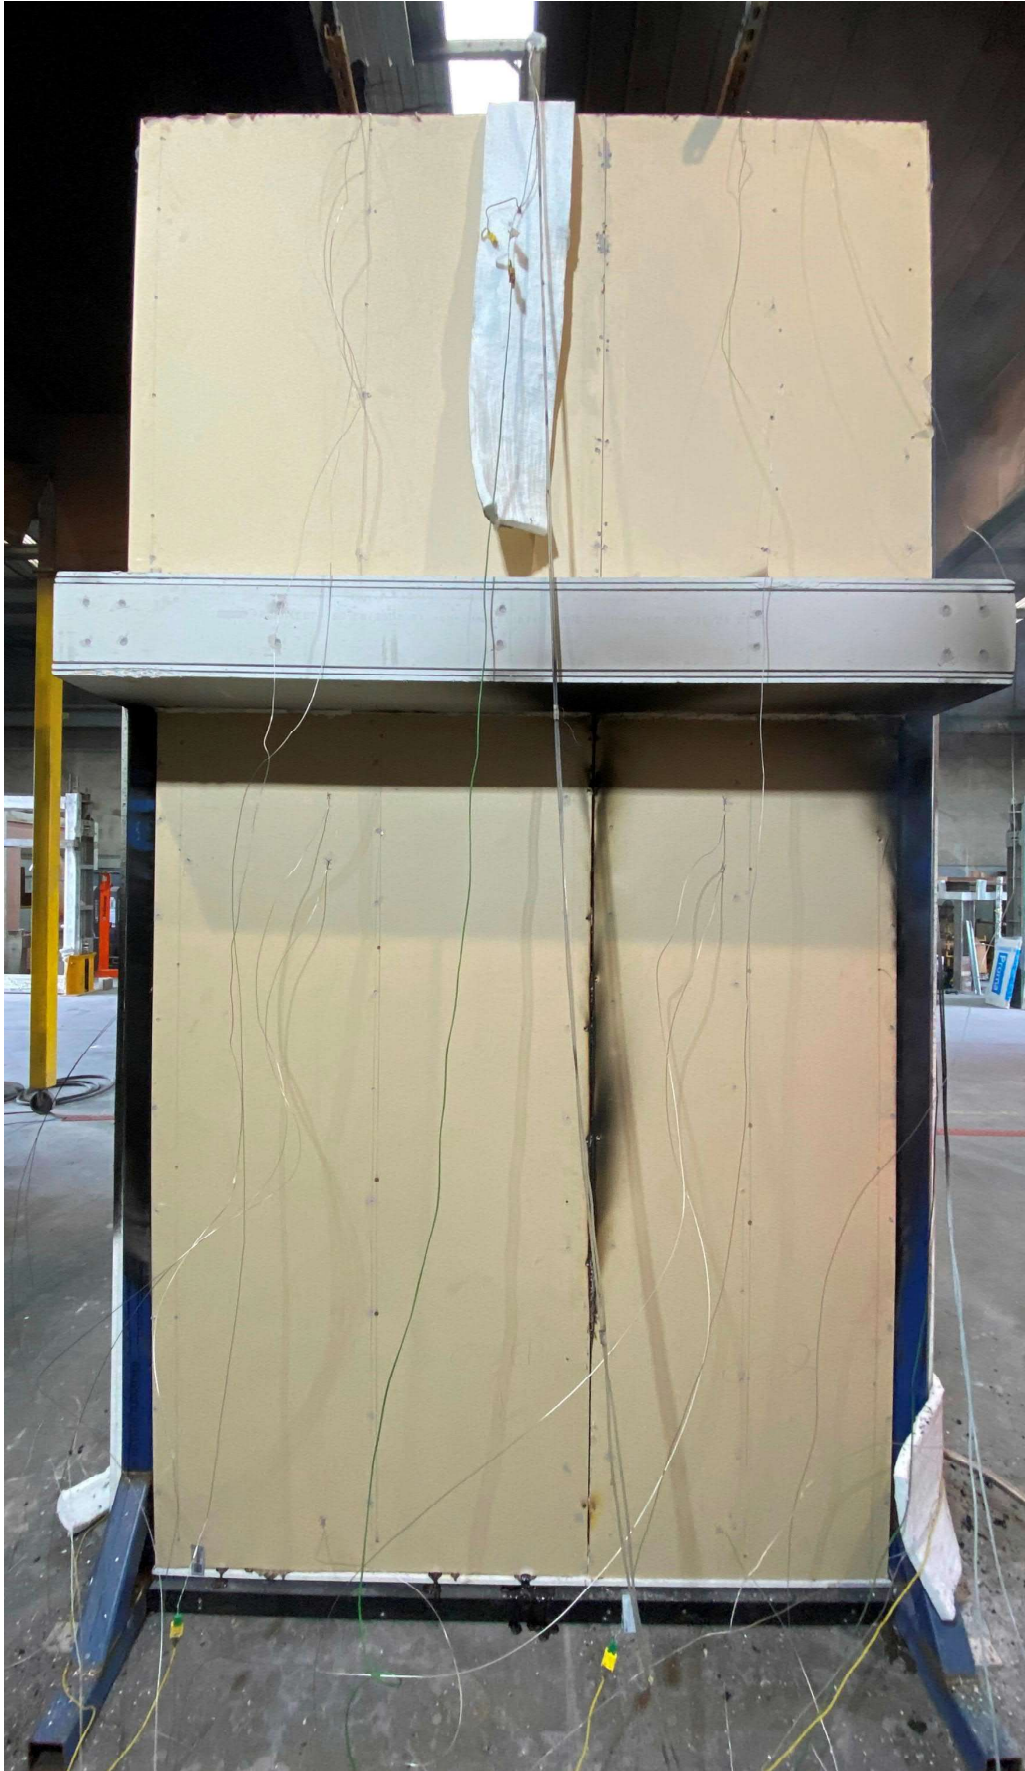
Figure 28 The specimen after the test – unexposed side.

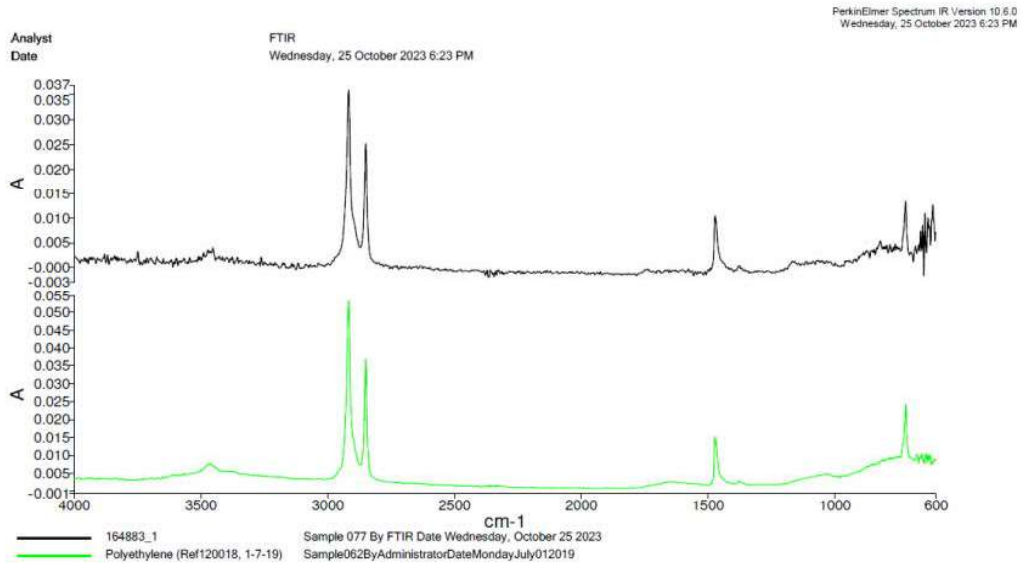
Figure 3: - FTIR Spectral Comparisons of Known Material with Sample 164883.

Sample ID	Sample Type	Core Colour	Identified Major Components by FTIR	Figure
164883	ACP	Black	Polyethylene with no filler	Figure 3
164884	ACP	Black	Polyethylene with unidentified filler	Figure 4
