# Reaction to fire test report

Test standard: Ad-hoc test based on ISO 13785-1:2002

System: An aluminium composite panel (ACP) wall system and a mock balcony setup representative of an in-situ façade - [REDACTED]

Job number: RTF230085

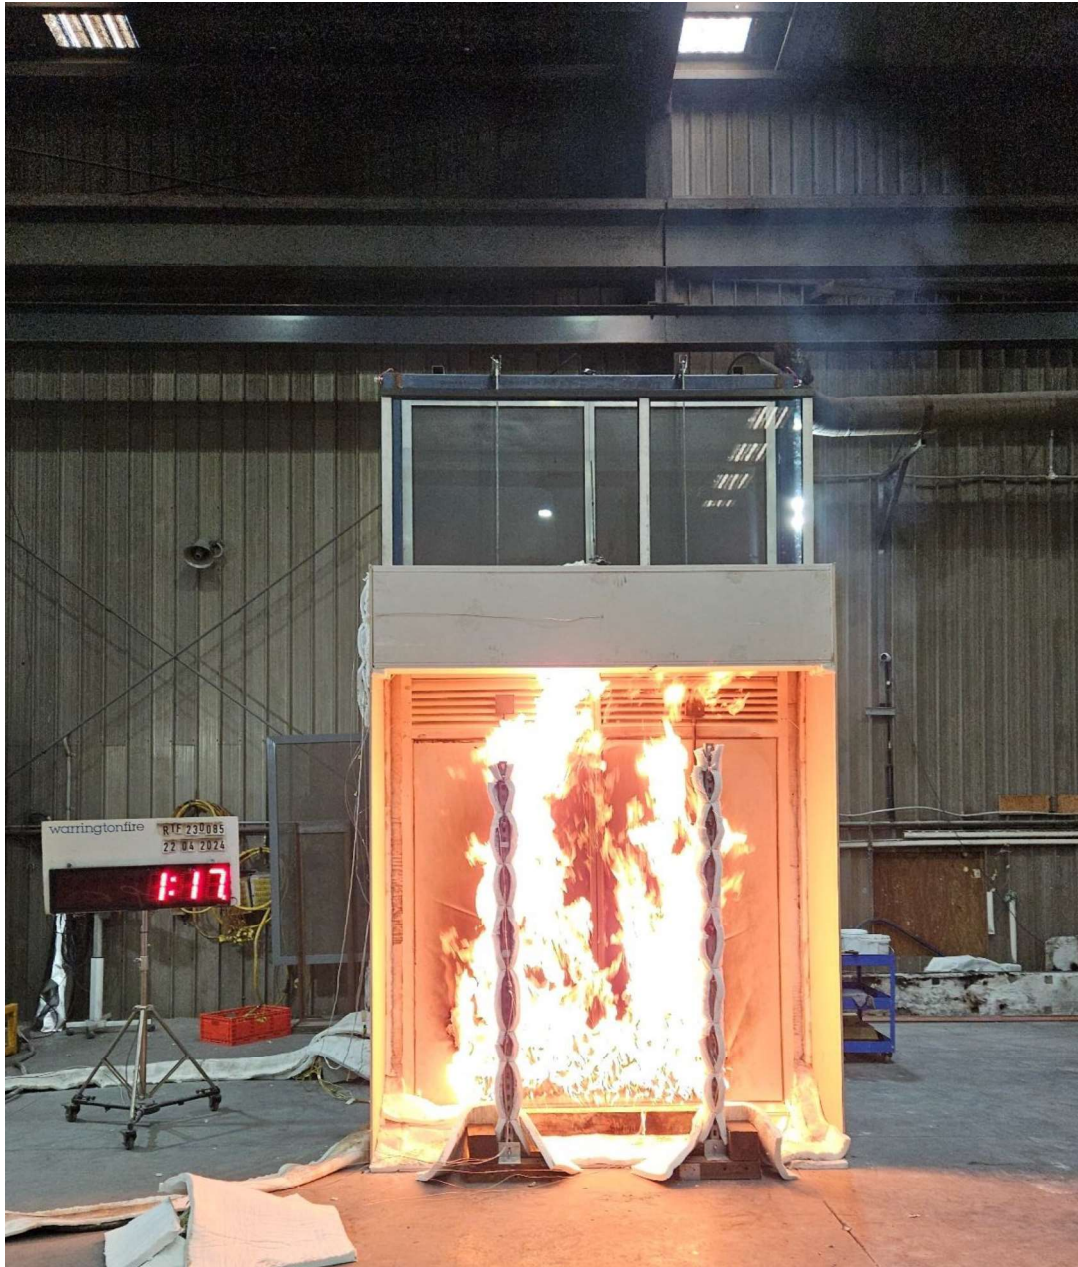
**Figure 21 The specimen 1 minute 17 seconds into the test (burner output set to 500 kW)**

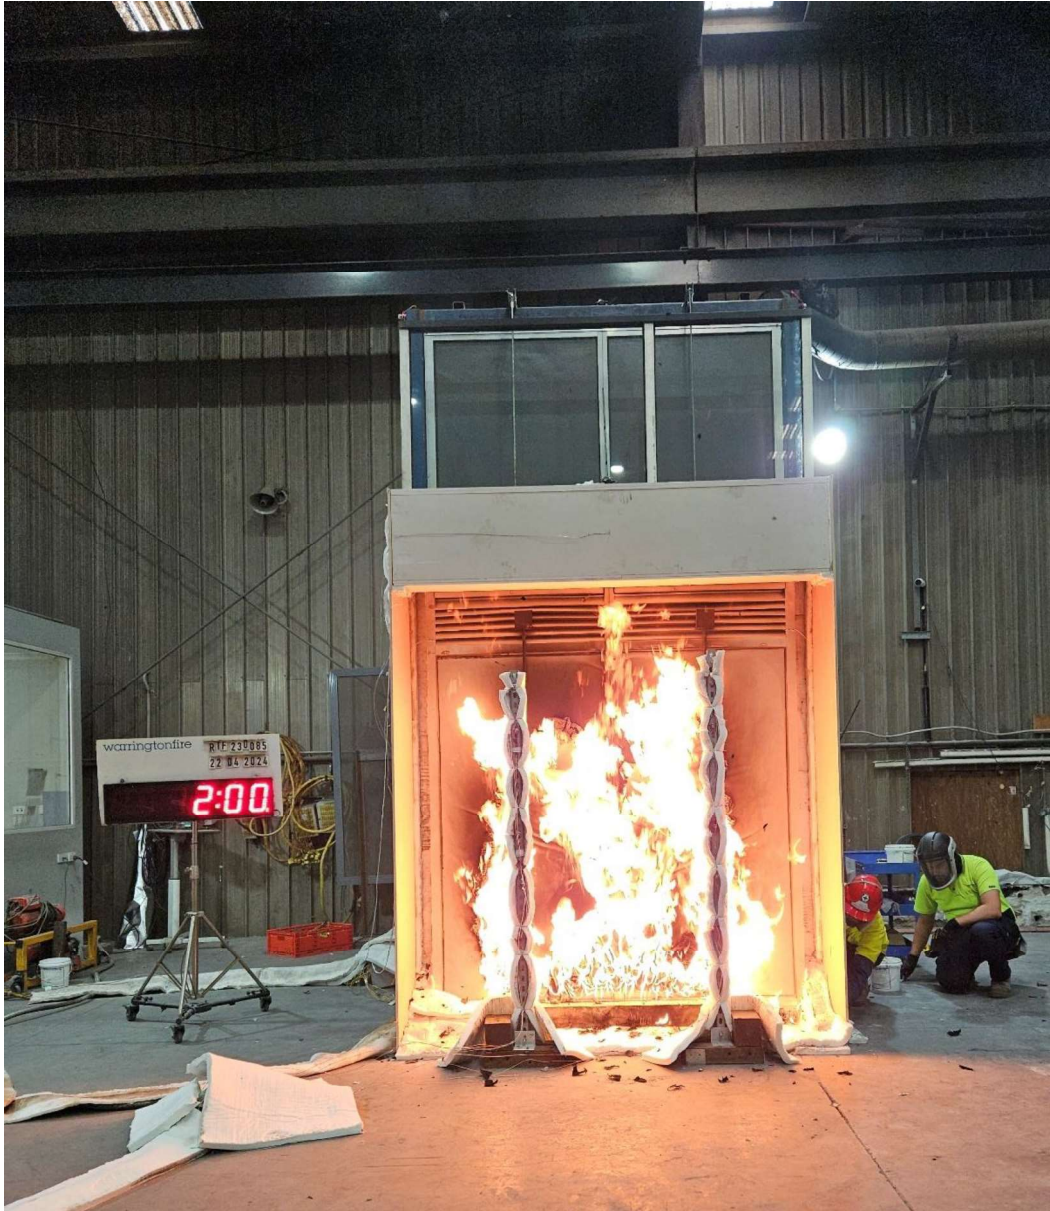
**Figure 22 The specimen 2 minutes into the test**

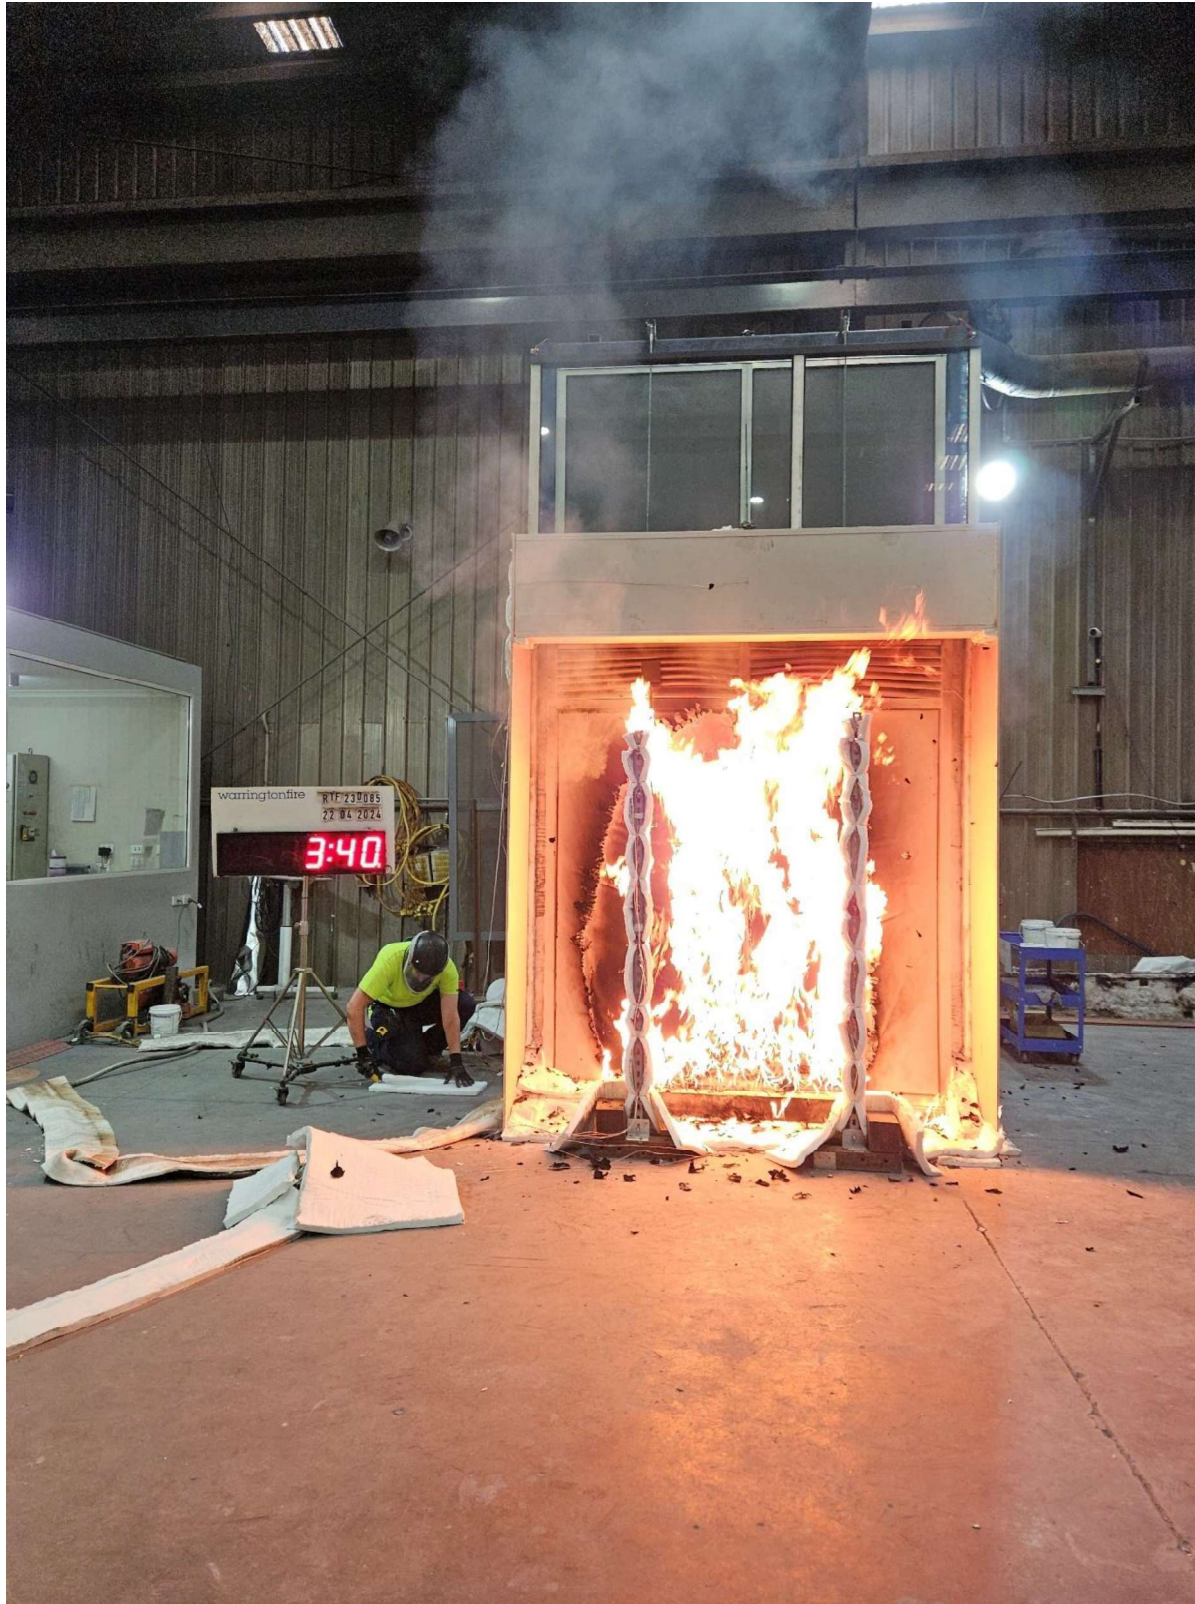
**Figure 23 The specimen 3 minutes 40 seconds into the test**

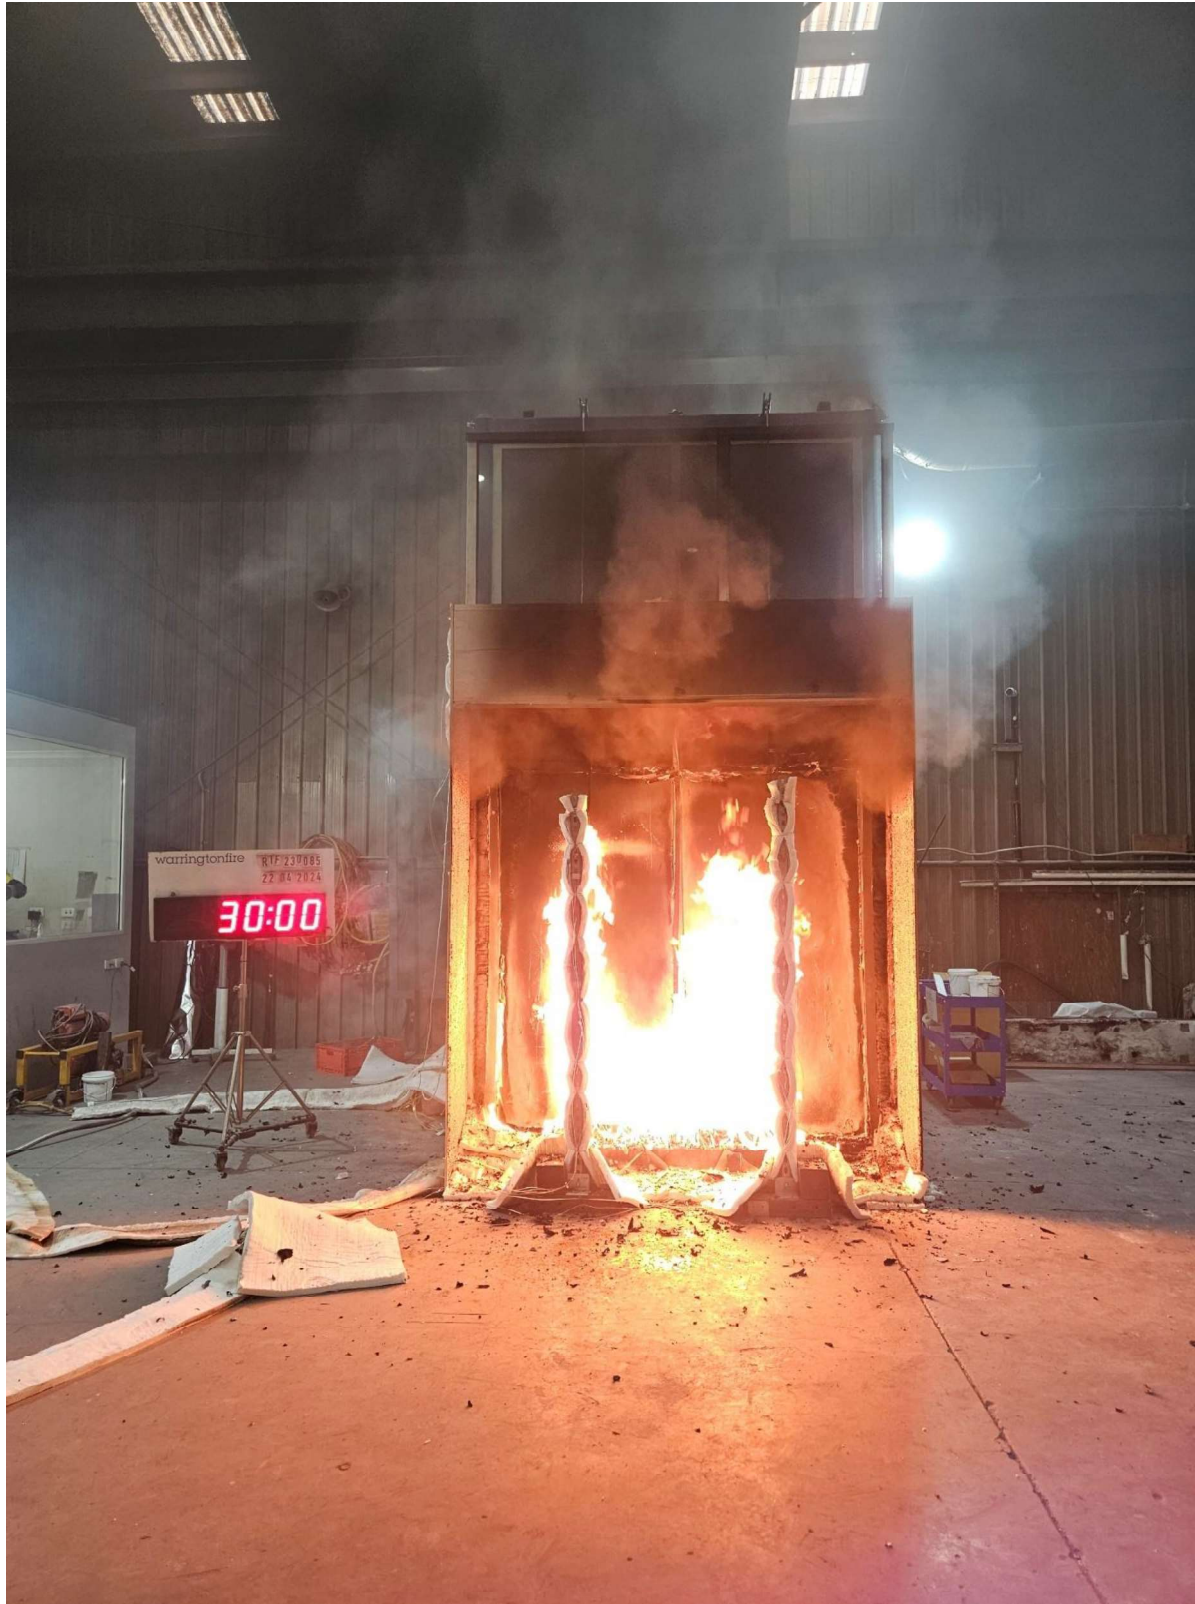
**Figure 36 The specimen 30 minutes into the test – the burner was turned off.**

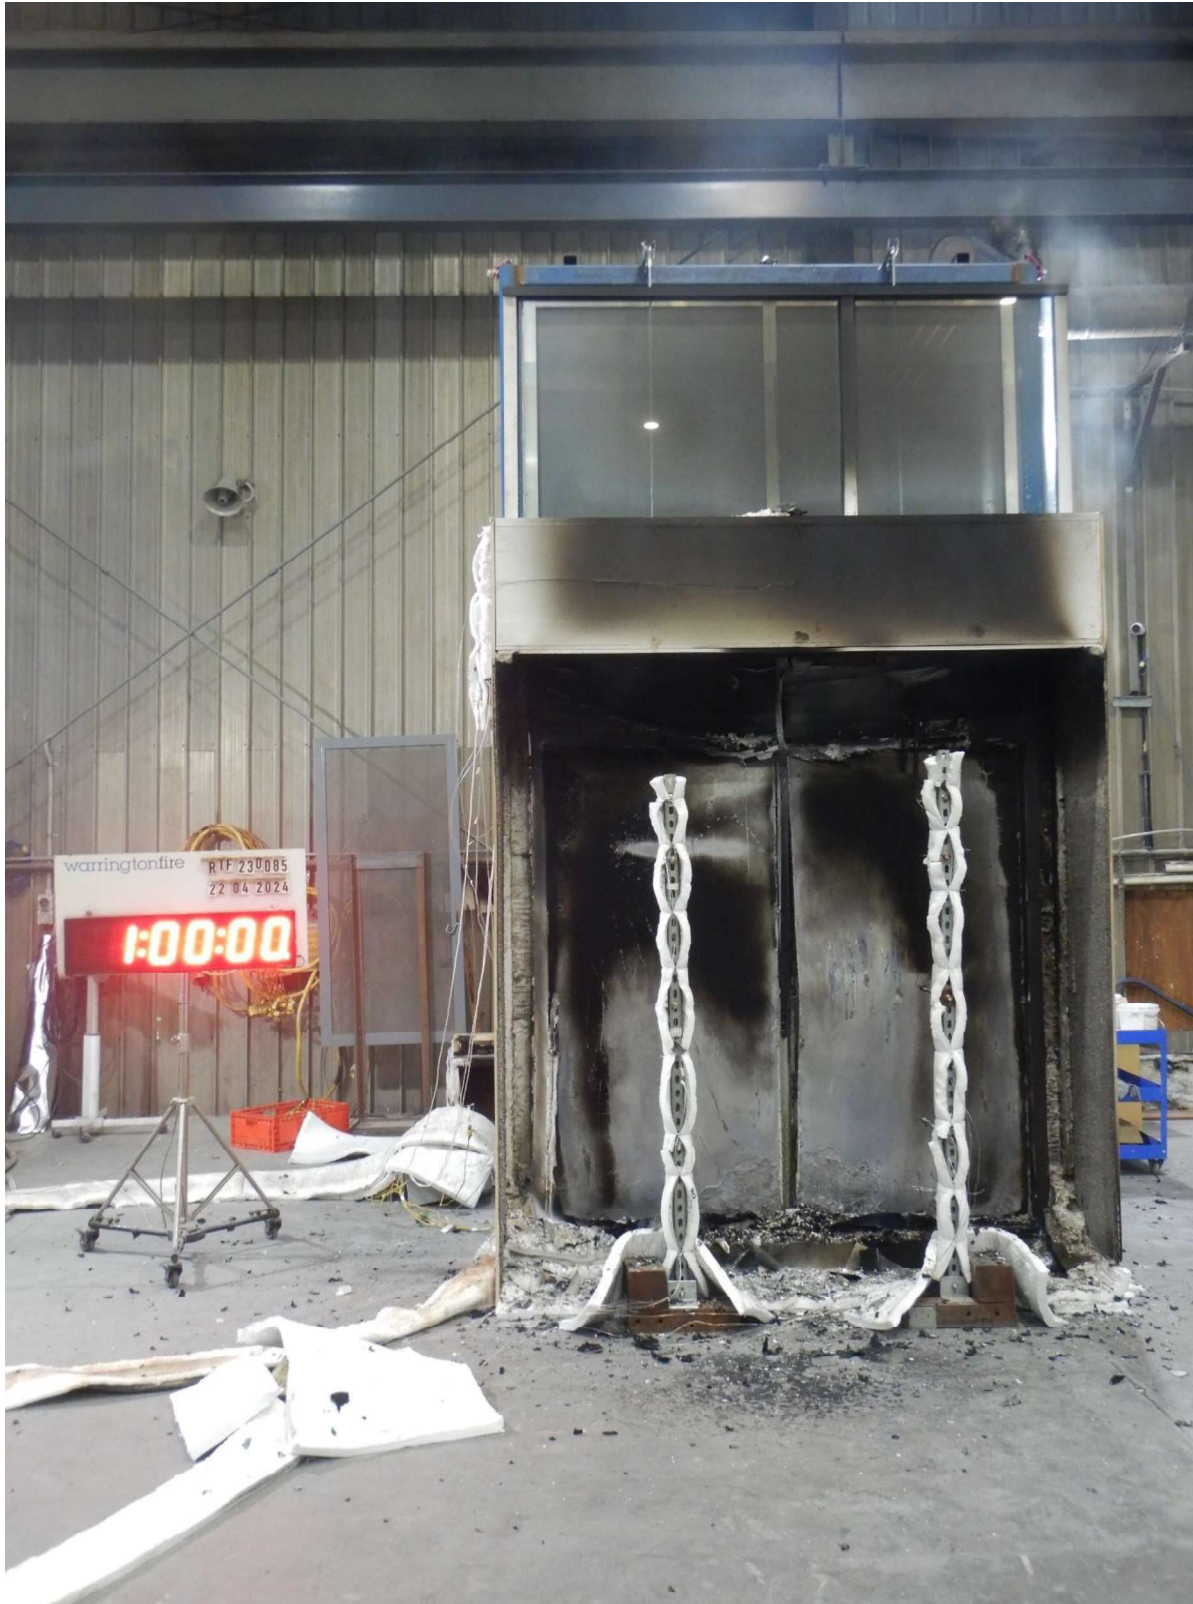
**Figure 40 The specimen at end the test.**

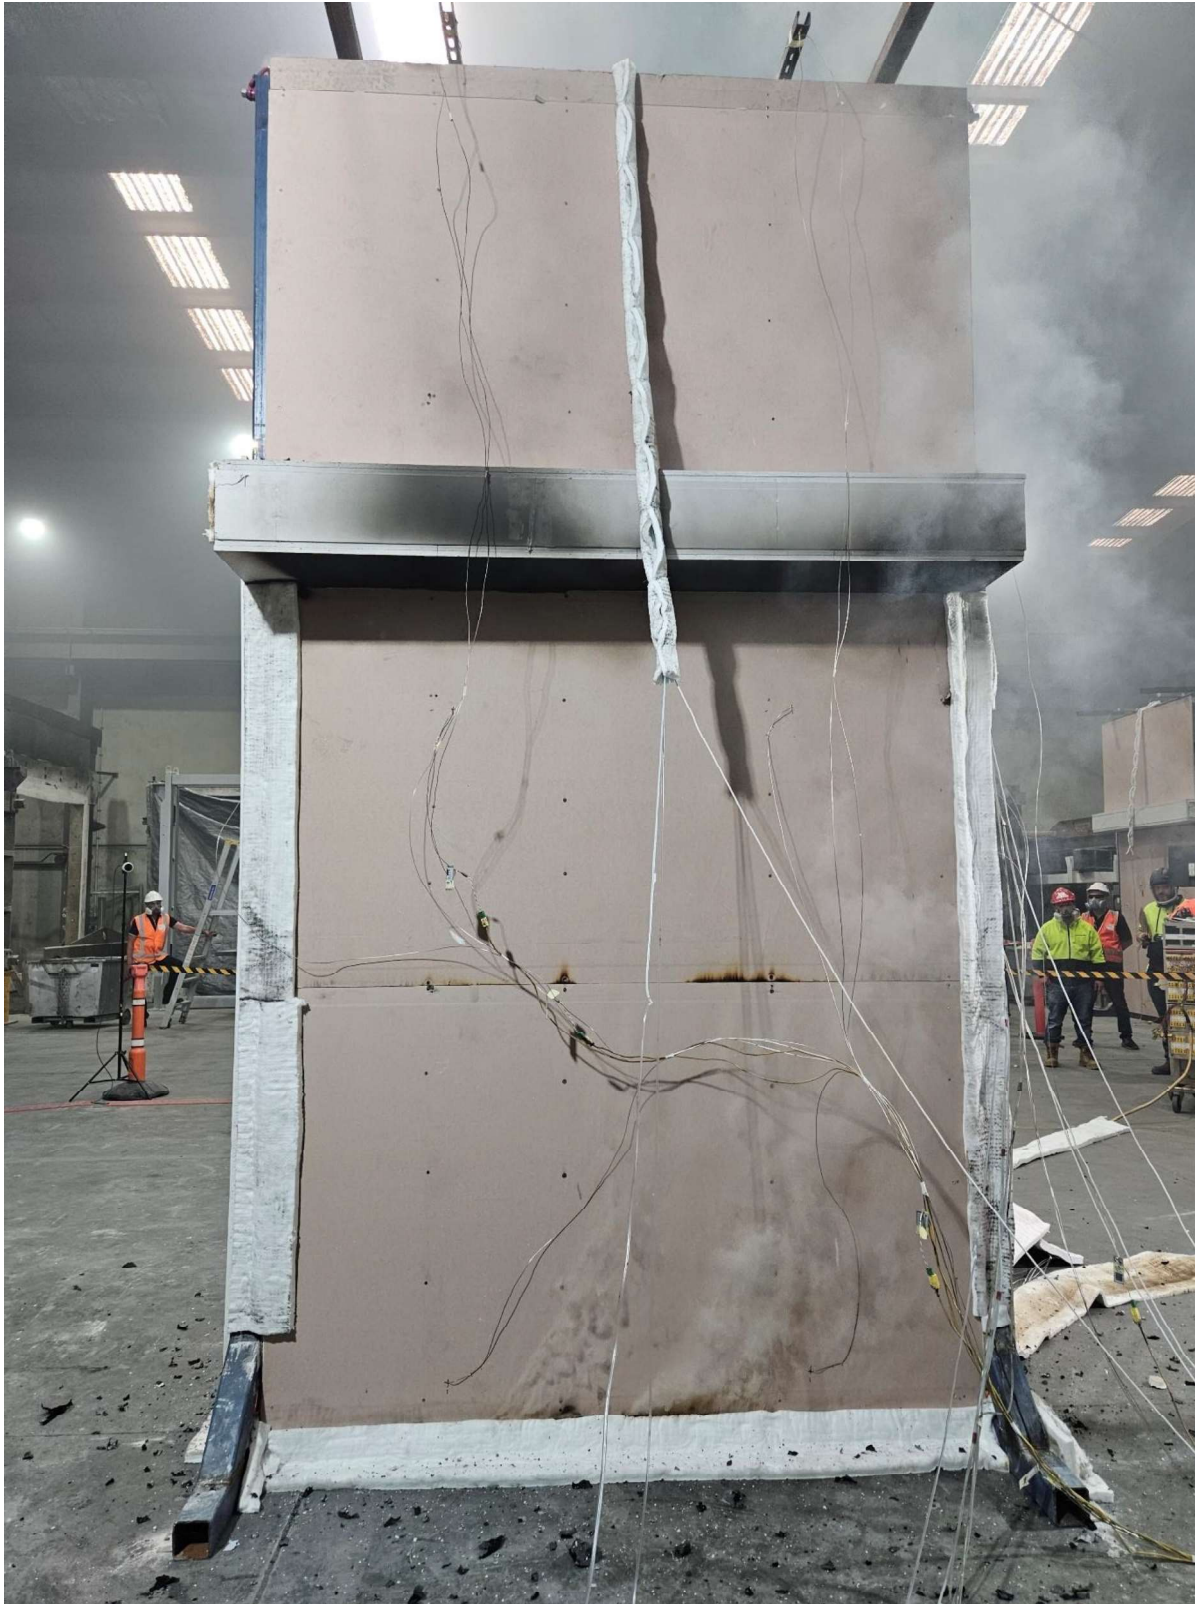
**Figure 41 The specimen after the test – unexposed side.**

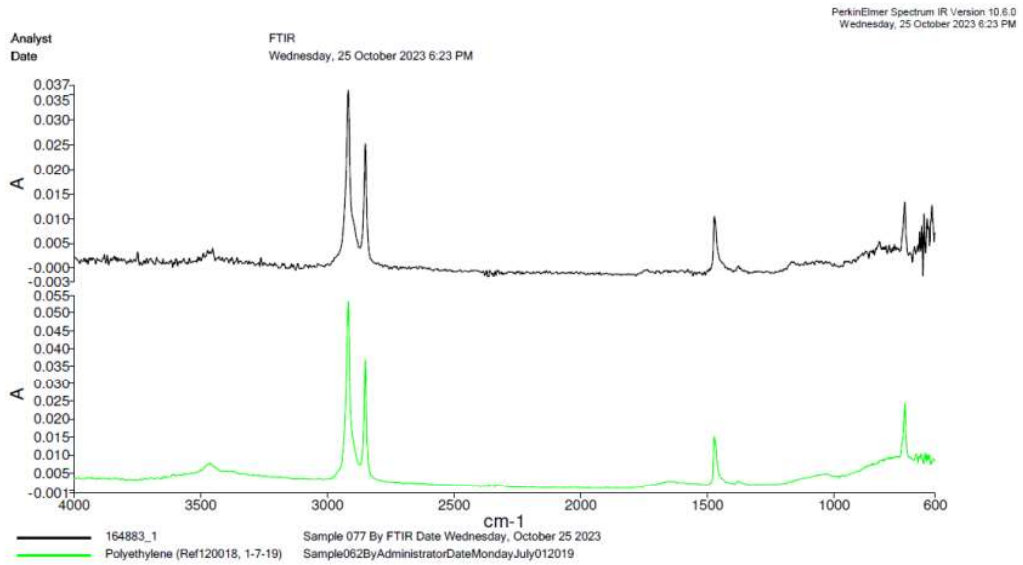
**Figure 3: - FTIR Spectral Comparisons of Known Material with Sample 164883.**

Sample ID	Sample Type	Core Colour	Identified Major Components by FTIR	Figure
164883	ACP	Black	Polyethylene with no filler	Figure 3
164884	ACP	Black	Polyethylene with unidentified filler	Figure 4

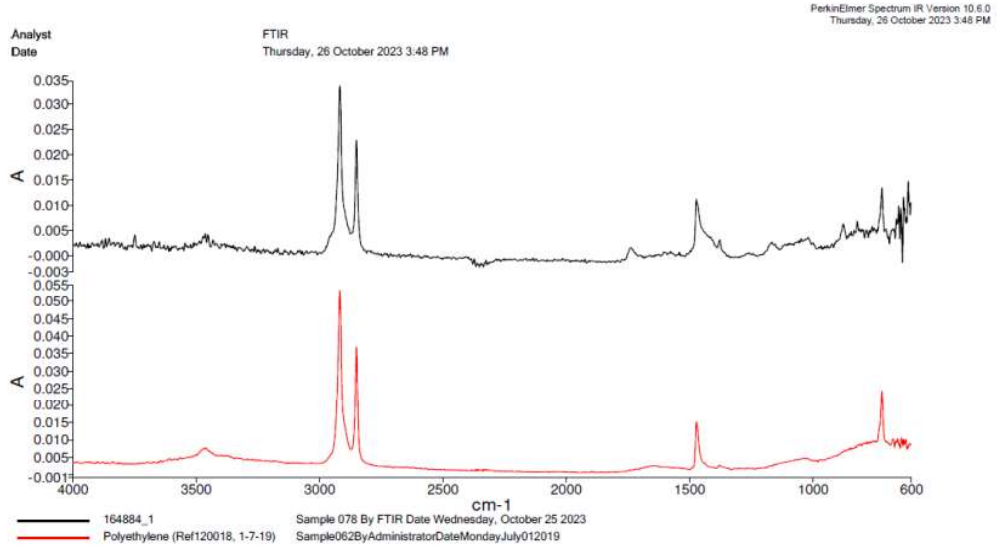
**Figure 4: - FTIR Spectral Comparisons of Known Material with Sample 164884.**

Sample ID	Sample Type	Identified Composition by FTIR	Calculated Filler Material (w/w%)	Calculated Combustible Material (w/w%)
164883	ACP	Polyethylene with no filler	0%	100%
164884	ACP	Polyethylene with unidentified filler	12%	88%
