Reaction to fire test report

Test standard: Ad-hoc test based off ISO 13785-1:2002

System: Aluminium composite panel (ACP) and glazing external wall cladding system

Job number: RTF230140

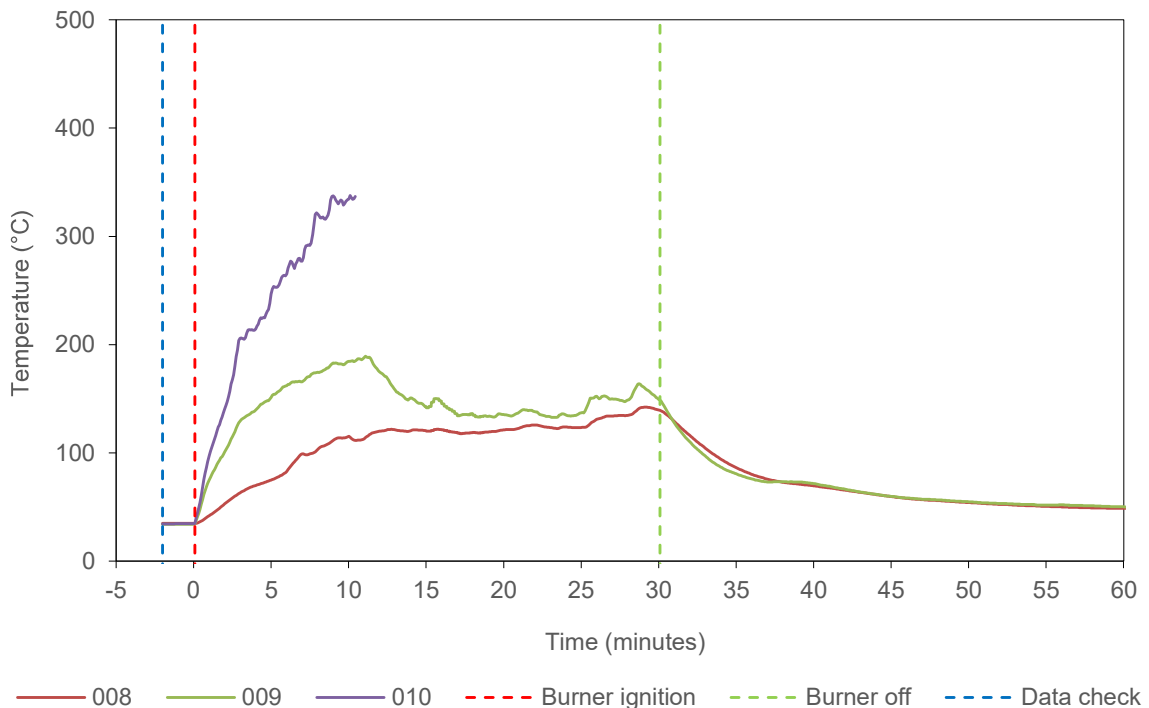
Figure 4 External temperature data collected by plate thermocouples in-line with ACP, above and below, respectively - in-line with the burner¹

¹ Thermocouple 010 malfunctioned during the test, thus causing spikes during the data collection process.

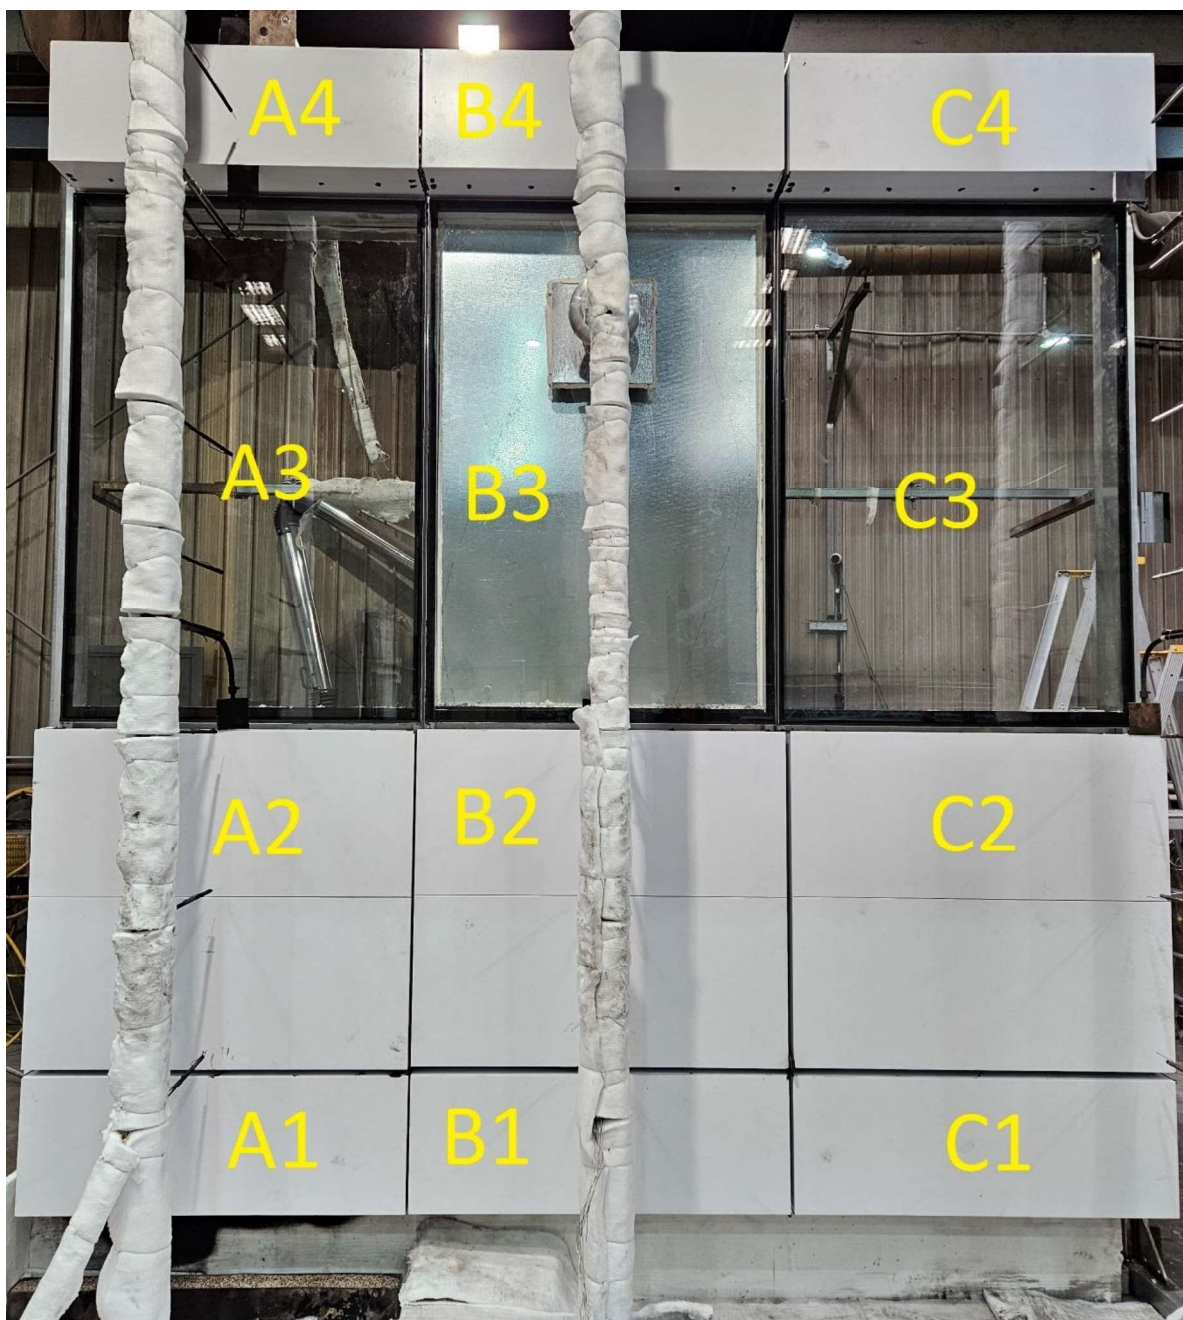
Figure 11 Designation of section for the test observations

Table 4 shows the observations of any significant behaviour of the specimen during the test. Figure 11 shows the panel and glazing designations sighted in the observations.

Time		System	Observation
Min	Sec		
-2	00	-	Data collection started.
0	00	-	The reaction to fire test was started with the burner ignited with a heat output set at 300 kW.
0	50	A1	The face of the lower side of panel started to discolour.
1	05	B1	The face of the lower side of panel started to discolour.
1	10	A2	The face discolouration had spread on to the mid-section of the panel.
1	38	A1	A sudden discharge of gas occurred from the panel front face.
1	57	A/B	Smoke started to escape from the vertical joint between the module.
2	23	B1	Flames spread across the bottom horizontal joint.
2	43	C	Smoke started to escape from the horizontal joint between the panels.
2	55	A1	Molten debris started to drip from the panel.
4	30	A/B	Molten debris started to drip from the vertical joint between the modules.
5	40	A1	Flaming on the unexposed side.
6	40	A1/A2	Flames started to spread across the east edge of the panels.
7	06	A2	A sudden discharge of gas occurred from the panel front face.

7	28	B1	Molten debris started to drip from the mid-section of the panel.
9	44	A3	Independent flaming at the bottom edge of the glazing.
10	14	A3	The flaming had died off.
10	50	A2	The east edge of the panel had opened up.
11	21	A2	The face of the panel had an opening from the exposed to unexposed side of the panel.
12	17	A3	The bottom east corner of the glazing was flaming independently.
13	01	A3	The independent flaming had spread across the bottom of the glazing.
13	28	A3	The flaming had stopped.
13	44	A3	The independent flaming restarted.
14	17	A2	Flames started to punch through the horizontal panel joint.
15	04	A3	The flames from the east edge were spreading upwards.
16	00	A2	The flames escaping from the horizontal joint increased in intensity.
18	44	A3	The flames had penetrated into the layer between the glazing.
20	48	A3	The glazing had cracked.
22	14	B2	The top east edge of the panel was flaming independently.

26	18	A3	The glazing layers started to open up.
30	00	-	The burner was turned off.
30	15	A/B 1/2	The panels still had independent flaming.
32	48	A2	The flames from the horizontal joint of the panel had died off.
35	00	A3	The fire on the east edge of the glazing had died off.
36	54	A2	Gas was released from the panel.

Time		System	Observation
Min	Sec		
38	39	A2	More gas was released from the panel.
47	55	A3	Some portion of the glazing had broken off.
58	40	A/B 1/2	Most of the independent flaming had died off, leaving some intermittent flaming.
60	00	-	The test was ended.

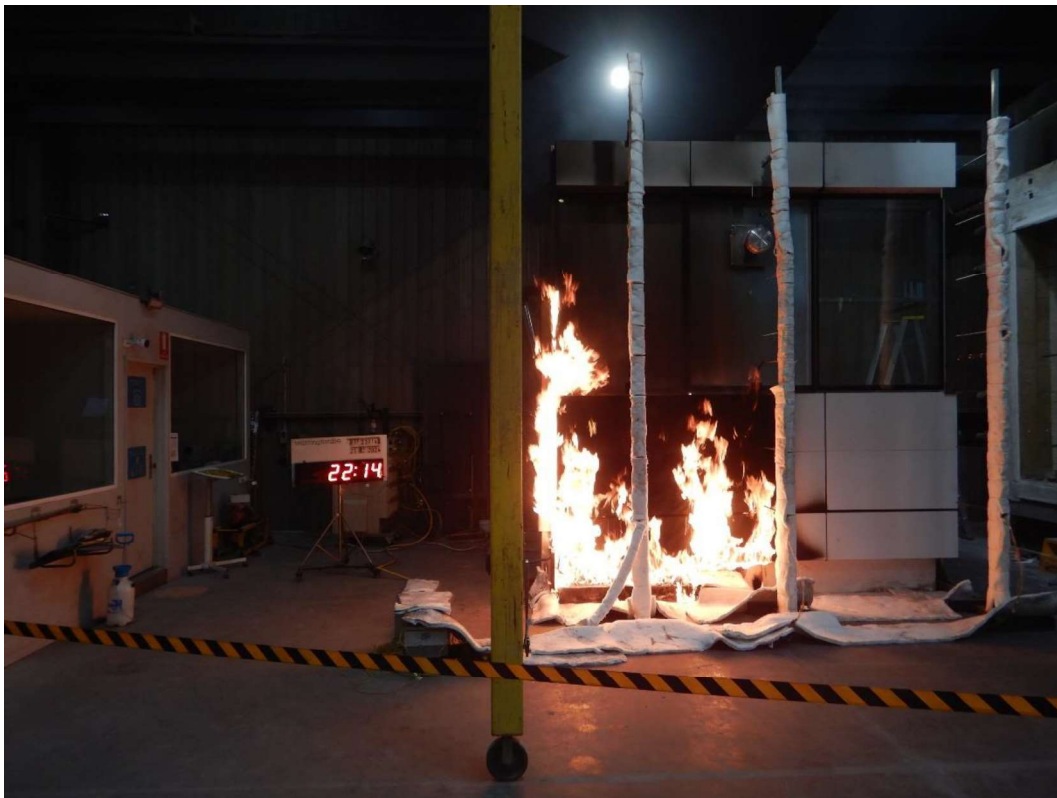
Figure 36 The specimen 22 minutes 14 seconds into the test (burner output at 300 kW)

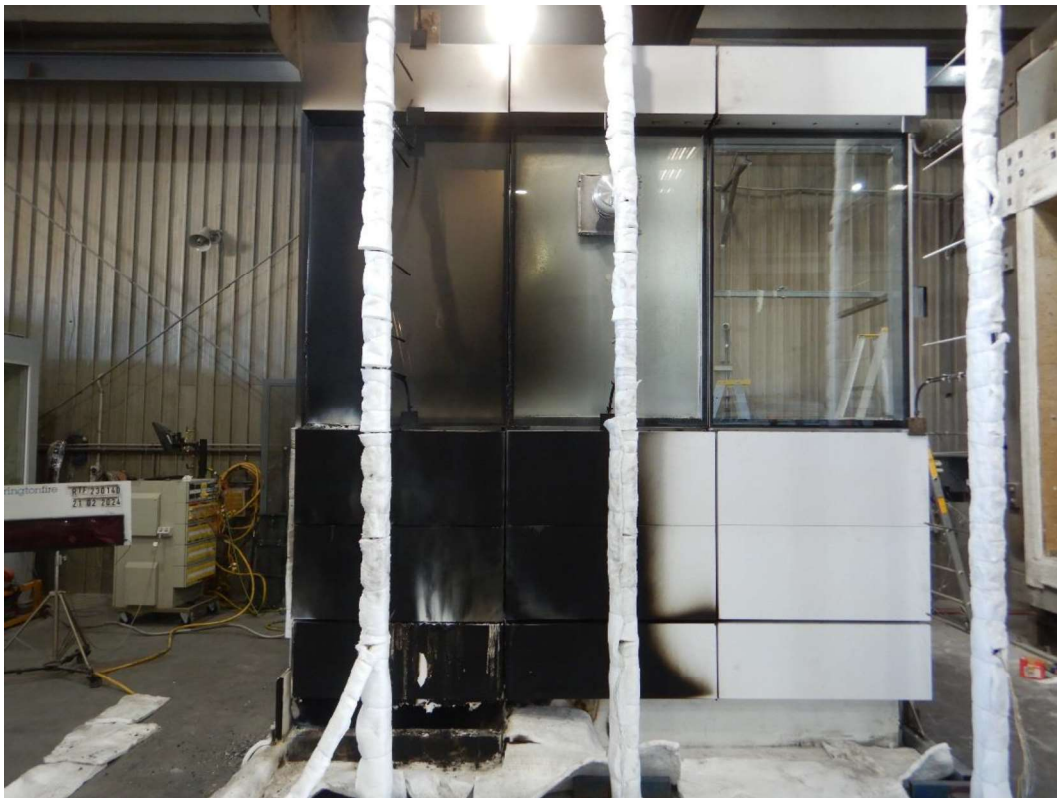
Figure 42 The specimen at end of test – exposed side

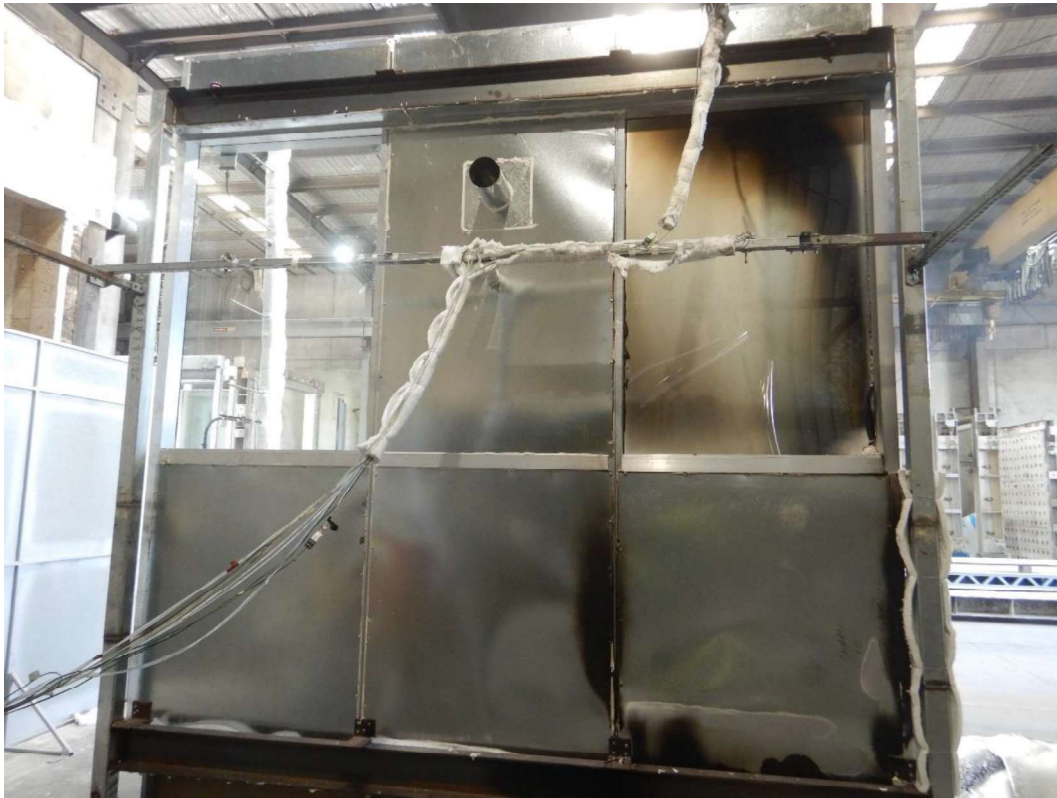
Figure 43 The specimen at end of test – unexposed side
