Rendered expanded polystyrene clad wall system AS 5113 external wall fire spread test

Fire test witness and review report

Report number: EP205417

Client: Victorian Building Authority

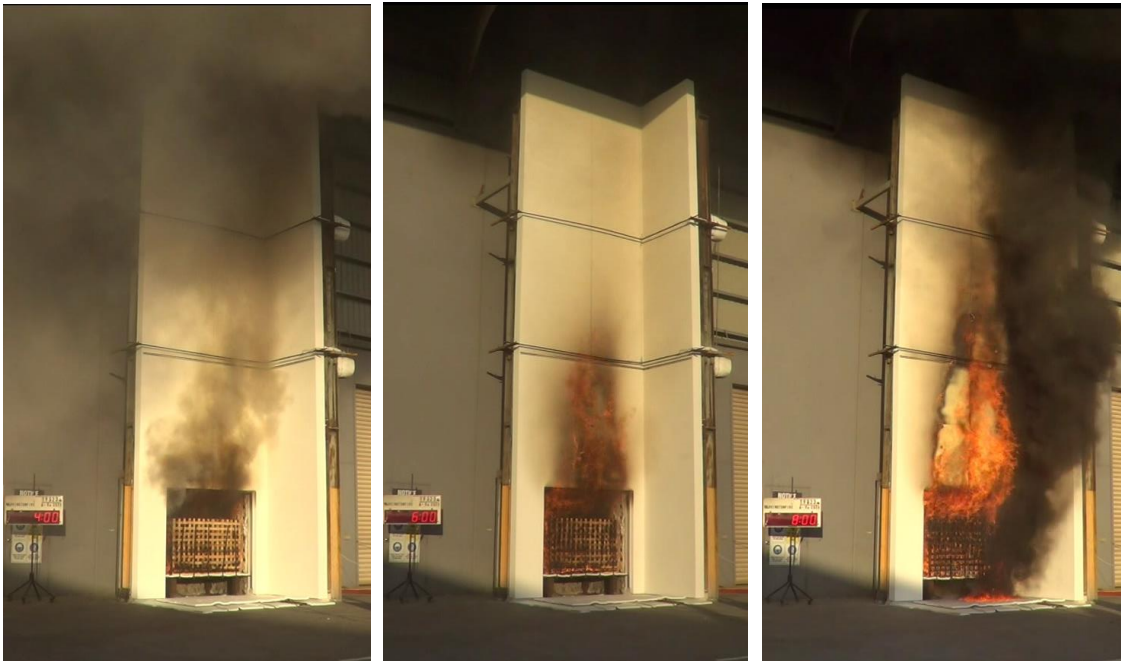
9:40	Render along vertical control joint between combustion chamber and level 1 is starting to peel open but remains in one piece and hangs in place rather than cracking. Flaming from the opening in the render at this location increases.

Figure 7. Rendered EPS external wall system at 4 minutes (left), 6 minutes (centre) and 8 minutes (right) after crib ignition

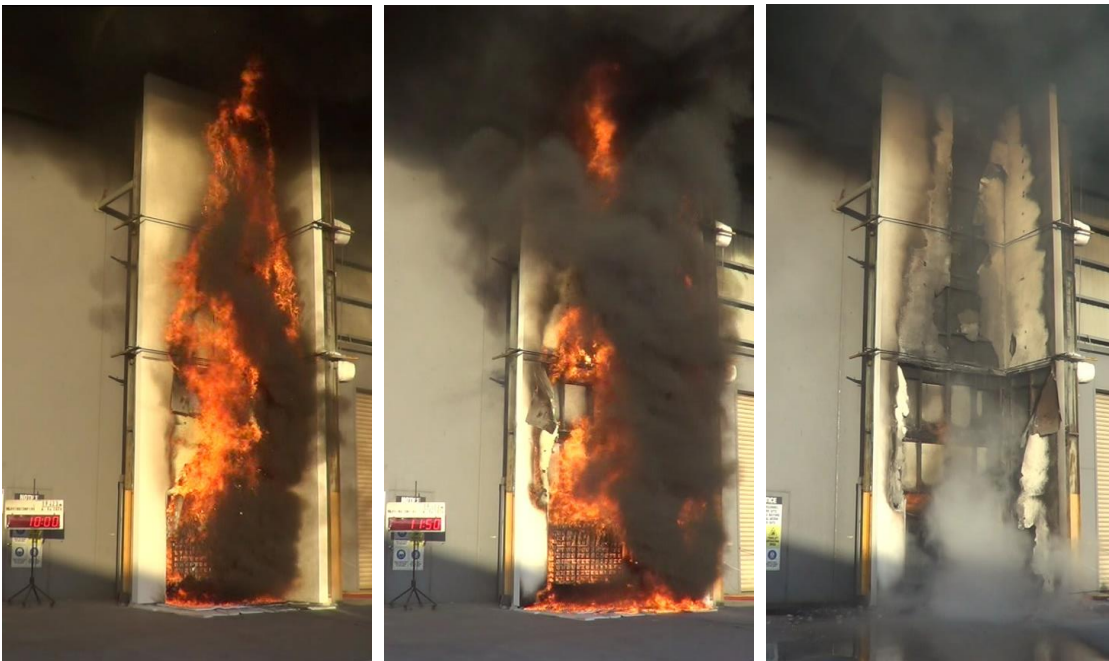
9:50	Render between combustion chamber and level 1 directly above combustion chamber breaks open with further increase in fire size. Surface of wing wall is now burning in area extending from combustion chamber to ~ 0.5 m below level 2. Fire plume is now continuously reaching the top of the specimen with flames issuing from vertical control joint on main wall up to ~1 metre below top of specimen.

11:00	Fire size continues to increase. Render is still mostly hanging in place in all regions except for main wall combustion chamber to level 1. However flaming or molten or pyrolyzed EPS is occurring on main wall and wing wall extending to top of specimen at numerous open joints or cracks in render. The render surface also appears to be flaming at the outer perimeter of the specimen surface flaming region.

Figure 8. Rendered EPS external wall system at 10 minutes (left), 11:50 minutes (centre), immediately after water suppression (right)

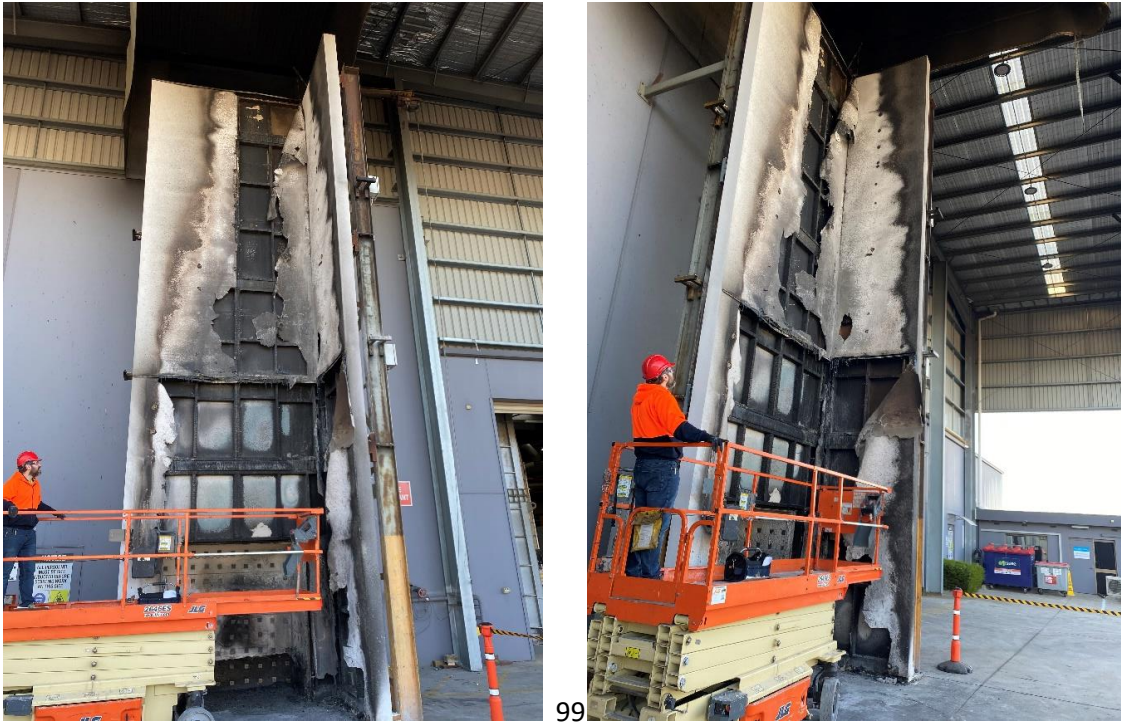
- On the wing wall, the render had fallen/peeled away with EPS behind mostly consumed in an area extending from finished ground level to Level 1.
- A significant region of the render which remained in place on the main wall and wing wall was heat effected showing charring with a white discolouration, with screw/washer heads visible and bounded at perimeter by black sooty discolouration. EPS behind this heat effected render region had mostly melted/burnt away.

- Regions of render externally along the outer edges of the main and wing wall had render which was either not heat effected or was black and sooty. EPS behind these regions above Level 1 was still in place and had mostly not melted or burnt away. EPS behind these regions below Level 1 had mostly melted or burnt away all the way to the outer edge of the wall specimen.

Figure 9. Post-test external rendered EPS wall system prior to any deconstruction. Main wall (left) wing wall (right)

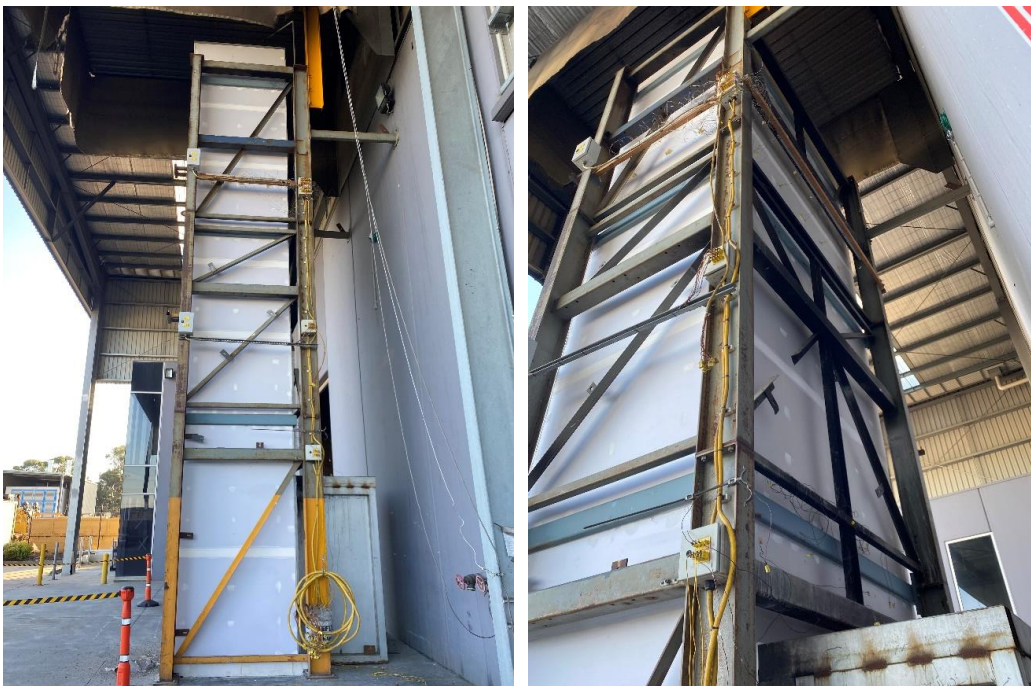
- Standard grade 10 mm plasterboard was exposed with some charring of paper surface within cavity where the EPS had melted/burnt away. However, no opening or gaps had formed in the plasterboard which resulted in no flaming on the non-fire exposed side of the wall system. This is due to the early suppression of the test.

Figure 10. Post-test wall system non-fire exposed side. Wing wall (left), Main wall (right)

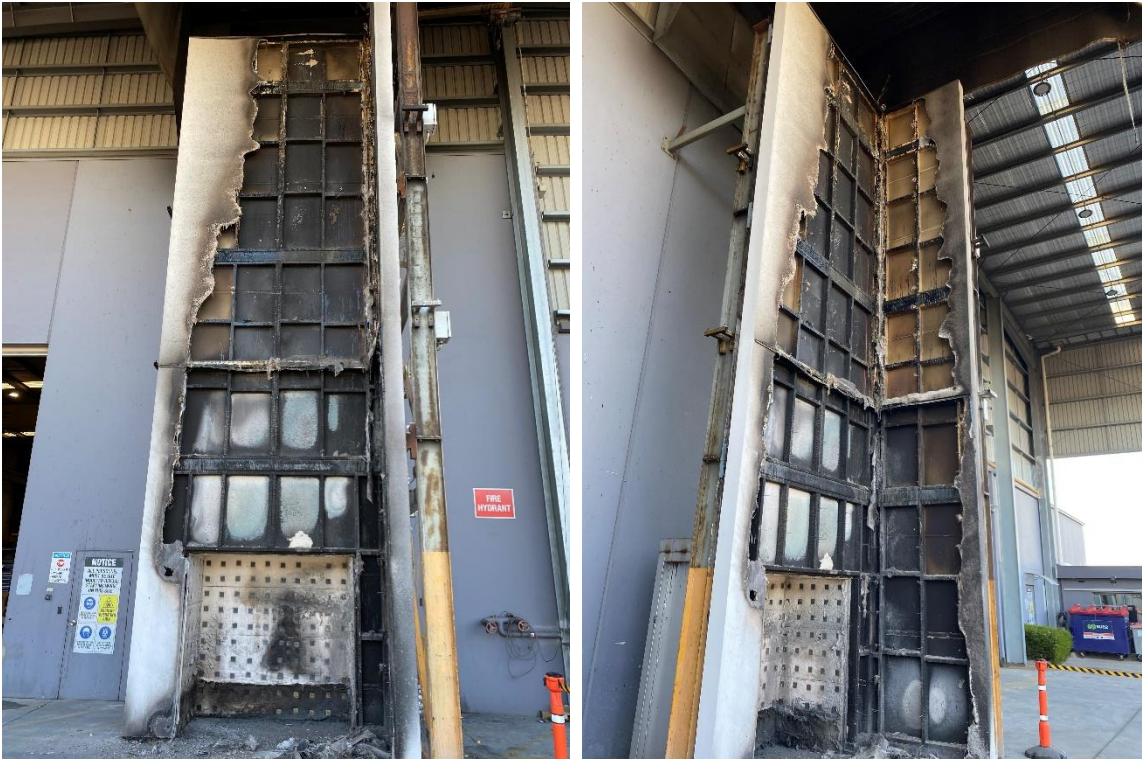
Figure 11. Post-test wall system with all regions of heavily heat affected render removed showing EPS behind melted/burnt away

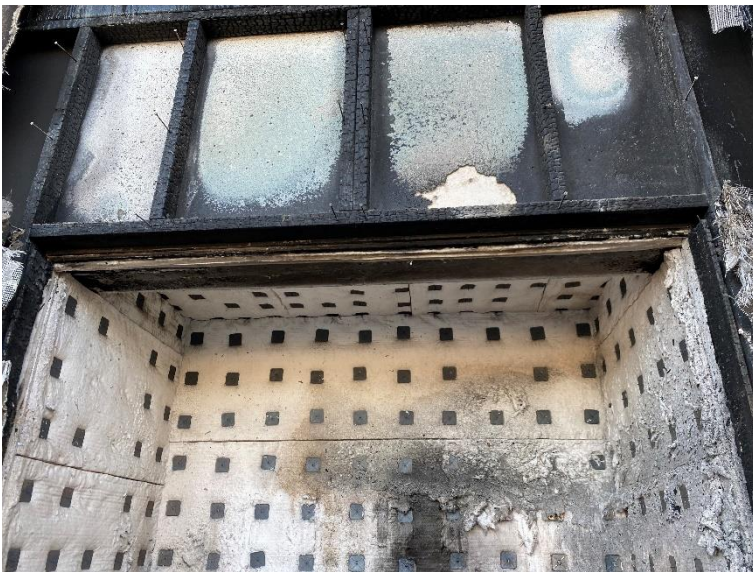
- Timber framing had surface charring in all regions where the EPS had mostly melted/burnt away but all timber framing elements remained in place and had not burnt away. This may be in part due to the early suppression of the test.

Figure 12. Post-test wall system close-up of combustion chamber opening and region of most heavily charred timber framing and heat effected plasterboard

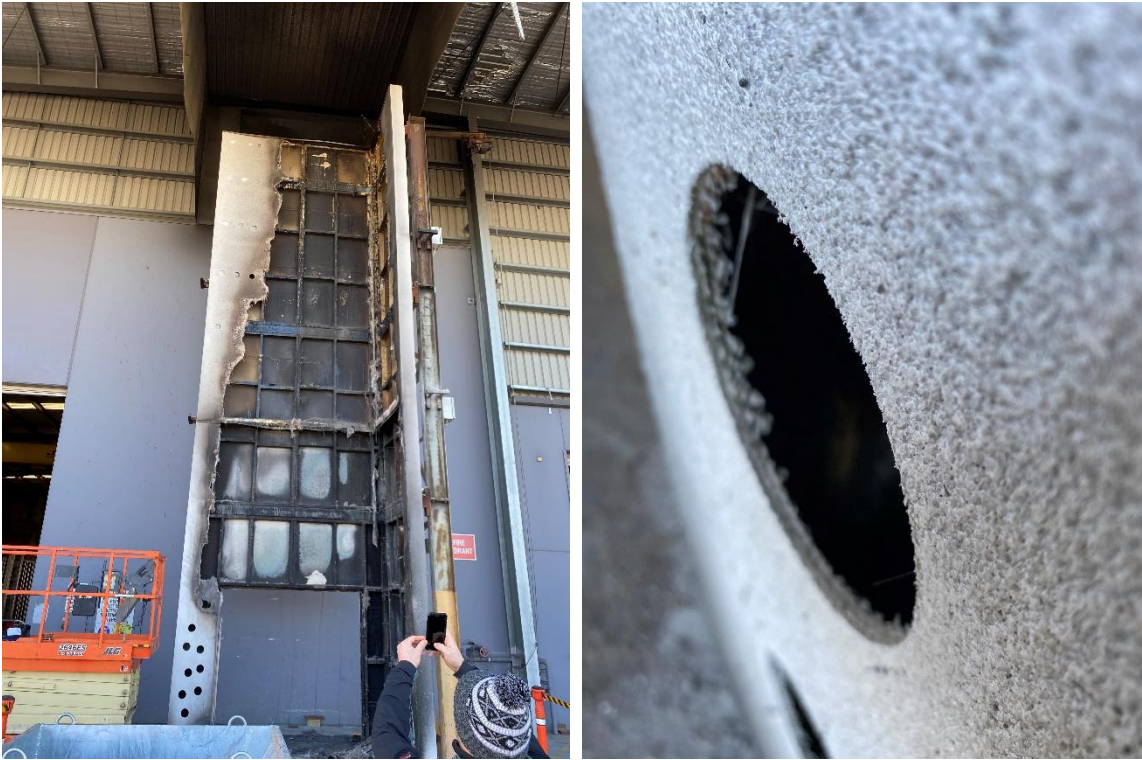
Figure 13. Post-test wall system showing render thickness hole saw samples. Right photo shows close up hole saw sample on left side of combustion chamber with EPS behind completely melted/burnt away.
