RESEARCH ANALYSIS NO. 3

Clerk of Works: Promoting quality and safety in construction

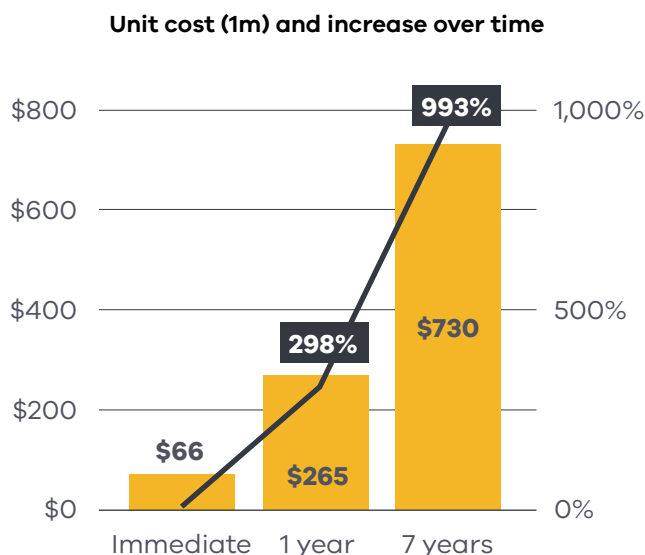
Figure 3. Aluminium Composite Panels (ACP) caulking

The theoretical additional cost to remove and replace one metre of caulking, using existing scaffolding during the building work would be approximately \$66.80. If this were to be undertaken a year later, additional supervision, insurance and permit applications would be required, along with barricade installation and other temporary protection measures. Assuming no structural or waterproofing damage has occurred, the estimated unit cost of repair would increase to around \$265.80 per metre. The third scenario makes assumptions on a common level of latent defects that has been observed

within CSV's residential Cladding Rectification Program. To remove and replace a metre of caulking, the cost increases to around \$730, as scaffolding is required, and there is some sub-frame and internal damage behind the ACP.

This translates to a 298 per cent increase in cost if the works occur after a year and potentially a 993 per cent increase after seven years. It should be noted the range of cost can vary drastically when latent defects are present, and this is just a typical cost.

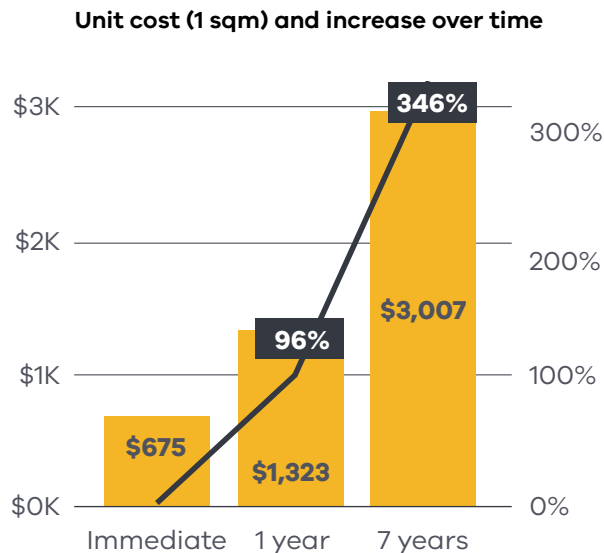
Figure 4. Autoclaved Aerated Conclave (AAC) panels

The theoretical additional cost to remove and replace one square metre of Hebel panels using existing scaffold during the building work would be around \$675. If this were to be undertaken a year later, additional supervision, insurance and permit applications would be required, along with the installation of scaffolding, painting and landscaping (where the scaffolding was). Assuming no structural or waterproofing damage has occurred, the unit cost of repair would increase to around \$1,323. The third scenario makes assumptions on a common level of latent defects that have been observed within CSV's residential Cladding Rectification Program. In this instance the cost increases to around \$3,007 to address the sub-frame and internal damage behind the AAC panels.

This translates to a 96 per cent increase in cost if the works occur after a year and potentially a 346 per cent increase after seven years. It should be noted the range of costs can vary drastically when latent defects are present, and this is just a typical cost.

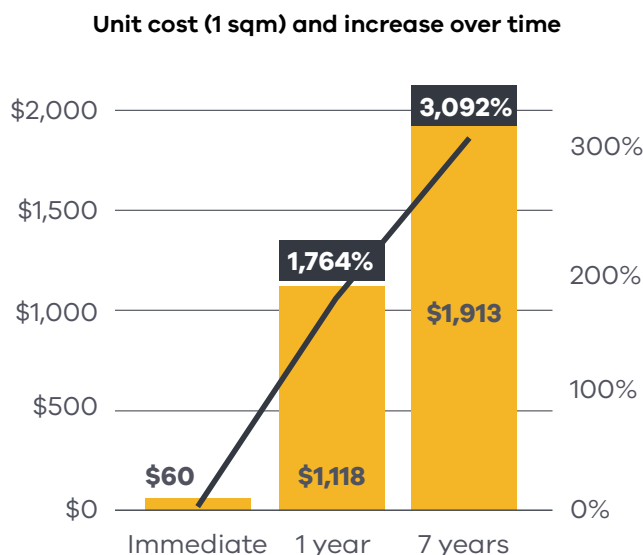
Figure 5. Sarking

The theoretical additional cost to remove and replace one square metre of Hebel panels using existing scaffolding during the building work is estimated to be \$60. If undertaken a year later, additional supervision, insurance, permit applications and scaffolding installation would be required. Assuming no structural or waterproofing damage has occurred, the estimated unit cost of repair would increase to around \$1,118. The third scenario makes assumptions on a common level of latent defects that has been observed within CSV's program. In this instance the cost increases to around \$1,913

to address the sub-frame and internal damage behind the Hebel panels, including evacuation and accommodation of the residents to enable repairs.

This translates to a 1,764 per cent increase in cost if the works occur after a year and potentially a 3,092 per cent increase after seven years. It should be noted the range of cost can vary drastically when latent defects are present, and this is just a typical cost.

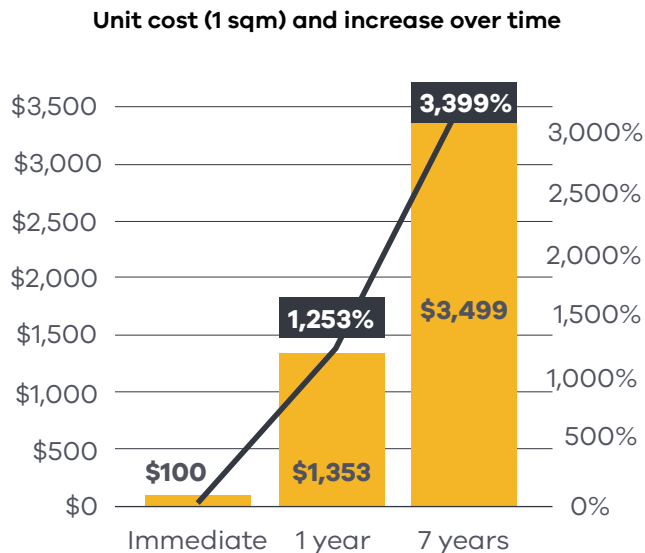
Figure 6. Flashings

The theoretical per metre square cost to remove and replace the flashing for a typical window (one metre wide and 1.2 metres high) with Hebel panels sarking and insulation, using existing scaffold during the building work would be around \$100. If this was required to be undertaken a year later, supervision, insurance, traffic management, and scaffolding installation would be required. Assuming no structural or waterproofing damage has occurred, the cost of repair would increase to around \$1,353. The third scenario makes assumptions on a common

level of latent defects that has been observed within CSV's Cladding Rectification Program. In this instance the cost increases to around \$3,499 to address the sub-frame and internal damage behind the Hebel panels.

This translates to a 1,253 per cent increase in cost if the works occur after a year and a potential increase of 3,399 per cent after seven years. It should be noted the range of costs can vary drastically when latent defects are present, and this is just a typical cost.

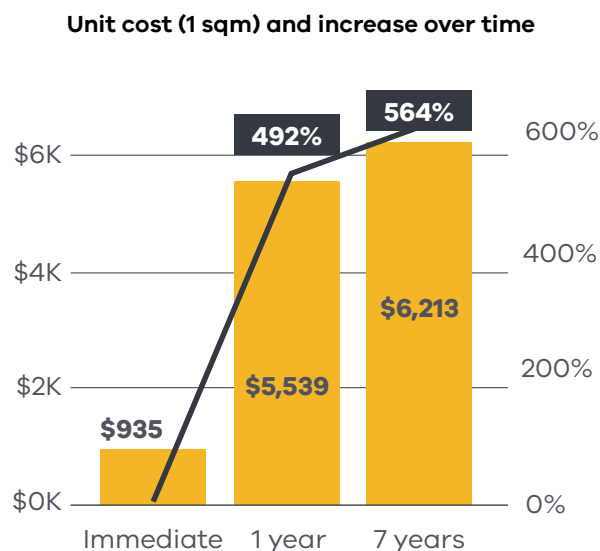
Figure 7. Fixings

The theoretical additional cost to remove and replace a two-metre square solid aluminium panel using existing scaffold during the building work would be around \$935. If this were required to be undertaken a year later, supervision, traffic management, and permit applications would be required along with the use of swing stage/ropes. Assuming no structural or waterproofing damage has occurred, the cost would increase to around \$5,539. The third scenario makes assumptions on a larger extent of the issue and

This translates to a 492 per cent increase in cost if the works occur after a year and potentially a 564 per cent increase after seven years. It should be noted the range of costs can vary drastically and this is just a typical cost.
