RESEARCH ANALYSIS

Non-cladding building defects

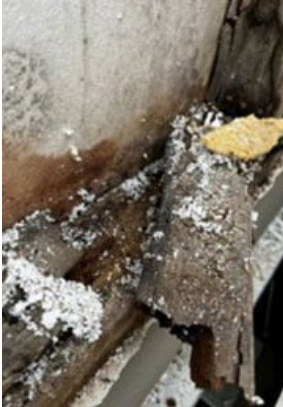
Bottom plate of timber framed balustrade.

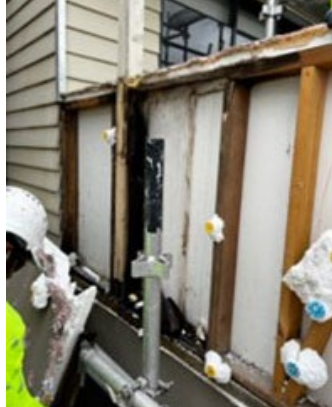
Timber framed balustrade showing water damage coming through capping.

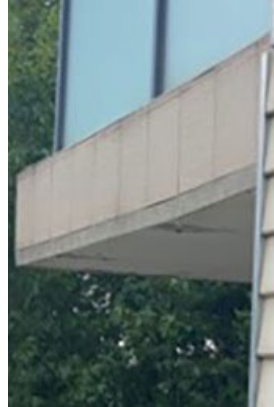
Water damage to soffit evident from balcony above.

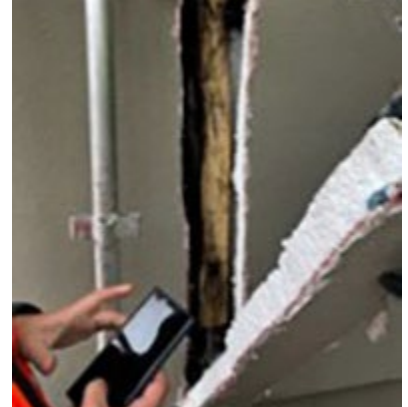
Timber framing to balustrade rotten from water ingress. No sarking sitting behind EPS cladding.

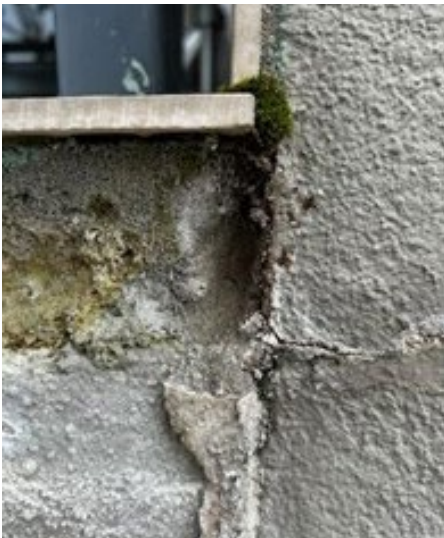
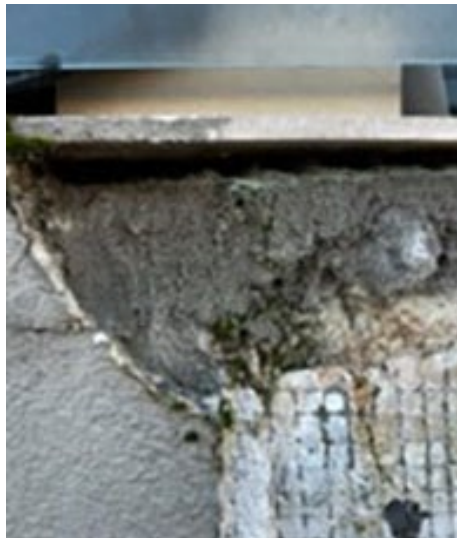
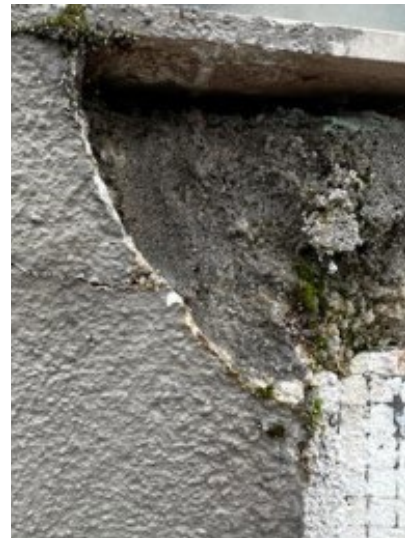
Tiling not sitting flush on concrete slab. No screed or membrane present. Moss and mould evident from pooled water.

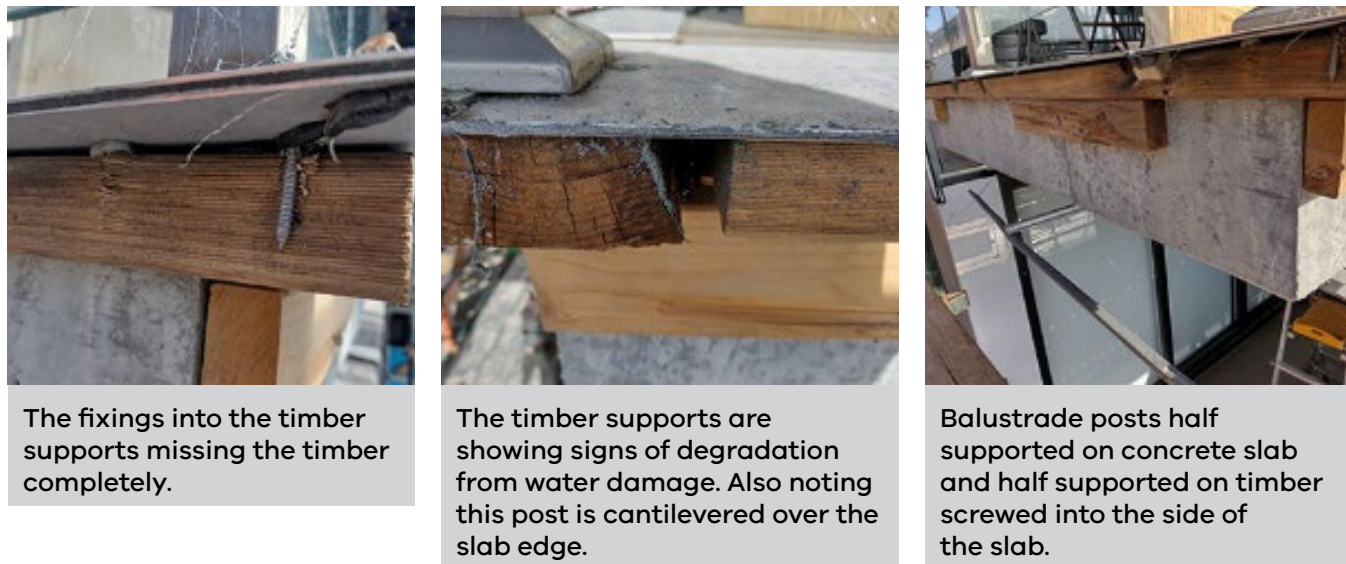
Figure 4. Example of balcony with structural issues on a funded building in CSV's program (comprising 35 sole occupancy units)

The fixings into the timber supports missing the timber completely.

The timber supports are showing signs of degradation from water damage. Also noting this post is cantilevered over the slab edge.

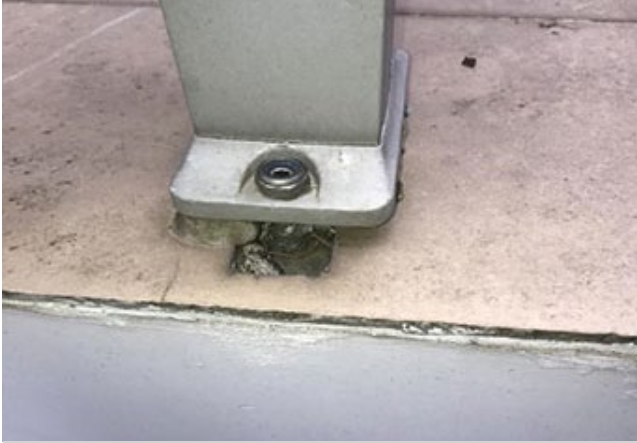
Improper water proofing around balustrade fixing providing areas for water ingress to structural elements.

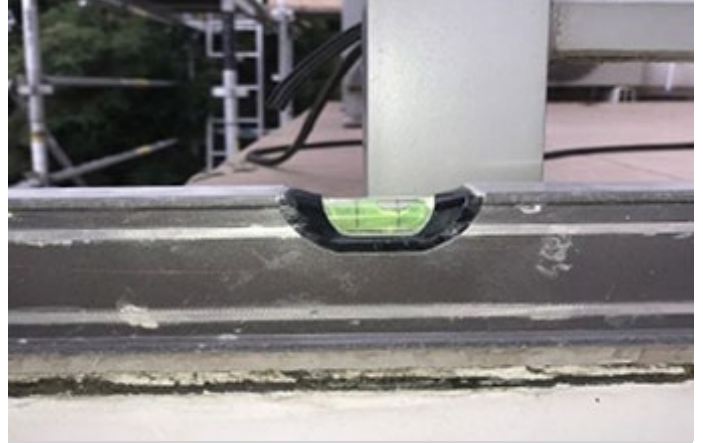
Balcony falling steeply away at edge.

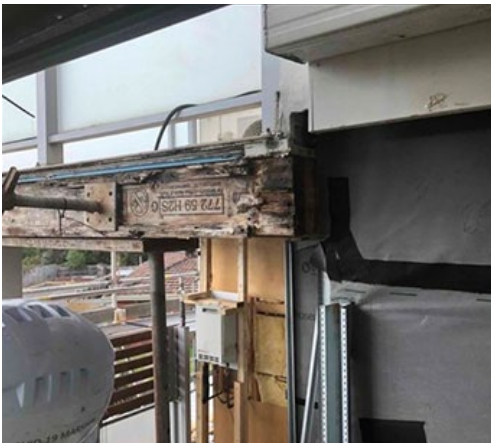
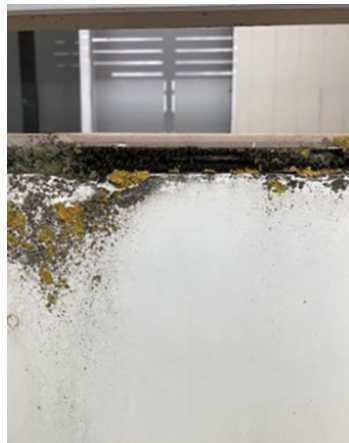
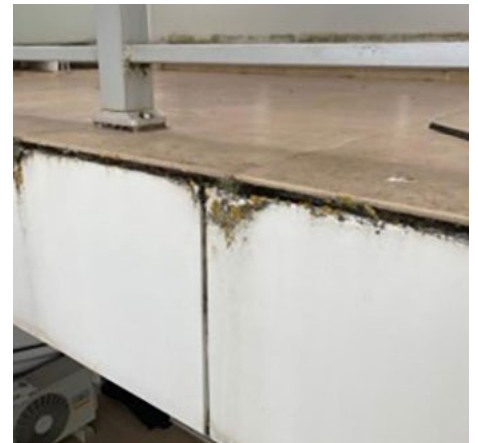
Water ingress to balconies – owners corporation not rectifying as part of the program. MBS has previously issued Emergency Order on these units.

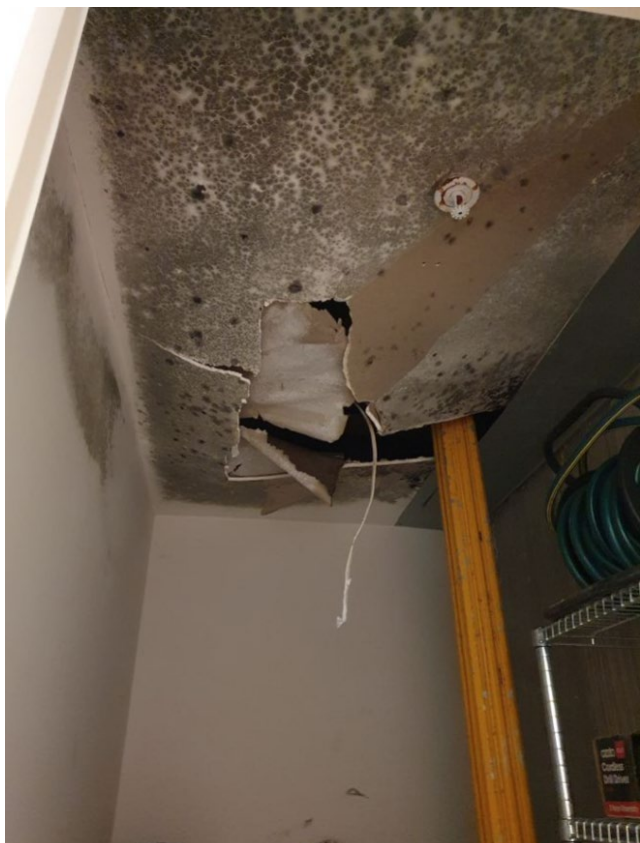
Figure 7. This apartment's ceiling has collapsed after years of water collected from the balcony above it

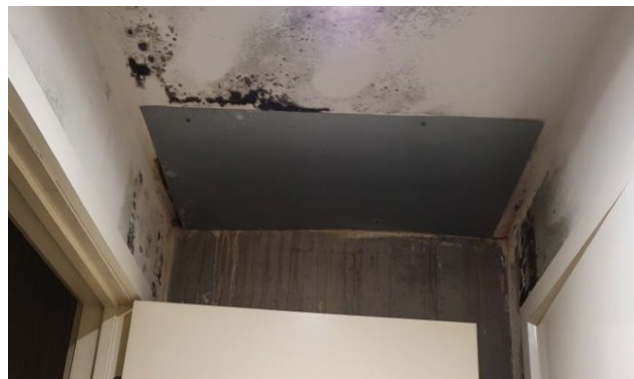
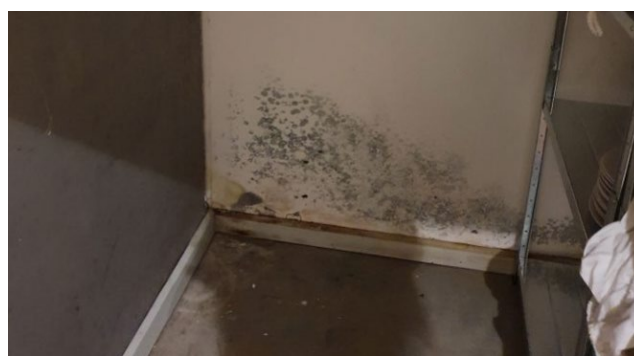
Figure 8. Black mould on the ceiling and walls in this apartment

The presence of black mould on parts of the ceiling and walls in this apartment is extensive and widespread.

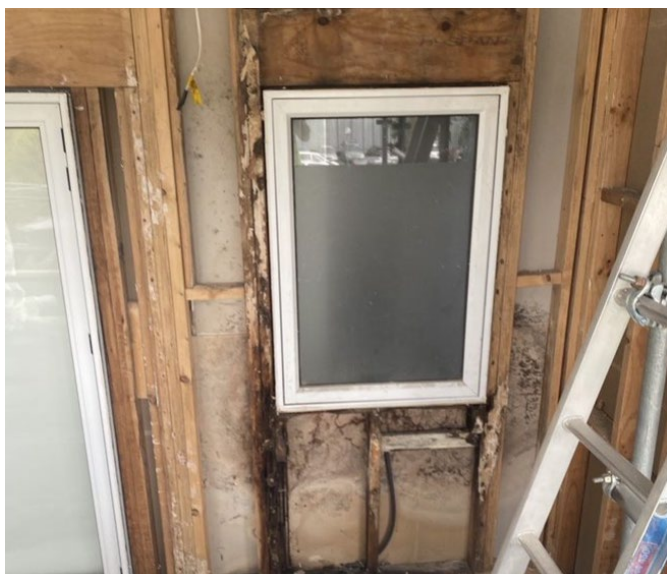
Rotting timber.

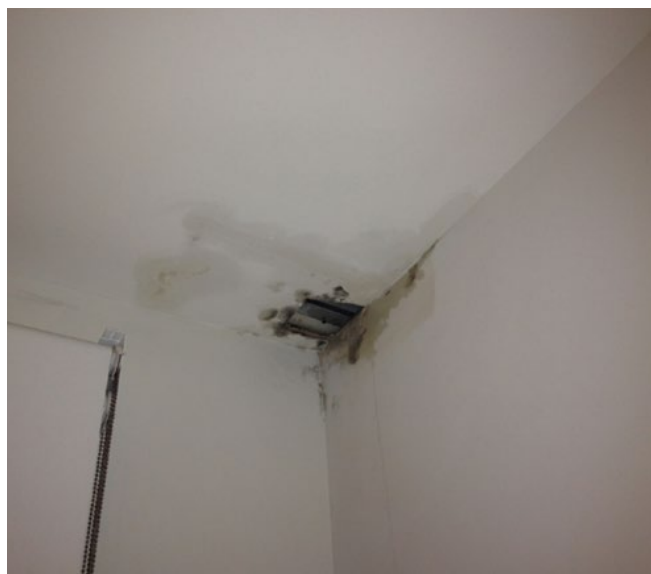
Moisture seeping through plaster walls.

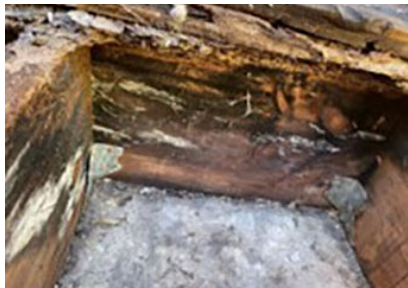
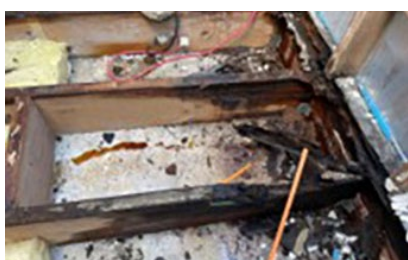
Upper level balcony; tiling removed to show rotten timber to balcony structure, and bottom of apartment stud wall.

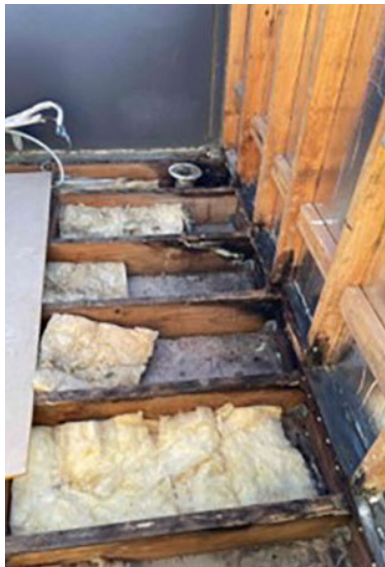
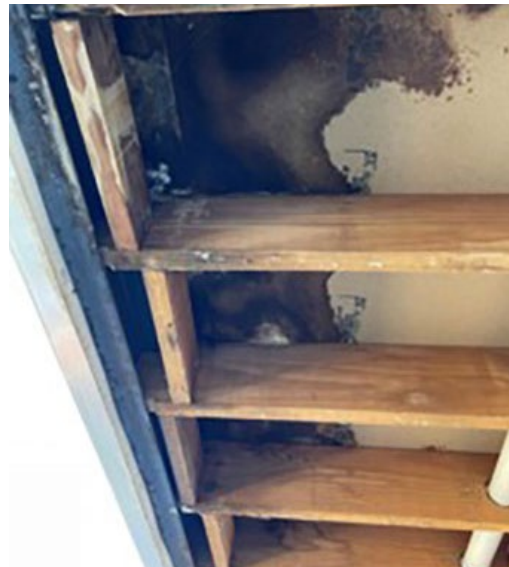
Underside of balcony; substrate with significant rot from water and timber joists showing rot.

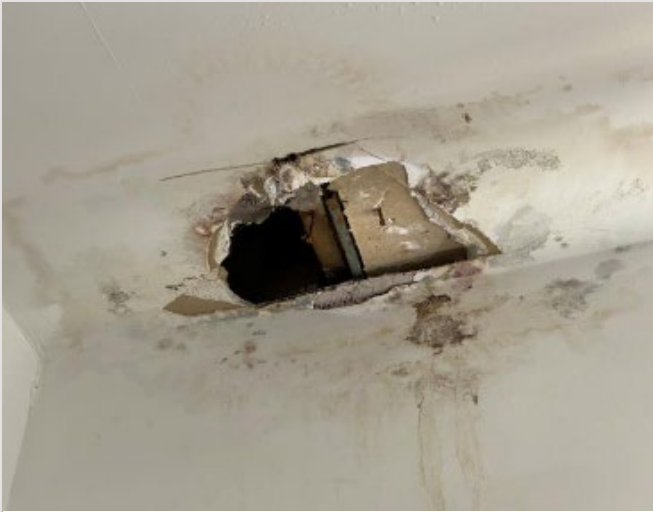
Mould and staining on apartment ceiling.

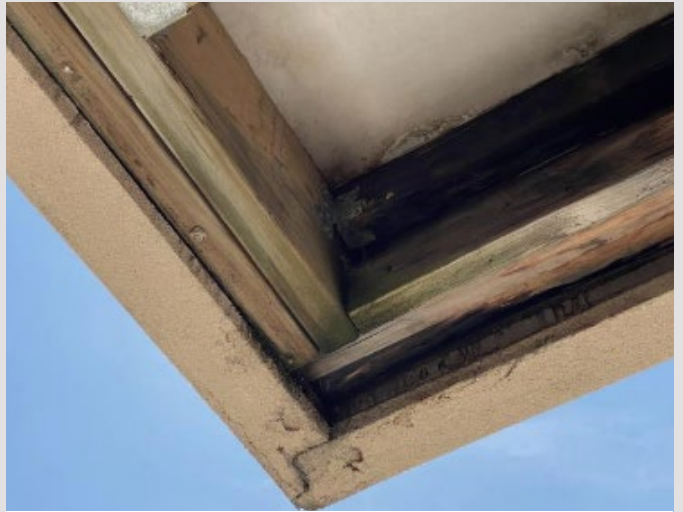
Deterioration of timber balcony.

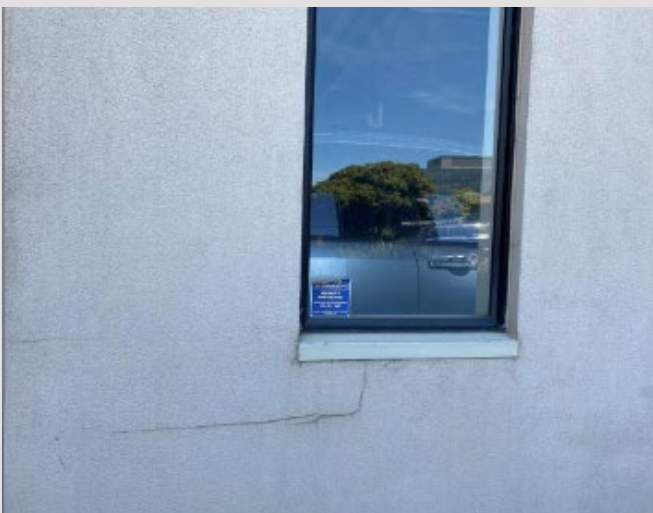
Cracking along blockwork joints.

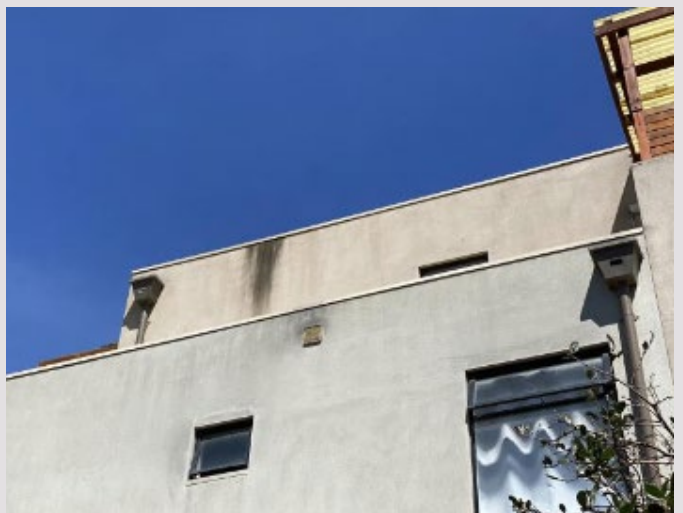
Widespread staining of rendered surfaces.

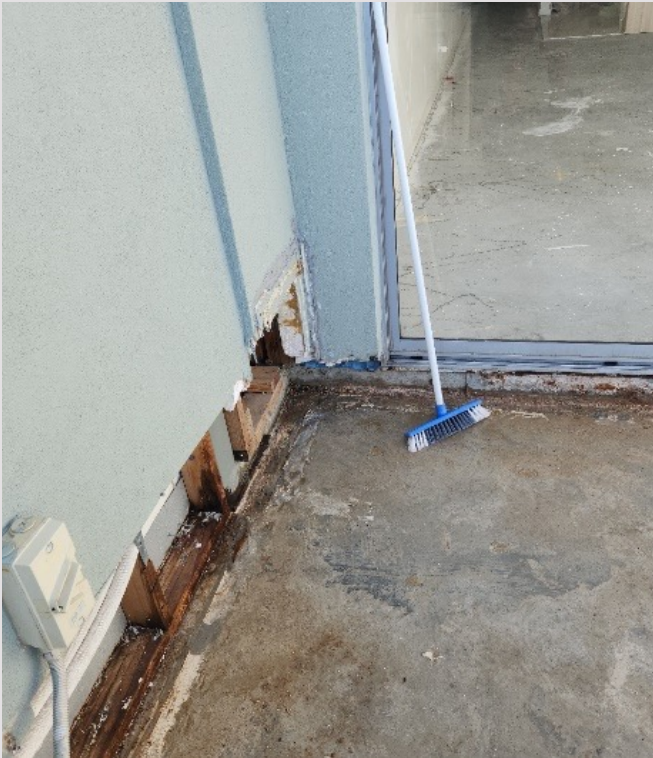
Rotten framework caused by water ingress.

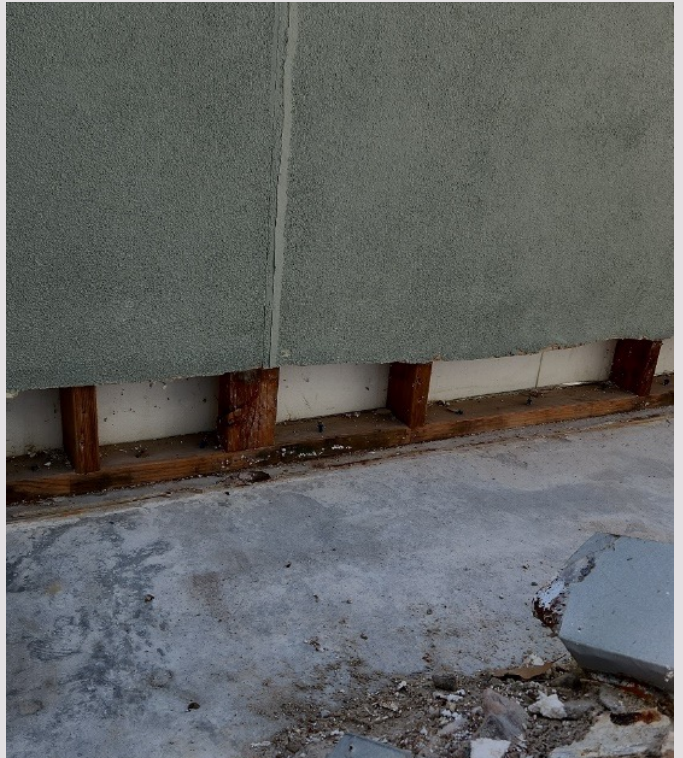
Example of waterproofing damage that is being replaced.

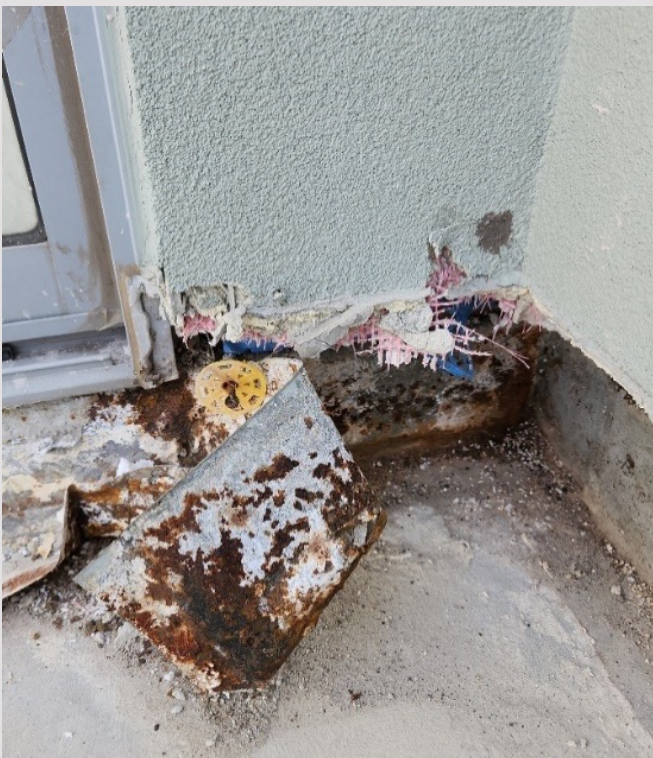
Corroded steel frames caused by water leakage.

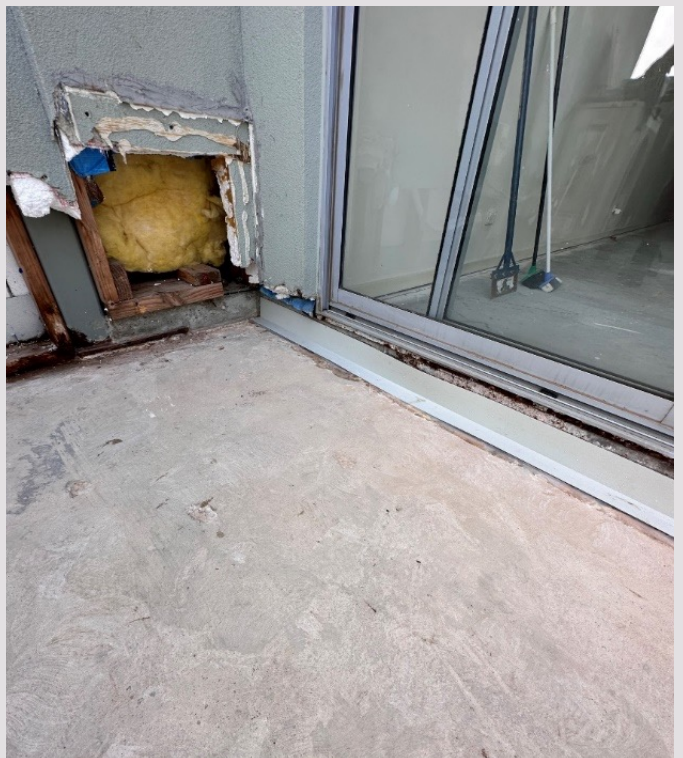
Damaged insulation.
