# Collision of truck with passenger coach

Western Highway, Pentland Hills, Victoria on 21 September 2022

**OCI Transport Safety Investigation Report**

BUS/22-1519

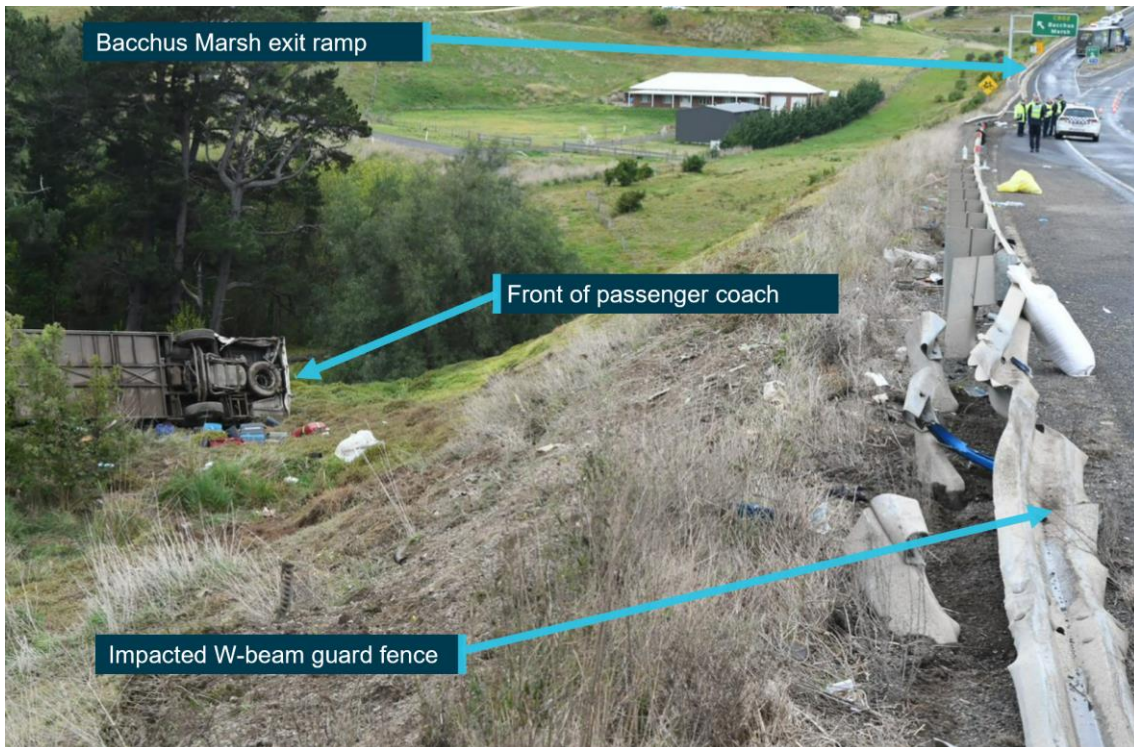
**Figure 5: Passenger coach in final resting position**

At that point, the driver of the B-Double truck directly following the passenger coach observed the rapidly approaching incident truck in their rear-view mirror and they manoeuvred left to allow the vehicle to pass between it and TMA 2. Their dashcam footage showed the incident truck pass to the right travelling at a speed of at least 100 km/h, then steer back into the left-hand lane before heavily impacting the rear of the passenger coach. The impact caused the passenger coach to veer to the left, mount the roadside barrier and traverse down an embankment where it rolled on to its left side before coming to rest (Figure 5).

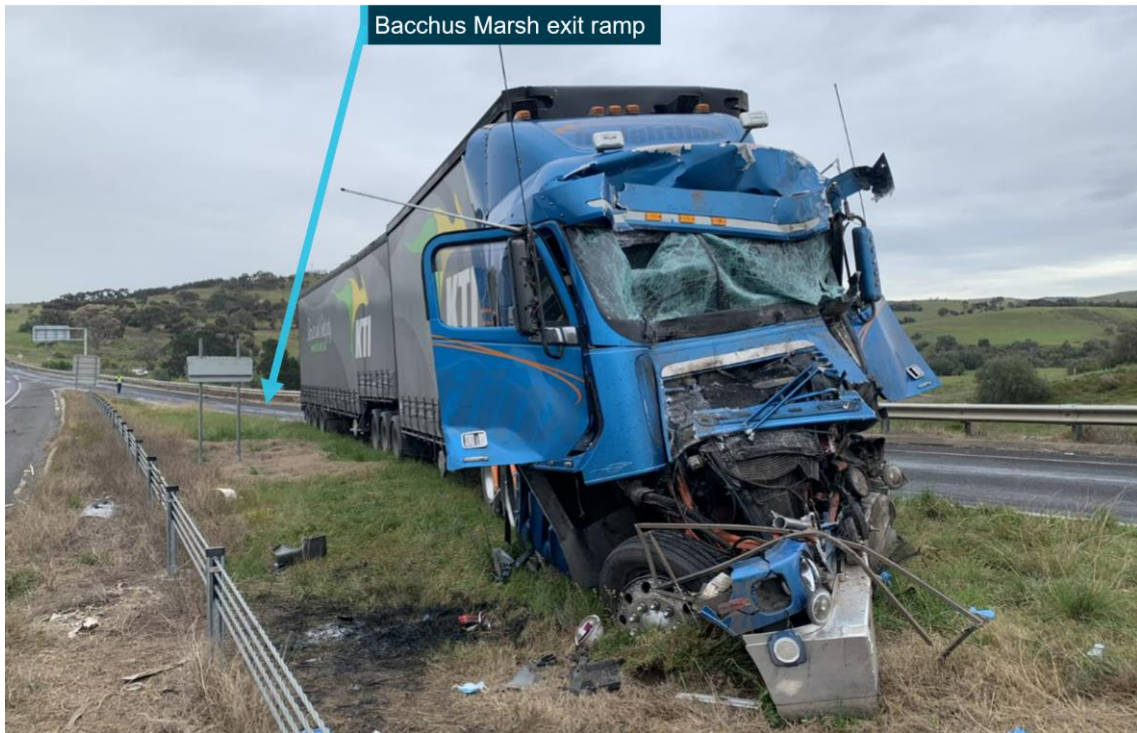
**Figure 6: Prime mover and semitrailers in final resting position**

The truck sustained major frontal damage on impact and continued a further 425 m before coming to rest facing an easterly direction on the exit ramp to Bacchus Marsh Road (Figure 6).

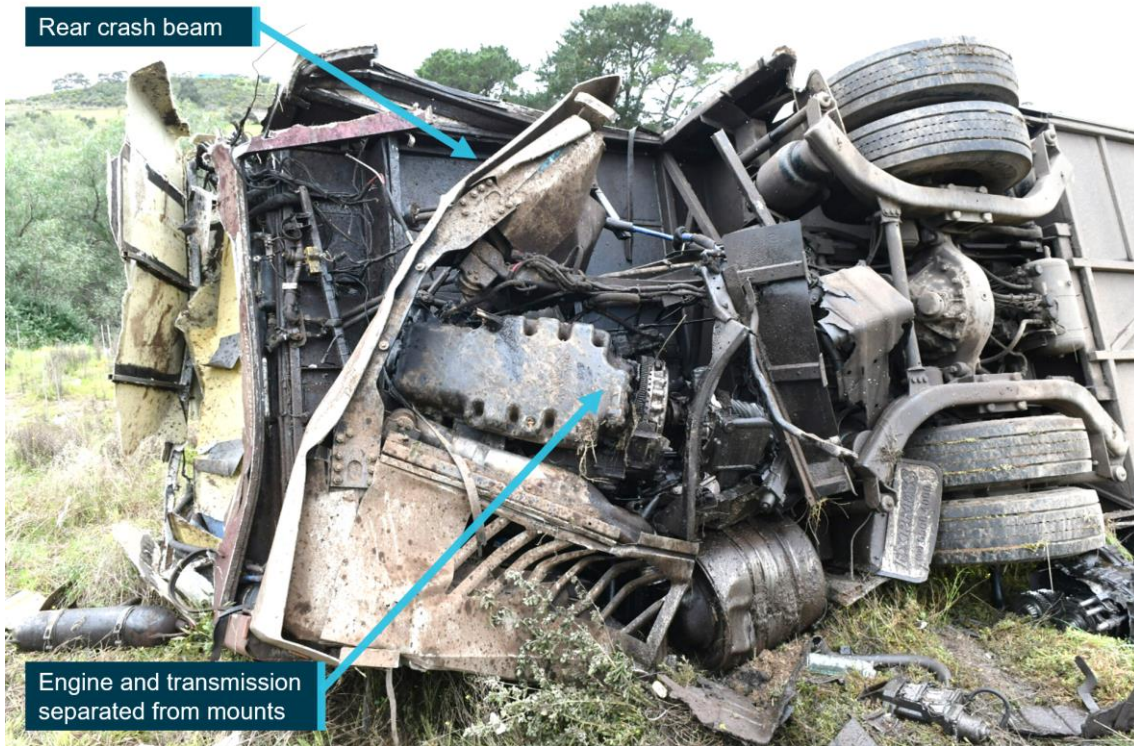
Figure 10: Passenger coach rear impact damage

The rear impact caused the engine and transmission to separate from the chassis and the rear crash beam to deform (Figure 10). Bodywork at the rear of the passenger coach was severely damaged leading to the 3 right rear glass panels fracturing. On the left side of the passenger coach, all the glass panels had fractured due to the roll over.

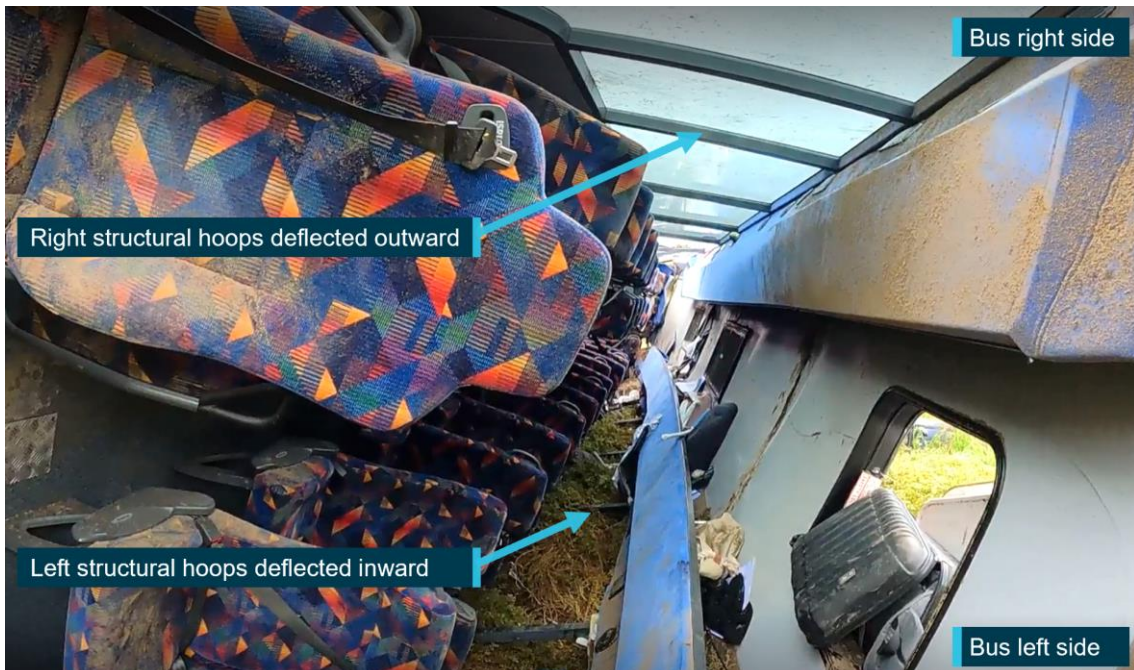
Figure 11: Passenger coach interior damage (view toward the rear of the vehicle)

Although severely damaged from the initial impact and subsequent roll-over on the left side, the passenger coach superstructure, seating and seatbelt anchorages withstood the impact forces (Figure 11). Along with the majority of passengers wearing seatbelts, this is likely to have contributed to limiting the number of serious injuries.

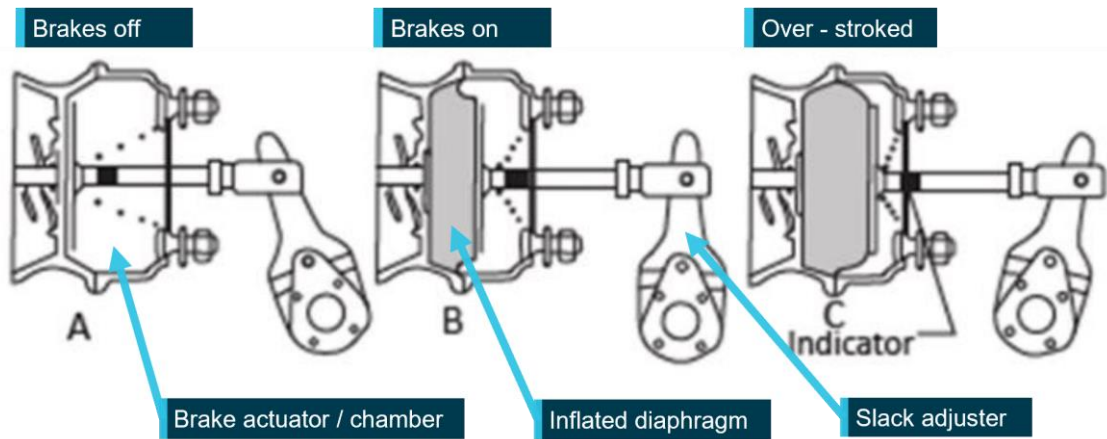
**Figure 15: Brake actuator over-stroke**

The inspection identified that the brakes on both trailers were not adjusted in accordance with the NHVIM and the manufacturer’s maintenance and service bulletins.<sup>20</sup> On applying a brake test pressure of 650 kPa, all but one of the 12 actuators were measured to exceed the maximum stroke specified by the manufacturer. For the one actuator that did not reach maximum stroke, the stroke measured 96% of nominal full stroke. However, for this actuator the slack adjuster was still loose at the 96% stroke position, indicating the actuator had fully stroked without applying significant force to the brake assembly.

Lack of adjustment causes a brake actuator to over-stroke (Figure 15) resulting in a significant reduction in brake performance to a level below the minimum design requirements outlined in the ADR.<sup>21</sup> This can also lead to the park brake not operating as designed.

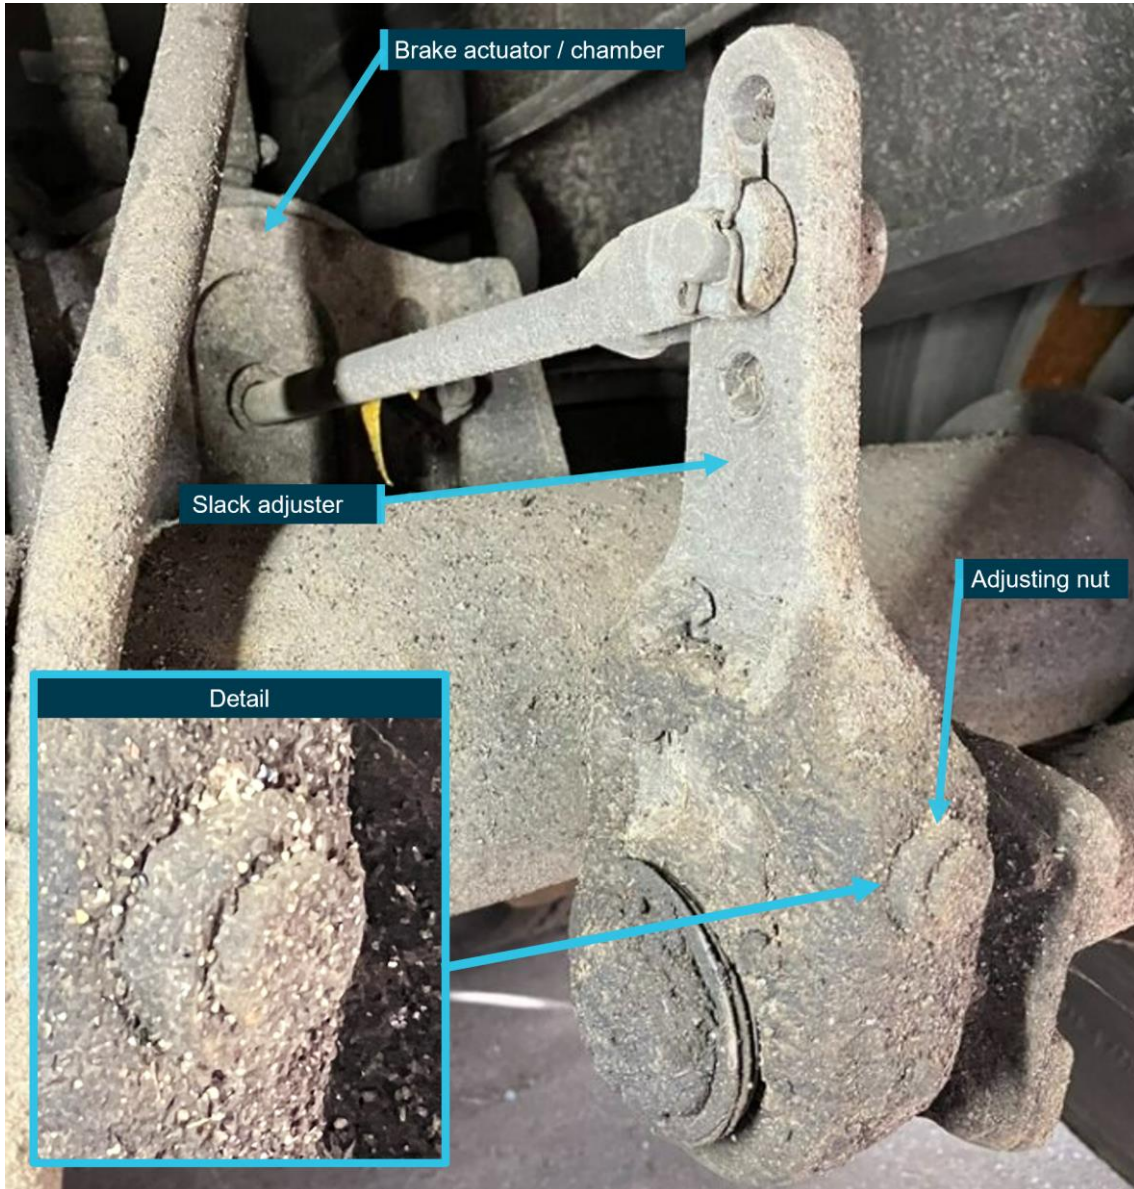
**Figure 16: Brake slack adjuster adjusting nut as inspected**

The inspected condition of the slack adjuster nuts on each axle indicated that they had not been recently adjusted. This suggested that the brakes had been out of adjustment prior to the incident (Figure 16).

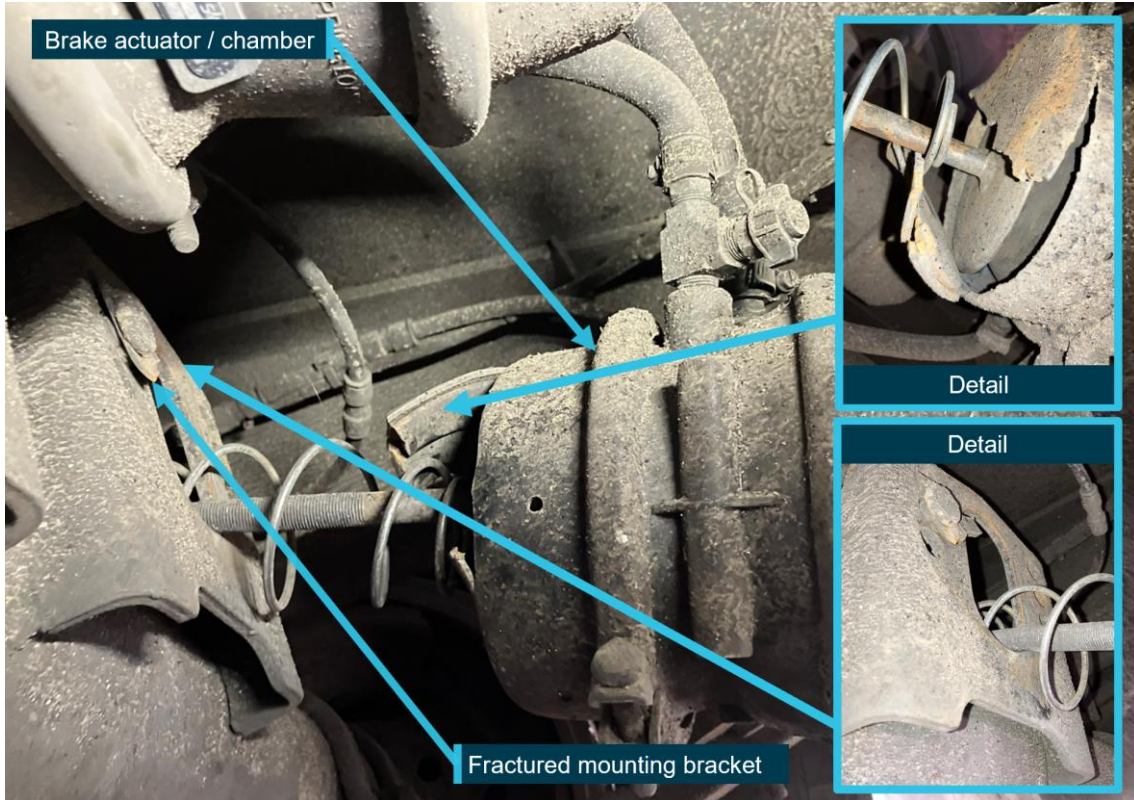
**Figure 17: Brake actuator bracket failure**

The lead trailer brake actuator fitted to the right-hand side of the third axle had broken away from the mounting bracket, reducing the trailer braking performance. Inspection of the bracket fracture surface and the presence of road grime on the piston normally sealed inside the actuator housing indicated that the actuator had probably broken away from the axle prior to the incident (Figure 17).
