Collision of truck with school bus

Exford Road, Exford, Victoria on 16 May 2023

OCI Transport Safety Investigation Report

BUS/23-809

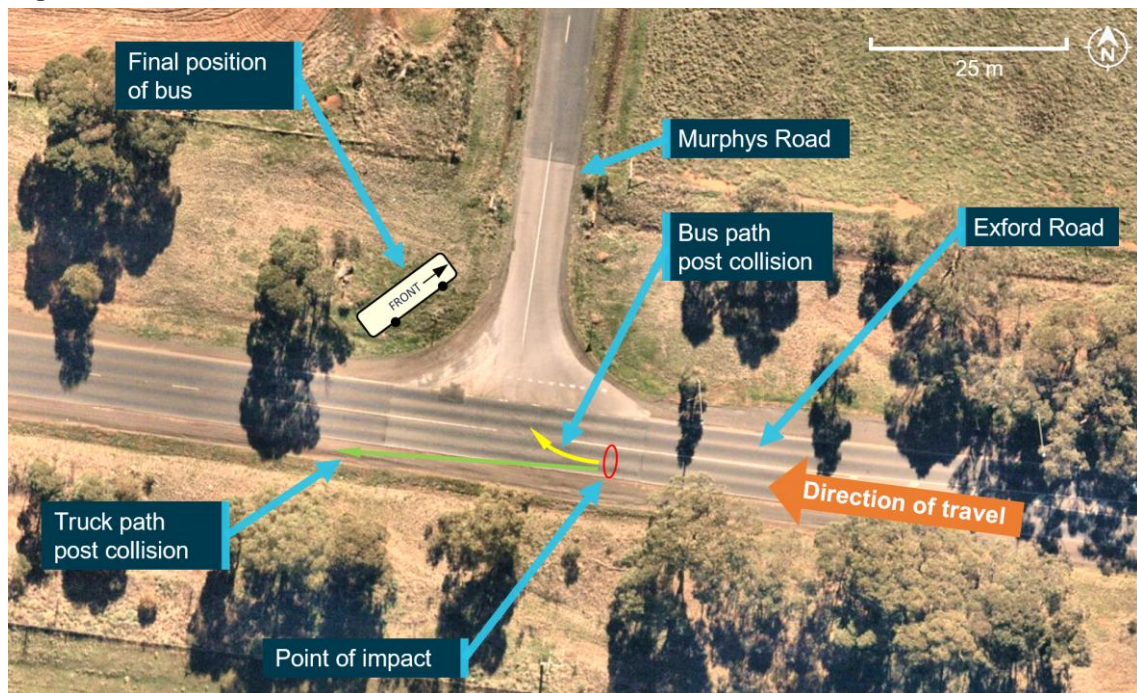
Figure 2: Collision location

At that point, the bus had commenced crossing the opposing lane, with its rear quarter section still in the west bound lane. With the truck brakes applied, it skidded for about 26 m before striking the rear of the bus causing it to yaw in a clockwise direction. The bus then rolled onto its left side and slid across the road surface onto a grass bank northwest of the intersection (Figure 2).

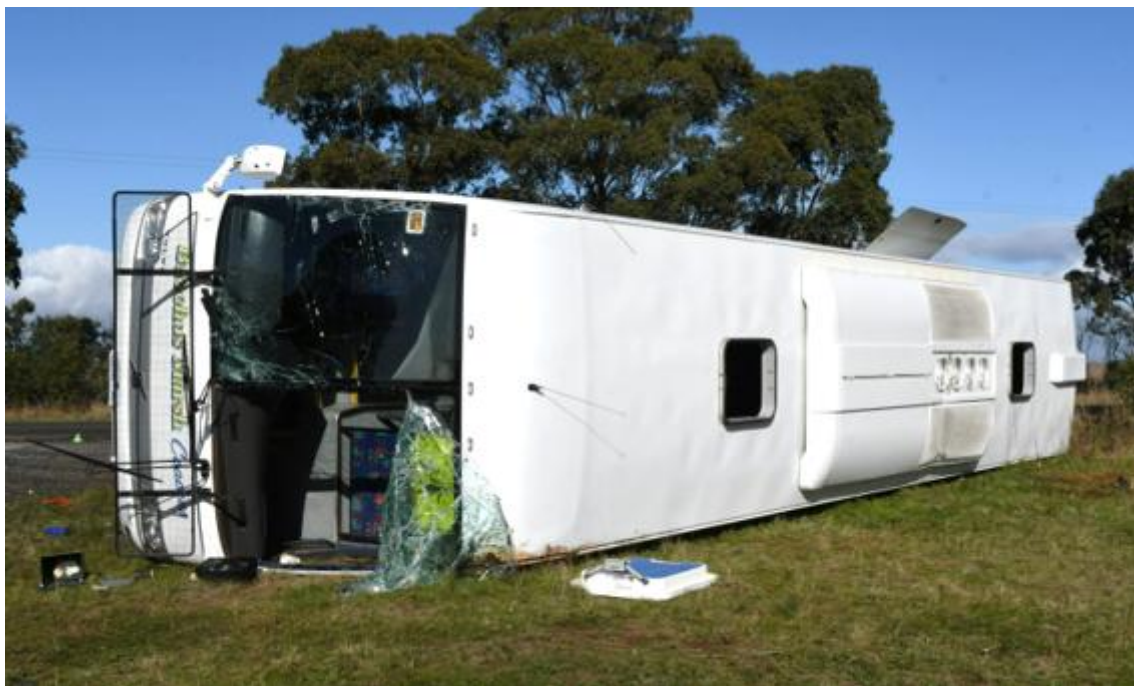
Figure 3: Bus final resting position

The bus sustained substantial impact damage to its rear engine bay with minor structural deformity as a result of rolling over. The left (near) side windscreen and all left side glazing had shattered due to impact with the road surface. The passengers were evacuated through either the

front windscreen, which was peeled back during the rescue, or through the two roof hatches (Figure 3).

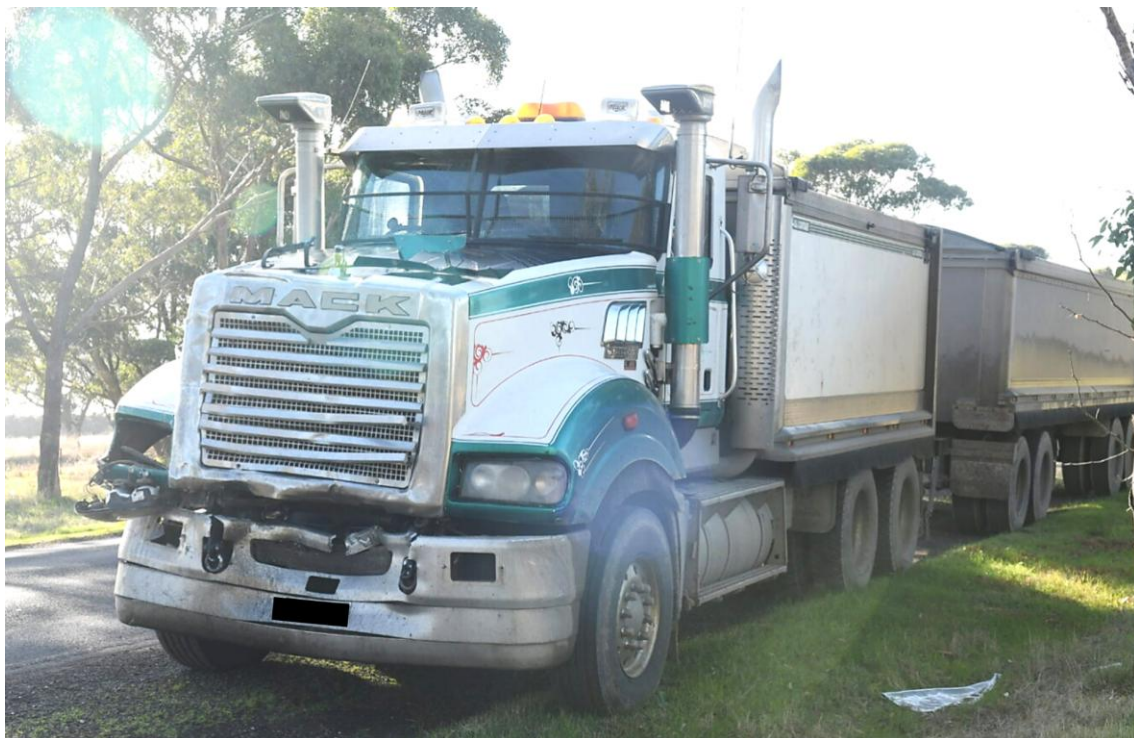
Figure 4: Truck and trailer front view

The truck suffered impact damage to its front bonnet grill and bumper (Figure 4).

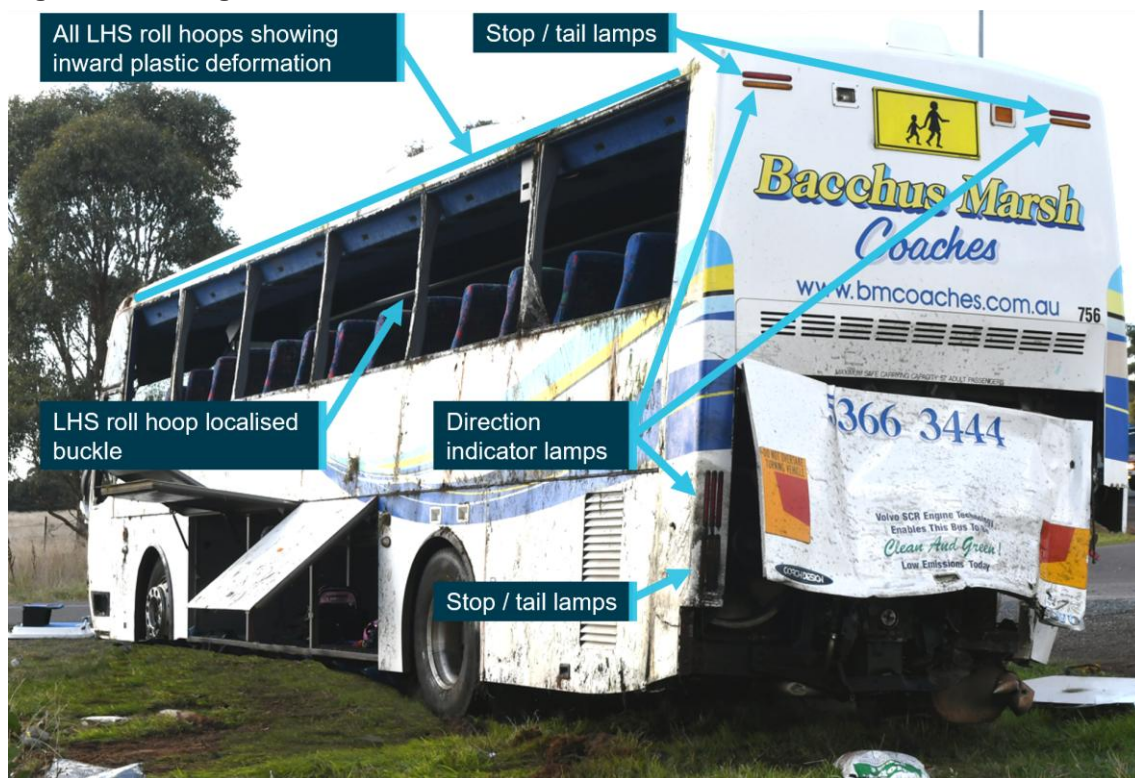
Figure 11: Damage to left side and rear of bus

The rollover led to plastic deformation of the bus structural roll hoops although with minimal intrusion into the passenger space. All glazing panels on the left side of the bus had fractured and separated from the bus frame due to contact with the road surface on rollover (Figure 11).

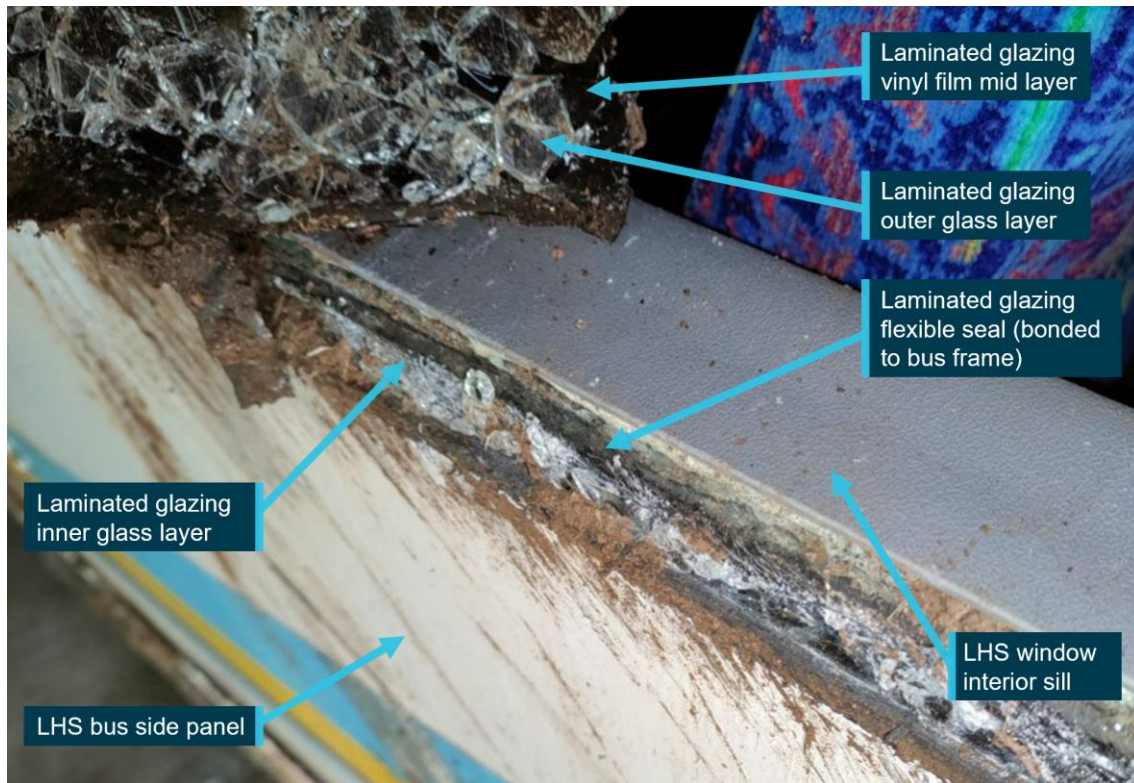
Figure 12: Side glazing fracture surfaces on the left side of the bus

Inspection of the laminated side glazing remnants on the LHS of the bus indicated that the glazing had sheered from the flexible bonding strips once the inner layer of glass had fractured (Figure 12). There was no requirement in the current Australian Design Rules to ensure glazing remained intact in a bus roll-over type incident.

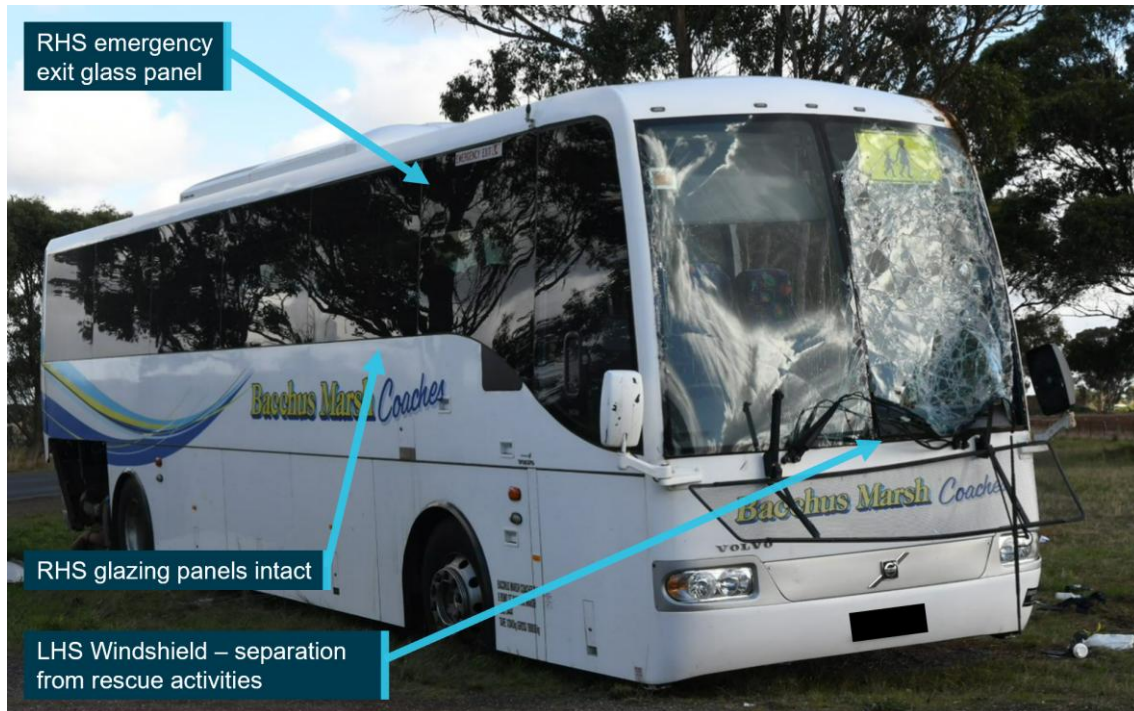
Figure 13: Undamaged right side of bus

All glazing panels on the right side of the bus remained intact. The windscreen glazing on both sides had fractured and the left side windscreen bonding was separated from the frame as a result of passenger rescue (Figure 13).

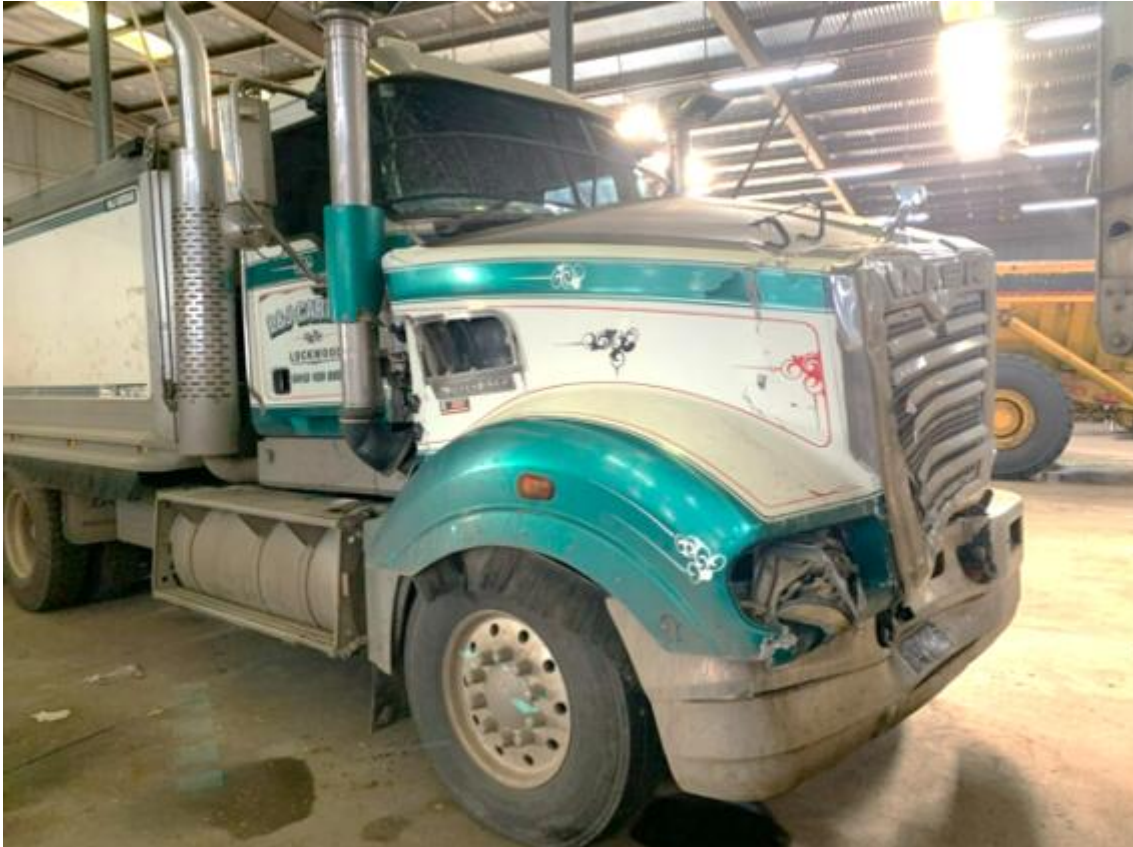
Figure 16: Mack tipper truck frontal damage

Damage sustained by the truck was consistent with a heavy frontal impact. The impact had deformed the front bumper had pushed the bonnet structure rearward impacting the driver side windscreen (Figure 16).

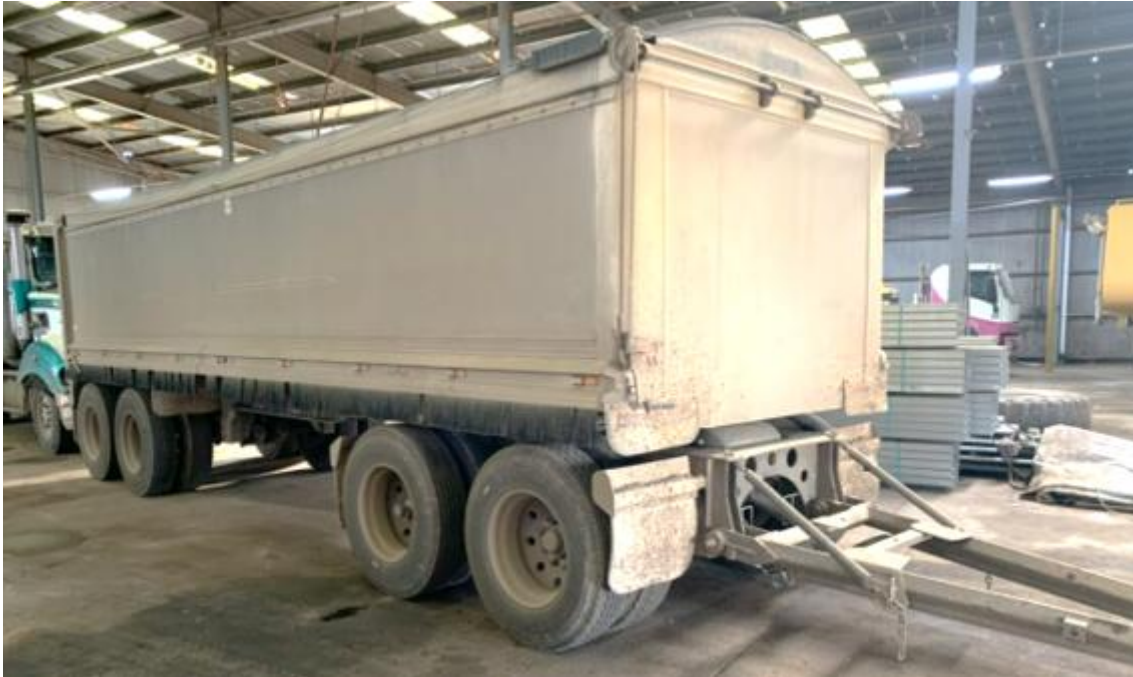
Figure 17: Maxitrans 4-axle dog trailer

There was no visible damage to the trailer as a result of the collision.

The brake system on the trailer consisted of air activated drum brakes with standard actuators / chambers on the front axle and spring brake actuators / chambers on the rear axles. The slack adjusters fitted on all axles were linked-type automatic adjusting units. The brake linings on each of the drum units had sufficient friction material. The front axle left side brake lining retaining spring had dislodged rendering the brakes on this wheelset inoperative. An air leak was also reported from the regulator at the air reservoir tanks.

A visual inspection of the tow hitch coupling, suspension and tyre systems did not identify any pre-accident defects.
