Reaction to fire test report

Test standard: Ad-hoc test based off ISO 13785-1:2002

System: A cassetted aluminium composite panel wall system

Job number: RTF230139

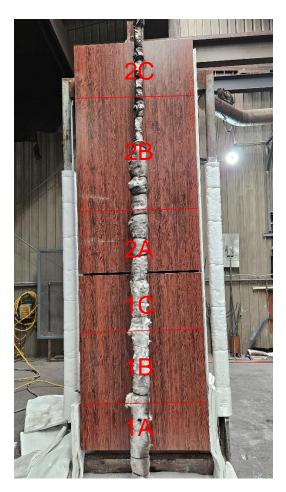
Figure 8 Designation for test specimen observations.

Table 4		Test observations	
Time		Section	Observation
Min	Sec		
-2	00	All	Data collection started.
0	00	All	The reaction to fire test was started with the burner ignited with a heat output set at 100 kW.
1	00	1A	The skin at the bottom edge was becoming discoloured.
1	20	1A	Smoke was emitted from the sides of the specimen.
3	15	1A	Flaming debris was dripping from the bottom right corner.
4	00	1A	Flaming debris was dripping from the bottom right corner of the specimen and continued flaming for longer than 20 seconds.
4	20	1A/1B	Discolouration of the panel skin reached 1B.
4	40	1A	Flaming debris was dripping from the bottom left corner.
6	03	1A/1B	Flames were present climbing vertically along both edges of the specimen.
8	52	1B/1C	Flames were present climbing vertically along the right edge of the specimen and intermittently reached the panel join.
11	57	1C/2A	Intermittent flaming was present in the panel join.

15	00	All	The burner output was increased to 300 kW.
15	50	1A	The panel skin was peeling off.
16	19	1C/2A	Flames at both sides of the specimen sustained a height above the panel join.
16	30	1A	The panel was deforming.
16	55	1B	The panel skin was peeling off at the right side.
17	15	1C	Discolouration of the panel skin.
18	20	1B	The panel was deforming.
18	37	1B	The panel skin was peeling off at the left side.
18	34	1C/2A	Independent flaming of the panel join was sustained.
32	25	2A	Gas was released from the bottom of the upper panel, causing deformation predominantly at the bottom left corner of the upper panel.
40	00	All	The burner was switched off.
40	32	2C	Gas was released from the top of the upper panel, initiating flaming of the top of the specimen on the left side.
42	26	2C	Flaming at the head had ceased.
47	09	1A/1B/1C/ 2A	Flaming at the right side of the lower panel ceased. Flaming at the right side of the panel join and inside the lower panel continued.

48	53	1C/2A	Both sides of the panel join were flaming.
52	46	1A/1B	The flaming inside the lower panel had formed an opening on the right side of the lower panel, and flaming was intermittently exiting the hole.
57	40	1A	A black plasticky substance was dripping from the bottom right side of the specimen, at the back.
60	00	All	The reaction to fire test ended.

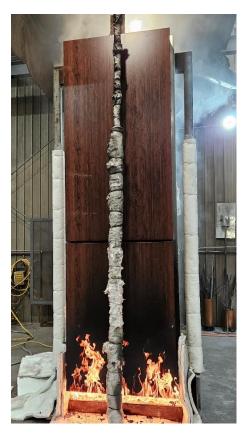
Figure 15 The specimen 12 minutes 56 seconds into the test (burner output at 100 kW)

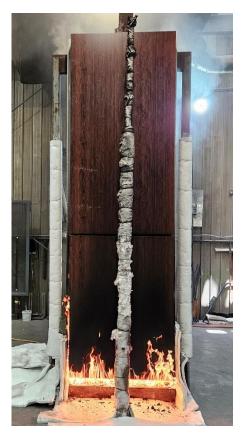
Figure 16 The specimen 14 minutes 59 seconds into the test (burner output at 100 kW)

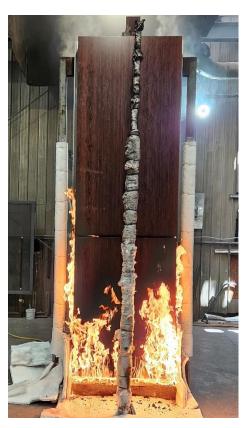
The specimen 15 minutes 30 seconds into the test (30 seconds after burner output was changed to 300 kW) $\,$ Figure 17

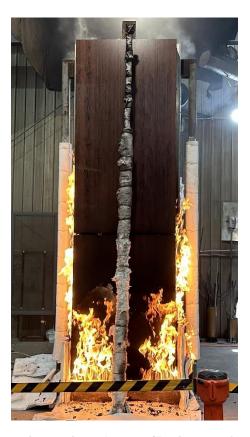
Figure 18 The specimen 20 minutes into the test (5 minutes after burner output was changed to 300 kW)

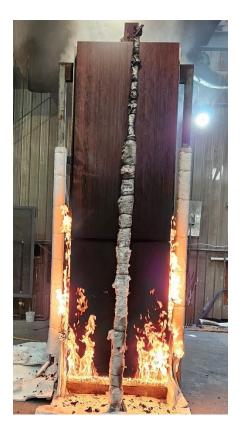
Figure 19 The specimen 33 minutes into the test (8 minutes after burner output was changed to 300 kW)

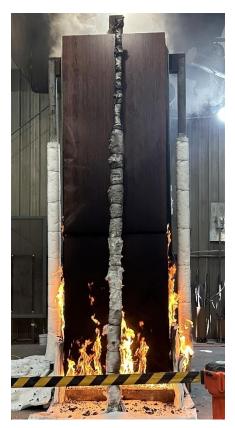
Figure 20 The specimen 39 minutes 42 seconds into the test (24 minutes 42 seconds after burner output was changed to 300 kW)

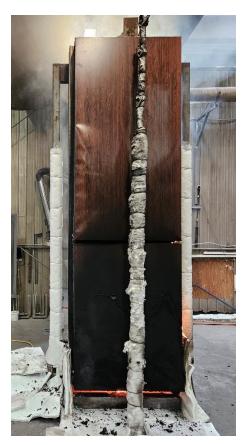
Figure 21 The specimen 41 minutes 50 seconds into the test (1 minute 50 seconds after burner was switched off)

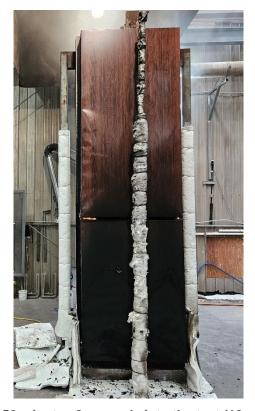
Figure 22 The specimen 50 minutes 3 seconds into the test (10 minutes 3 seconds after burner was switched off)

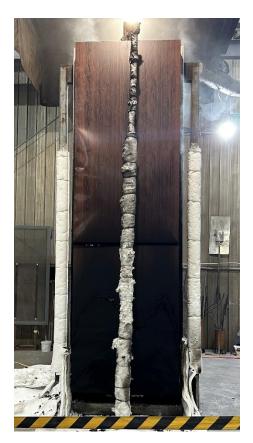
Figure 23 The specimen at the end of the test

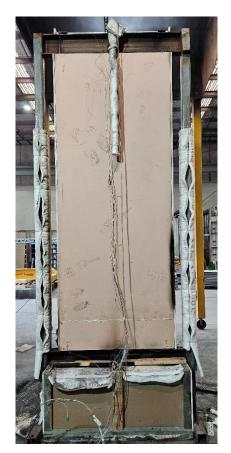
Figure 24 The specimen after the test – unexposed side.
