Reaction to fire test report

Test standard: Ad-hoc test based off ISO 13785-1:2002

Test sponsor: Cladding Safety Victoria (CSV)

System: A cassetted aluminium composite panel wall system

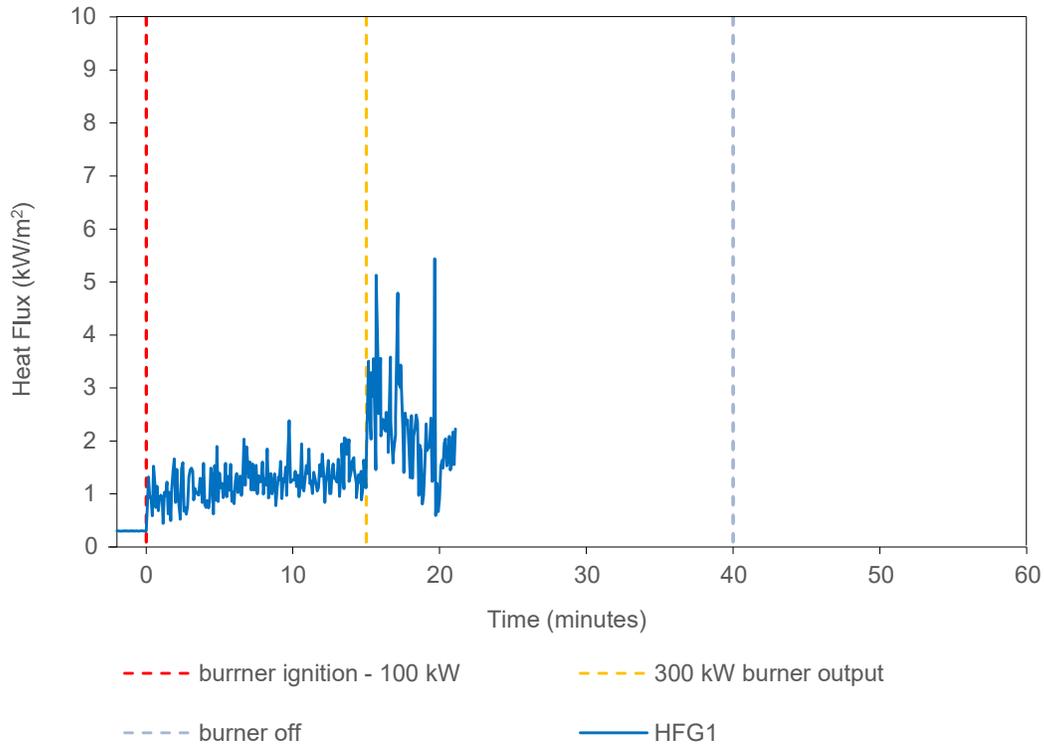
Figure 4 Heat flux data collected by heat flux gauge.

Note: At 21 minutes 7 seconds, the water cooling pipe became disconnected from the heat flux gauge.

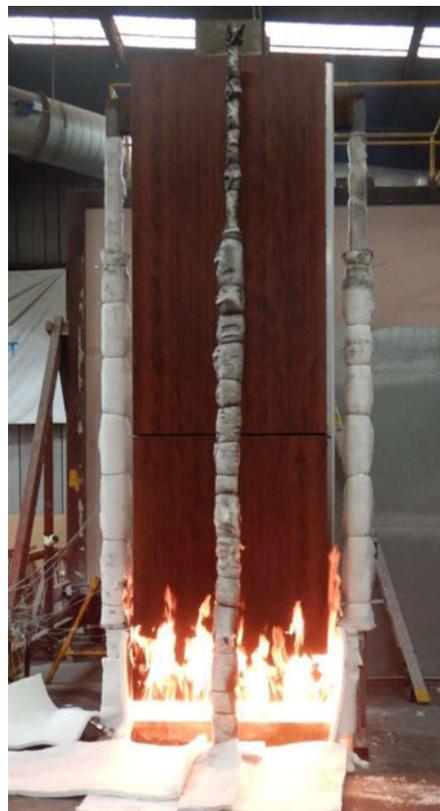
Figure 13 The specimen 2 minutes 44 seconds into the test (burner output at 100 kW)

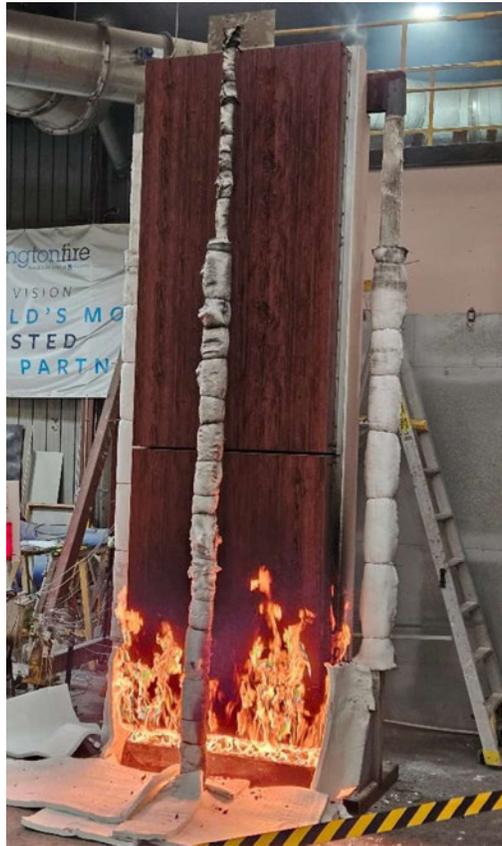
Figure 14 The specimen 8 minutes 35 seconds into the test (burner output at 100 kW)

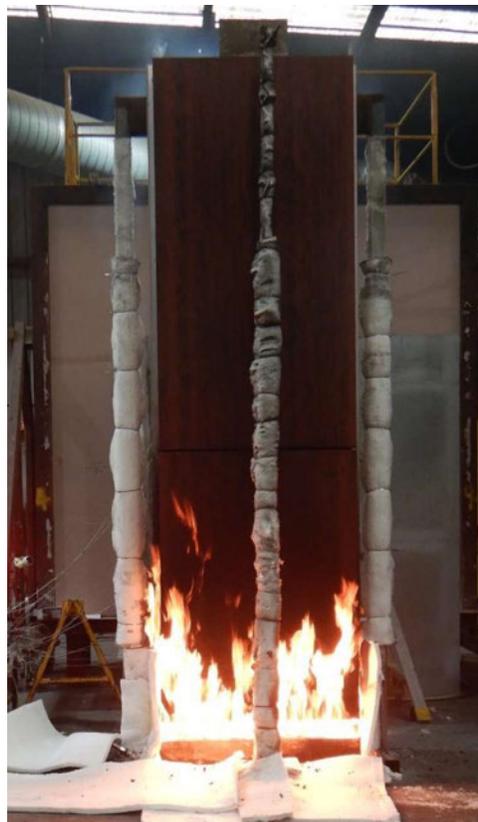
Figure 15 The specimen 14 minutes 55 seconds into the test (burner output at 100 kW)

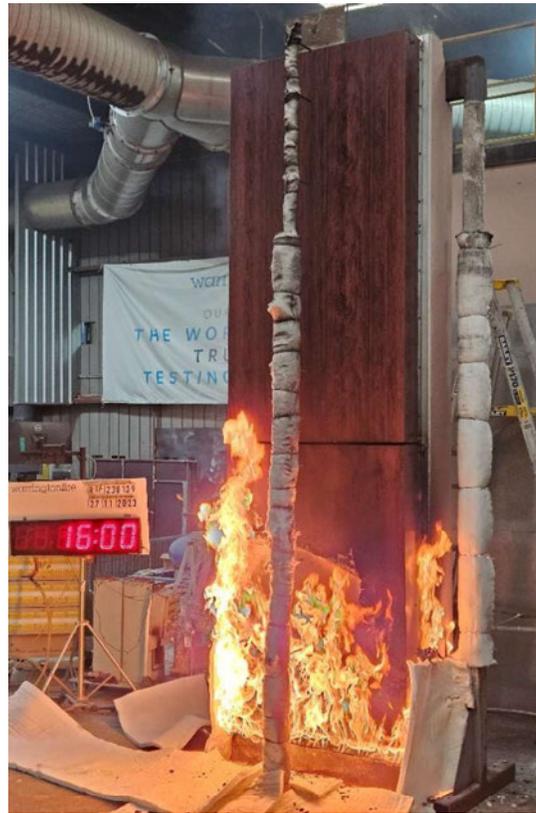
Figure 16 The specimen 16 minutes into the test (1 minute after burner output was changed to 300 kW)

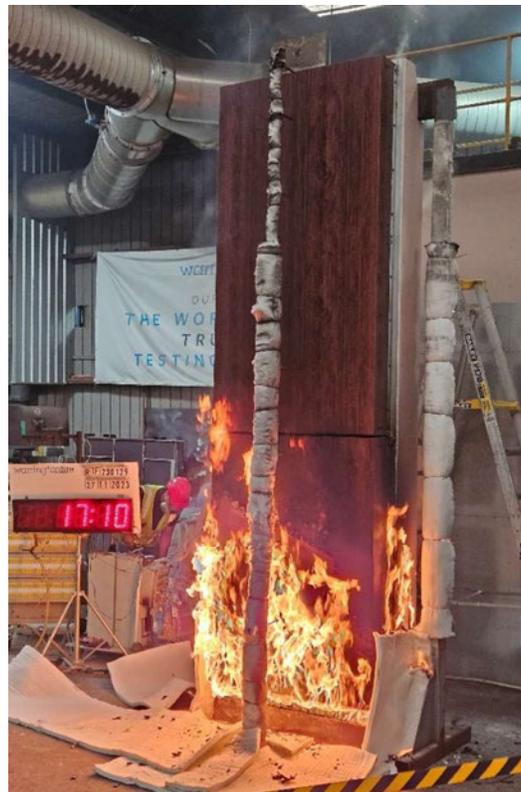
Figure 17 The specimen 17 minutes 10 seconds into the test (2 minutes 10 seconds after burner output was changed to 300 kW)

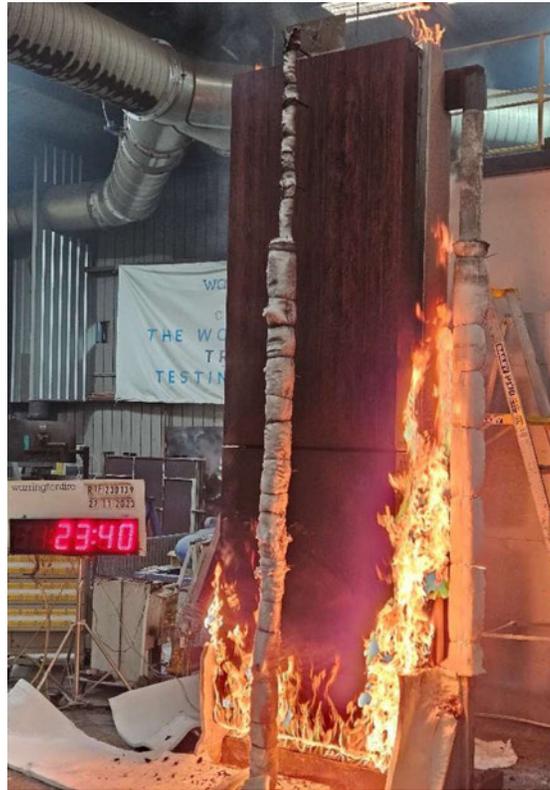
Figure 18 The specimen 23 minutes 40 seconds into the test (8 minutes 40 seconds after burner output was changed to 300 kW)

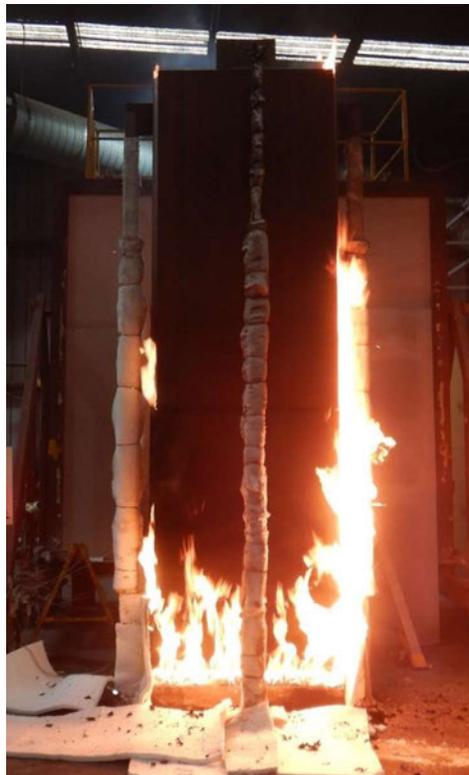
Figure 19 The specimen 29 minutes 50 seconds into the test (14 minutes 50 seconds after burner output was changed to 300 kW)

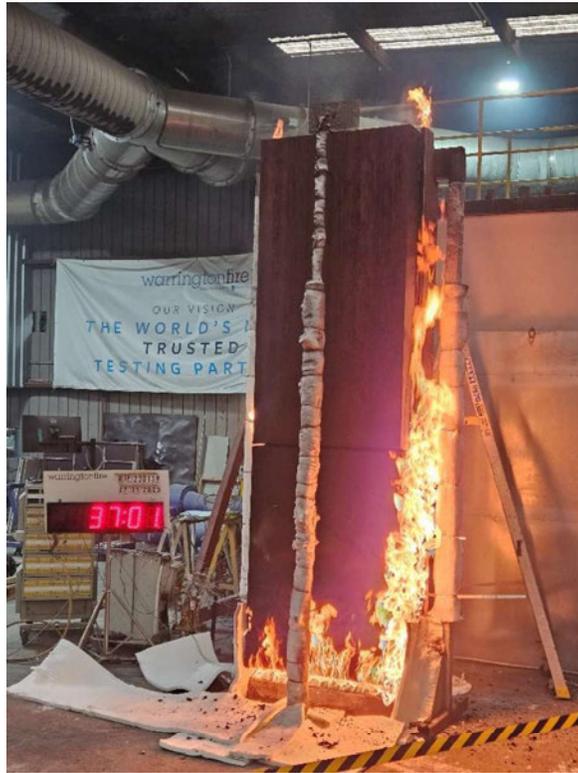
Figure 20 The specimen 37 minutes 1 second into the test (22 minutes 1 second after burner output was changed to 300 kW)

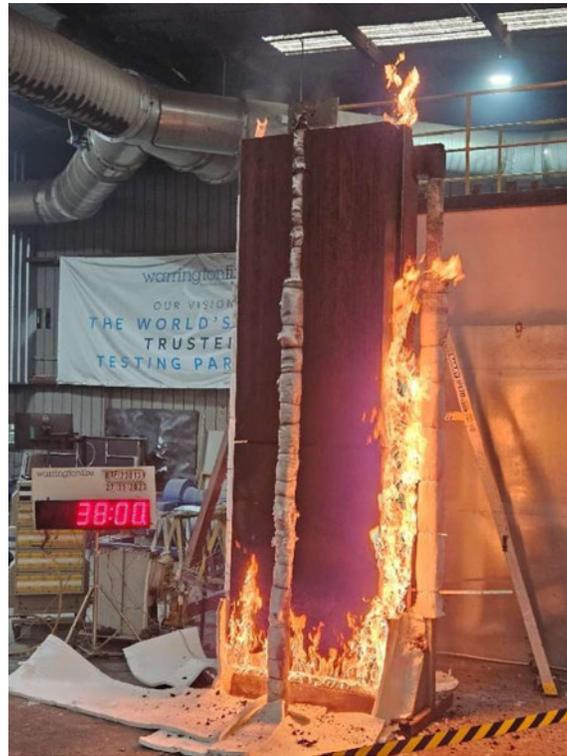
Figure 21 The specimen 38 minutes into the test (23 minutes after burner output was changed to 300 kW)

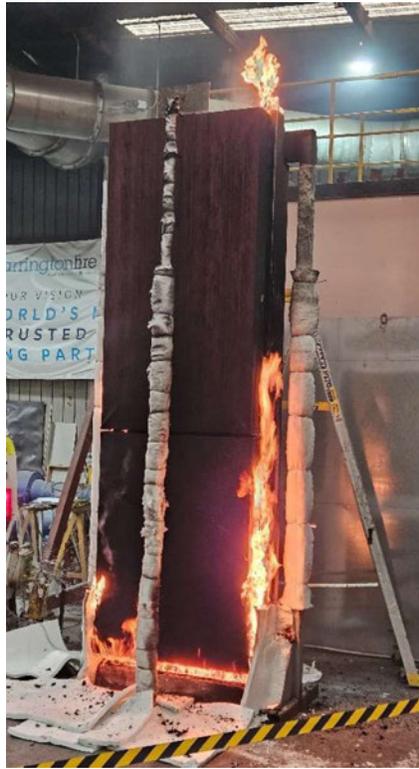
Figure 22 The specimen 40 minutes 30 seconds into the test (30 seconds after burner was switched off)

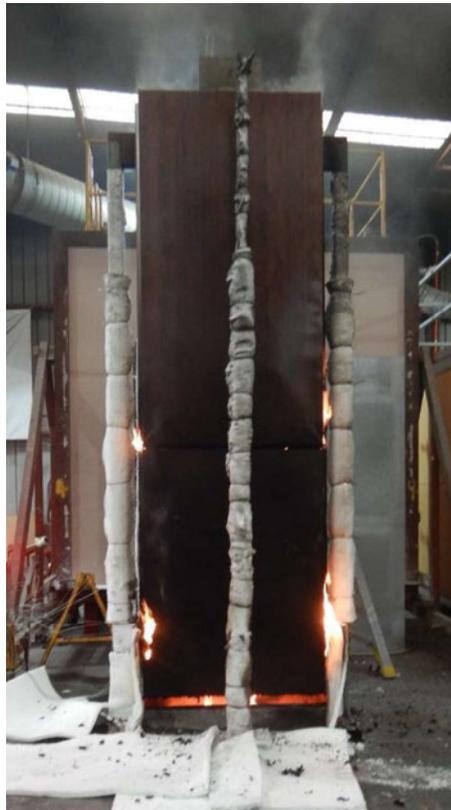
Figure 23 The specimen 42 minutes 25 seconds into the test (2 minutes 25 seconds after burner was switched off)

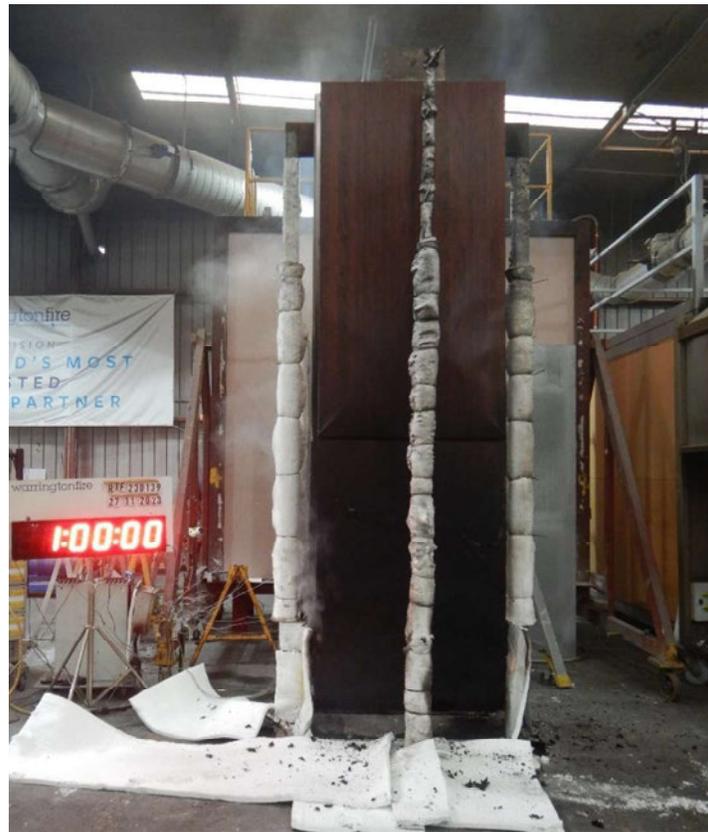
Figure 24 The specimen at the end of the test

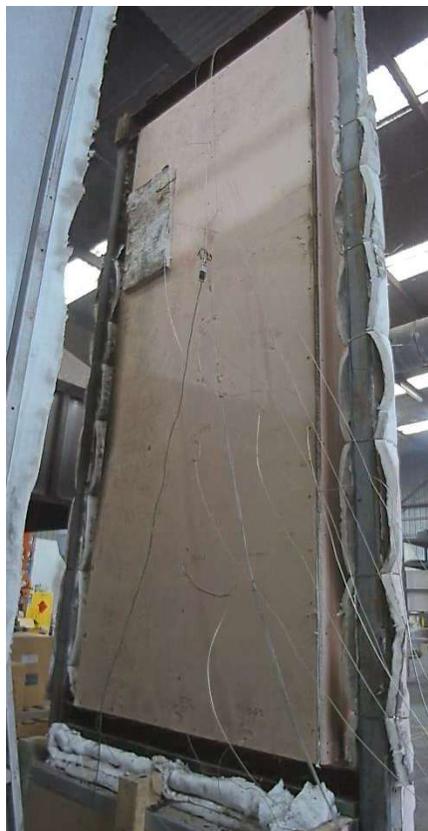
Figure 25 The specimen after the test – unexposed side
